## **GEOTECHNICAL INVESTIGATION:**

### **New Boatshed at 1772 Pittwater Road, Bayview**

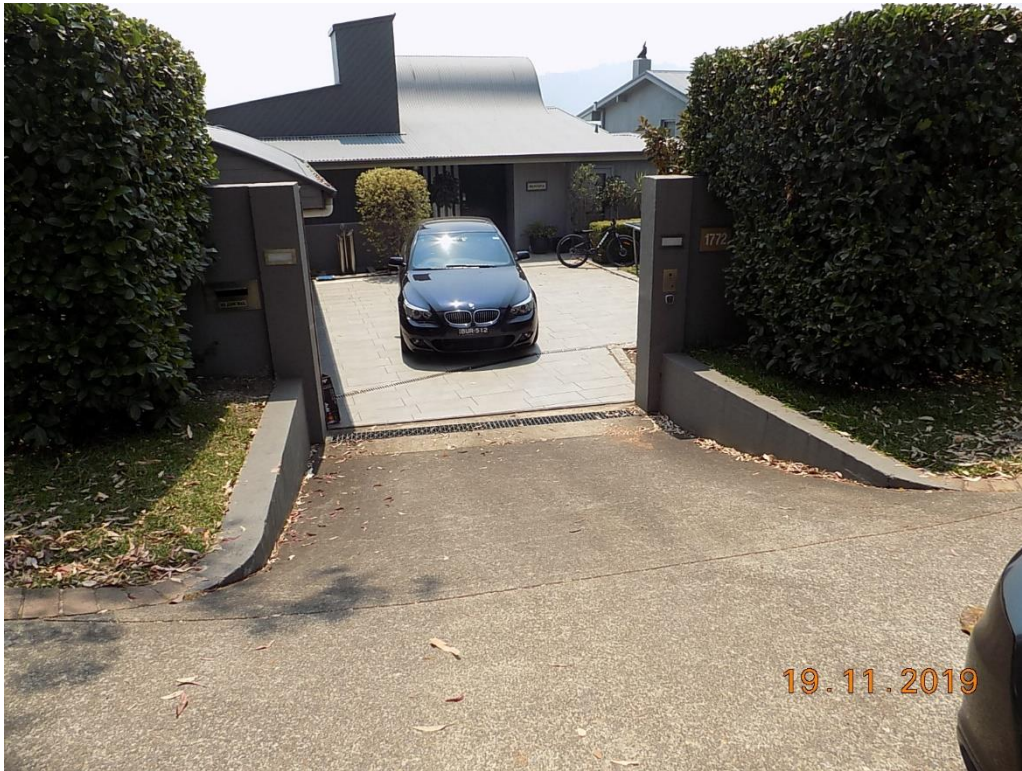
Photo 1

- 2.3** At the road frontage, a concrete driveway runs to a suspended parking platform and lawn area on the uphill side of the property (Photo 1). The platform is supported by steel posts over the old brick driveway (Photo 2). The cut for this sub-floor area is supported by a ~2.0m high stable concrete retaining wall (Photo 3). The part three-storey brick house will be demolished as part of a separate approved application (Photo 4). The cut for the house is supported by a ~5.3m high rendered masonry retaining wall that lines the NW common boundary (Photo 5). A gently sloping lawn-covered fill extends off the downhill side of the house. The fill is supported by a ~1.0m high stack rock retaining wall that will be demolished as part of a separate approved application (Photo 6). To the SE of the fill is a pool that will also

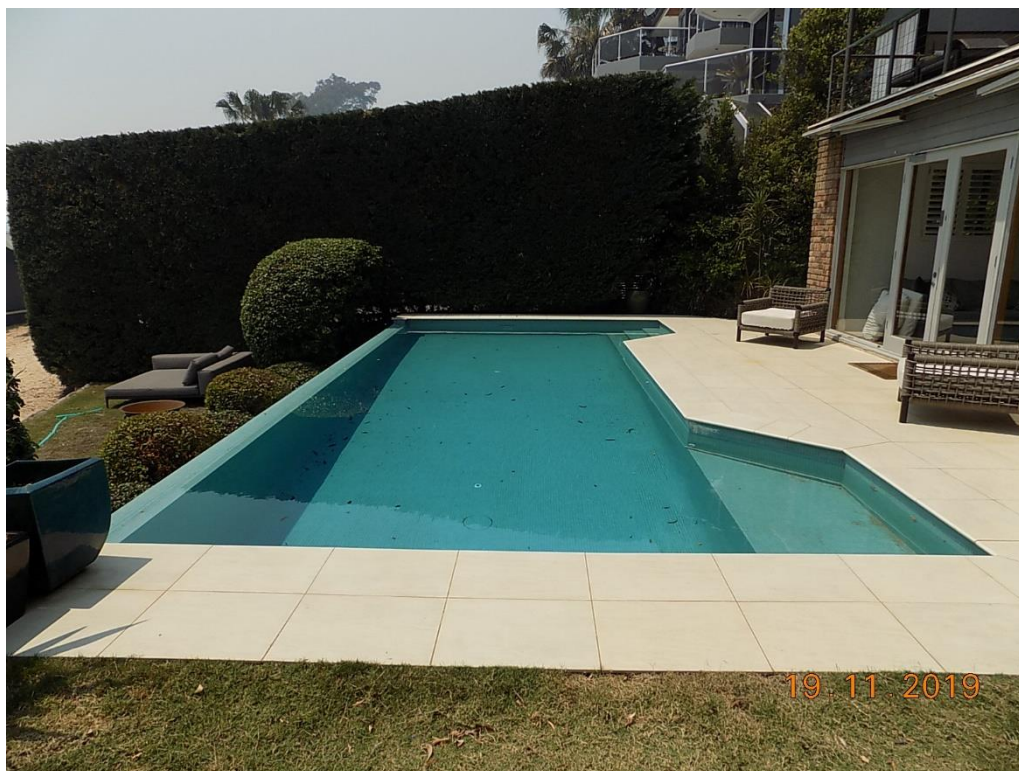
Photo 7

be demolished as part of a separate approved application (Photo 7). Below the fill and the pool, a gently sloping lawn falls to a beach at the waterfront (Photo 8).

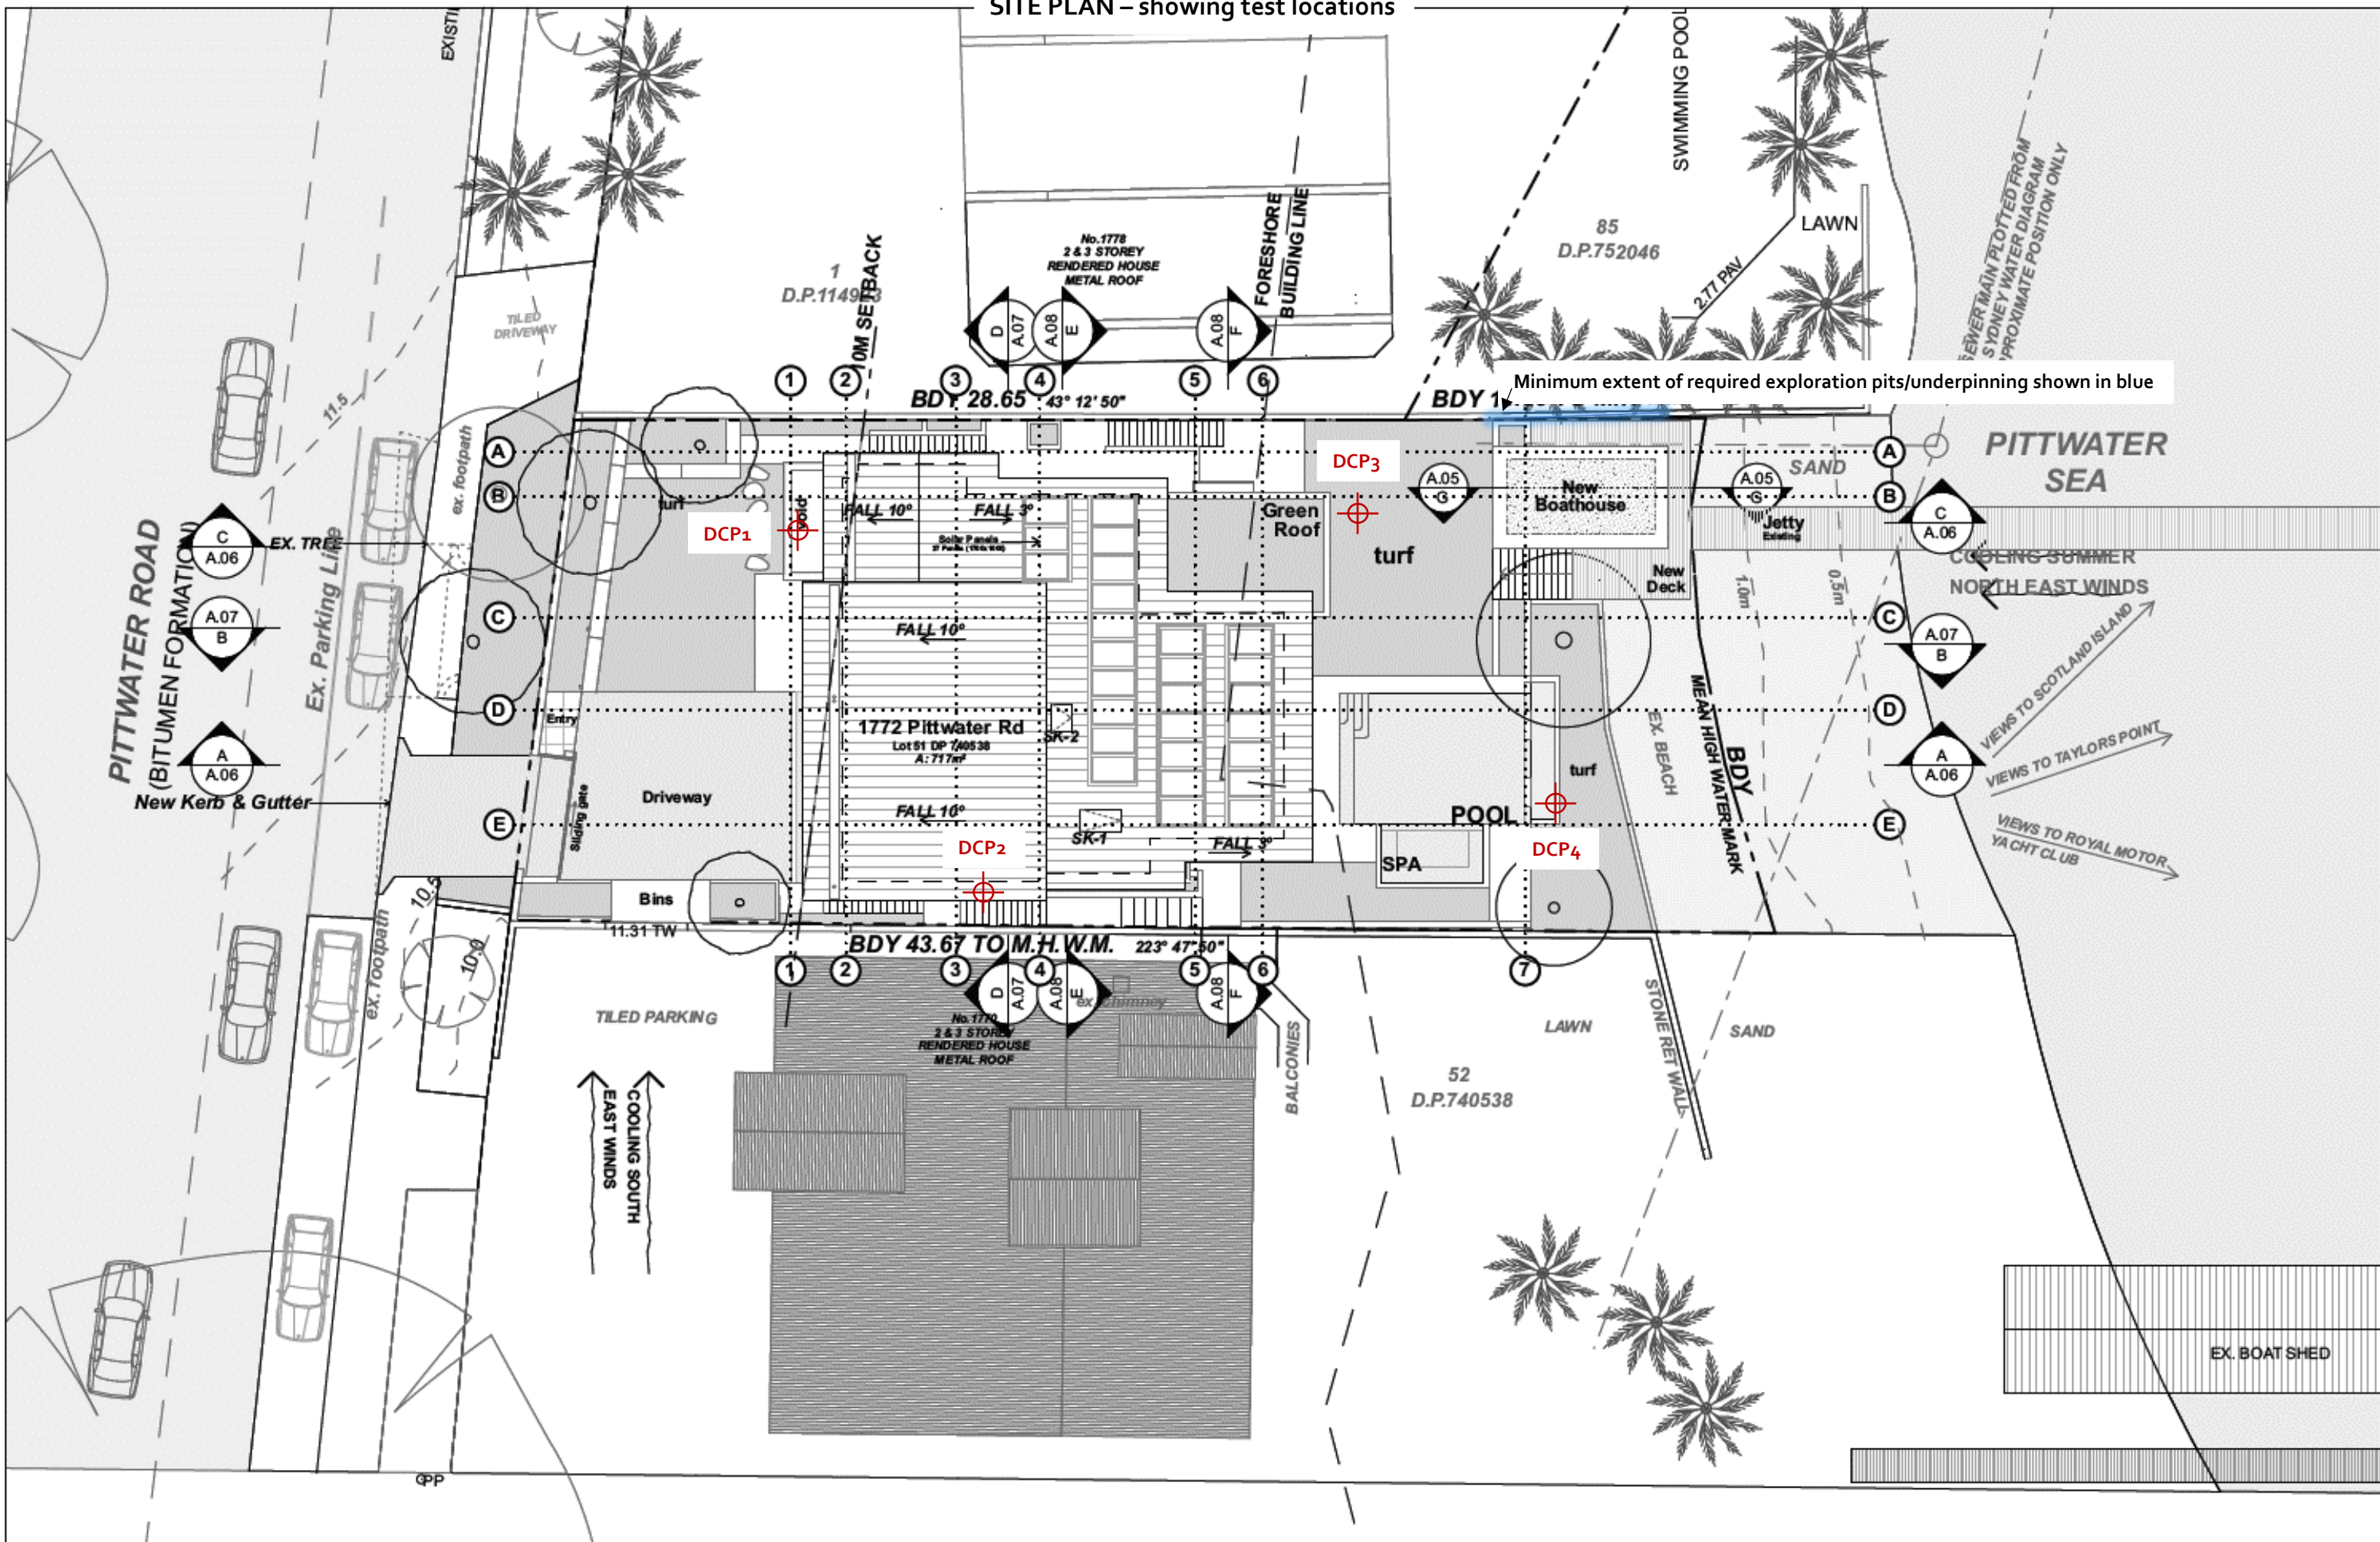
# SITE PLAN – showing test locations

Four Dynamic Cone Penetrometer (DCP) tests were put down to determine the relative density of the overlying soil and the depth to weathered rock. The locations of the tests are shown on the site plan attached. It should be noted that a level of caution should be applied when interpreting DCP test results. The test will not pass through hard buried objects so in some instances it can be difficult to determine whether refusal has occurred on an obstruction in the profile or on the natural rock surface. This is not expected to be an issue for the testing on this site. However, excavation and foundation budgets should always allow for the possibility that the interpreted ground conditions in this report vary from those encountered during excavations. See the appended "Important information about your report" for a more comprehensive explanation. The results are as follows:

commencing. The owner/s of the NW neighbouring property will need to give their permission to carry out the underpinning works. If permission cannot be granted, our office is to be contacted to provide an alternative means of support. See the site plan attached showing the minimum extent of the required exploration pits/underpinning works.

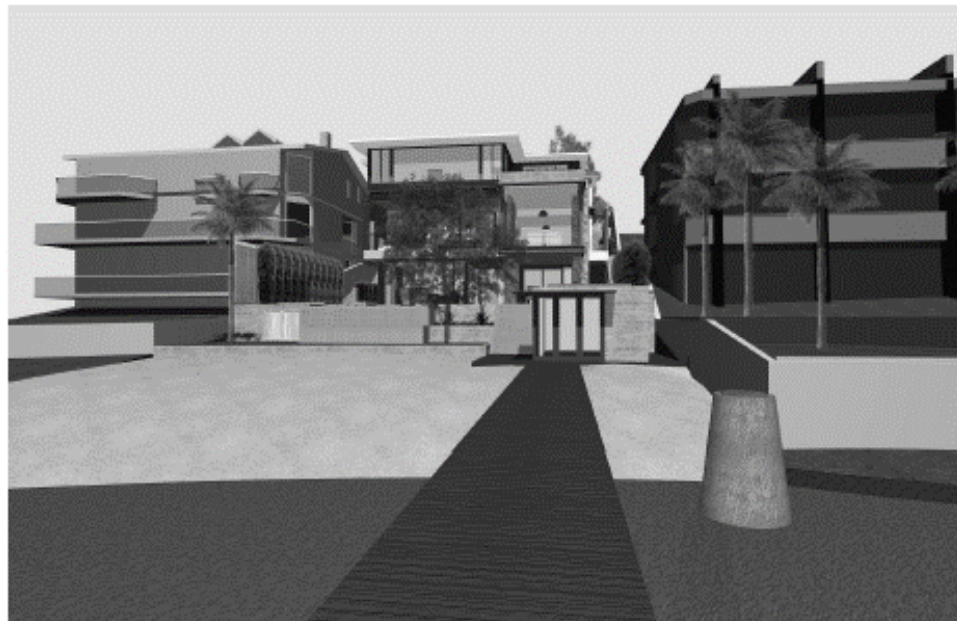
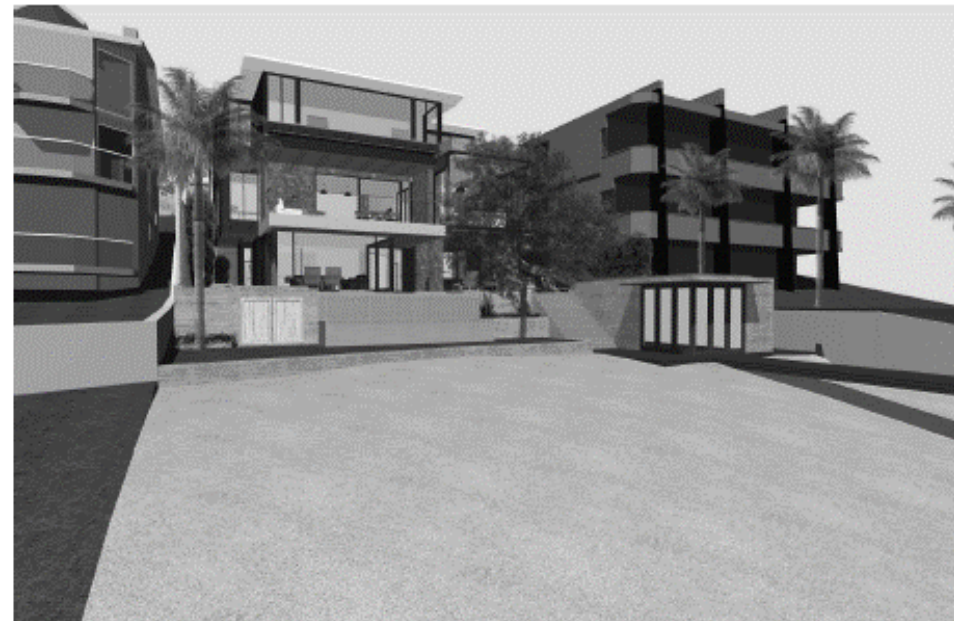
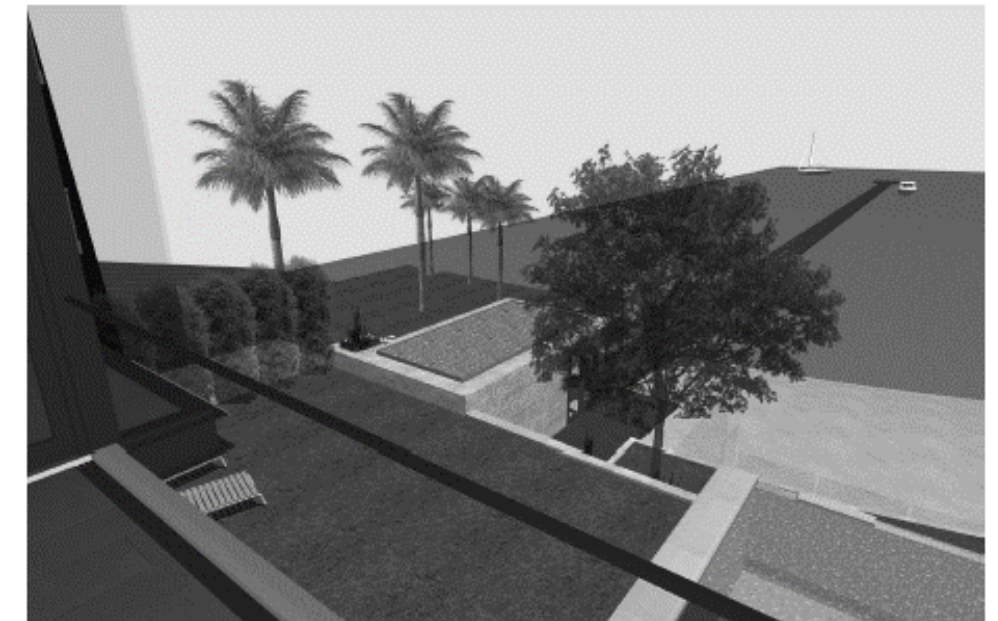
## SECTION G

existing excavations on site as the soil material has already been removed and due to the underlying weathered rock being buried by sandy sediments closer to the waterfront. The weathered zone is interpreted to be Extremely Low Strength Shale. The sandy sediments at the waterfront consist of Loose to Medium Dense Sand. See Type Section attached for a diagrammatical representation of the expected ground materials.
