GEOTECHNICAL INVESTIGATION:

New Pool and Decks at 135 Seaforth Crescent, Seaforth

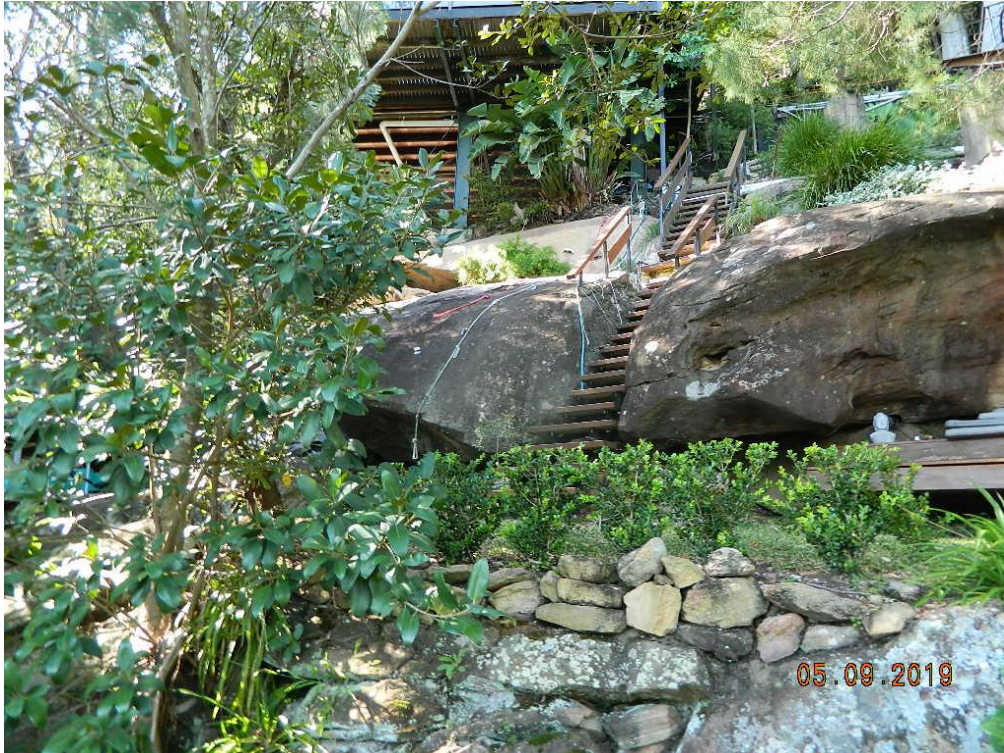
Photo 5

- 2.3** At the road frontage, a concrete driveway runs to a suspended carport on the uphill side of the property (Photo 1). A timber and steel stair case runs downslope from the carport to the house (Photo 2). Outcropping sandstone was observed across the entire site. The three storey timber framed and clad house continues downslope. The house is partially suspended and is supported by steel beams and concrete footings on sandstone (Photo 3). All visible footings showed no signs of movement and are considered stable. An inclined lift runs along the S boundary and rough sandstone block set of stairs along the E side of the property (Photo 4). A $\sim 3.0\text{m}$ high sloped and jointed sandstone rock face extends downslope of the house (Photo 5). The rock face is considered stable. The footprint of the suspended pool will fall over

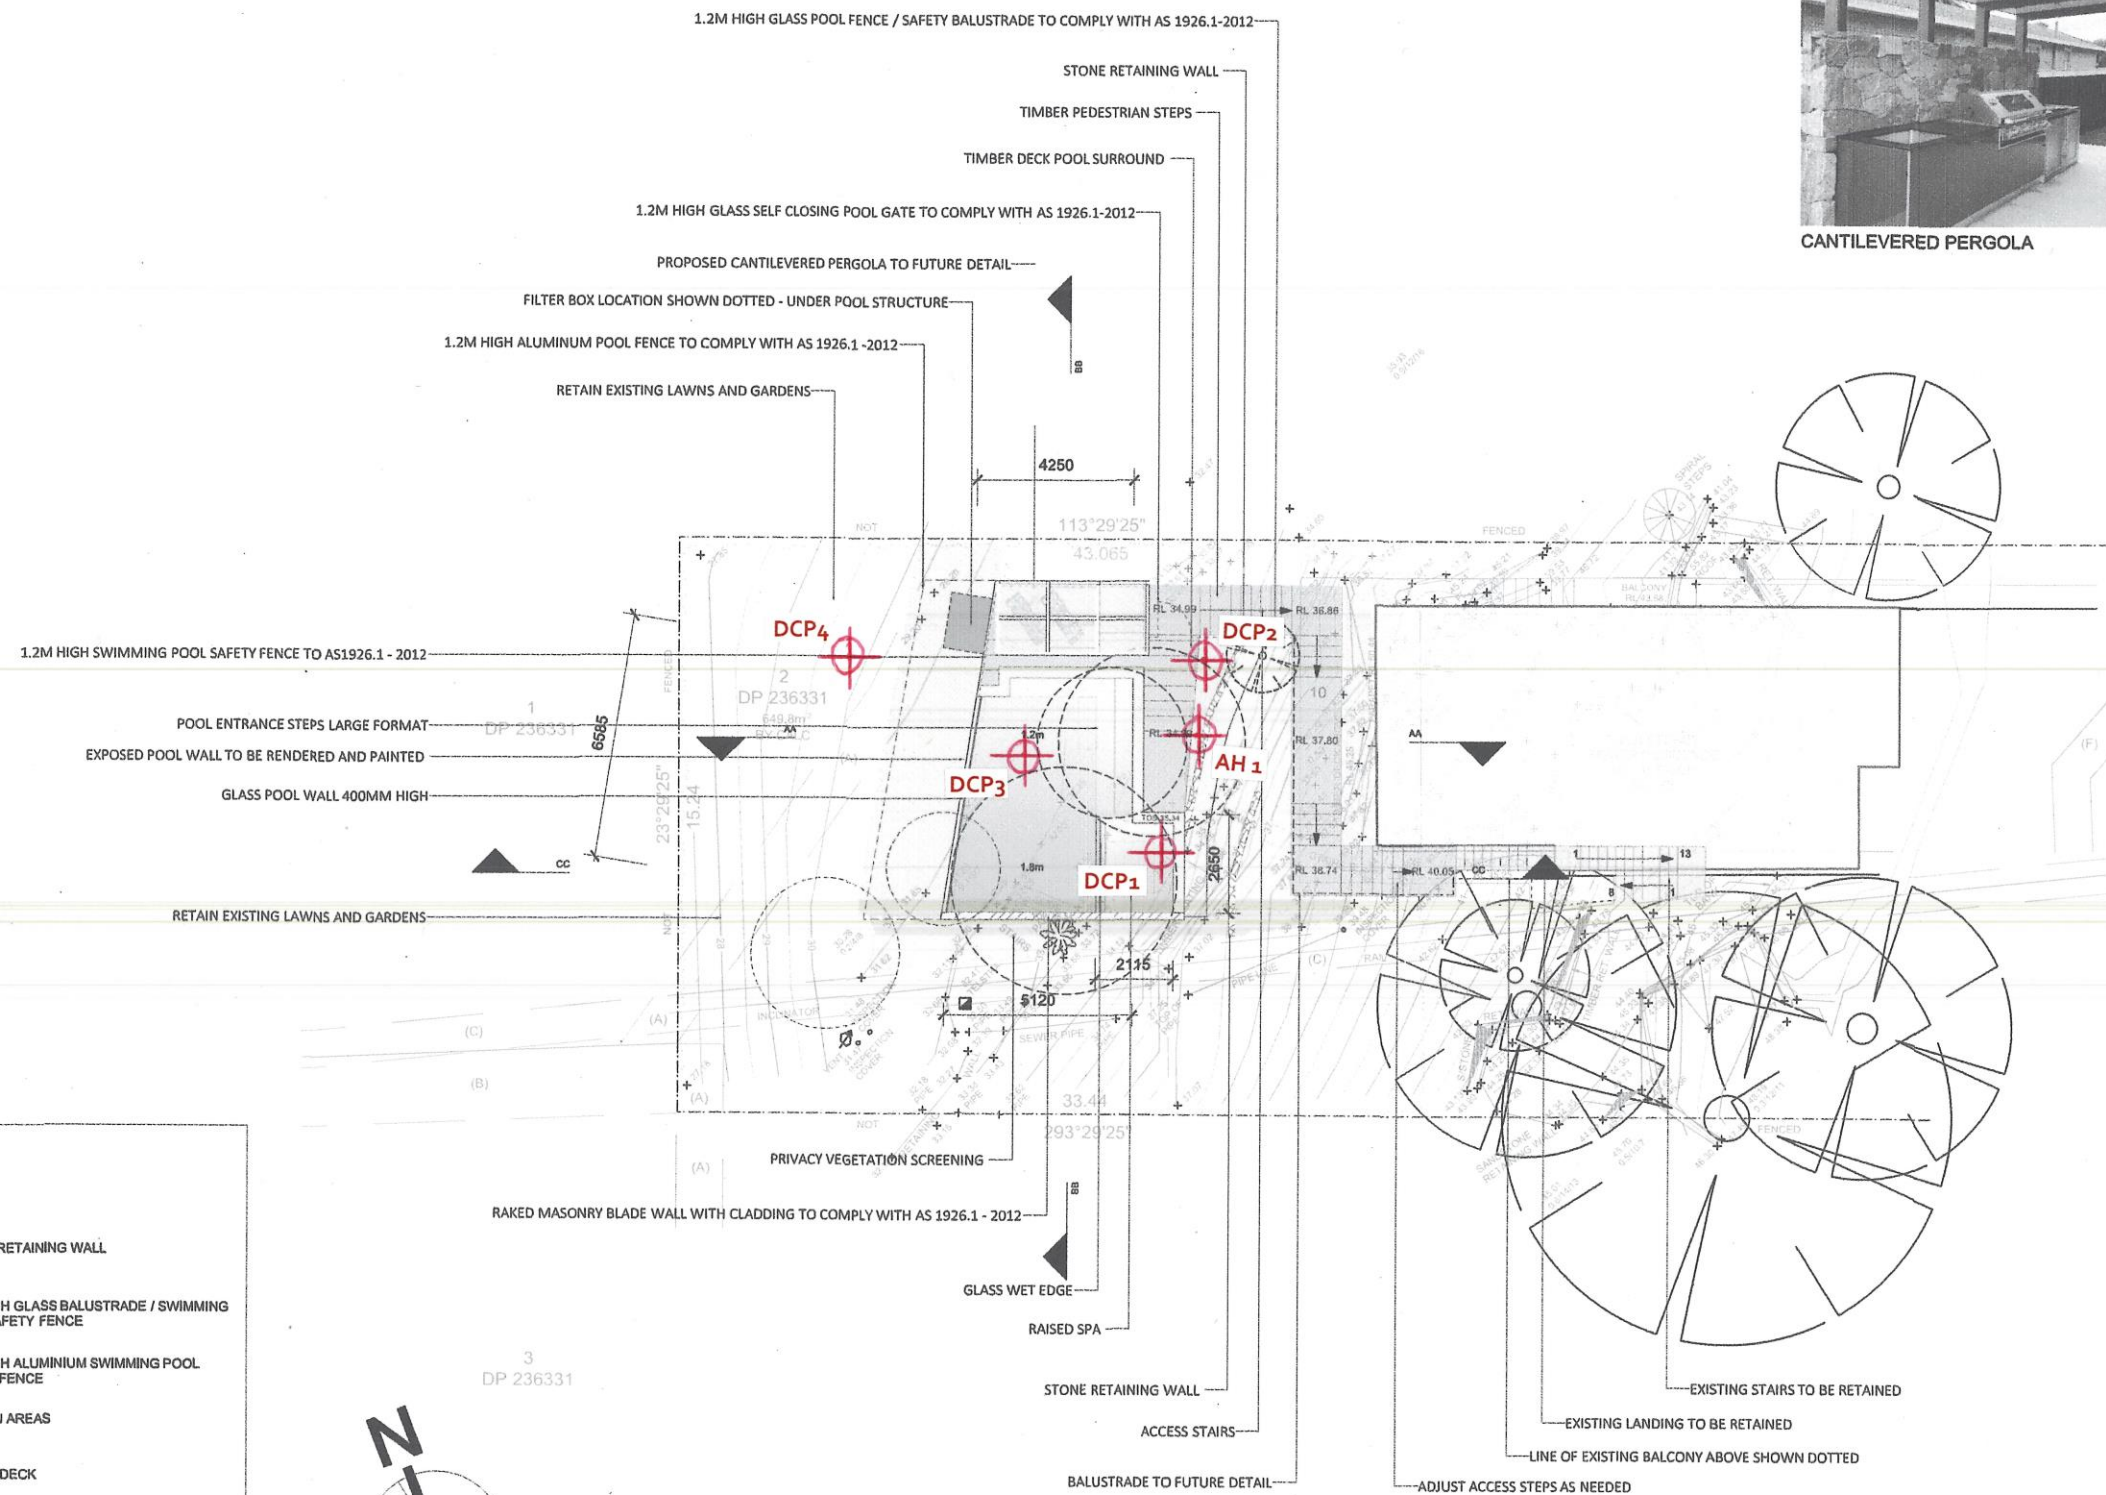
SITE PLAN – showing test locations

One auger hole was put down to identify the soil materials. Four Dynamic Cone Penetrometer (DCP) tests were put down to determine the relative density of the overlying soil and the depth to bedrock. The locations of the tests are shown on the site plan. It should be noted that a level of caution should be applied when interpreting DCP test results. The test will not pass through hard buried objects so in some instances it can be difficult to determine whether refusal has occurred on an obstruction in the profile or on the natural rock surface. This is not expected to be an issue for the testing on this site and the results are as follows:
