13 Bungendore Street, Ingleside

Assess Slope Stability

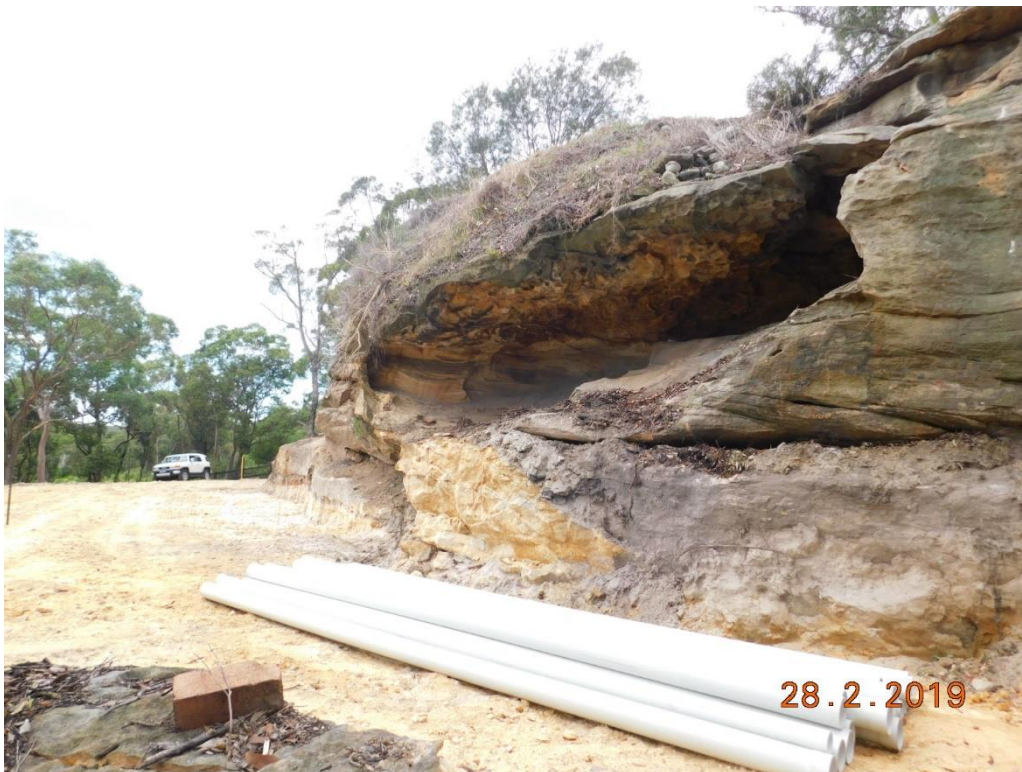
Photo 2

This is an assessment of the risk to life and property of the slope immediately surrounding the existing Farm Building and the accessway to the shed from the road. The undercut rock face above the Farm Building is a potential hazard (**Hazard One**). The filling that has been placed immediately below the Farm Building is a potential hazard (**Hazard Two**).

HAZARDS	Hazard One	Hazard Two
TYPE	The undercut rock face failing and impacting on the proposed works below (Photo 2).	The fill that has been placed on the downhill side of the existing Farm Building failing and causing instability (Photo 4).
LIKELIHOOD	'Rare' (10^{-5})	'Unlikely' (10^{-4})
CONSEQUENCES TO PROPERTY	'Major' (60%)	'Medium' (15%)
RISK TO PROPERTY	'Low' (6×10^{-5})	'Low' (2×10^{-5})
RISK TO LIFE	8.3×10^{-7} /annum	1.3×10^{-7} /annum
COMMENTS	'ACCEPTABLE' level of risk to life & property.	'ACCEPTABLE' level of risk to life & property.

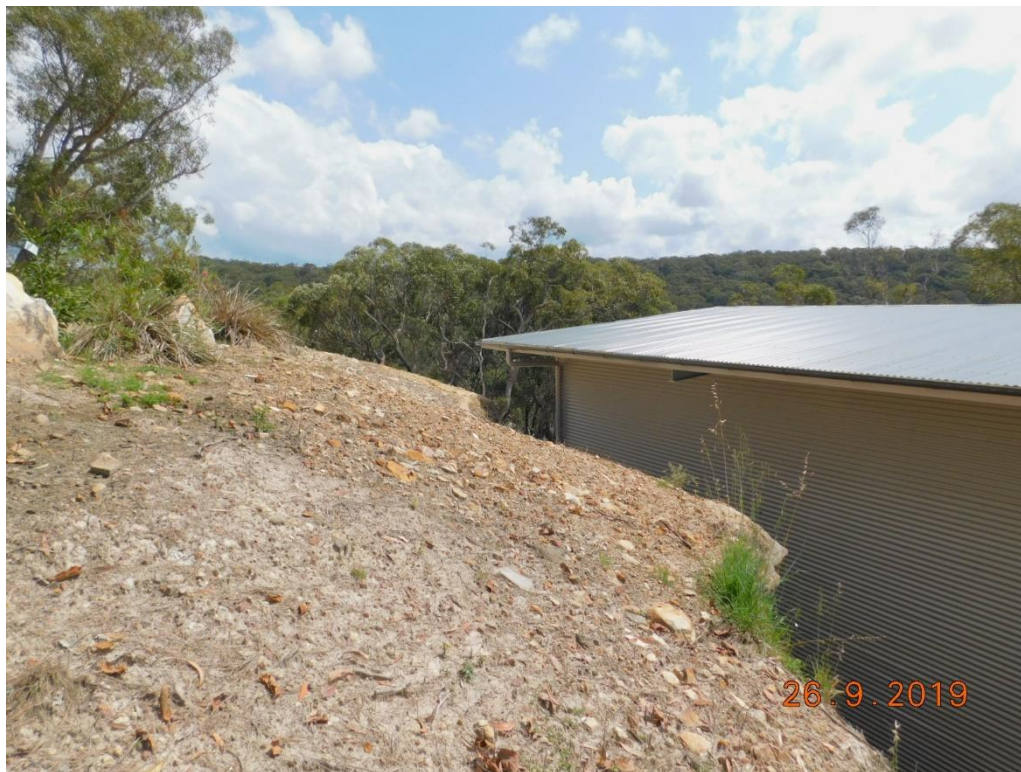
Photo 3

Historically, filling has been pushed off the rock face from the yard of the house above. As such, the top of the rock face is capped with fill (Photo 3). The fill has recently been battered to stable angles. The fill portion of the cut and fill platform for the existing Farm Building is also battered to stable angles (Photo 4). Medium Strength Sandstone was observed to be outcropping near the base of this fill batter.
