GEOTECHNICAL INVESTIGATION:

Alterations and Additions at **44 Greycliffe St, Queenscliff**

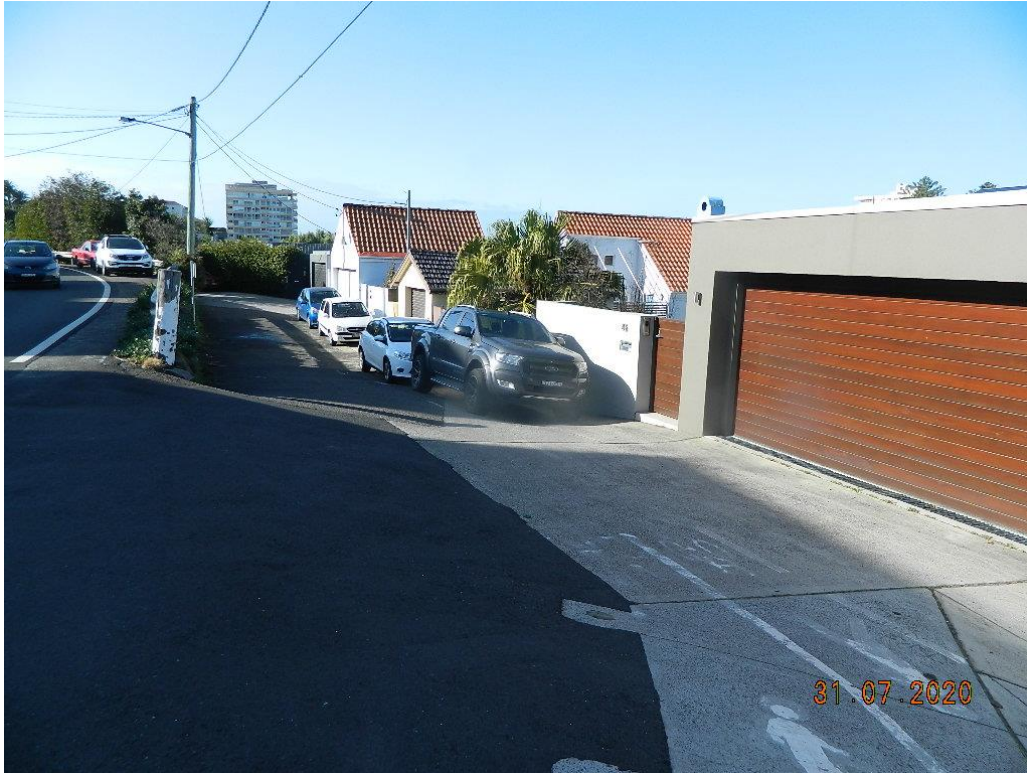
Photo 1

- 2.3** At the road frontage a bitumen and concrete right of carriageway (ROW) runs to a brick garage in good condition on the uphill side of the property (Photos 1 & 2). A pavement extends from the uphill property boundary to the existing house (Photo 3). Competent Medium Strength Hawkesbury Sandstone outcrops under the downhill side of the garage and pavement (Photo 4). The garage is supported by concrete columns on the downhill side. The part three storey brick and sandstone block house is supported by brick walls, sandstone block walls and concrete slabs

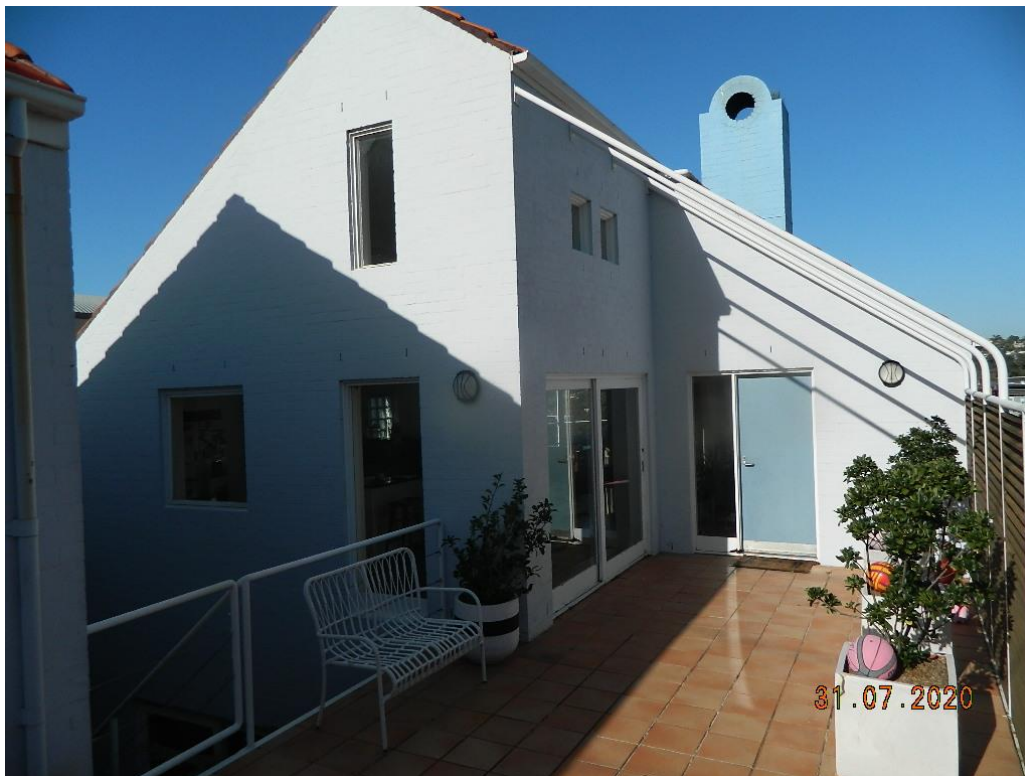
Photo 5

(Photos 5 & 6). The external supporting walls show no significant signs of movement. A two storey timber balcony supported by steel posts extends of the downhill side of the house (Photo 7). The balcony is in good condition. Outcropping Hawkesbury Sandstone steps down the slope downhill of the house (Photos 8 & 9). No significant geological defects were observed on the exposed rock faces that could affect their stability. A stable ~1.8m high brick retaining wall supports fill above the upper rock face (Photo 8). Manly Creek is located downhill of the property (Photo 10). No signs of slope instability were observed on the property. The adjoining neighbouring properties were observed to be in good order as seen from the street and subject property.

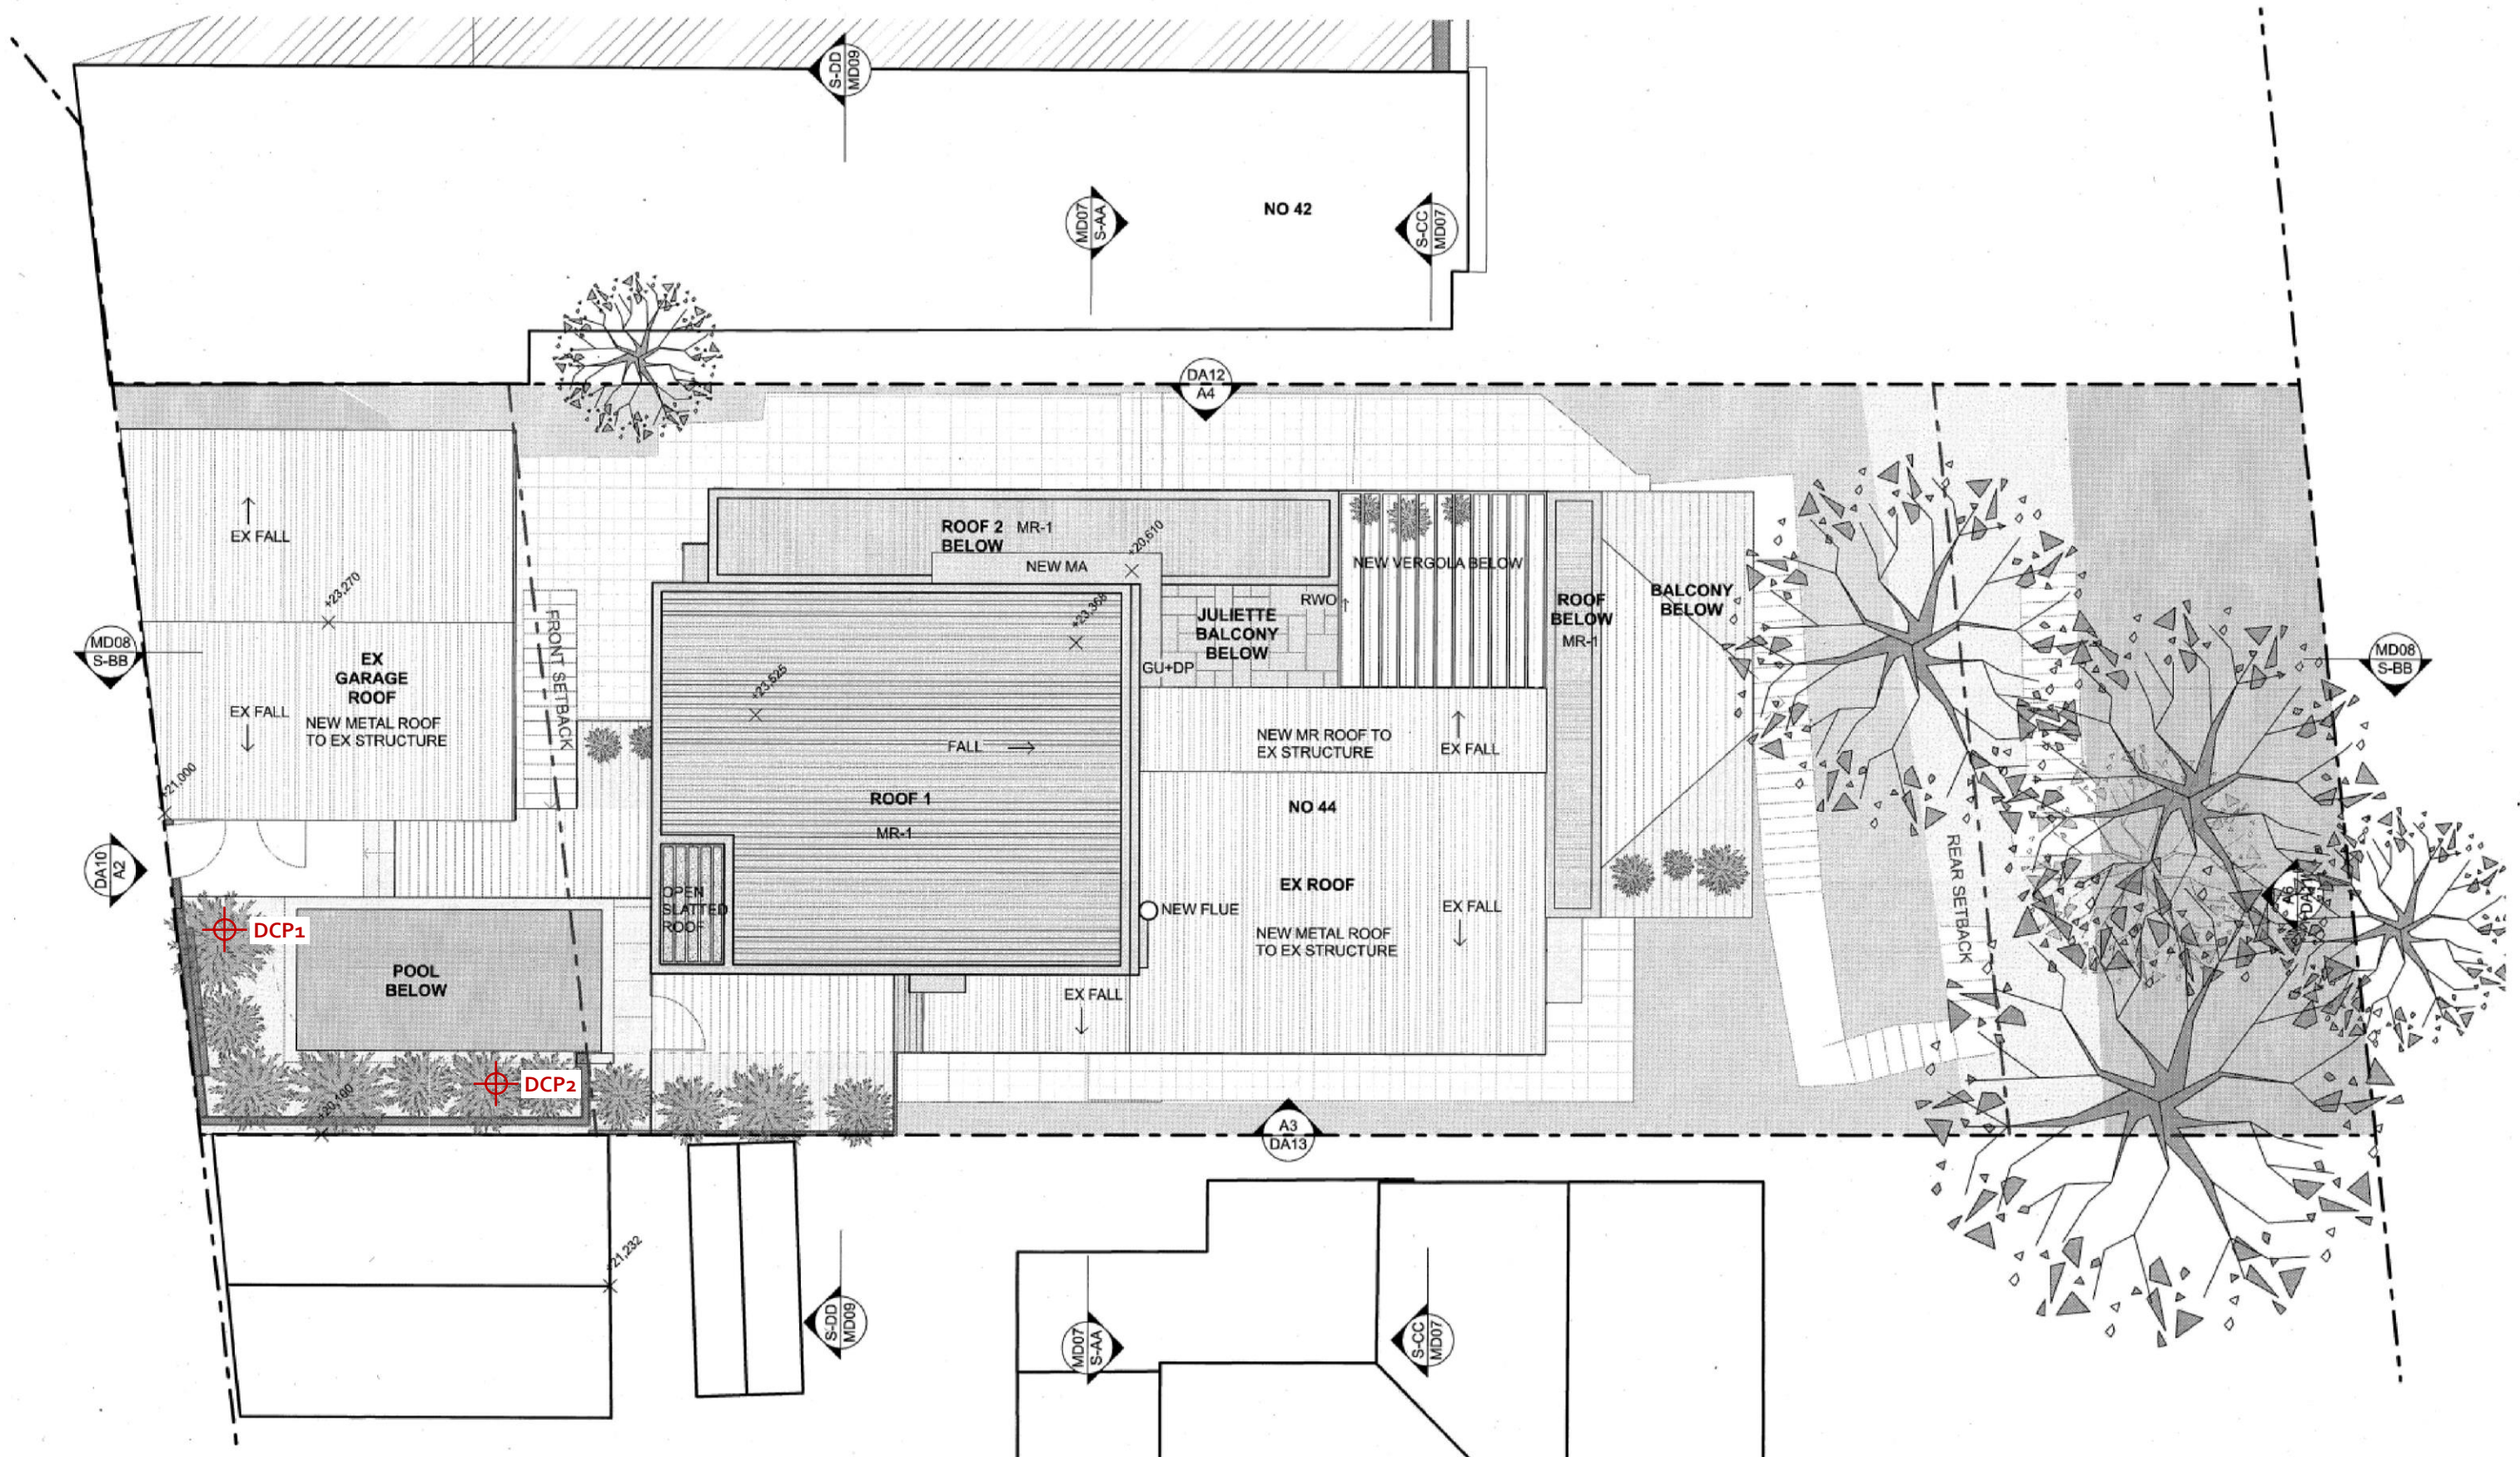
SITE PLAN – showing test locations

Two Dynamic Cone Penetrometer (DCP) tests were put down to determine the relative density of the overlying soil and the depth to weathered rock. The locations of the tests are shown on the site plan. It should be noted that a level of caution should be applied when interpreting DCP test results. The test will not pass through hard buried objects so in some instances it can be difficult to determine whether refusal has occurred on an obstruction in the profile or on the natural rock surface. It is interpreted that DCP1 and DCP2 hit refusal on a concrete slab. Due to the possibility that the actual ground conditions vary from our interpretation there should be allowances in the excavation and foundation budget to account for this. We refer to the appended "Important Information about Your Report" to further clarify. The results are as follows:

DCP1 – Refusal @ 0.4m, DCP bouncing, white impact dust on moist tip.

DCP2 – Refusal @ 0.4m, DCP thudding, brown soil on moist tip.

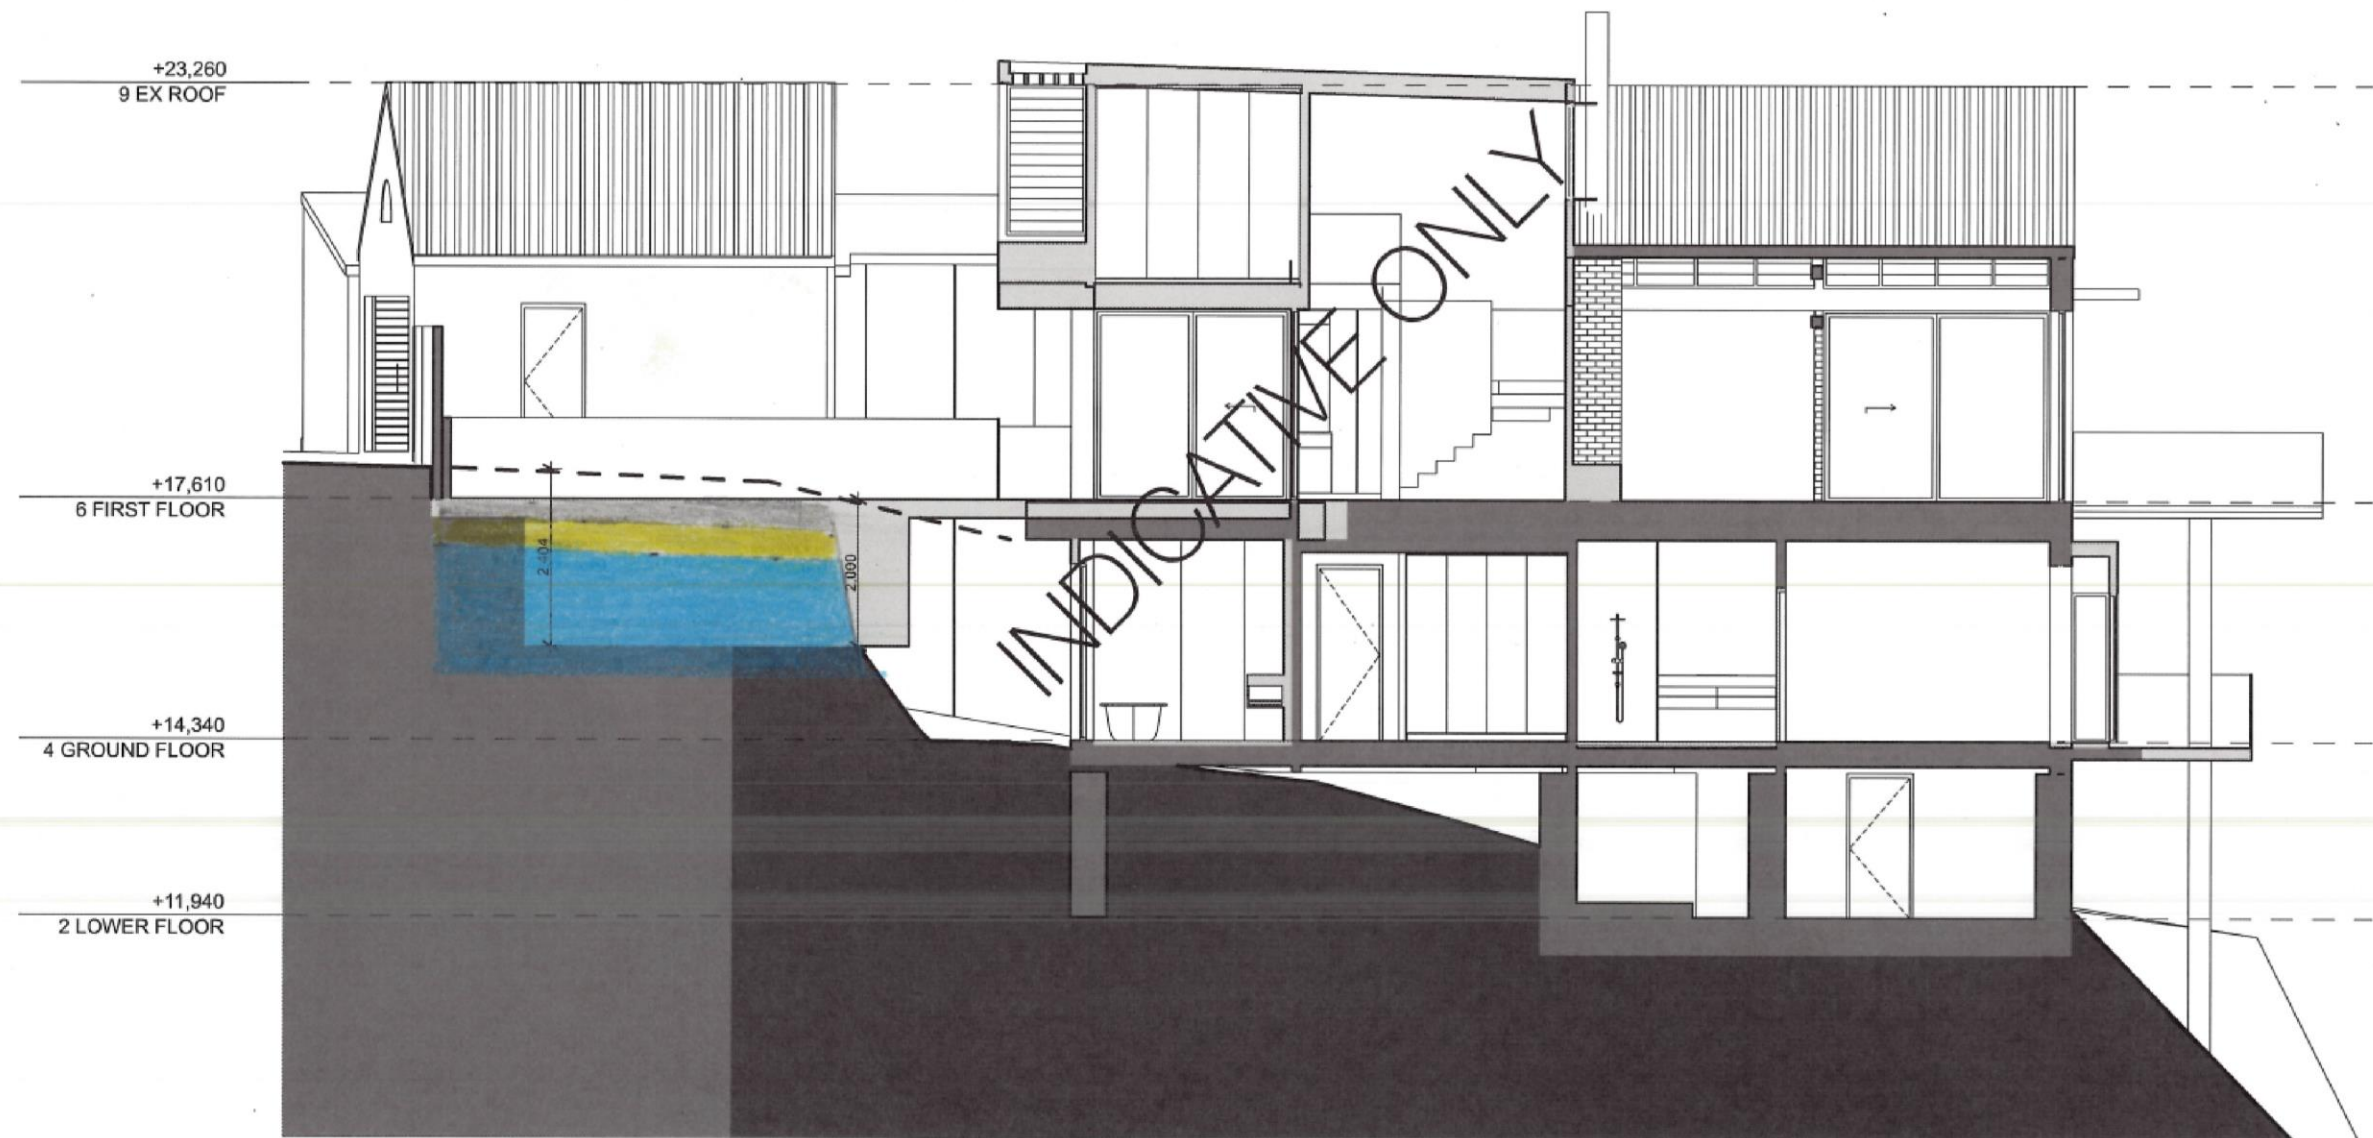
TYPE SECTION – Diagrammatical Interpretation of expected Ground Materials

The surface features of the block are controlled by the underlying sandstone bedrock that steps down the property forming sub-horizontal benches between the steps. Where the grade is steeper, the steps are larger and the benches narrower. Where the slope eases, the opposite is true. The rock is overlain by fill, sandy soils and sandy clays that fill the bench step formation. Fill provides a level platform below the balcony on the downhill side of house. It is interpreted that DCP1 and DCP2 hit refusal on the concrete pavement slab below the garden where the tests were done. From observation and measurement of the outcropping rock underneath the pavement, the depth to rock is ~1.0m below the surface of the pavement and ~1.4m below the surface of the garden. See Type Section attached for a diagrammatical representation of the expected ground materials.
