Preliminary Geotechnical Assessment

Project: Alterations & Additions
205 Headland Road, North Curl Curl

REF: AG 21036
17 February 2021

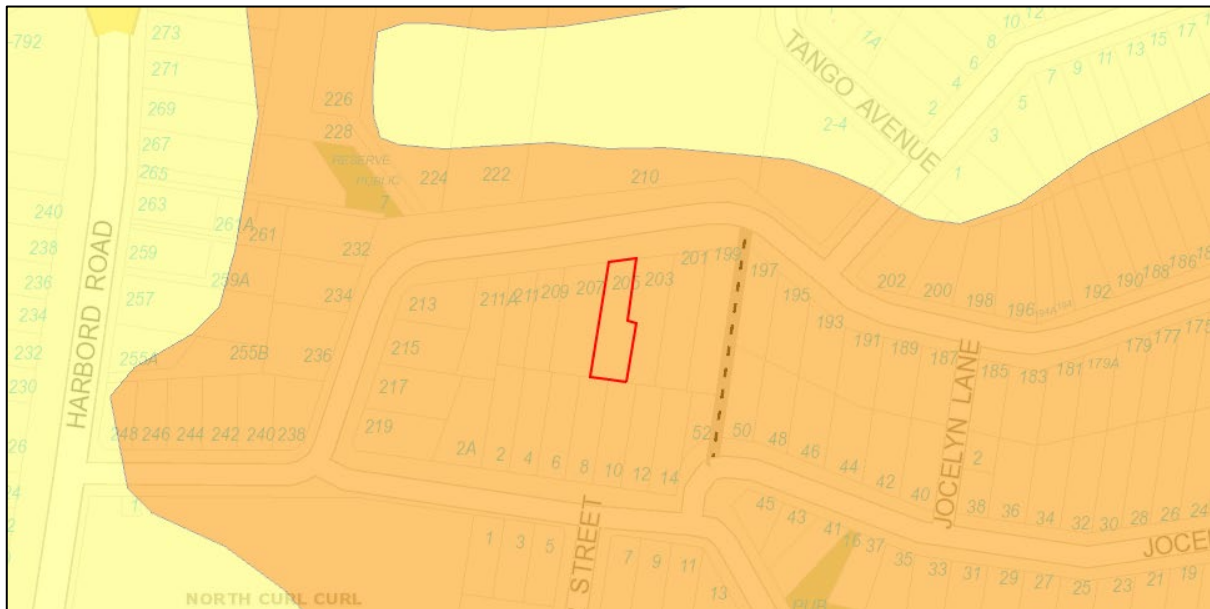
- The site is mapped as **Area B** subject to specific landslip risk/geotechnical hazard mapping with reference to the Warringah Landslip Risk Map (**Image 1**).

Image 1. Warringah Landslip Risk Map:
205 Headland Road, North Curl Curl NSW (© NBC)
