## **INFILTRATION TESTING:**

For Proposed Infiltration Trench at **52 Seaview Street, Balgowlah**

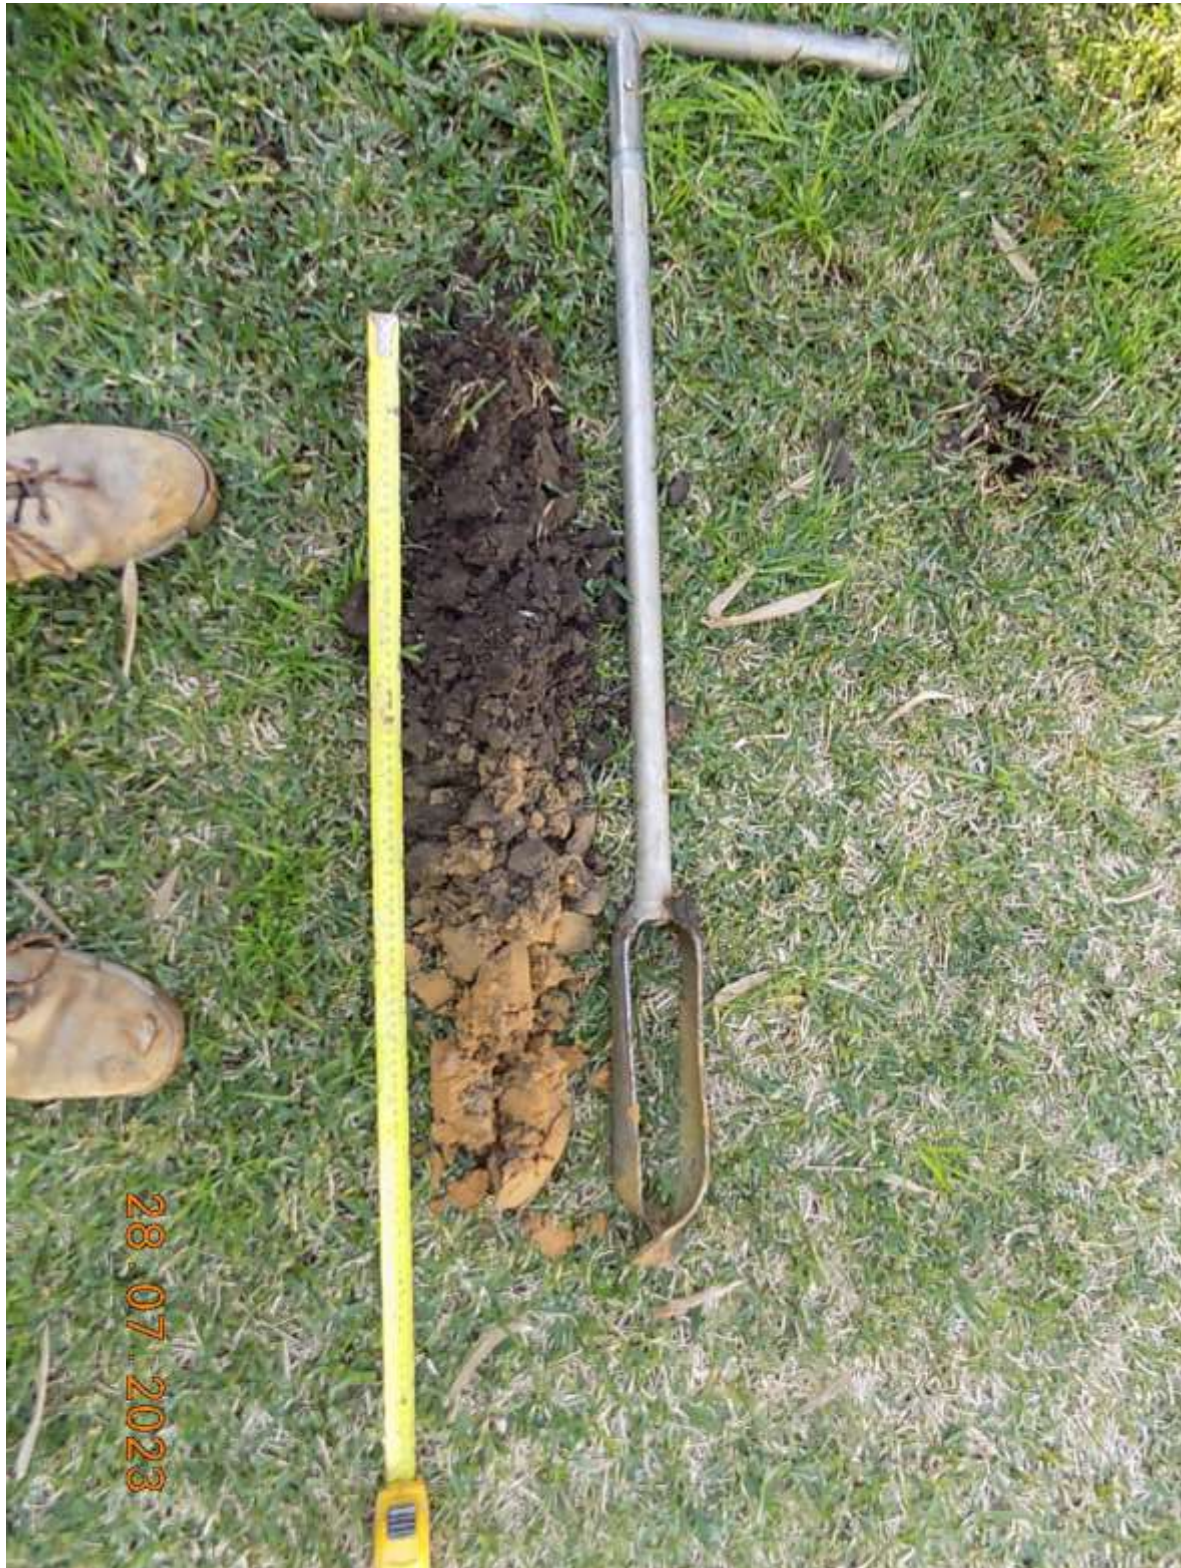
Photo 1

## AUGER HOLE 1 (~RL62.4) – AH1 (Photo 1)

Depth (m)	Material Encountered
0.0 to 0.4	<b>SOIL</b> , sandy, brown, medium grained, fine trace of organic matter, dry.
0.4 to 0.7	<b>SAND</b> , clayey, orange, coarse grained, medium dense, dry.

Refusal on rock @ 0.7m. Auger grinding. No water table encountered.

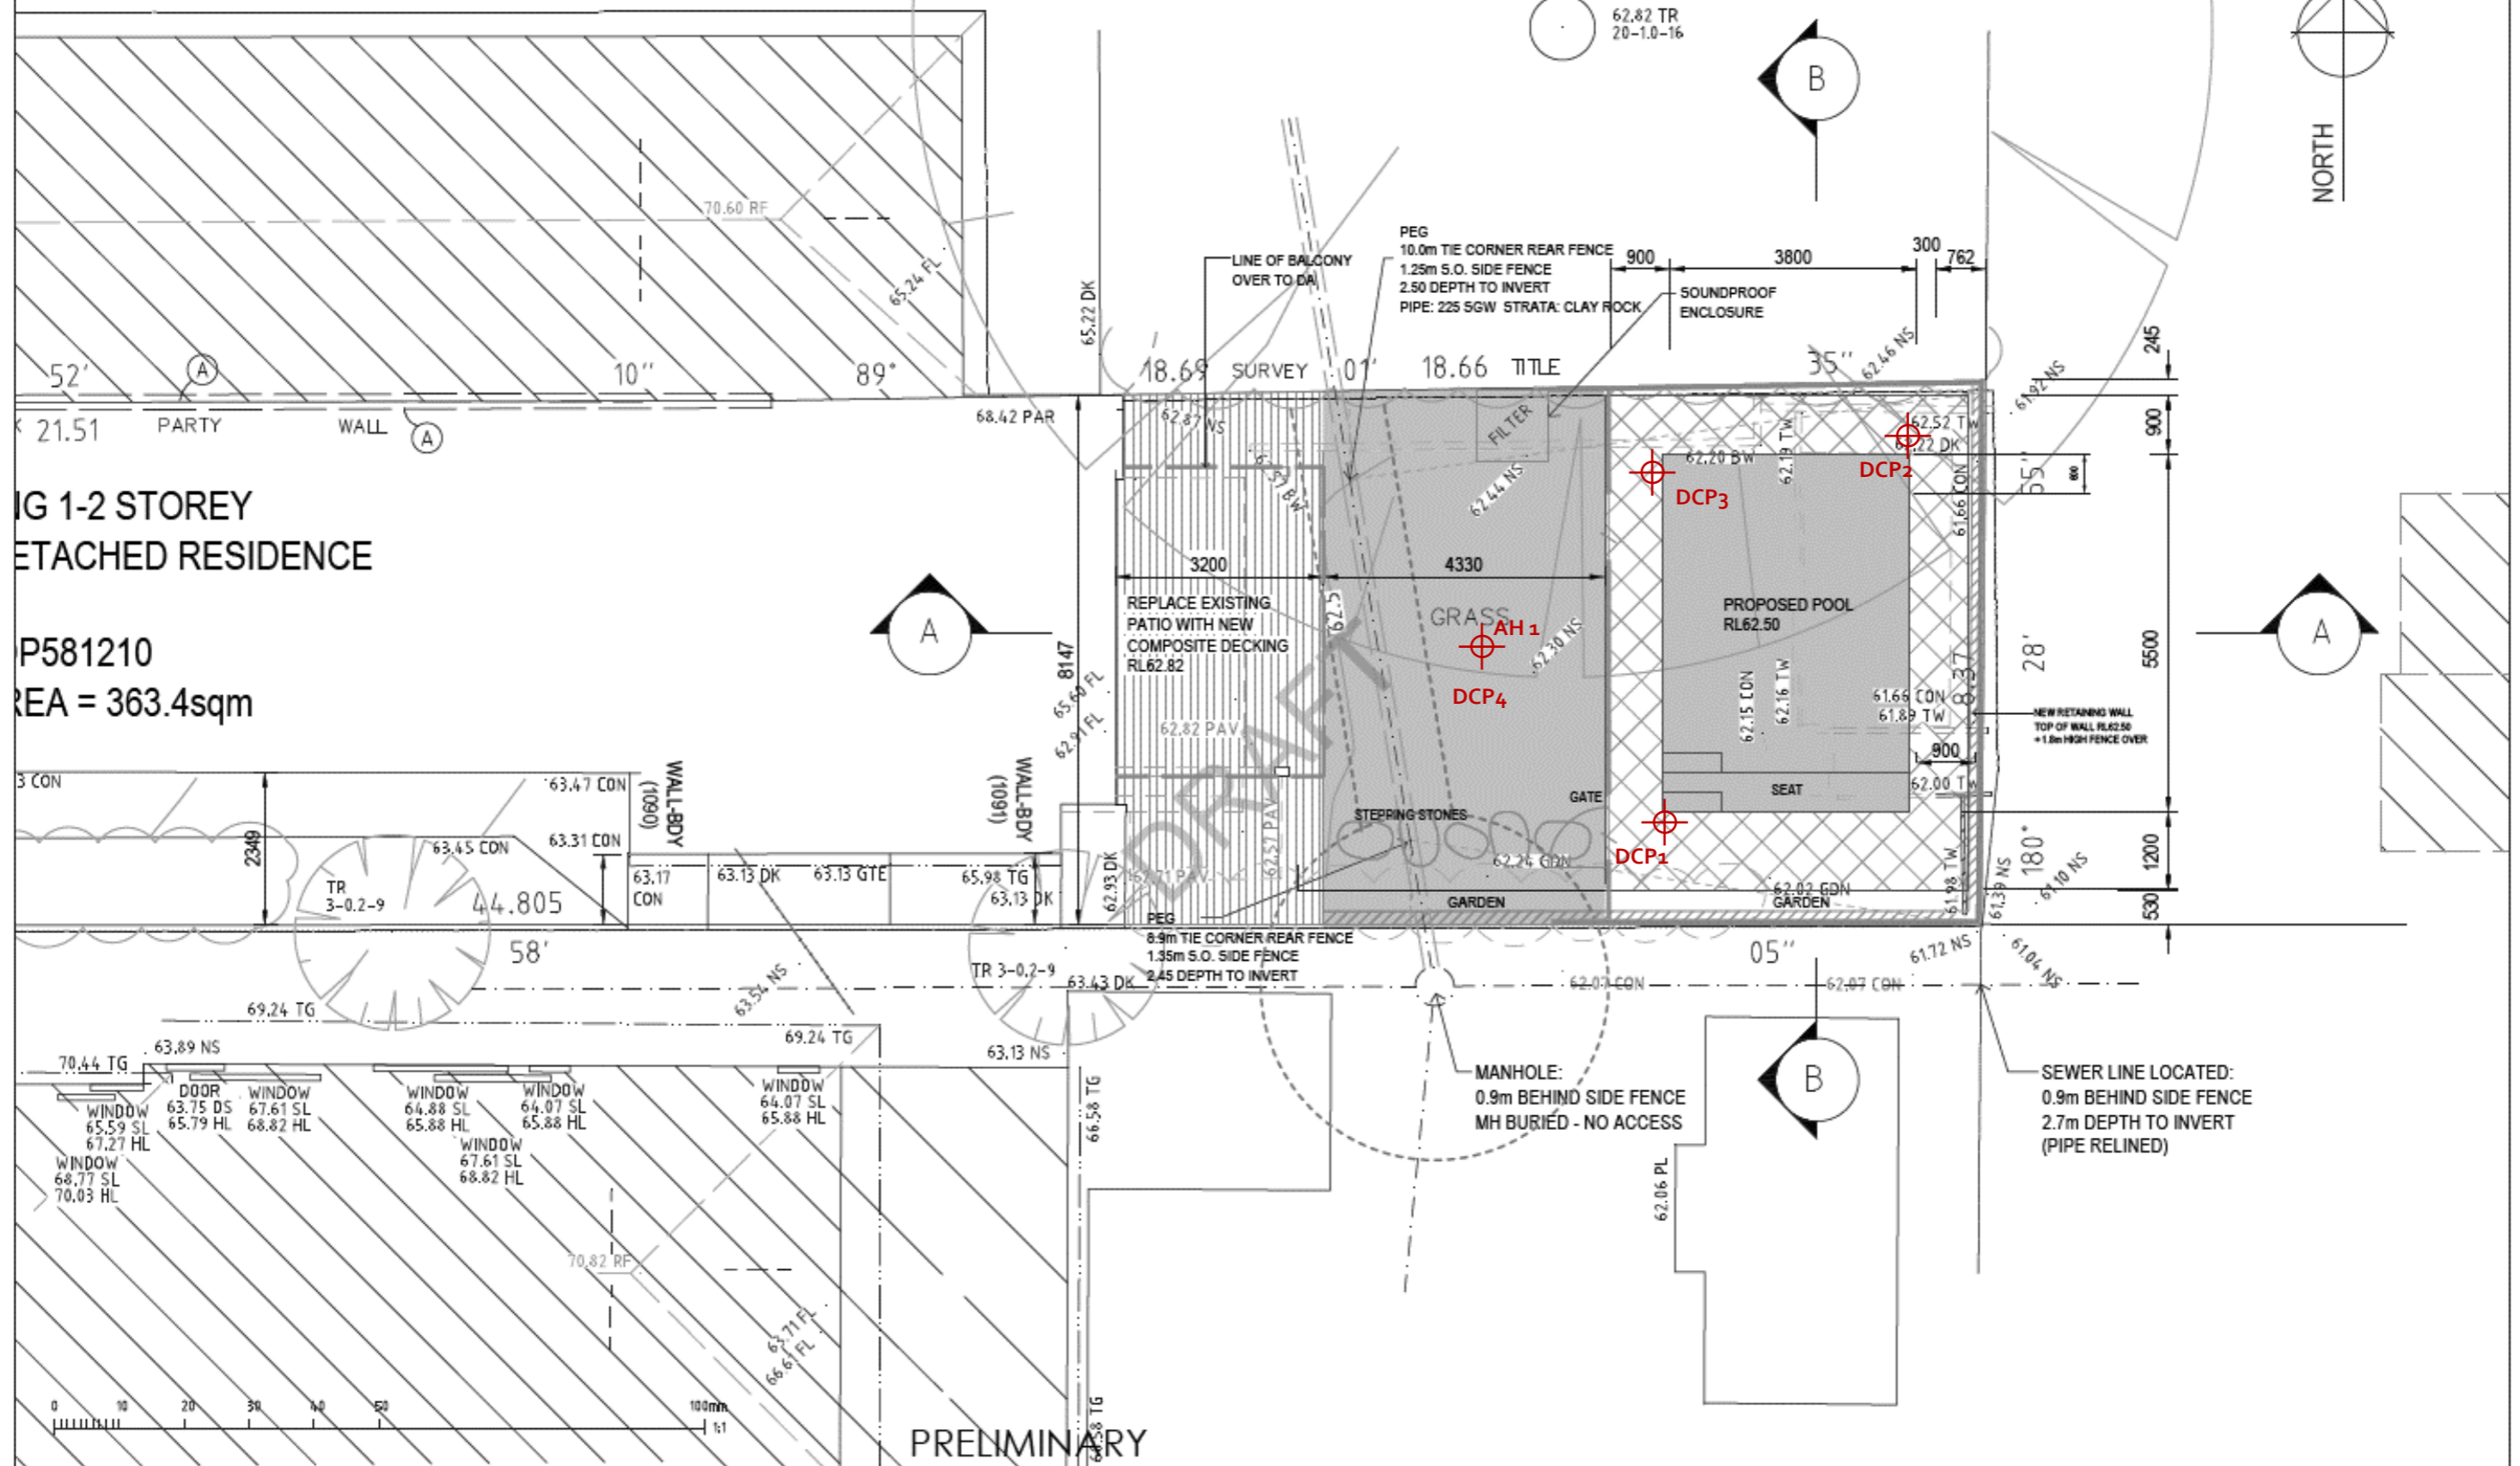
# SITE PLAN – showing test locations

In the test locations, soil and clayey sand overlies Medium Strength Sandstone encountered at depths of between 0.5 to 1.0m below the current surface. Rock is expected at shallow depths across the entire property.

The ground testing revealed shallow rock at a maximum depth of ~0.7m below the current surface in the area of the proposed trench. In order to complete the infiltration testing, sandy soil overburden must extend to a depth of at least 0.8m. Thus, the infiltration testing was not performed.

Given the shallow depth to bedrock across the slope below the house (ideally for infiltration trenches soil should be at least 1.6m deep), it is not considered suitable for infiltration.

Ideally, all stormwater is to be piped to the street drainage system that runs below the downhill neighbouring property. If this is not feasible, other methods for stormwater disposal can be considered by the stormwater engineer under the guidance of the local council stormwater disposal policy. A spreader pipe/dispersal trench is feasible by reducing the stormwater runoff to the natural rate for the site with the use of tanks and an orifice provided council also approve.
