Geotechnical Assessment

Project: Alterations & Additions
21 Condoever Street, Balgowlah NSW

Prepared for:
Ben & Lori Macoun
21 Condoever Street
Balgowlah, NSW

Ref: AG 22143
26 April 2022

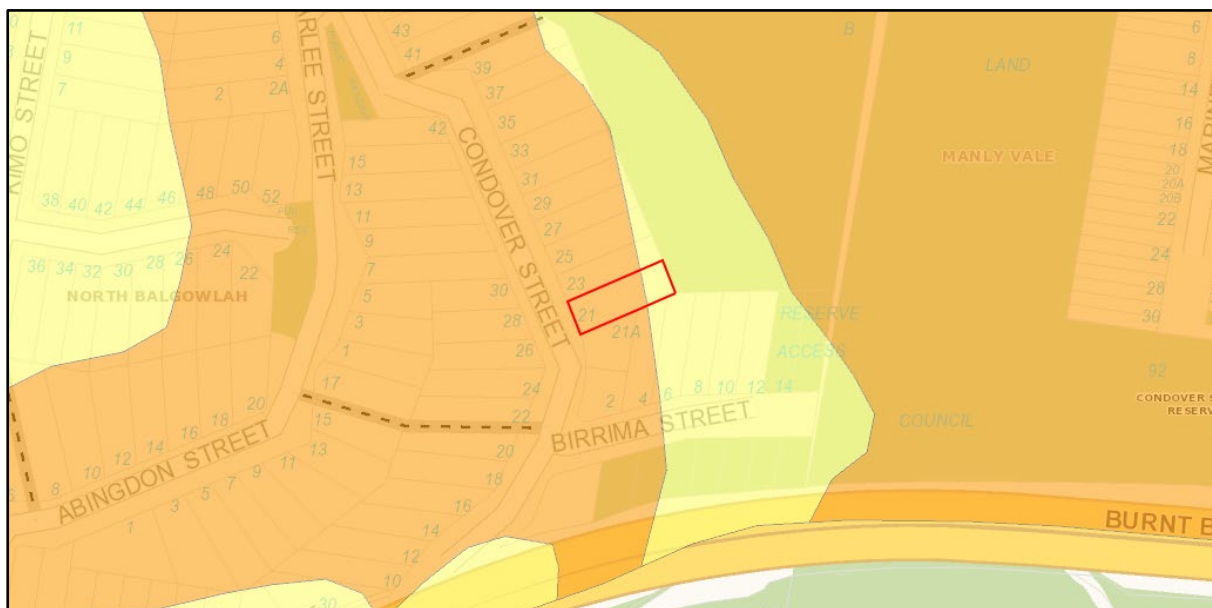
- No evidence of significant soil creep, tension cracks or landslip instability were identified across the site or on adjacent properties as viewed from the subject site at the time of our inspection.
- The property is classified as **Areas A & B** with reference to Northern Beaches Council WLEP – Warringah Landslip Risk Map (**Image 2**).

Image 2. WLEP Landslip Risk Map – 21 Condoover Street, Balgowlah NSW ((c) NBC Maps)

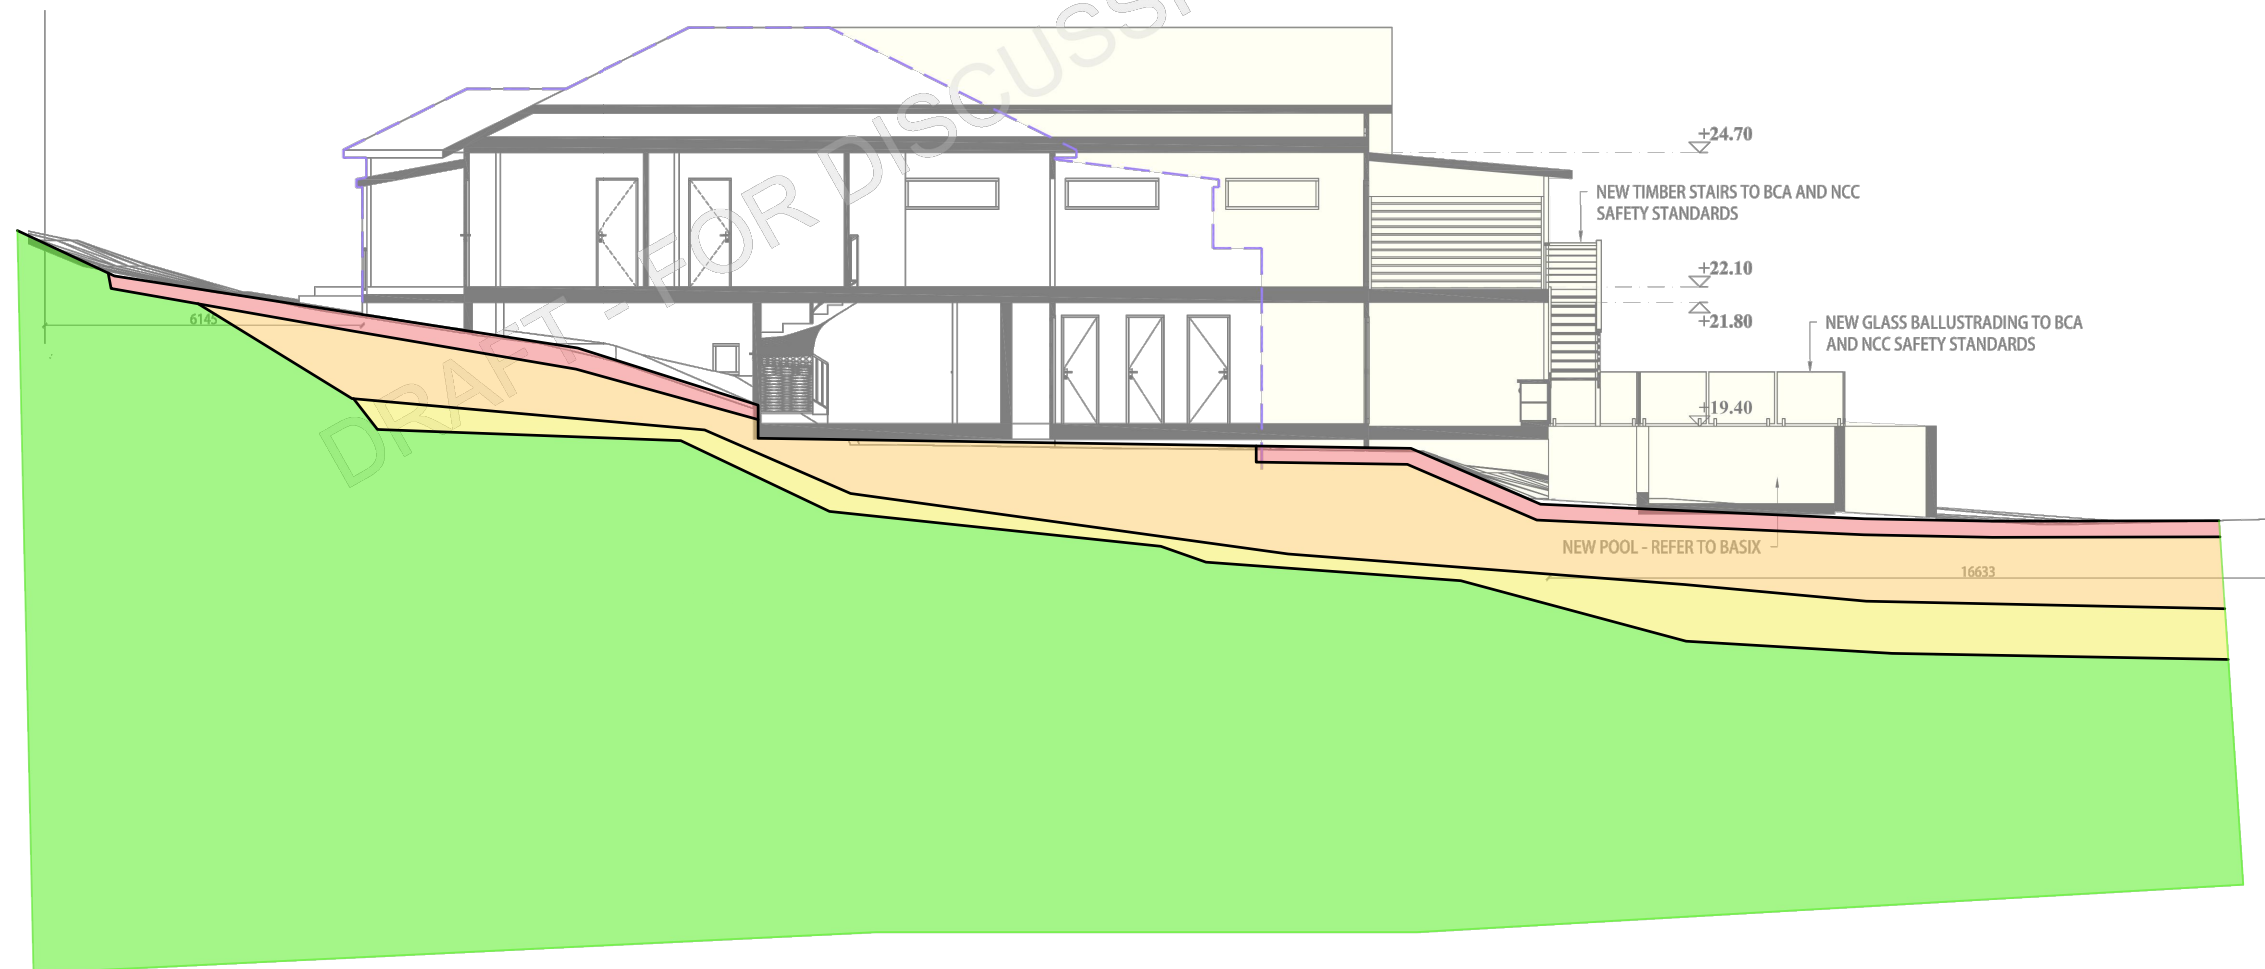
INFERRED GEOLOGICAL SECTION
SCALE NTS

The soil profile consists of shallow uncontrolled fill and sandy topsoil (O & A Horizons), clayey sand and sandy clay (B Horizon) and weathered bedrock (C Horizon). Based on our observations and the results of testing on site, we would expect weathered shale bedrock to be found within 0.35 to 2.50 metres below current surface levels across the area of the proposed works.

INTERPRETED SUBSURFACE SECTION ONLY.
ACTUAL GROUND CONDITIONS MAY VARY.
