## **Marine Habitat Survey**

**Address | 963 Barrenjoey Road, Plam Beach**

**Job Number 24-097-11**

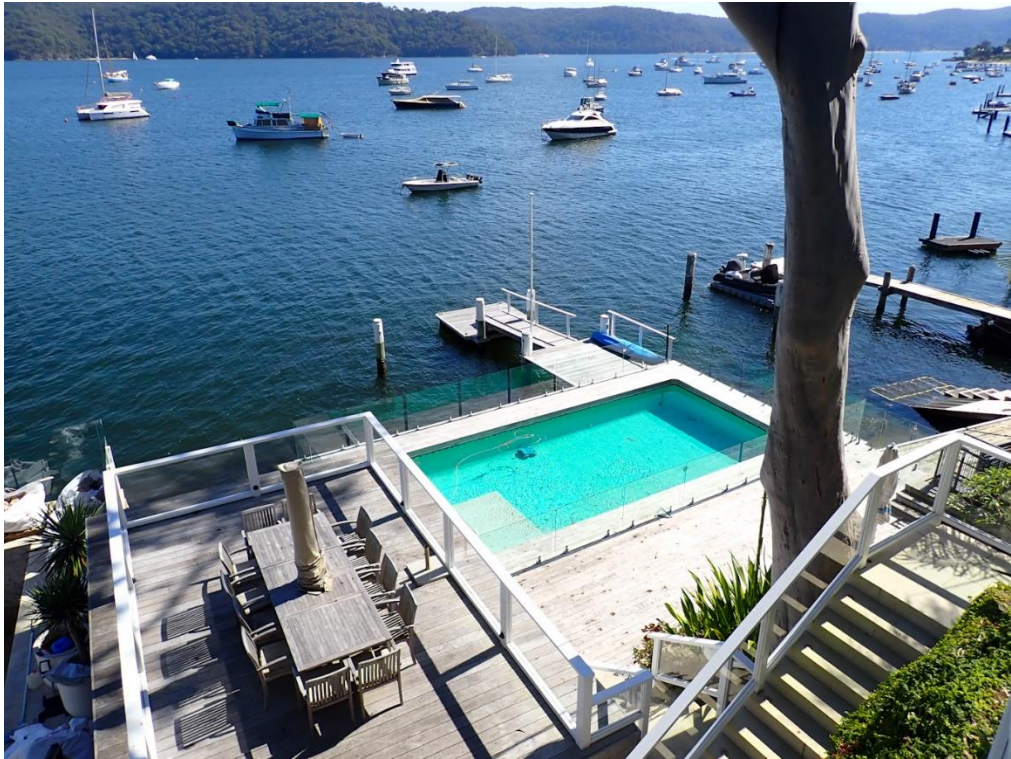
**Photo 1.** The foreshore at The property - with the unauthorised jetty, ramp, pontoon and mooring pile off the right-hand side of the pool.

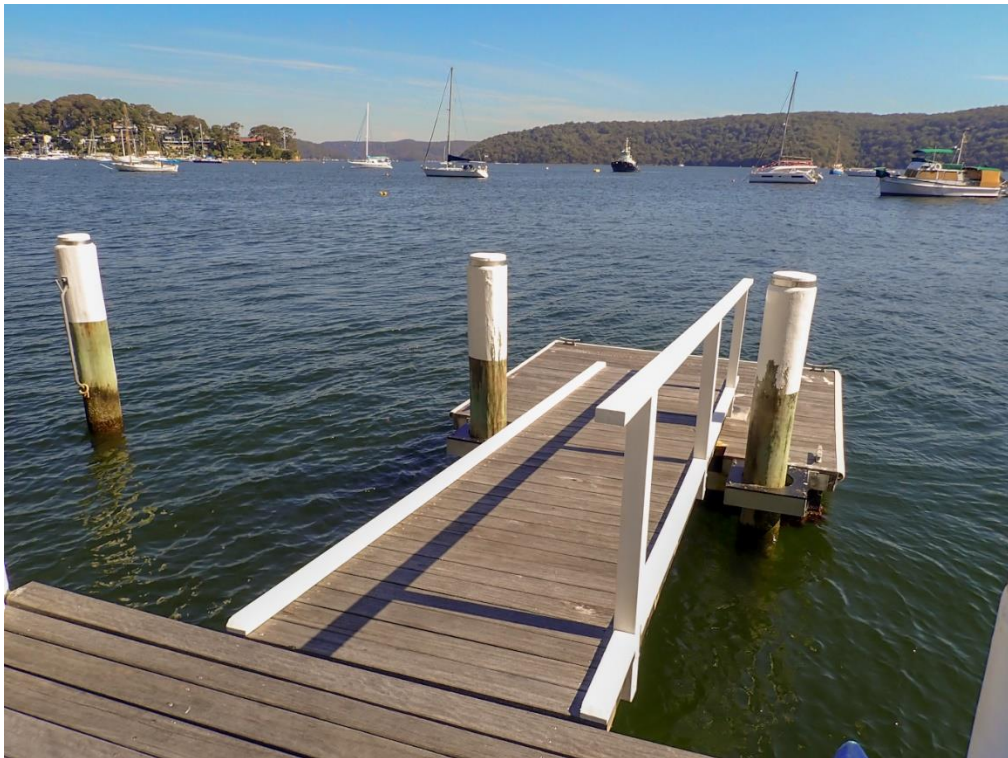
**Photo 2.** The unauthorised timber ramp, pile stabilised pontoon and single mooring pile.

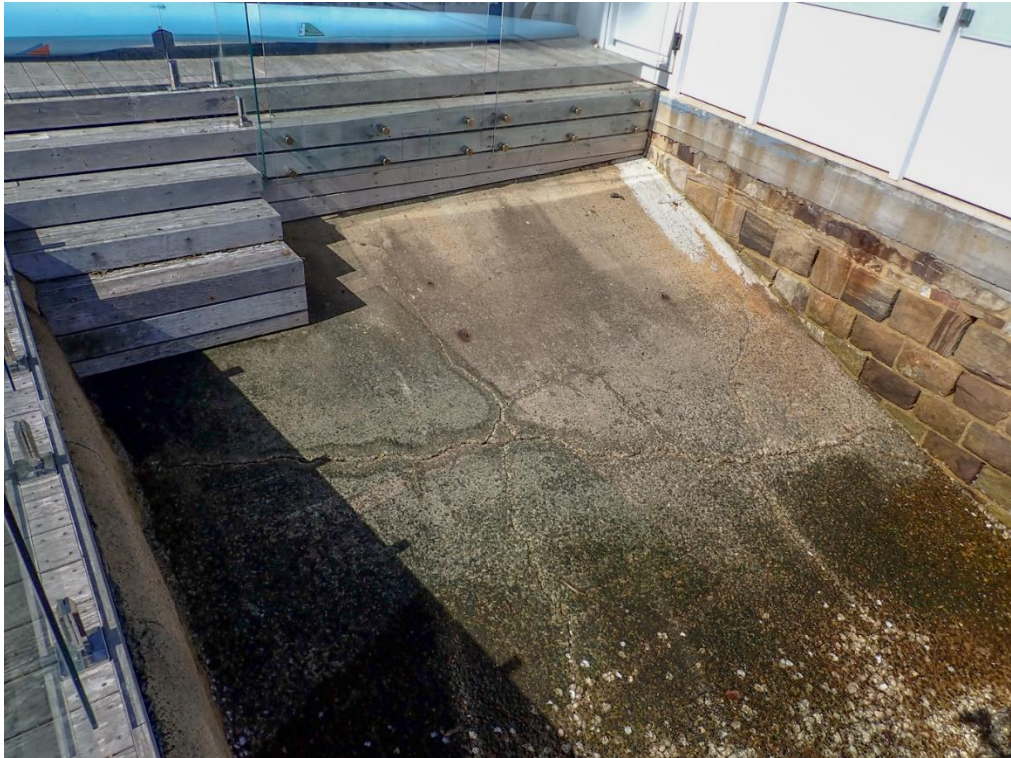
The unauthorised timber deck was devoid of any intertidal biota (Photo 3). The intertidal sections of the unauthorised timber jetty and pontoon piles were bare. The intertidal section of the single unauthorised timber mooring pile was colonised by barnacles (*Tesseropora rosea*).

**Photo 3.** The unauthorised timber deck at the top of the concrete ramp, which was bare of intertidal biota.

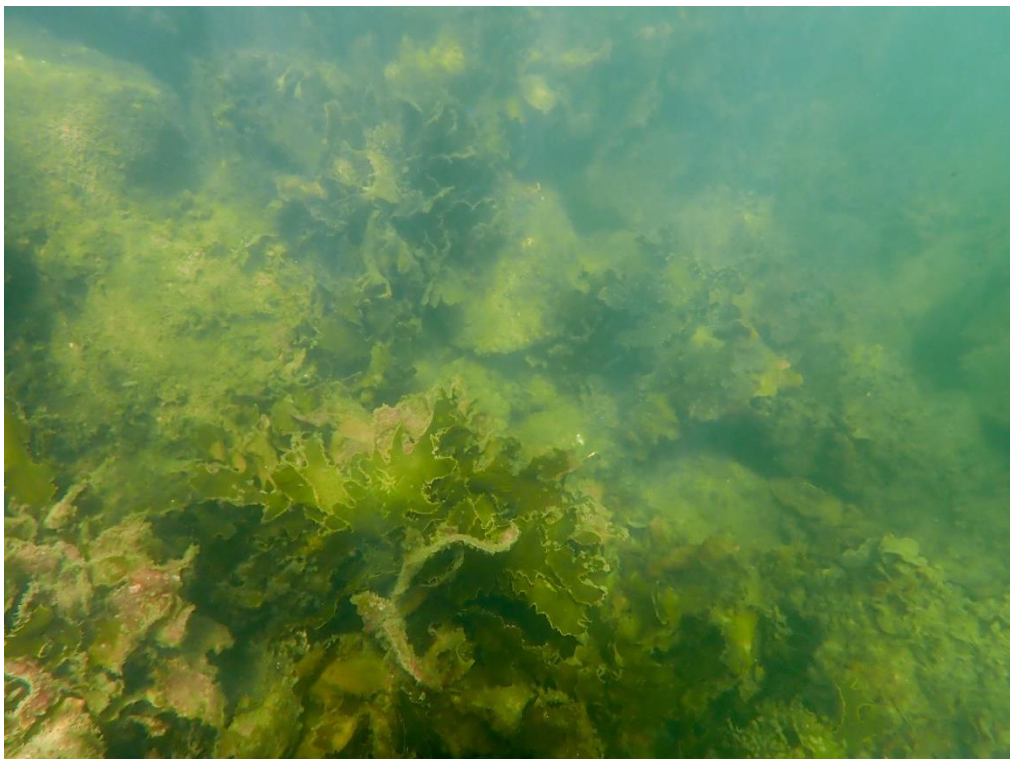
The rocky reef under the unauthorised jetty was not adversely impacted by the jetty, as it had the same diversity and cover of algae as the adjacent rocky reef habitat.

**Photo 4.** The subtidal rocky reef located off the front of the seawall and under the unauthorised timber jetty.

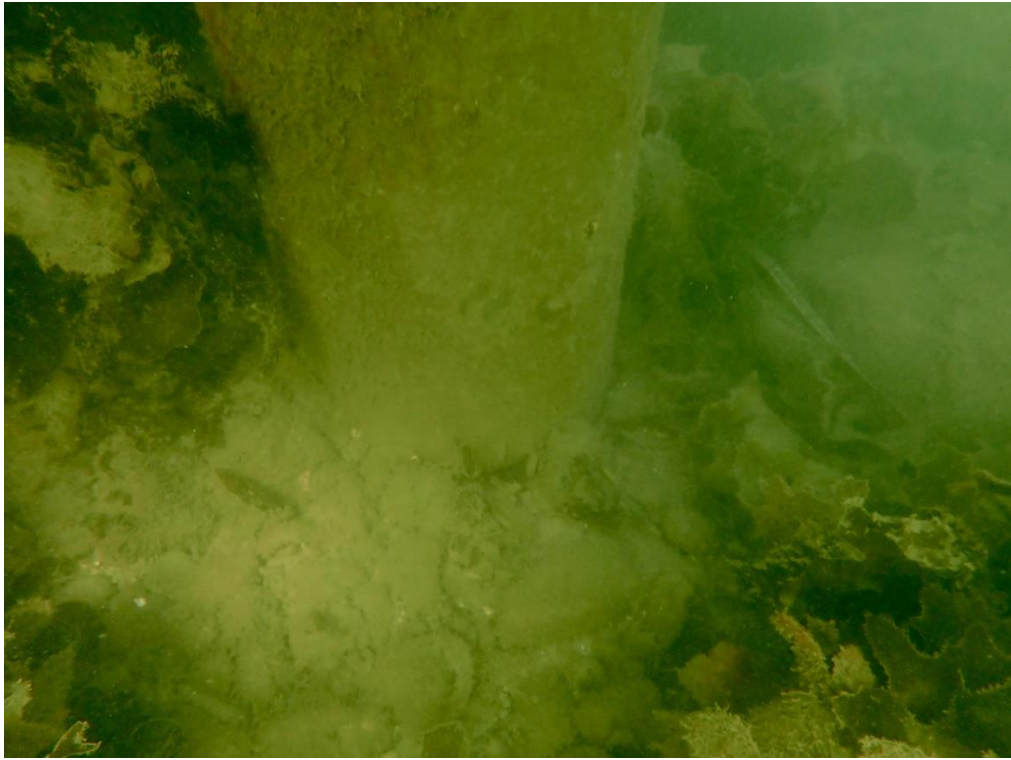
**Photo 5.** The unauthorised outer jetty pile located within the rocky reef habitat.

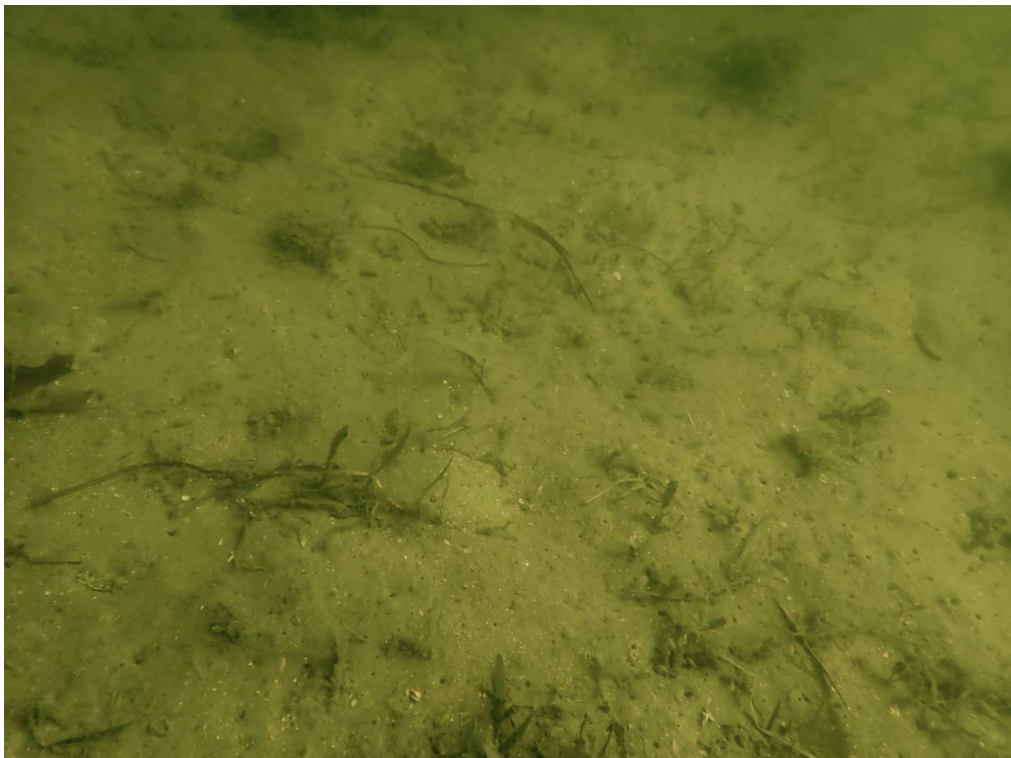
The unauthorised ramp and pontoon were located over a soft seabed colonised by a low density cover of *Caulerpa* (Photo 6), there was not any seagrass under these unauthorised structures.

The unauthorised ramp and pontoon were located over a silty sand seabed. This soft seabed was colonised by a low density cover of the green pest alga *Caulerpa taxifolia* across much of the site. There were no seagrass habitats observed in the footprint of any of the unauthorised structures. The closest seagrass habitat was a patch of low density *Halophila* located 1.5 m and 0.5 m south of the unauthorised ramp and pontoon respectively. There were low numbers of sparsely scattered individual shoots of *Posidonia* mixed within the *Halophila* patch, however, there was a buffer of 1 m from the southern edge of the pontoon to the closest the *Posidonia* shoots.

**Photo 6.** The silty sand seabed in the footprint of the unauthorised ramp and pontoon, colonised by a low density cover of *Caulerpa*.

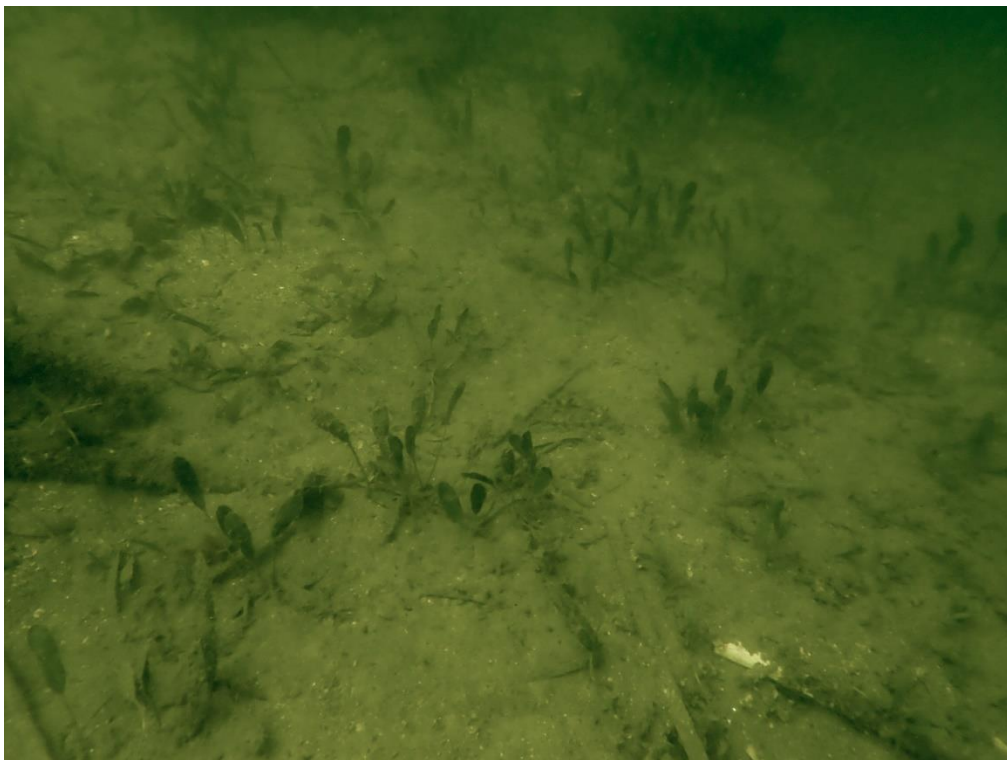
There was a patch of low density *Halophila* seagrass (HalC1S; Photos 7 - 8) present on the southern side of the outer half of the ramp and the pontoon (see seagrass mapping in Appendix B). The *Halophila* started 1.5 m south of the unauthorised ramp and 0.5 m south of the unauthorised pontoon. The *Halophila* patch surrounded the unauthorised mooring pile (Photo 8). Within the *Halophila* patch there were low numbers of sparsely scattered individual shoots of *Posidonia* (PosA1L; Photo 9). The closest the *Posidonia* shoots were to the southern edge of the unauthorised was 1 m (see seagrass mapping in Appendix B).

**Photo 7.** Low density patch of *Halophila* located to the south of the unauthorised pontoon.

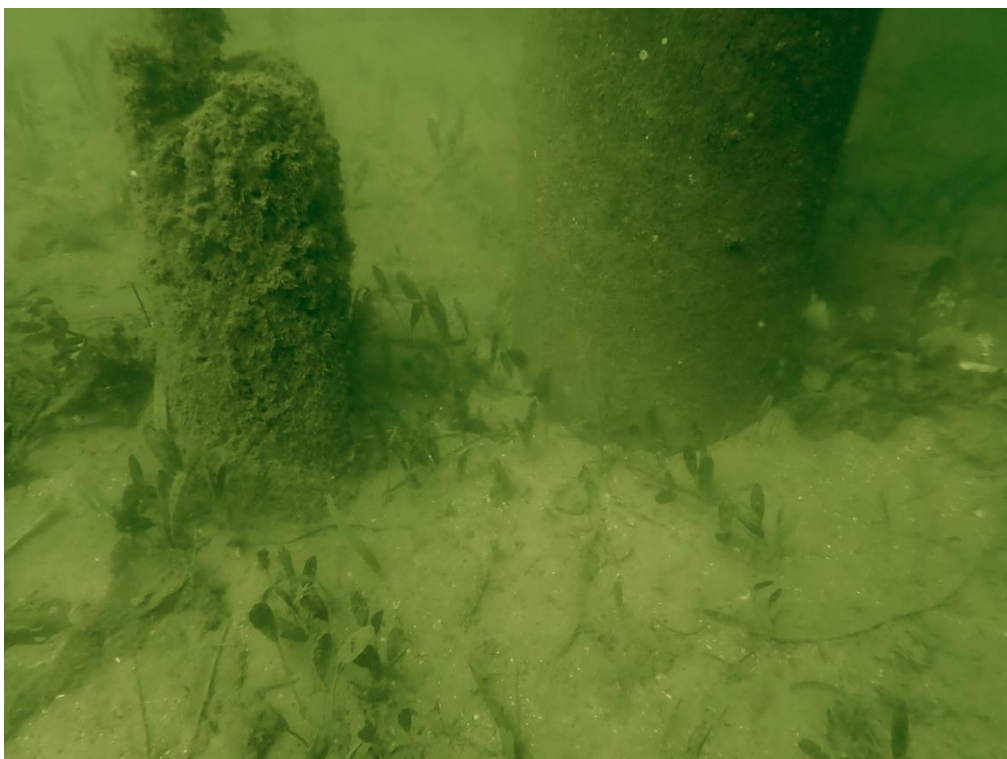
**Photo 8.** Low density *Halophila* colonising the soft seabed around the unauthorised mooring pile.

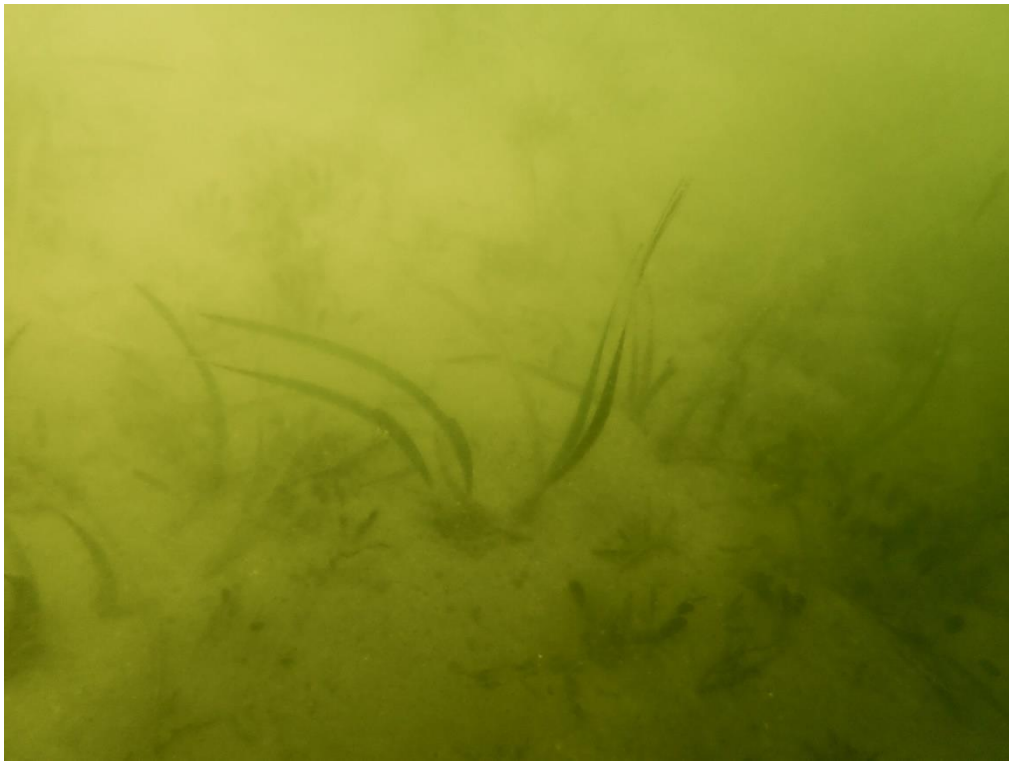
**Photo 9.** Low density patch of *Halophila* with sparsely scattered individual shoots of *Posidonia*, located to the south of the unauthorised pontoon.

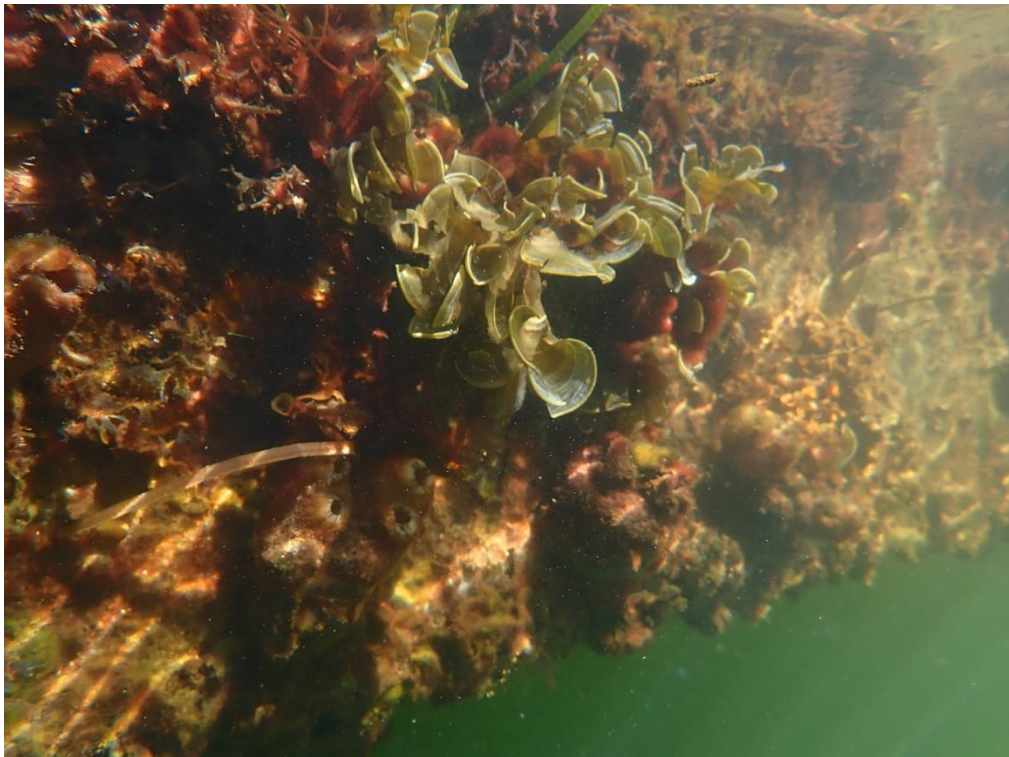
The subtidal sections of the unauthorised timber jetty, pontoon and mooring piles were colonised by turfing cover of brown and red filamentous algae, along low numbers of barnacles (*Tessieropora rosea*). The unauthorised pontoon (Photo 10) provided a subtidal habitat that was colonised by a diverse matrix including brown algae (scrollweed and filamentous), green alga (sea fingers *Codium fragile*), red algae (branching *Laurencia* sp. and filamentous *Gelidium* sp.), solitary ascidians (*Styela plicata*), hard bryozoa (*Watersipora* sp.) and barnacles.

**Photo 10.** Matrix of subtidal biota colonising the unauthorised pontoon.

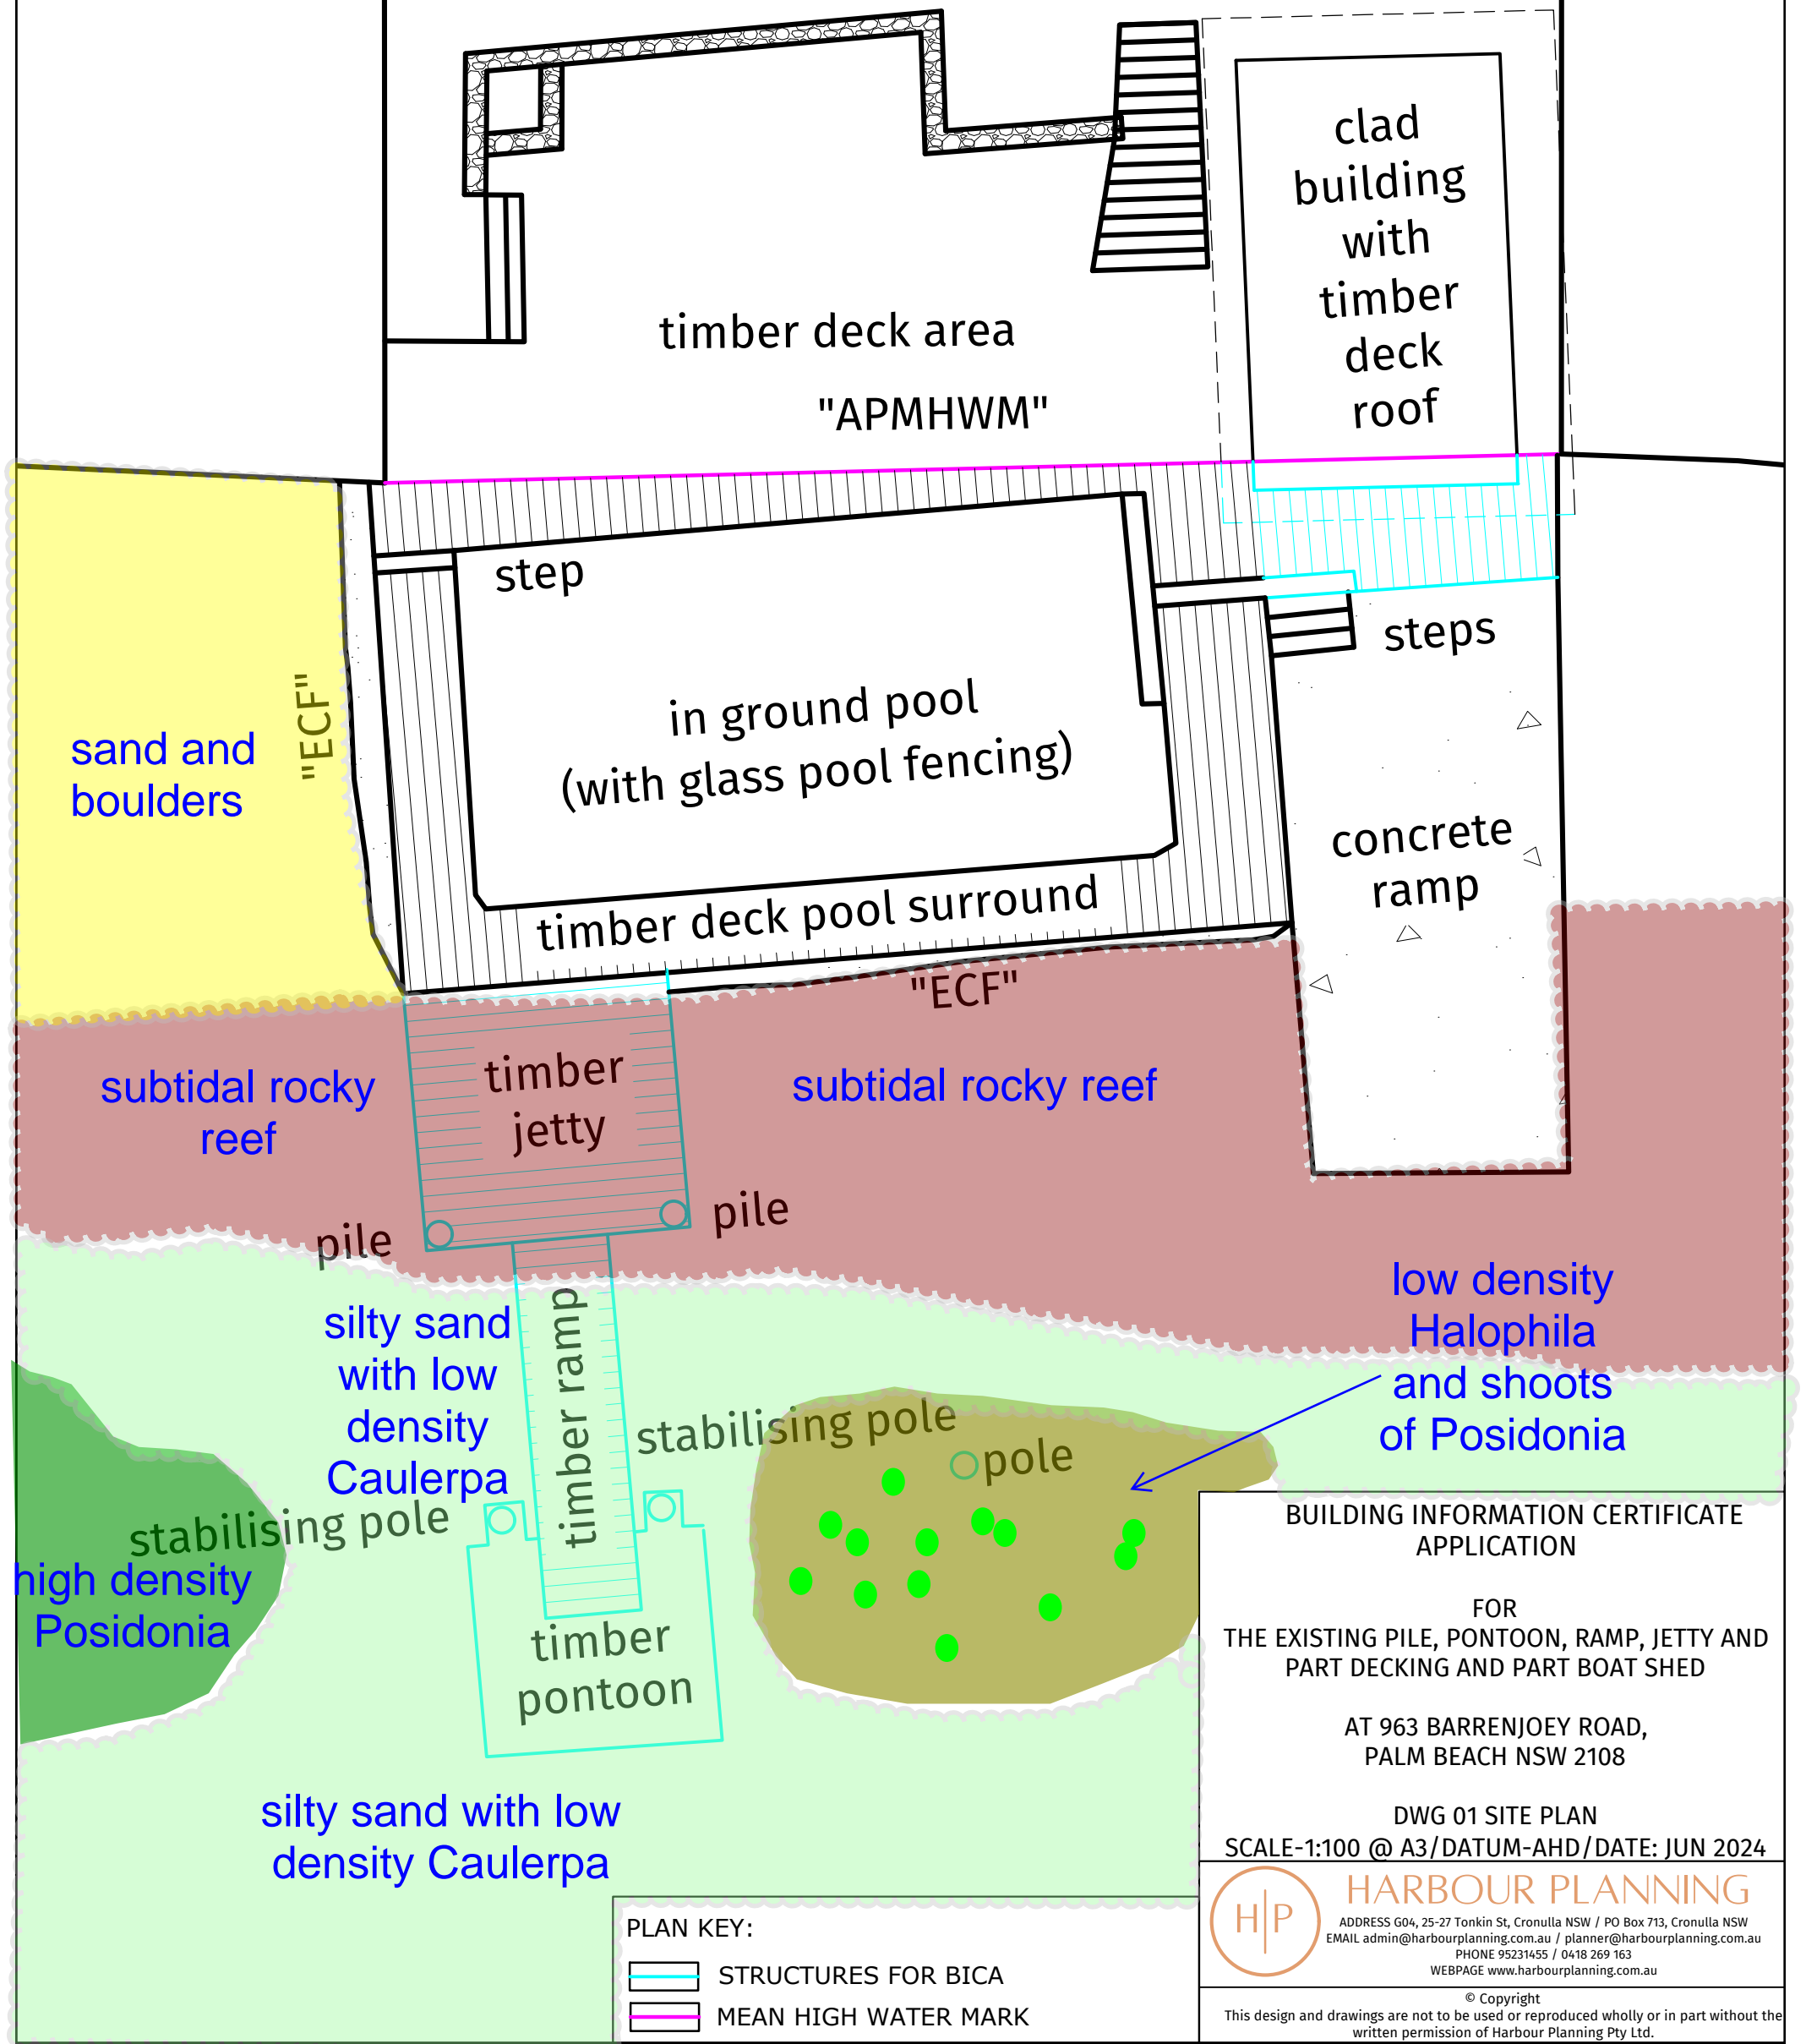
## **Appendix B – Site Plan and Seagrass Map**

There was a patch of high density *Posidonia* located in the northern neighbouring property, that started 3 m north of the unauthorised ramp and pontoon.
