Geotechnical Assessment

Project: Alterations & Additions
13 Amiens Road, Clontarf NSW

For Alterations & Additions at

13 Amiens Road, Clontarf NSW

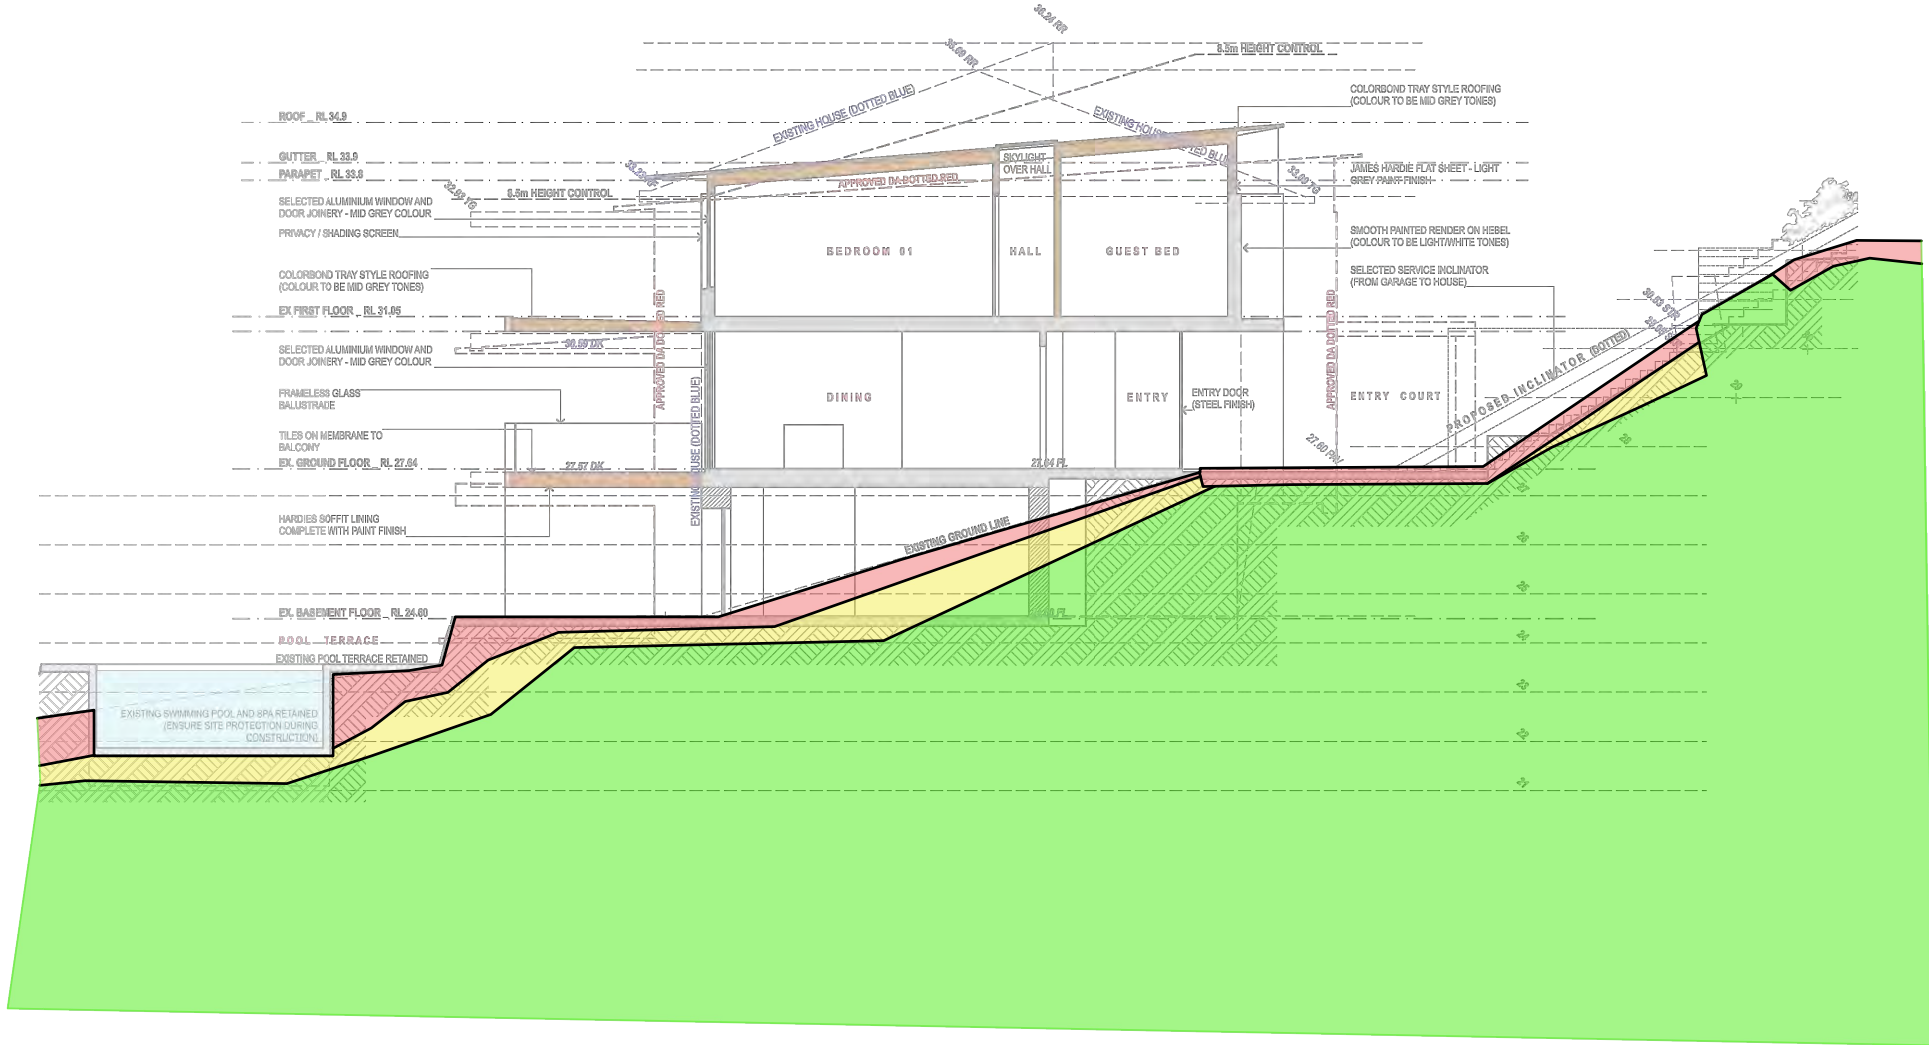
INFERRED GEOLOGICAL SECTION
SCALE NTS

INTERPRETED SUBSURFACE SECTION ONLY.
ACTUAL GROUND CONDITIONS MAY VARY.
