17 February 2019

Project No.: G2002

## **RE: Preliminary Geotechnical Assessment Report for 11 Sherwood Crescent, Narraweena**

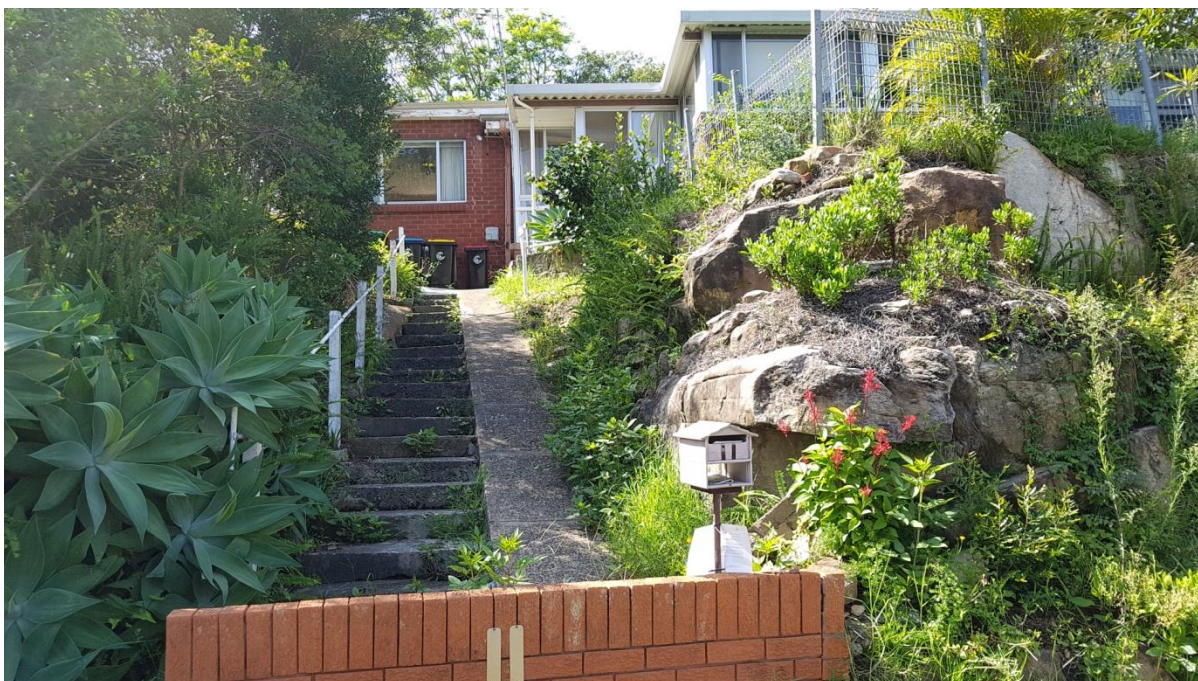
Front left side of the property - access to the dwelling (roadside)

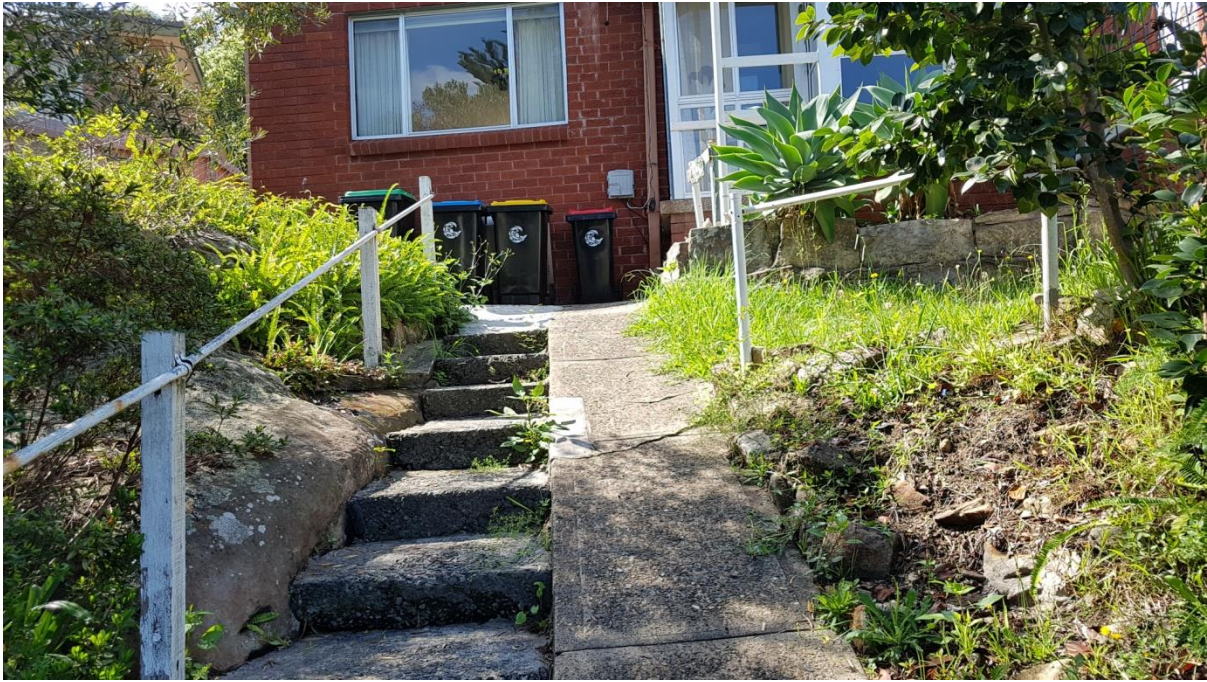
A minor seepage was observed through the fractured rocks near the concrete steps during the site visit. It is anticipated that seepage was occurred due to heavy rain for couple of days before the site visit. The minor seepage could be happened within the excavation, during the rainy season from within the soils overlying bedrock and / or from joints/ bedding defects within the rock mass.

Closer view of the concrete steps and rock outcrops near the dwelling

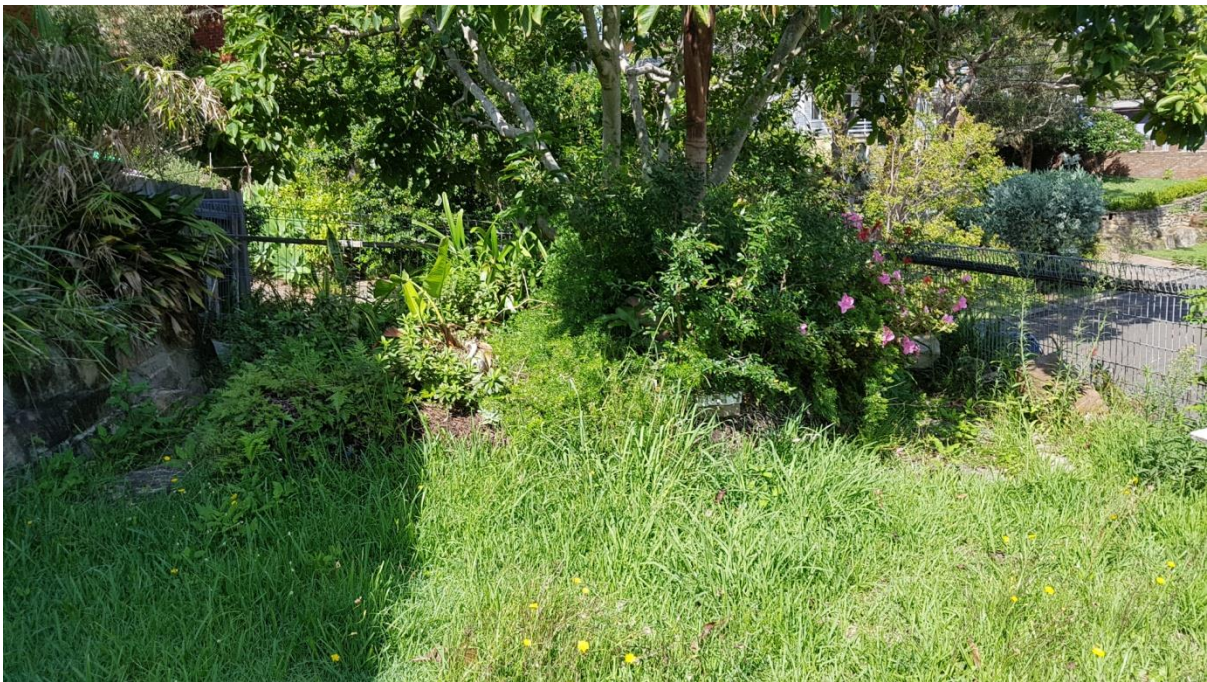
The front yard of the dwelling

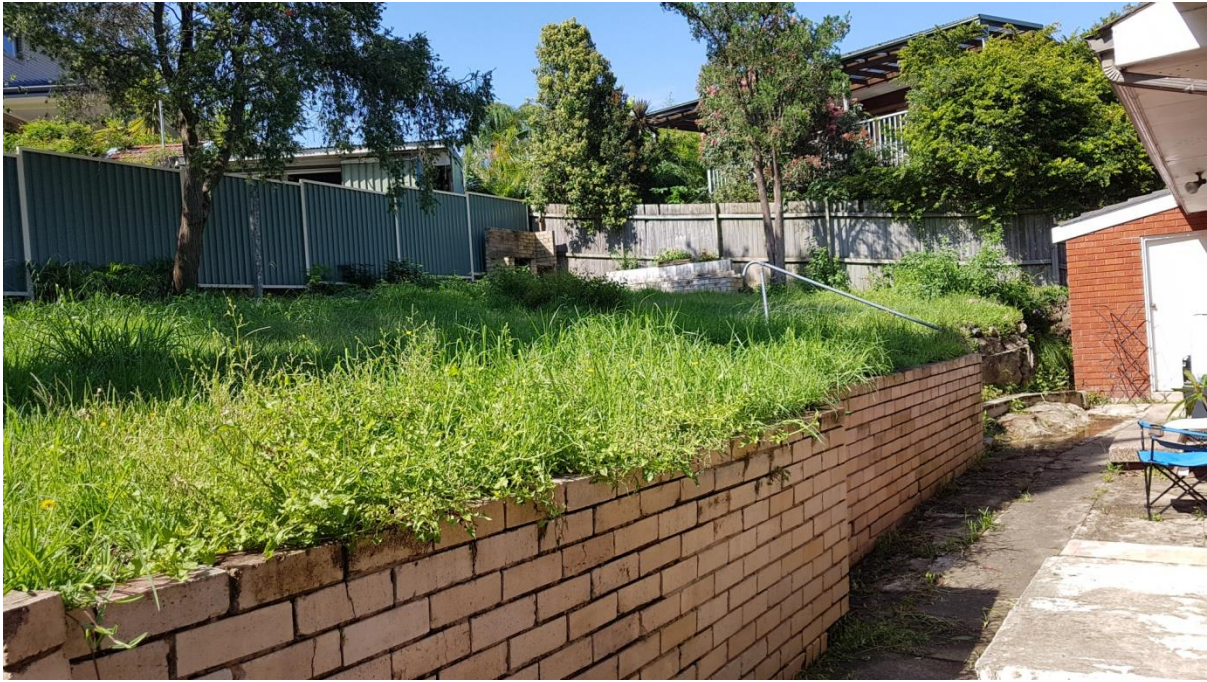
Backyard of the dwelling - exposer of rock at the right corner

The vulnerable boulders and detached rocks next to the excavation site should be carefully removed and relocated in a safe place to prevent from possible boulder roll if any. The strength of the front

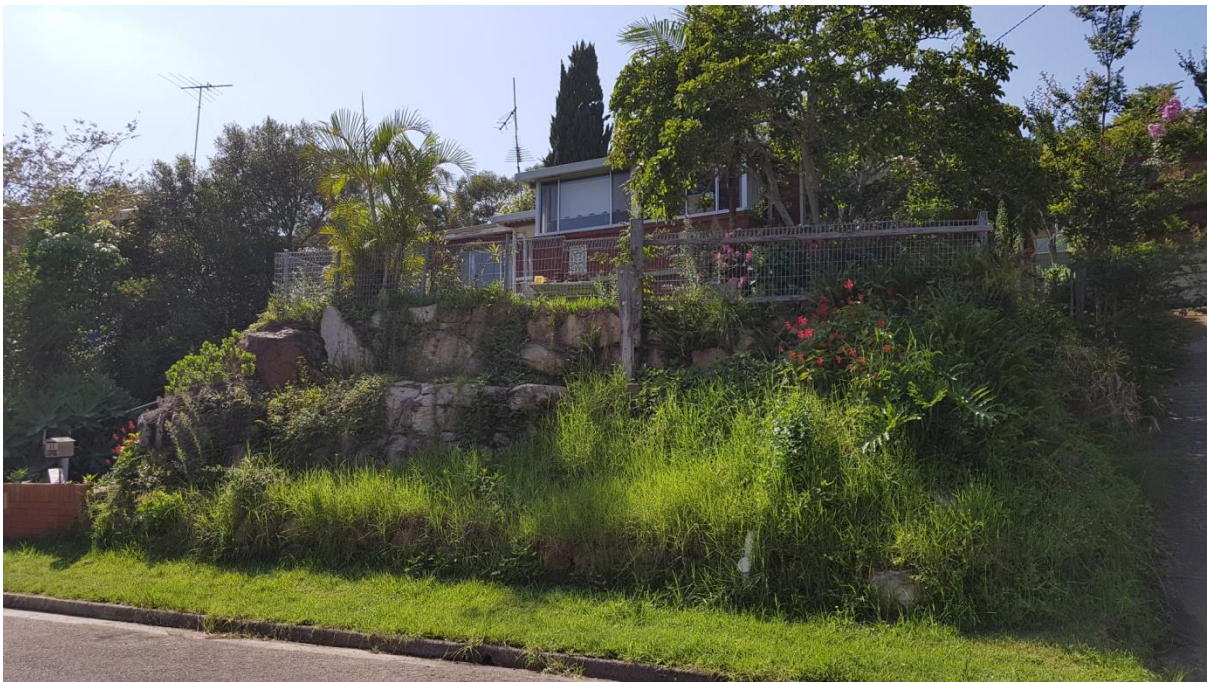
Front view of the dwelling – exposure of rock outcrops and rock wall

rock wall next to the excavation adjacent to the road should be assessed and strengthened where necessary.

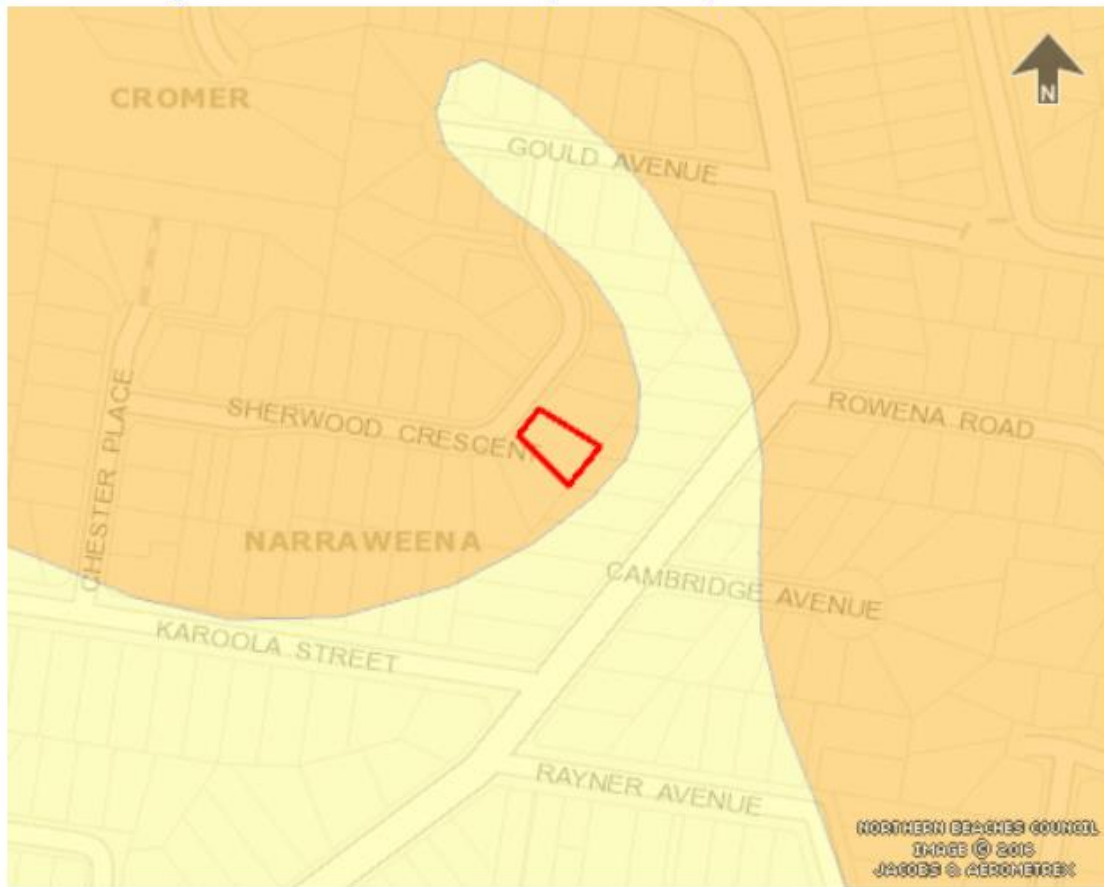
Figure 4. Council Landslip Risk Map of the site

Based on the council landslip risk map, the site is located at the Area B as shown in Figure 4. A preliminary assessment of site conditions prepared in accordance with the Checklist for Council's assessment of site conditions has been carried out for the proposed development. Based on the flowchart of the conditions (Figure 5) and need of geotechnical report in Geotechnical Class B and D, it is considered that detailed geotechnical report is not required.

➔ Warringah LEP2011 - Land Slip Risk Map-Area B
