DILAPIDATION REPORT

Lorikeet Grove, Warriewood

This report is intended to be a record of the council assets at Lorikeet Grove, Warriewood at the time of the inspection.

The inspection was carried out on 11 November 2024.

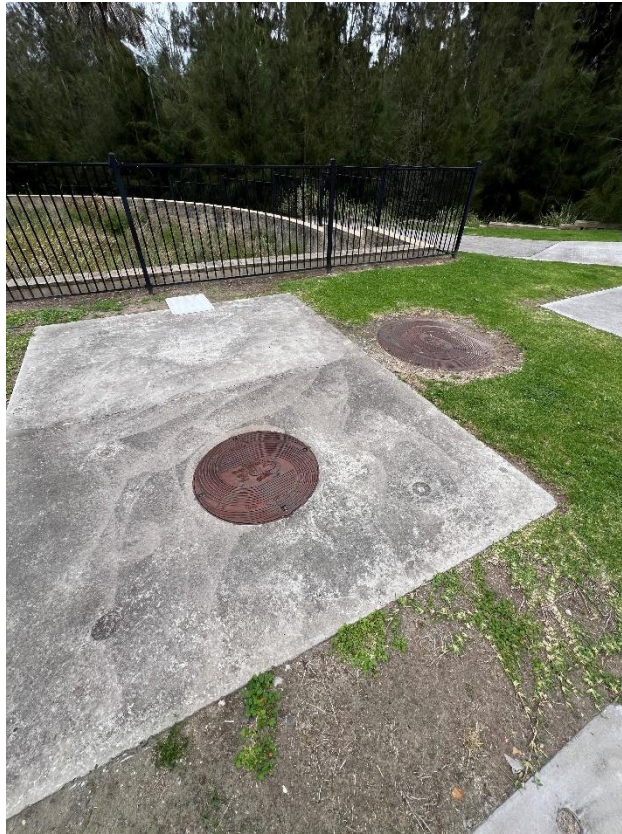
Figure 1 – General condition of the pit.

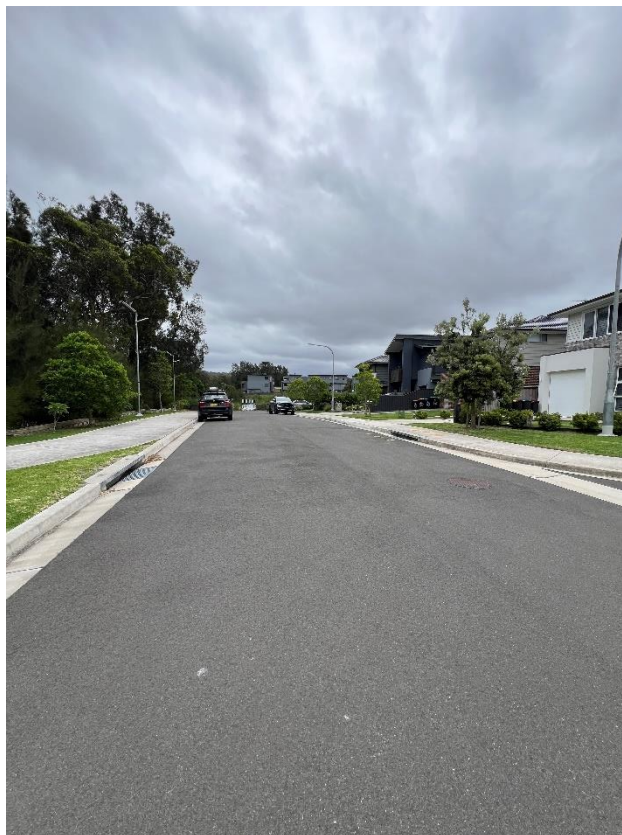
Figure 2 – General condition of the road.

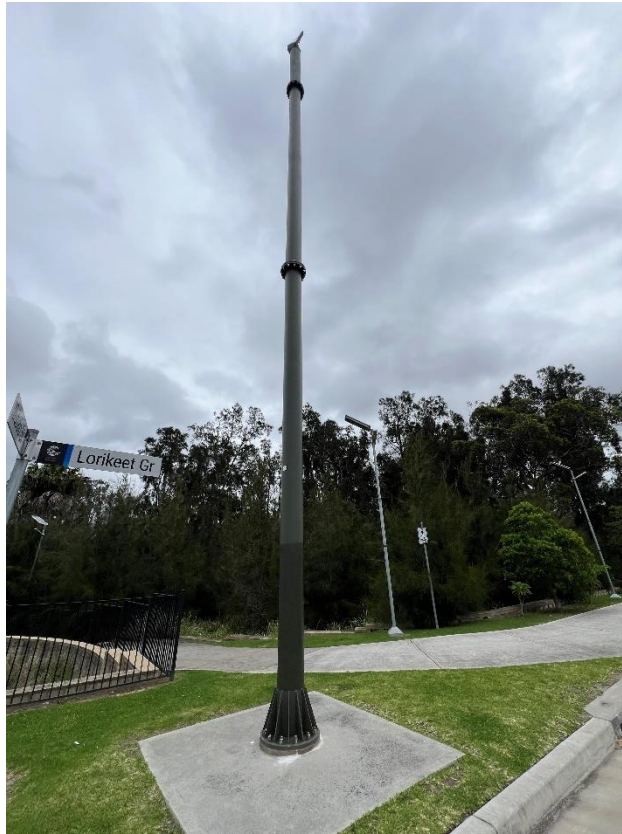
Figure 3 – General condition of the pole.

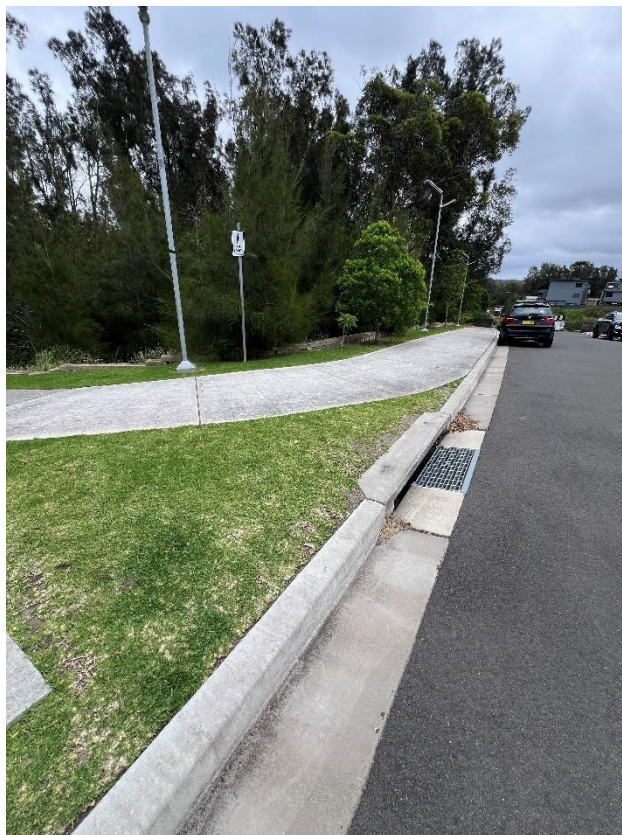
Figure 4 – General condition of the kerb.

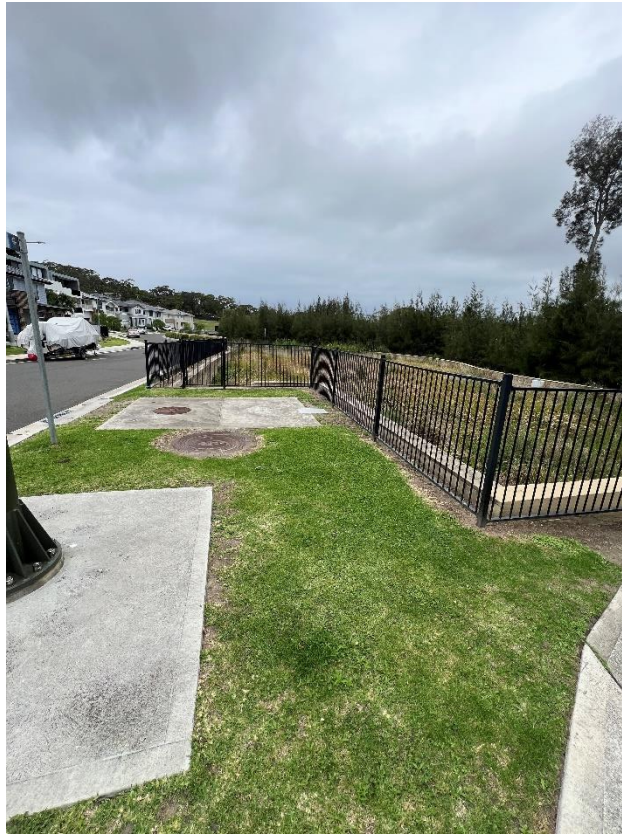
Figure 5 – General condition of the nature strip.

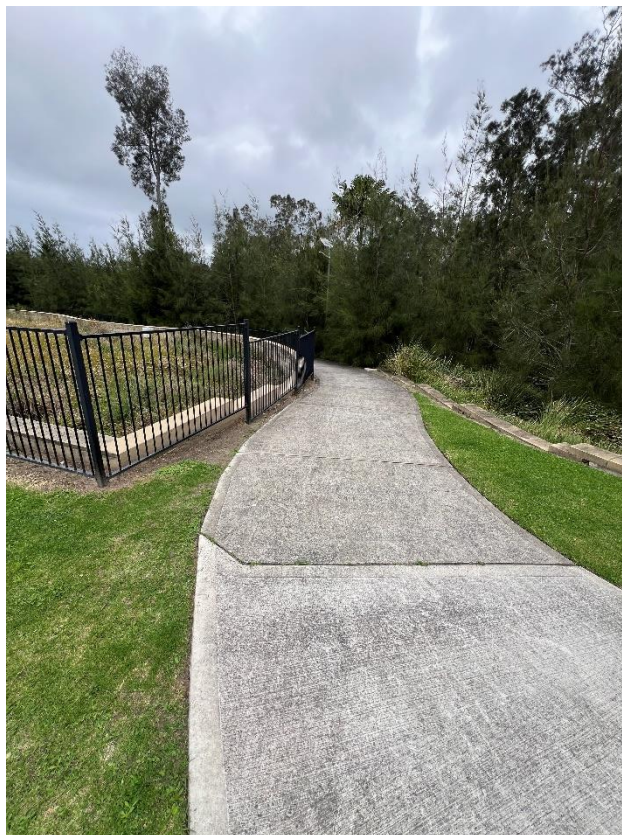
Figure 6 – General condition of the footpath.

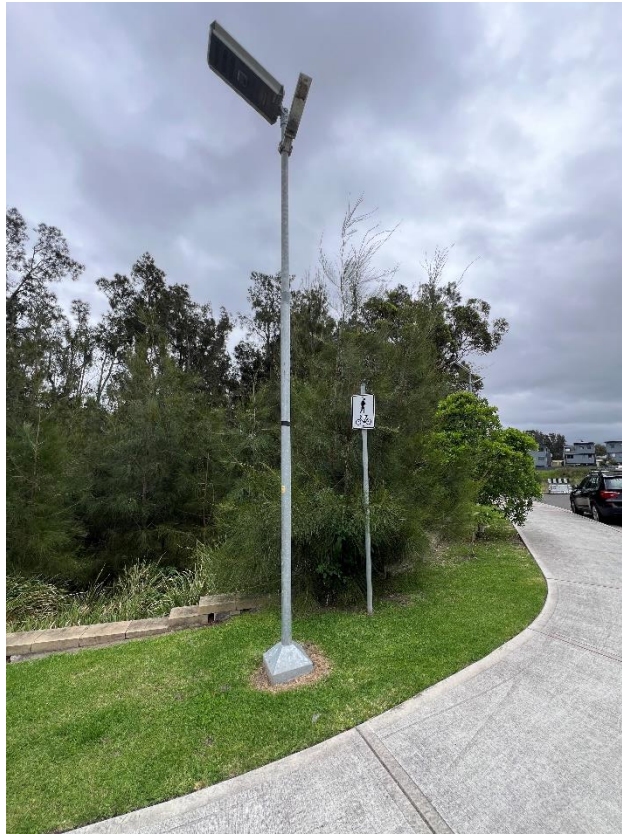
Figure 7 – General condition of the street/traffic post.

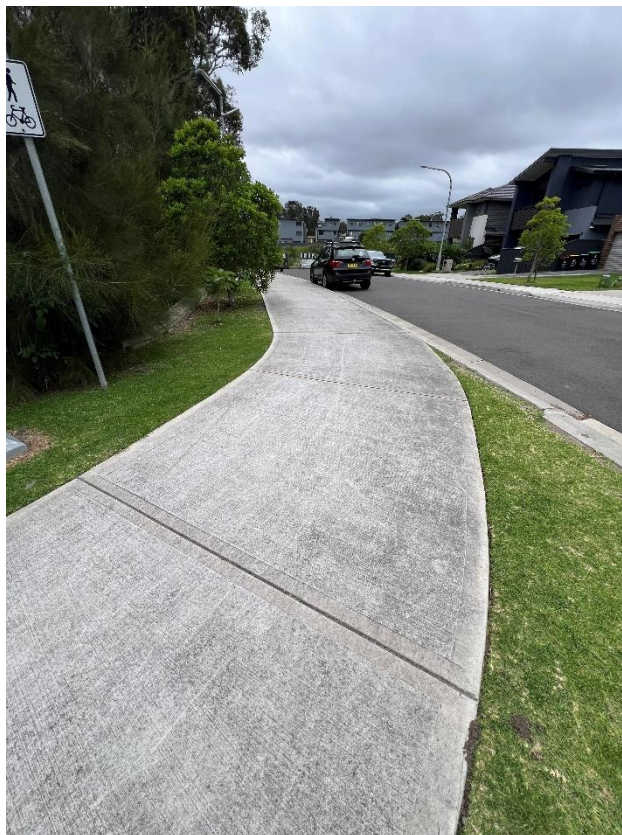
Figure 8 – General condition of the footpath.

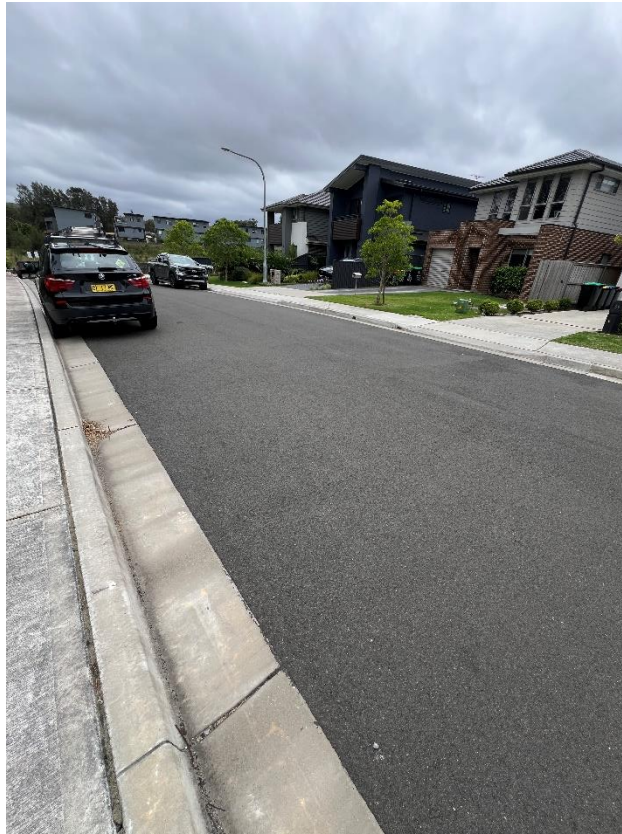
Figure 9 – General condition of the kerb/road.

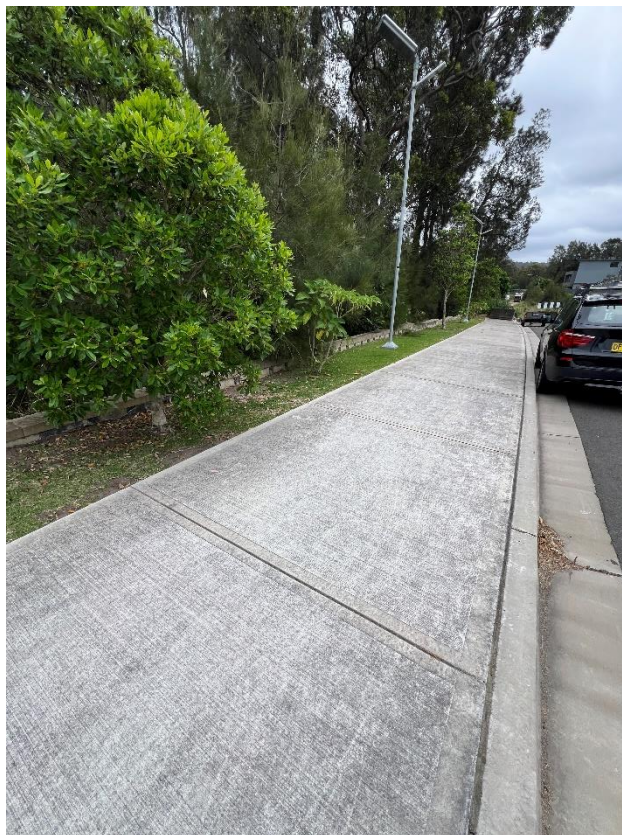
Figure 10 – General condition of the footpath.

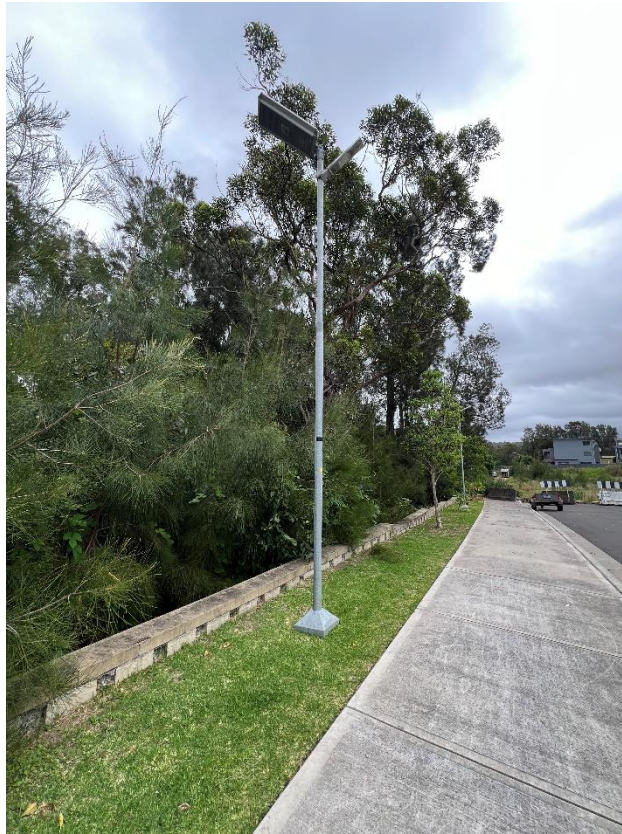
Figure 11 – General condition of the street light.

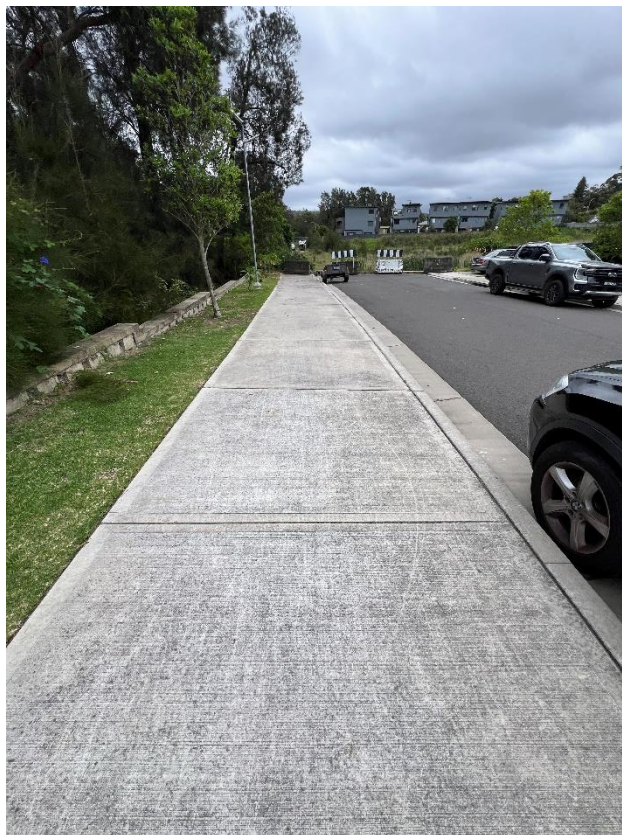
Figure 12 – General condition of the footpath.

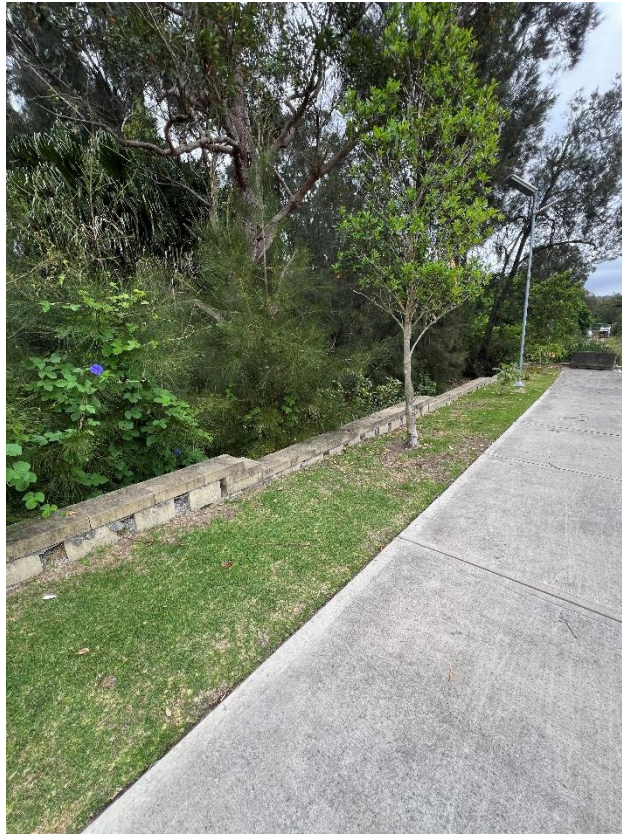
Figure 13 – General condition of the retaining wall/nature strip.

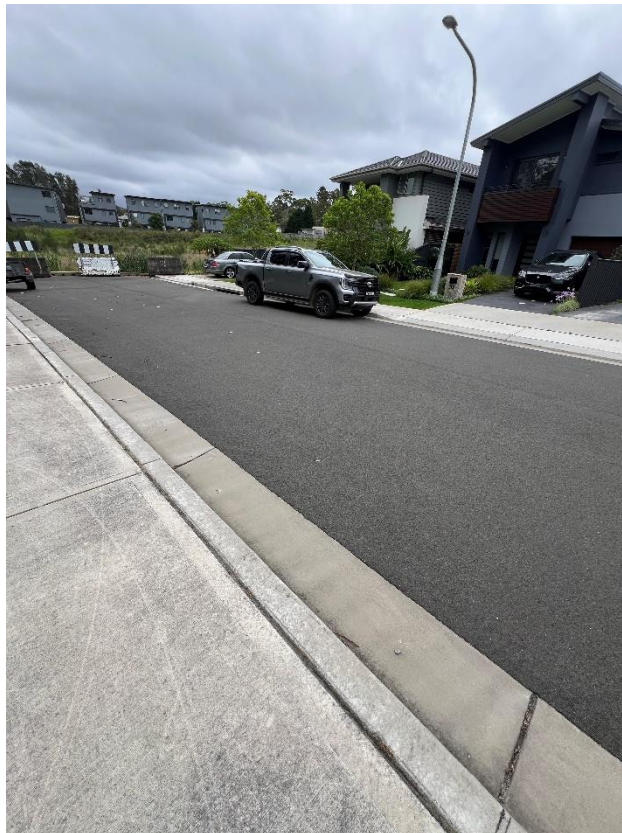
Figure 14 – General condition of the kerb/road.

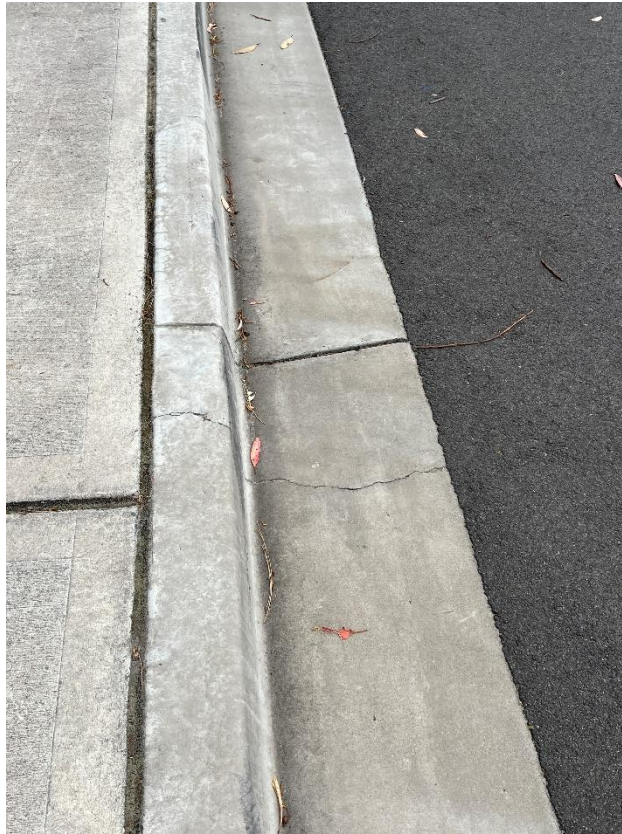
Figure 15 – Crack is evident to the kerb.

The council assets were found to be in a fair condition with evidence of crack to the driveway, kerb and footpath.

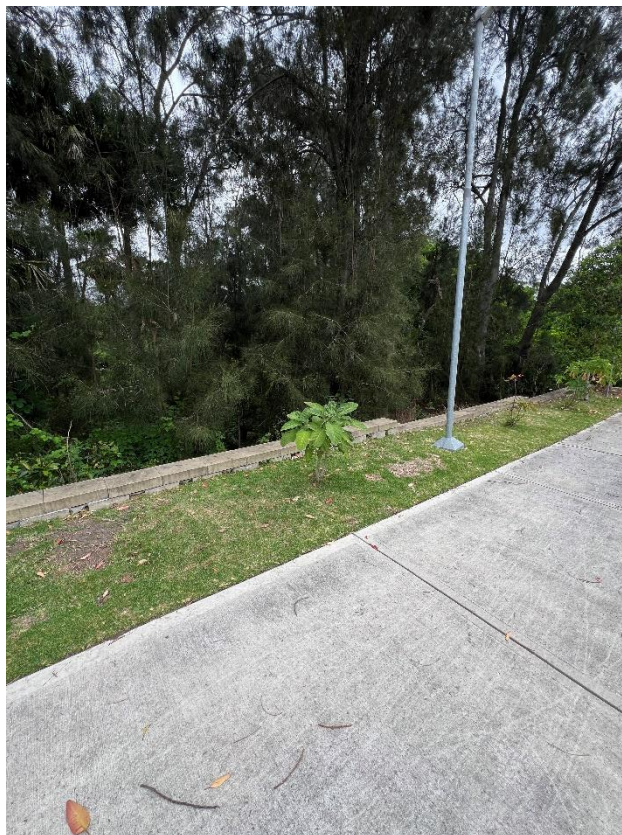
Figure 16 – General condition of the footpath/nature strip.

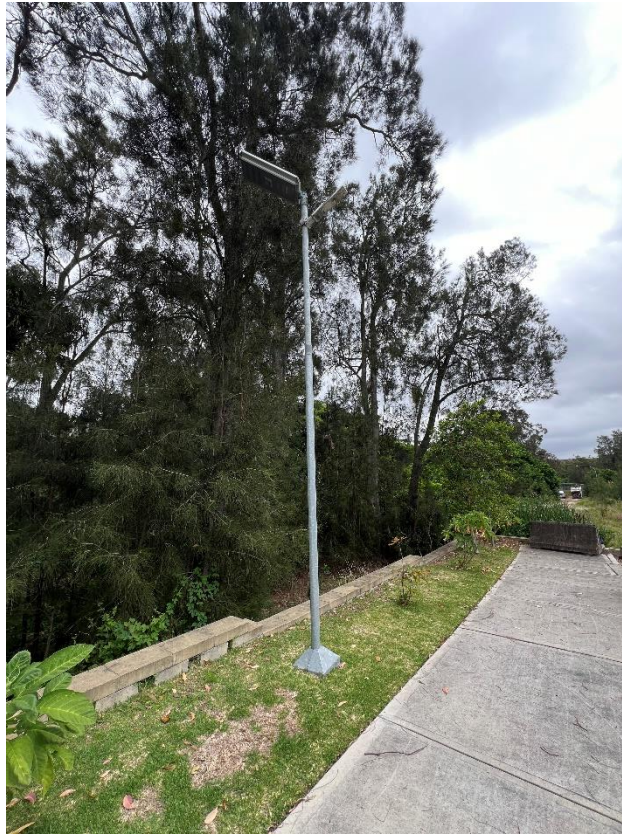
Figure 17 – General condition of the street light.

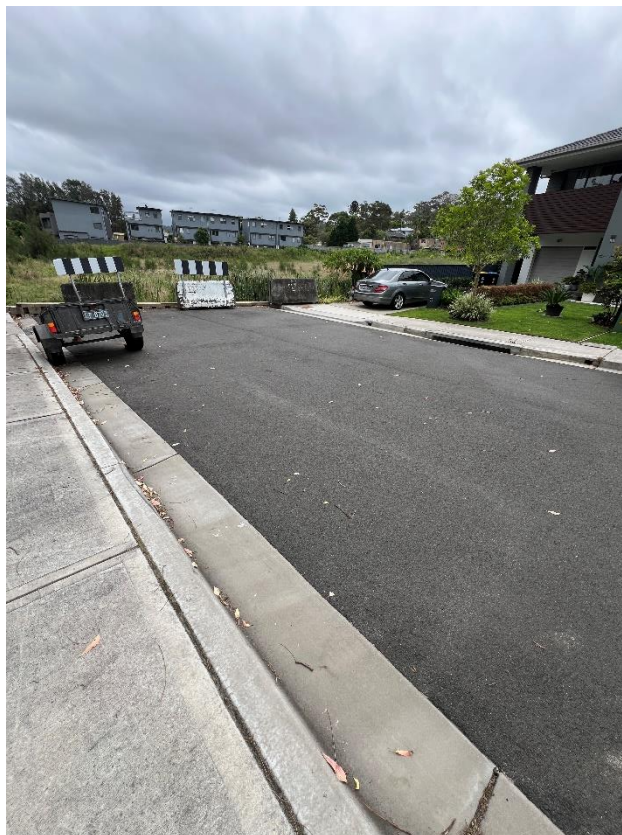
Figure 18 – General condition of the kerb/road.

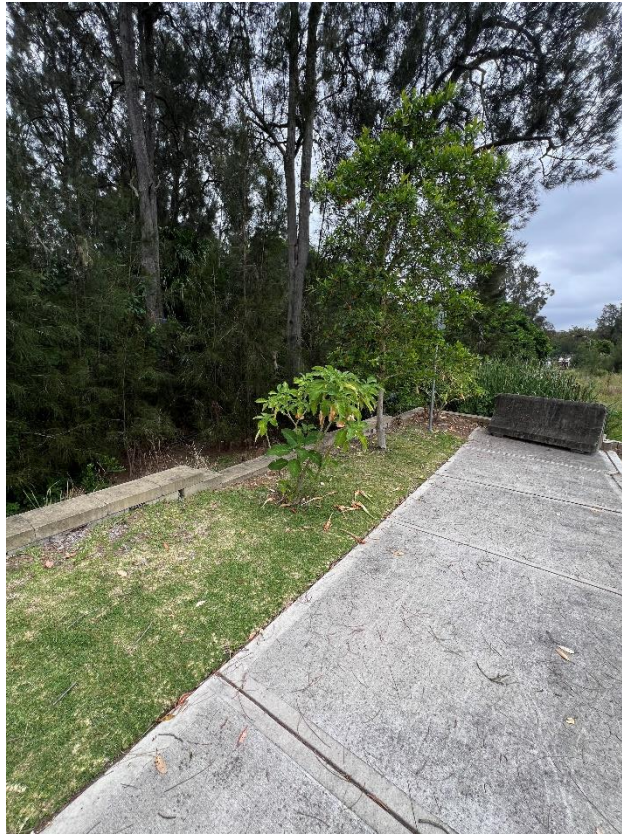
Figure 19 – General condition of the footpath.

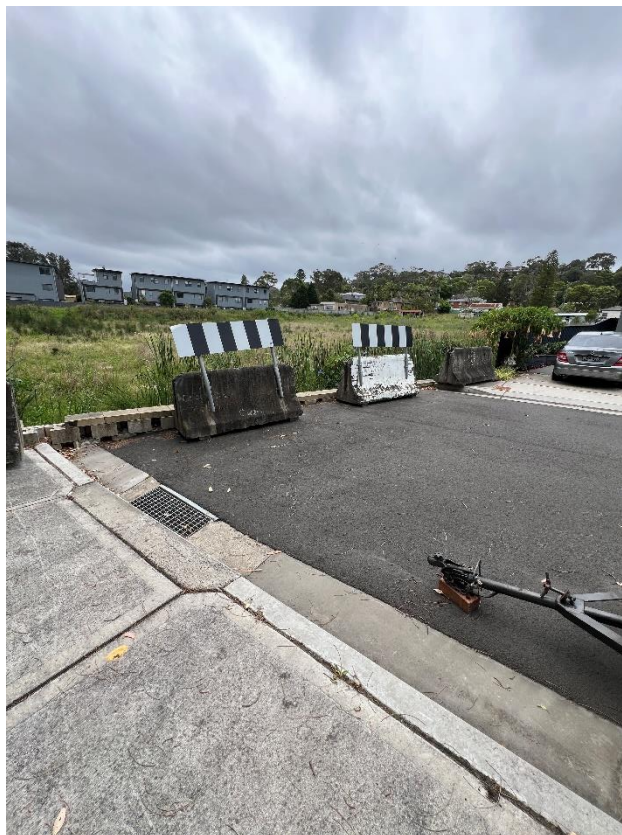
Figure 20 – General condition of the kerb/pit.

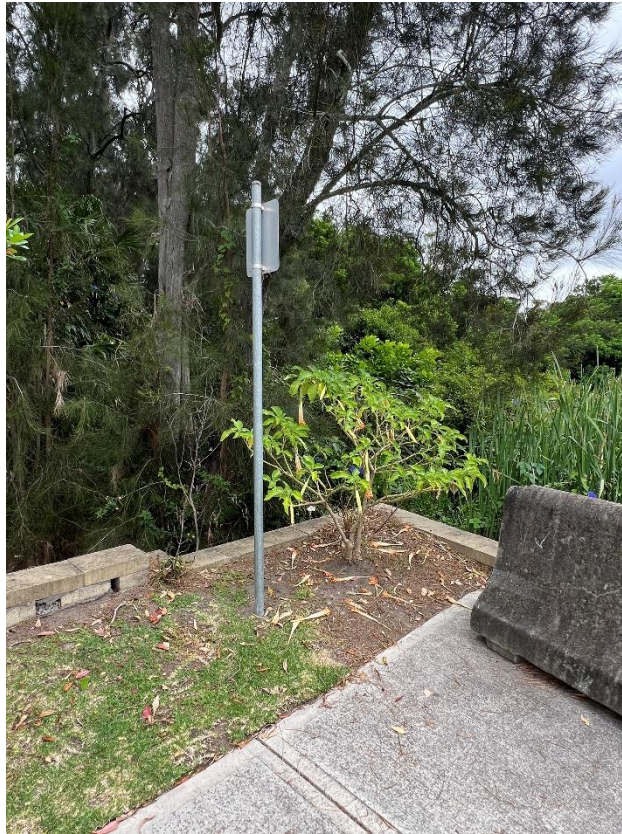
Figure 21 – General condition of the street signpost.

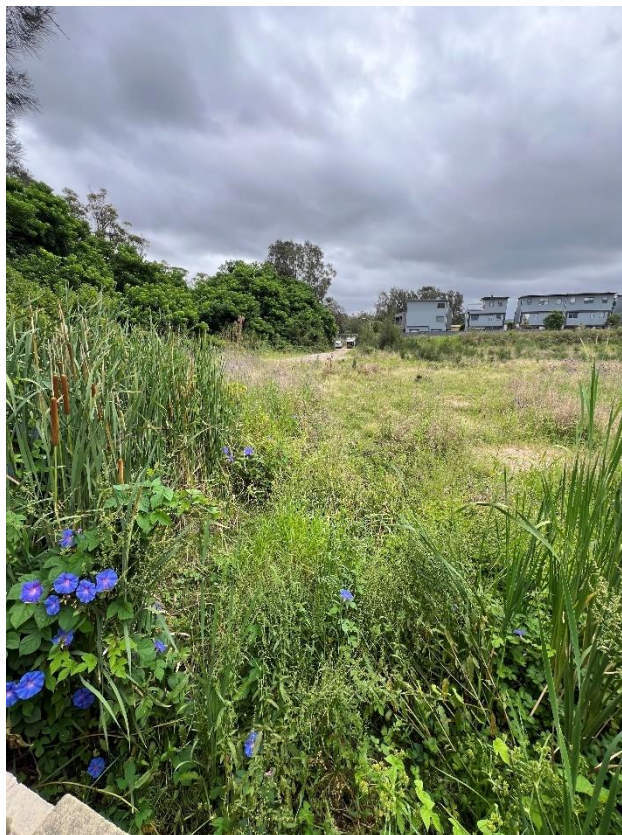
Figure 22 – General condition of the nature strip.

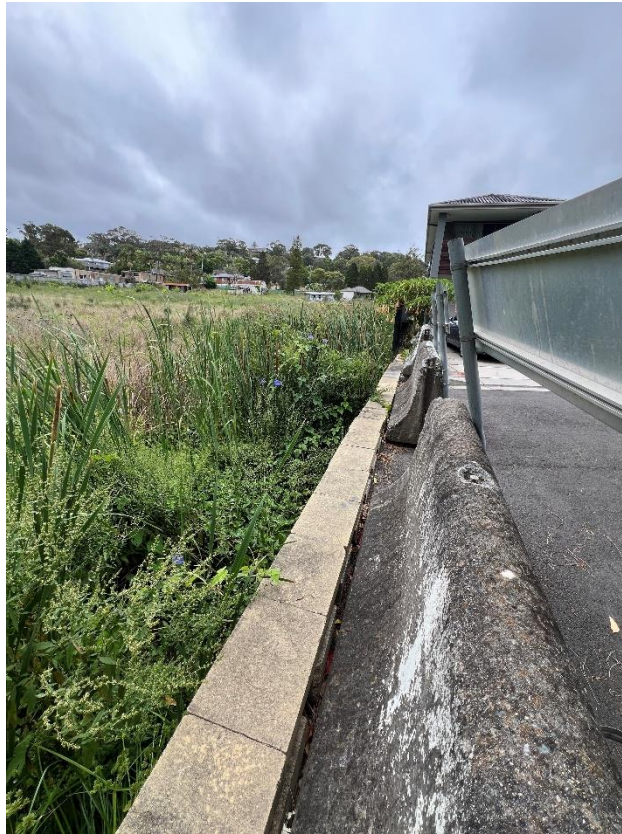
Figure 23 – General condition of the concrete barrier.

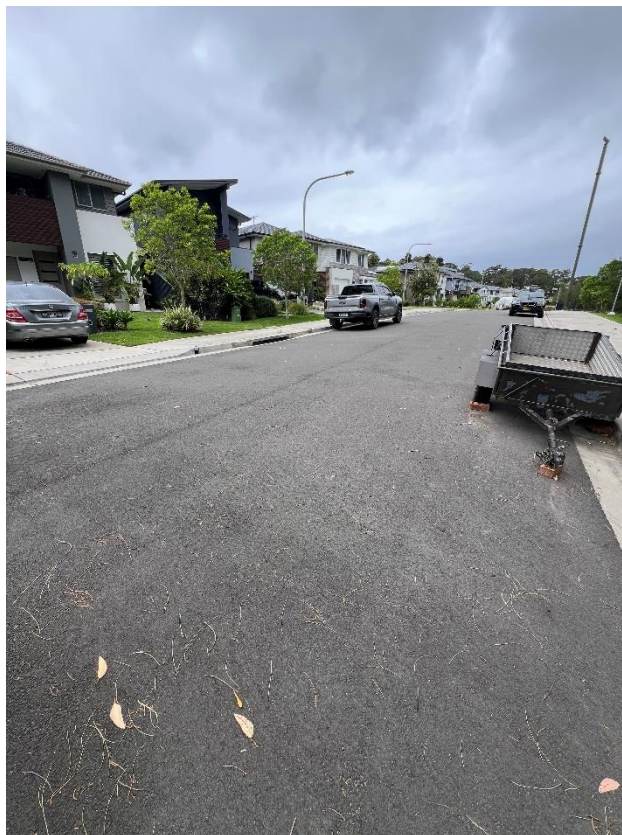
Figure 24 – General condition of the road.

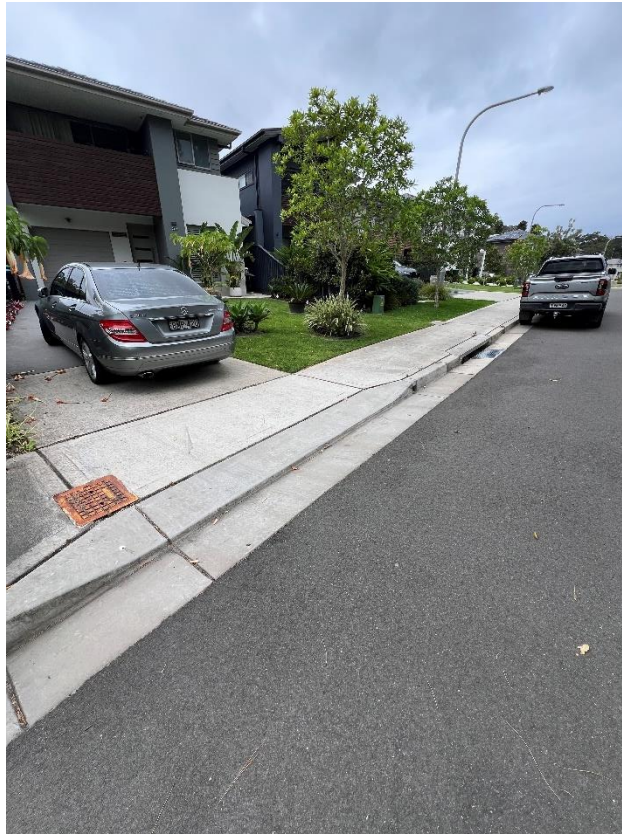
Figure 25 – General condition of the driveway.

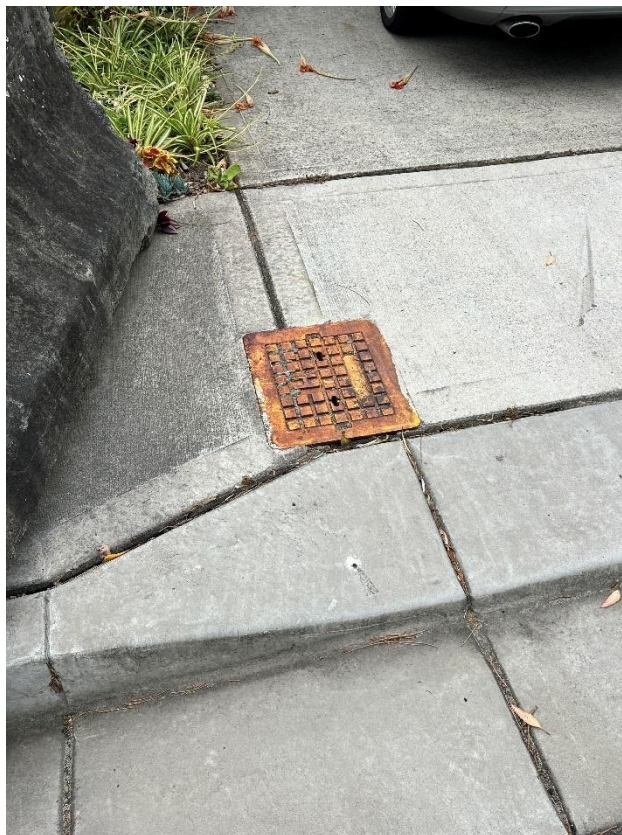
Figure 26 – General condition of the utility lid.

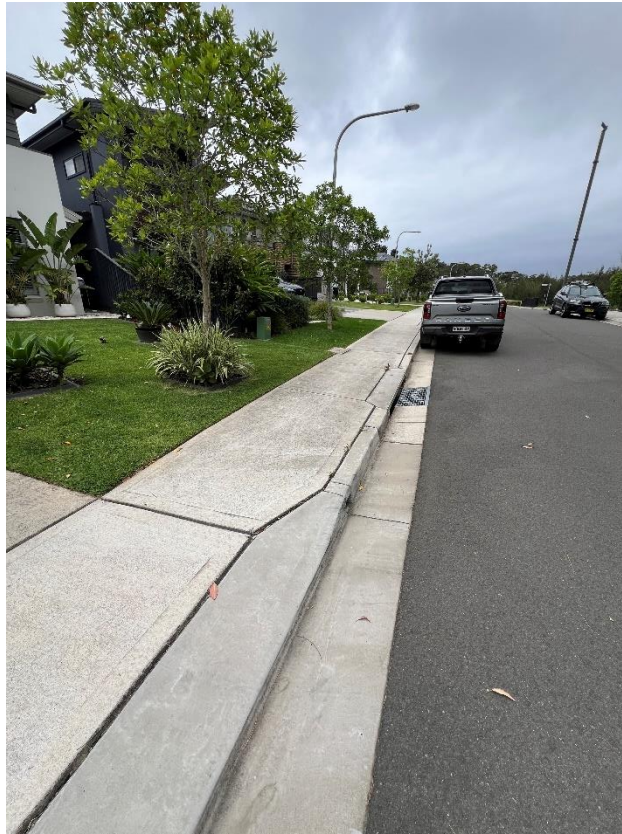
Figure 27 – General condition of the footpath/kerb.

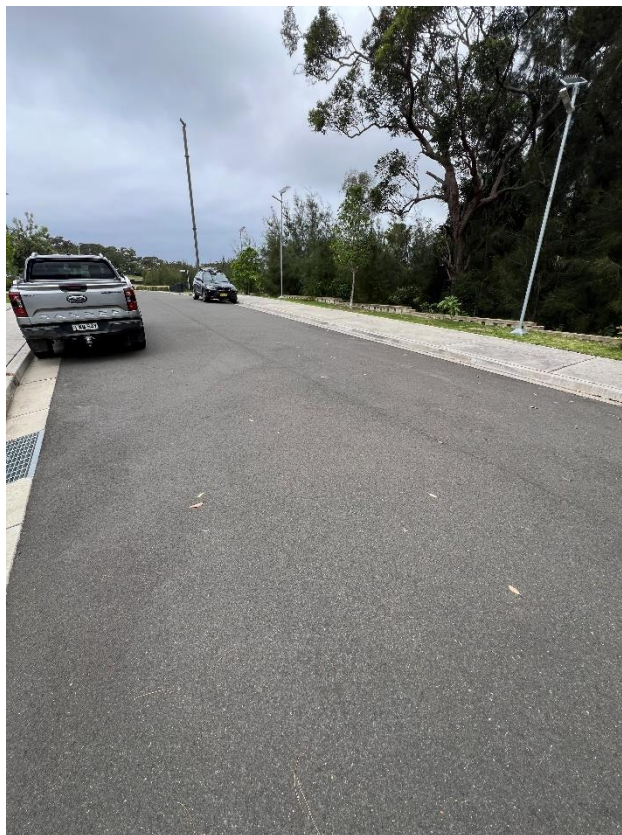
Figure 28 – General condition of the road.

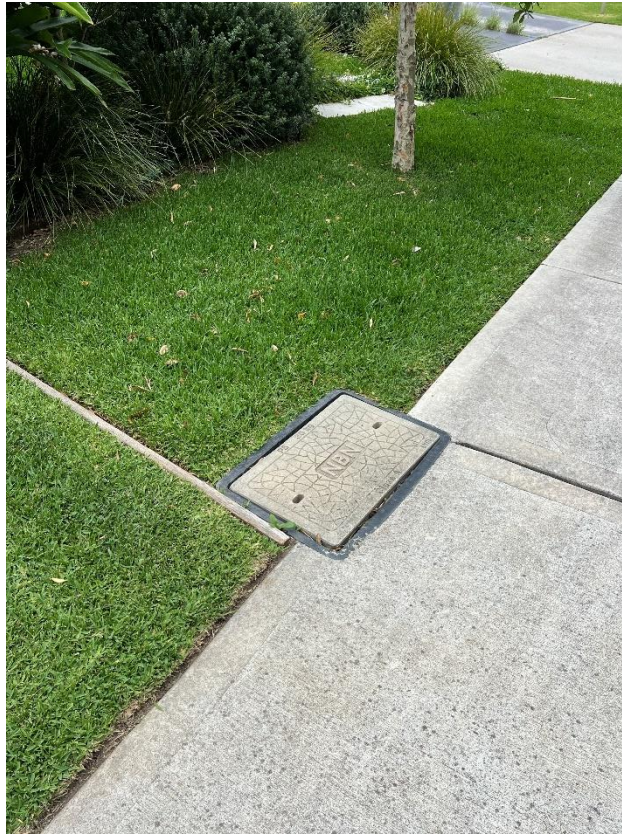
Figure 29 – General condition of the pit.

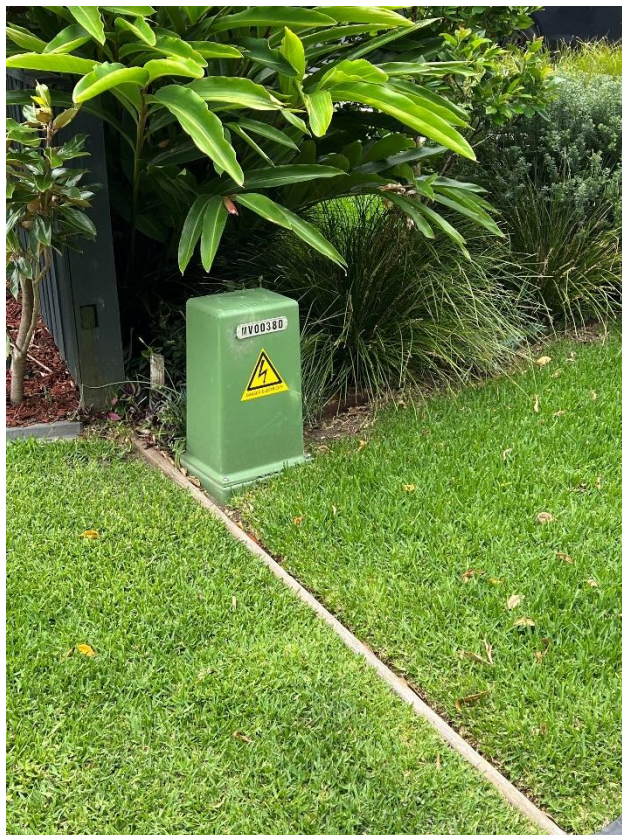
Figure 30 – General condition of the transformer box.

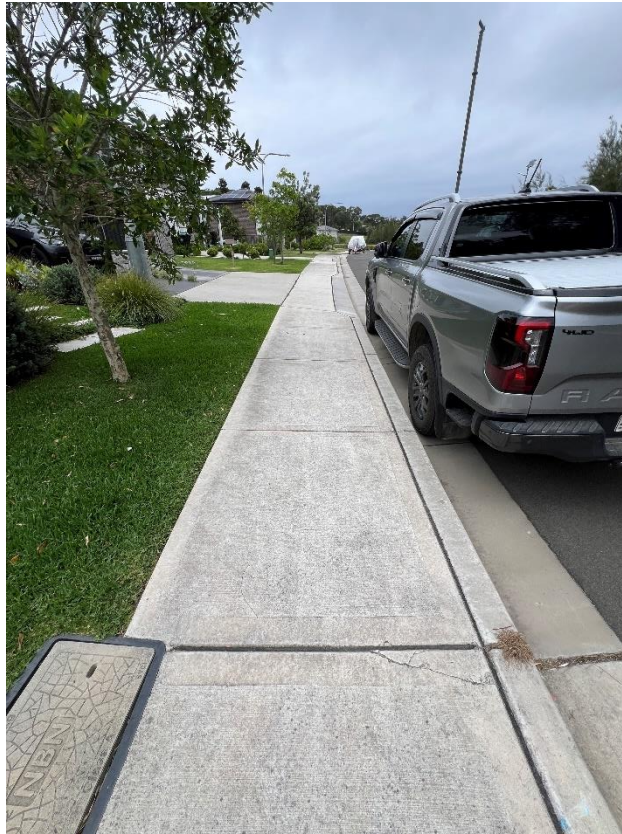
Figure 31 – Crack is evident to the footpath.

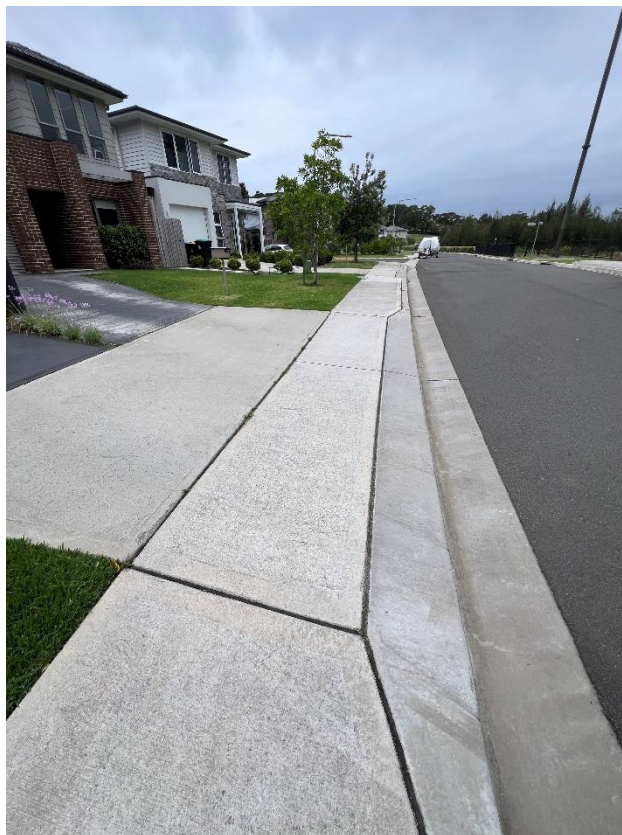
Figure 32 – General condition of the driveway.

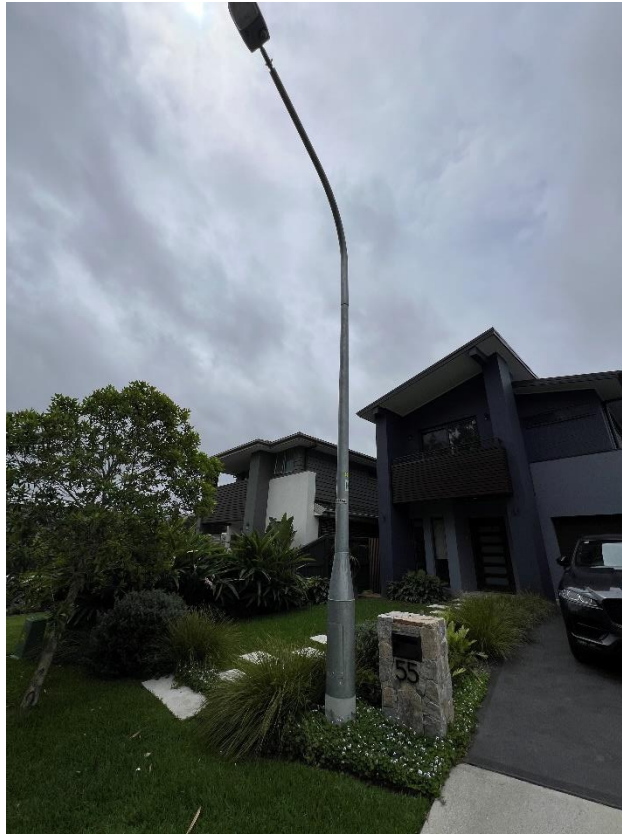
Figure 33 – General condition of the street light.

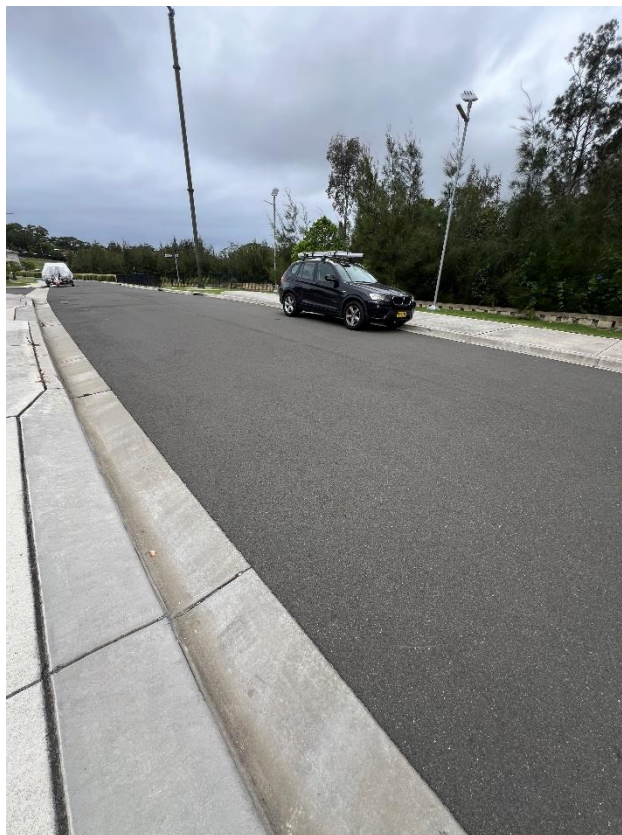
Figure 34 – General condition of the kerb/road.

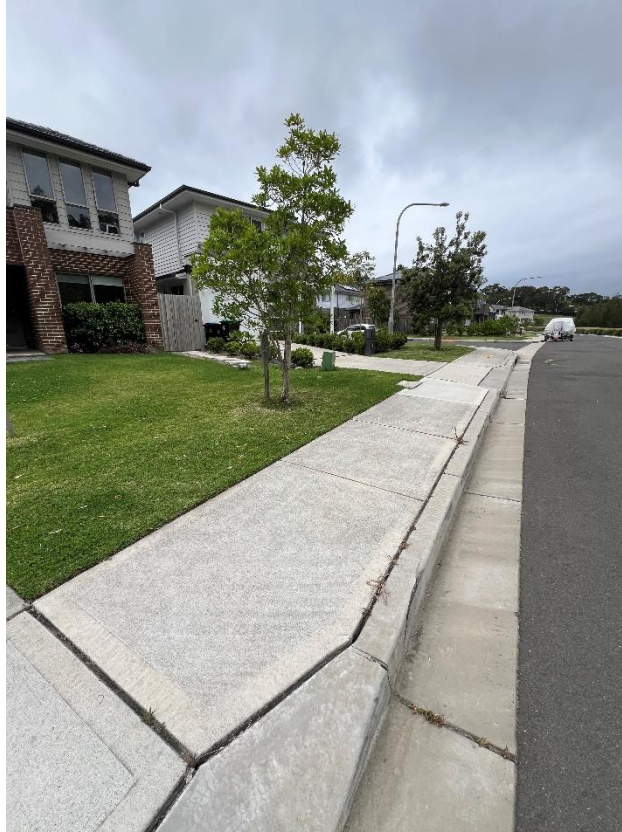
Figure 35 – General condition of the footpath.

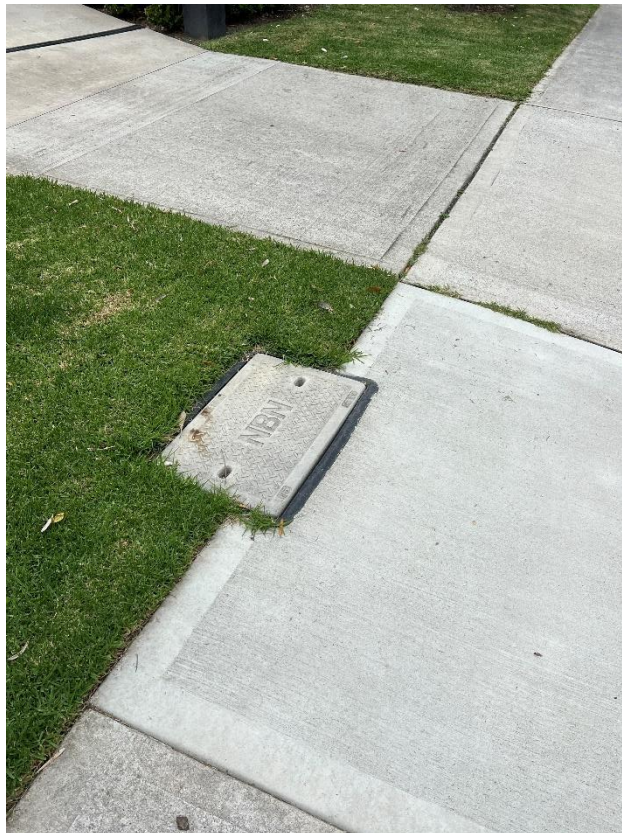
Figure 36 – General condition of the pit.

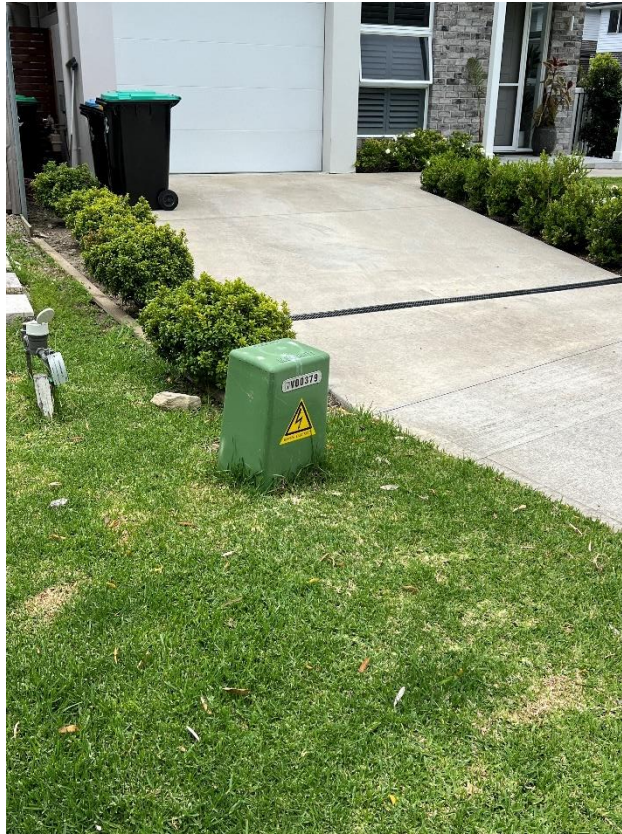
Figure 37 – General condition of the transformer box.

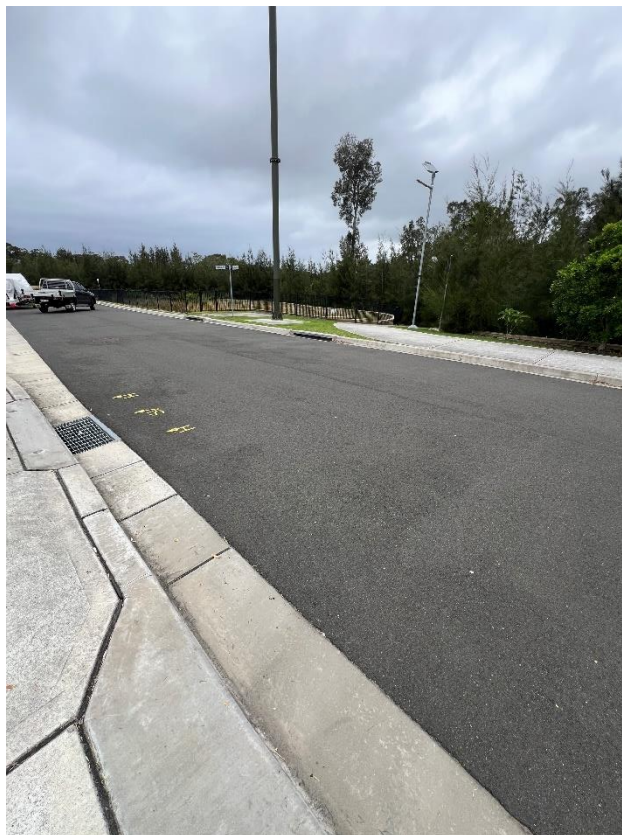
Figure 38 – General condition of the road.

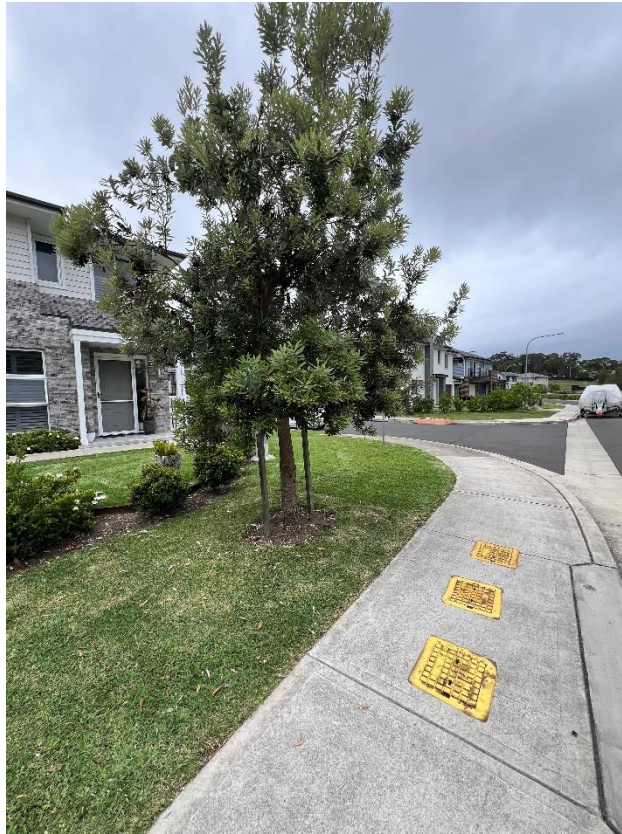
Figure 39 – General condition of the tree.

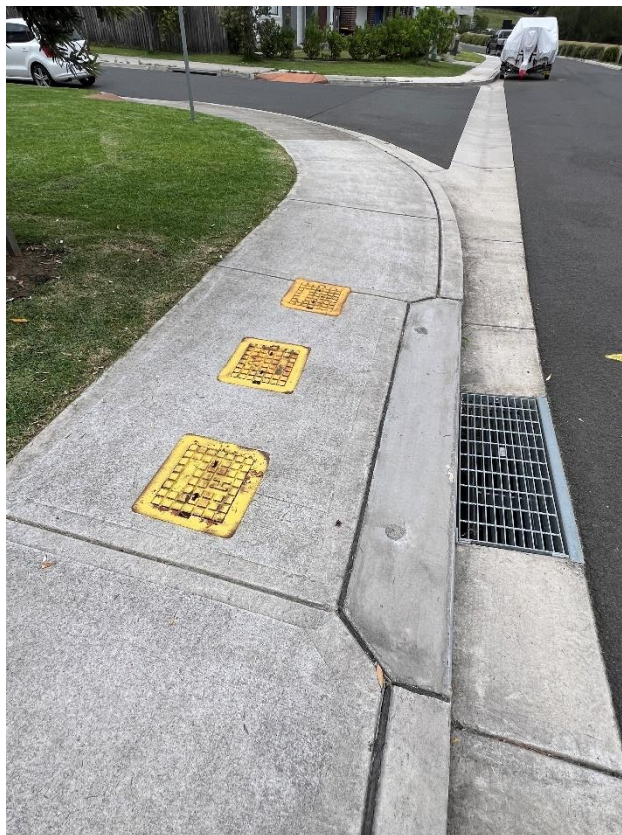
Figure 40 – General condition of the footpath/utility lid.

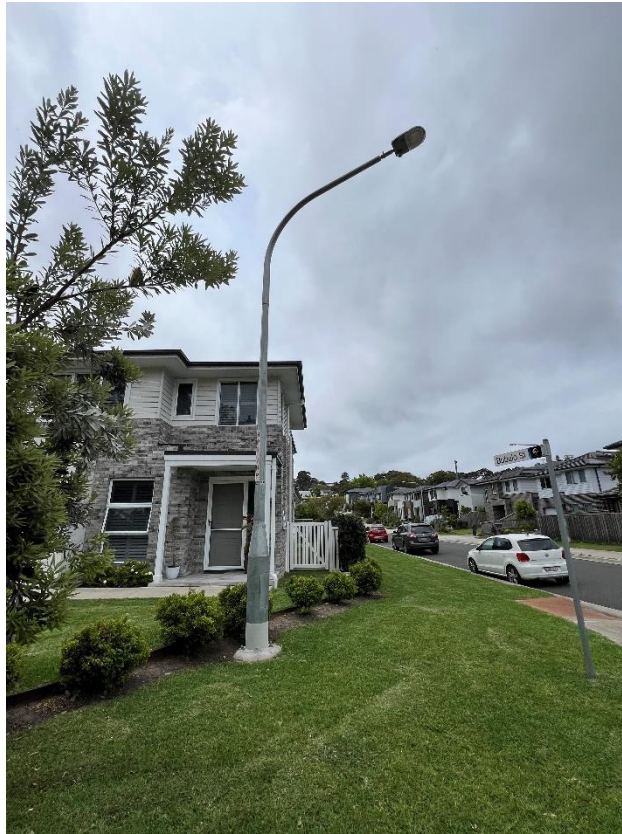
Figure 41 – General condition of the street light.

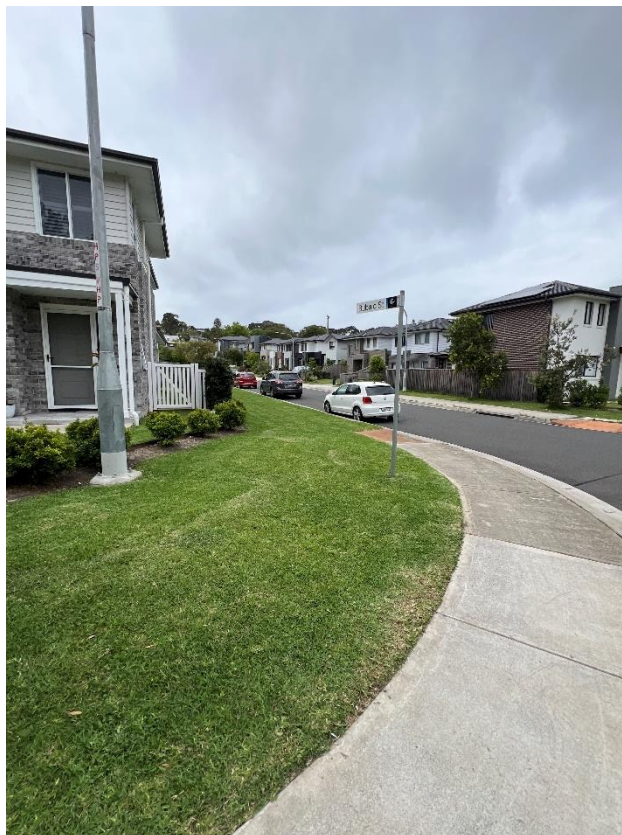
Figure 42 – General condition of the footpath/nature strip.

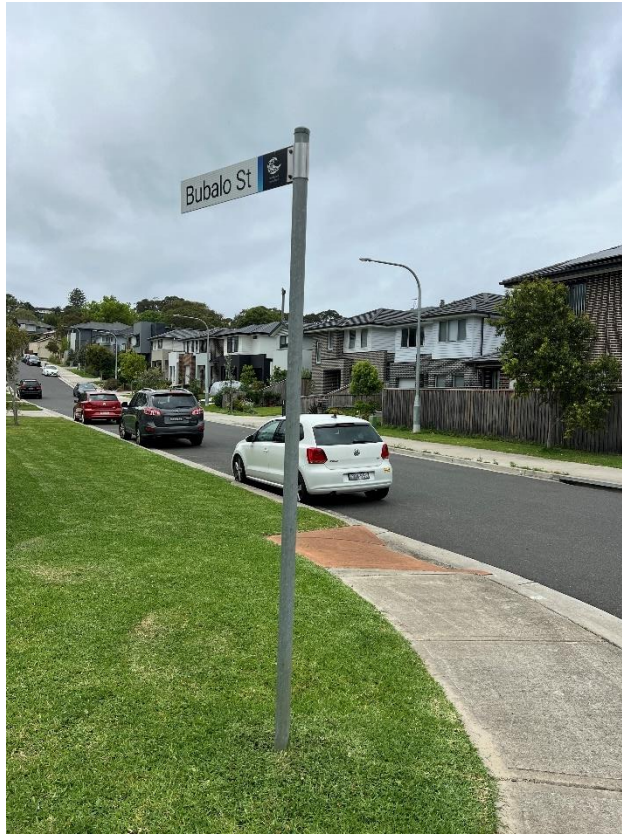
Figure 43 – General condition of the street signpost.
