DILAPIDATION REPORT

Lorikeet Grove, Warriewood

This report is intended to be a record of the council assets at Lorikeet Grove, Warriewood at the time of the inspection.

The inspection was carried out on 11 November 2024.

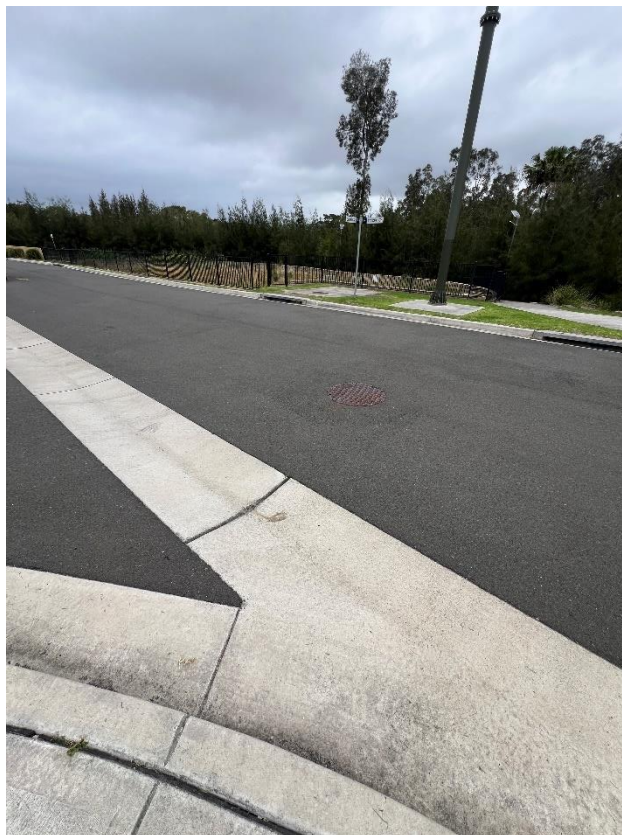
Figure 44 – General condition of the kerb/road.

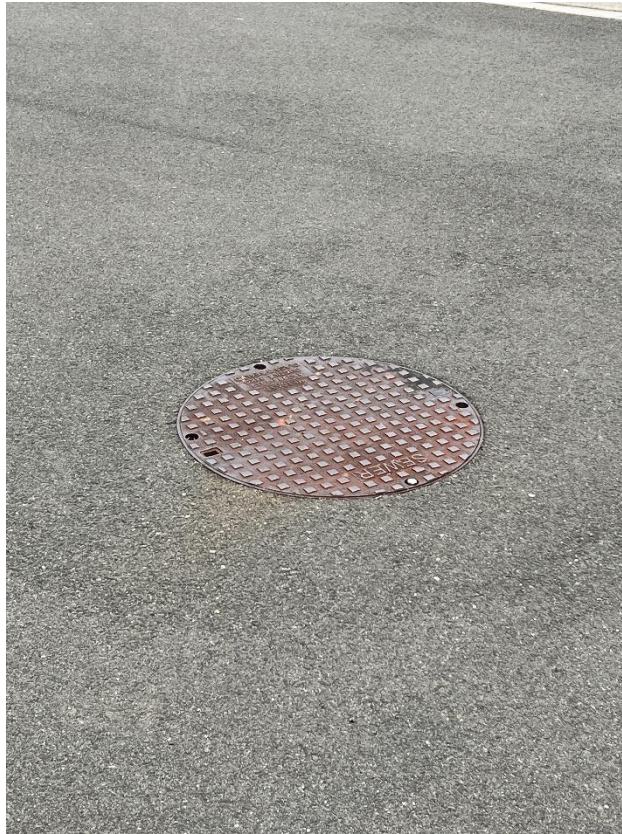
Figure 45 – General condition of the pit.

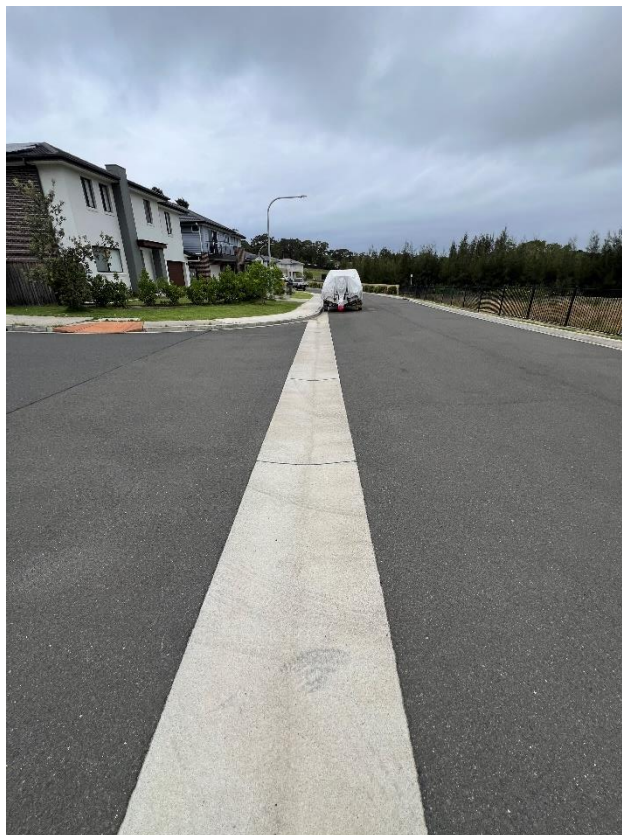
Figure 46 – General condition of the road.

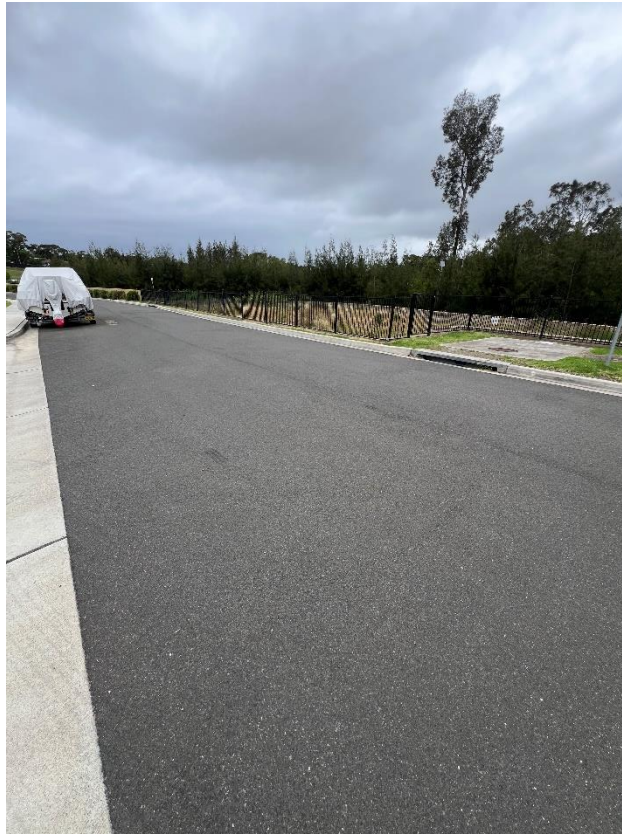
Figure 47 – General condition of the road.

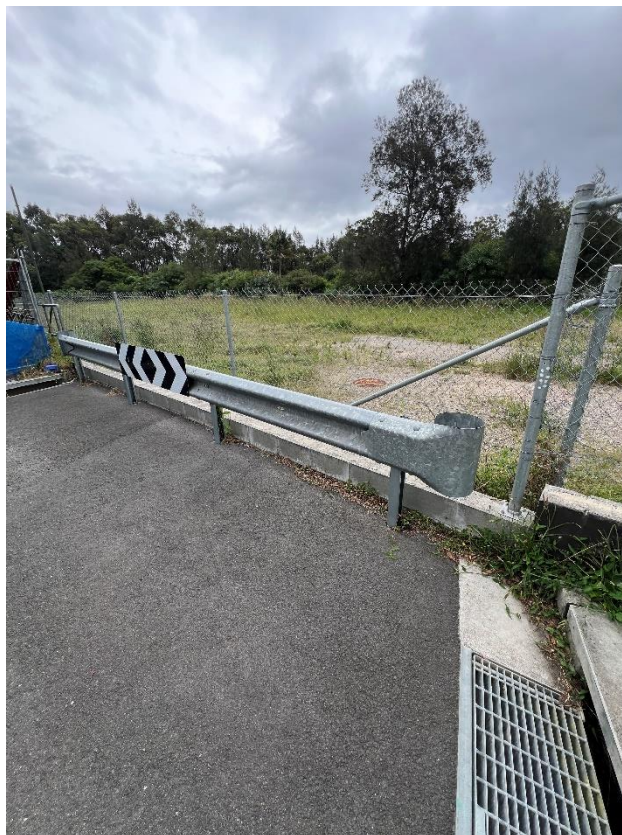
Figure 48 – General condition of the railings.

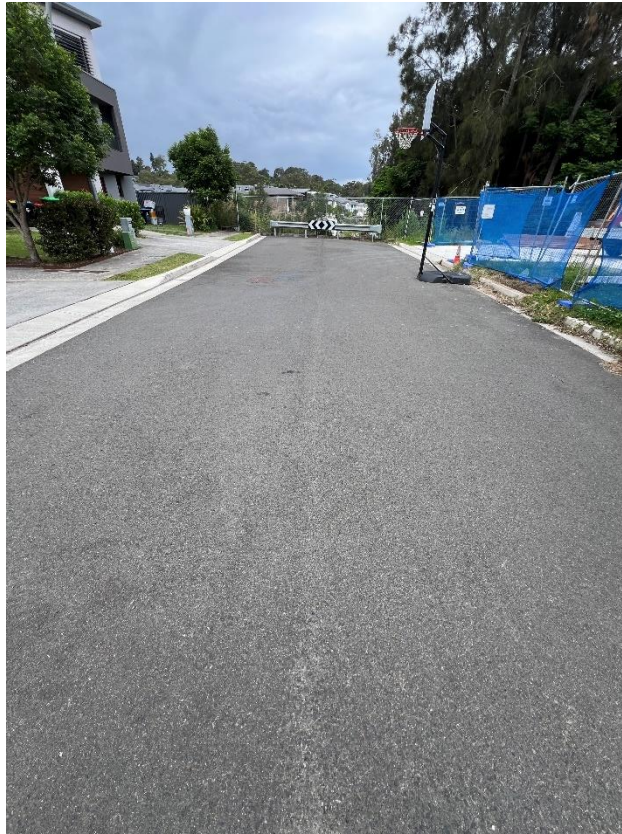
Figure 49 – General condition of the road.

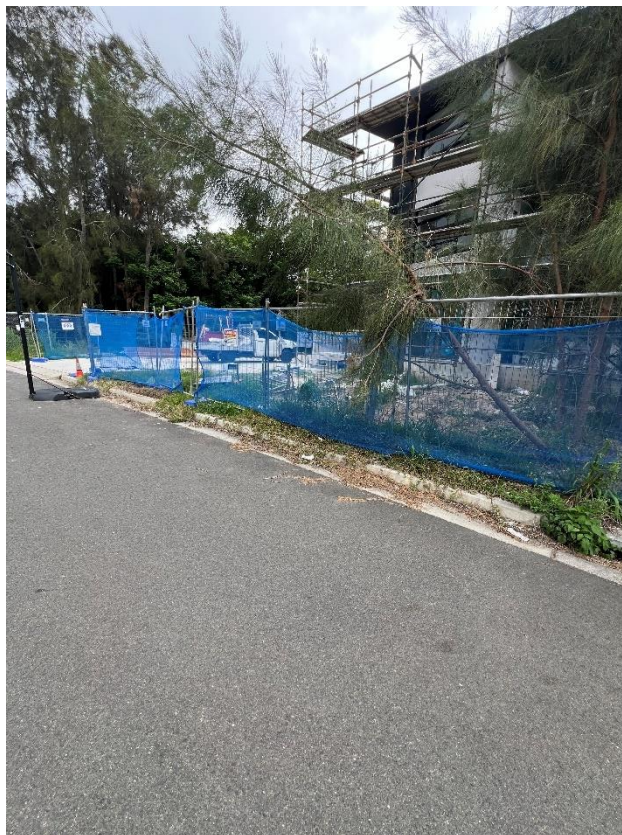
Figure 50 – General condition of the road/kerb.

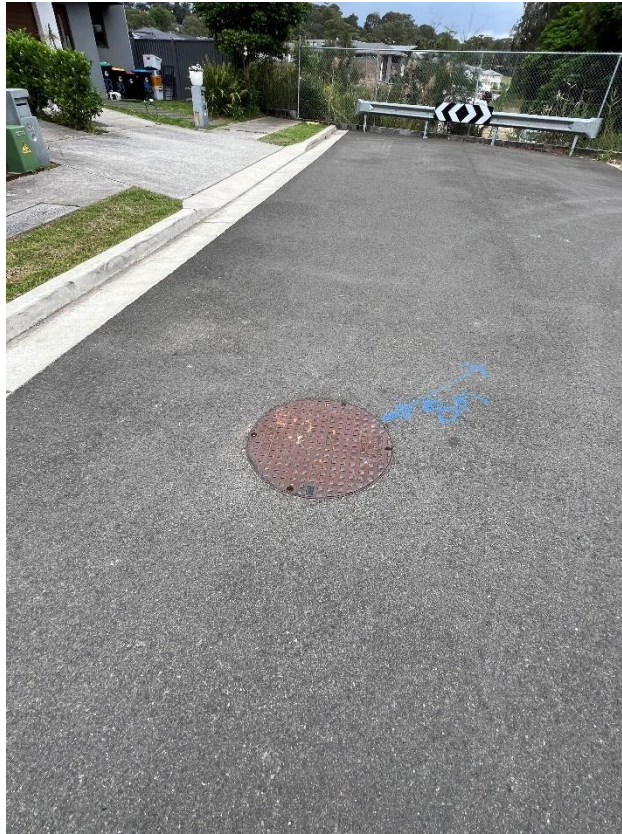
Figure 51 – General condition of the pit.

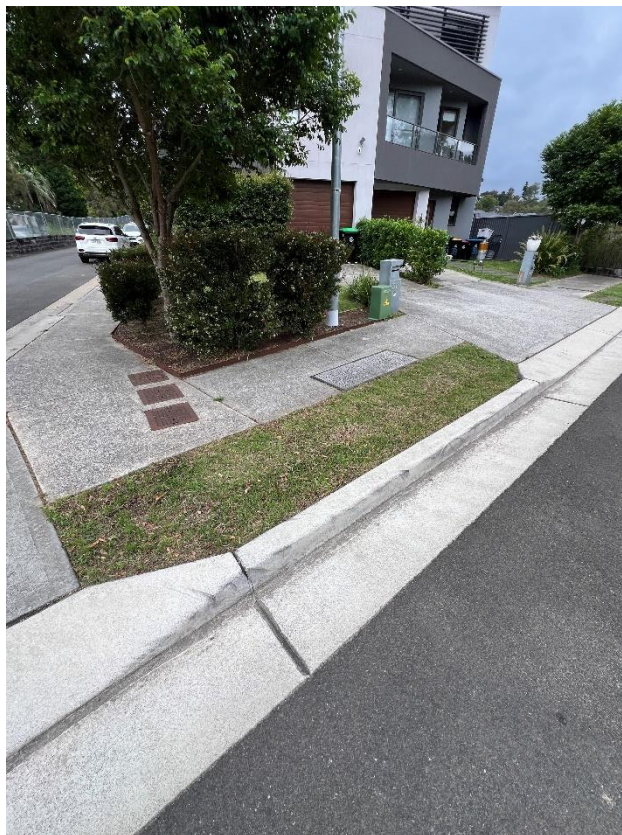
Figure 52 – General condition of the kerb.

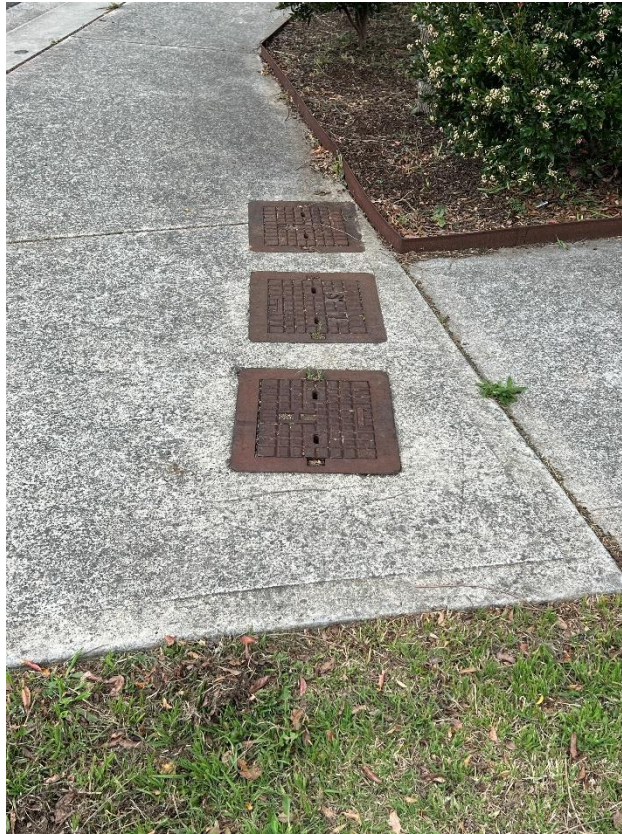
Figure 53 – General condition of the utility lid.

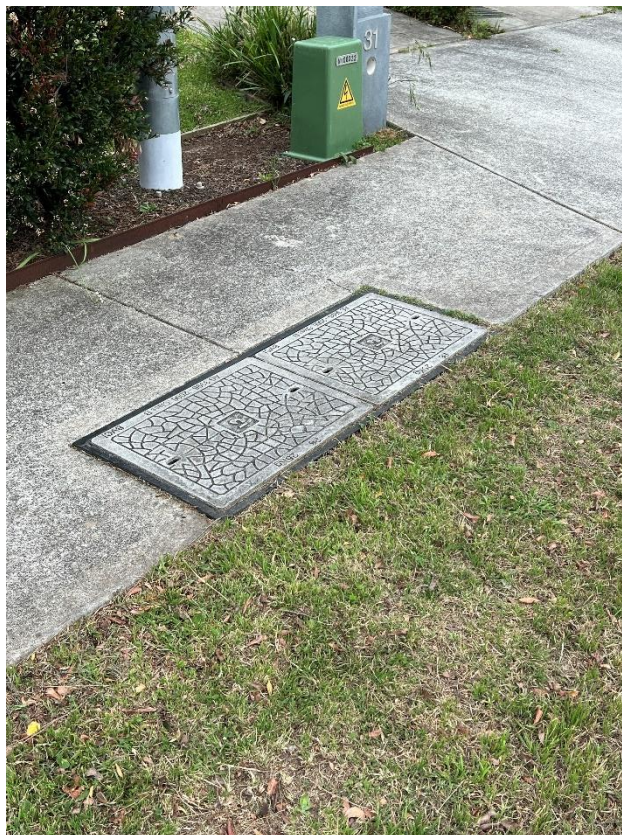
Figure 54 – General condition of the pit.

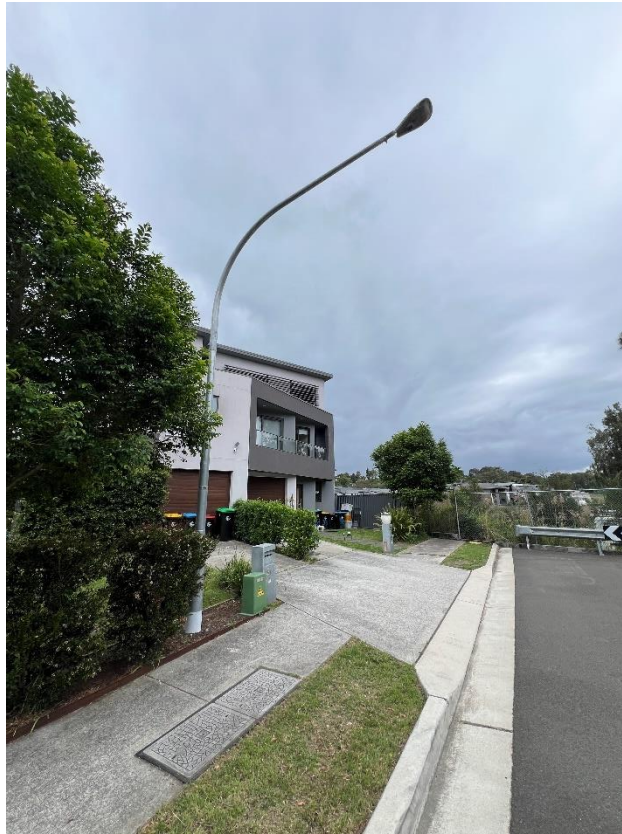
Figure 55 – General condition of the street light.

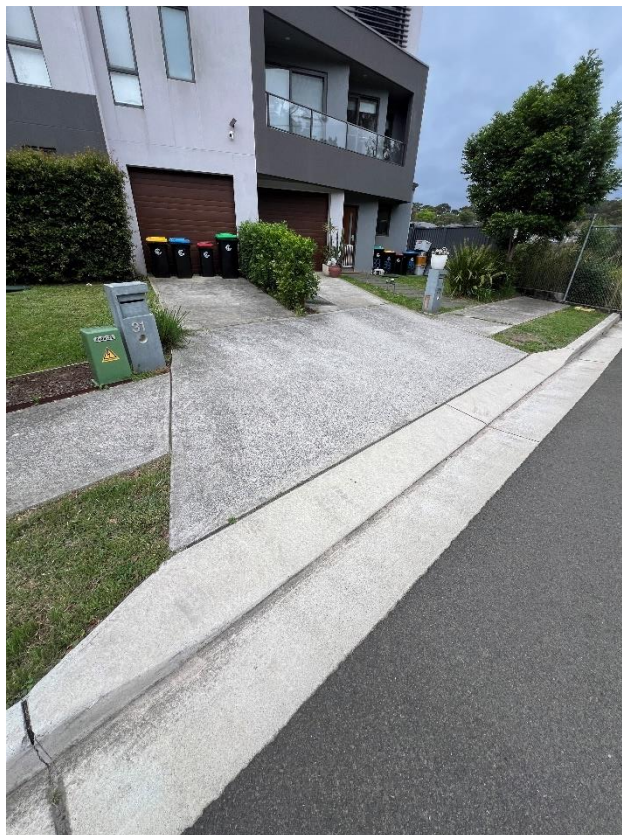
Figure 56 – General condition of the driveway.

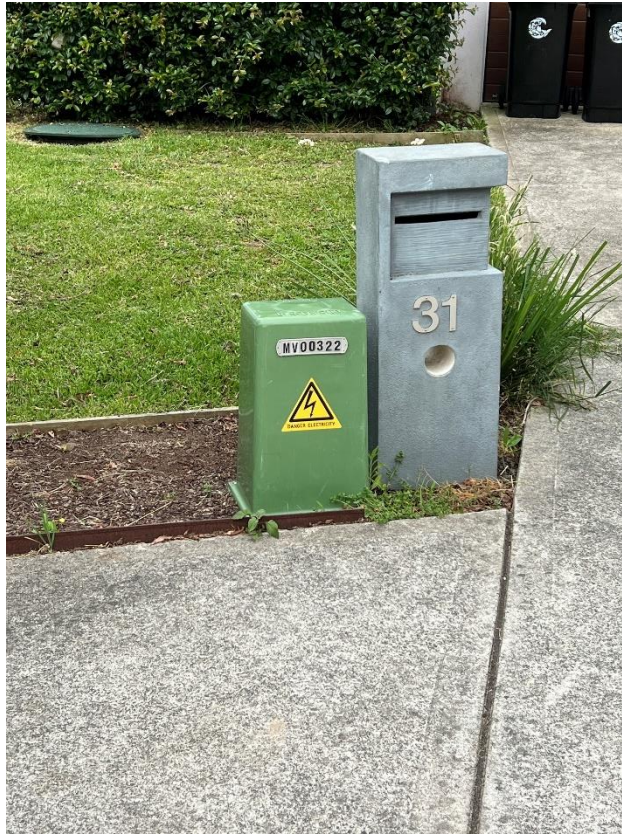
Figure 57 – General condition of the transformer box.

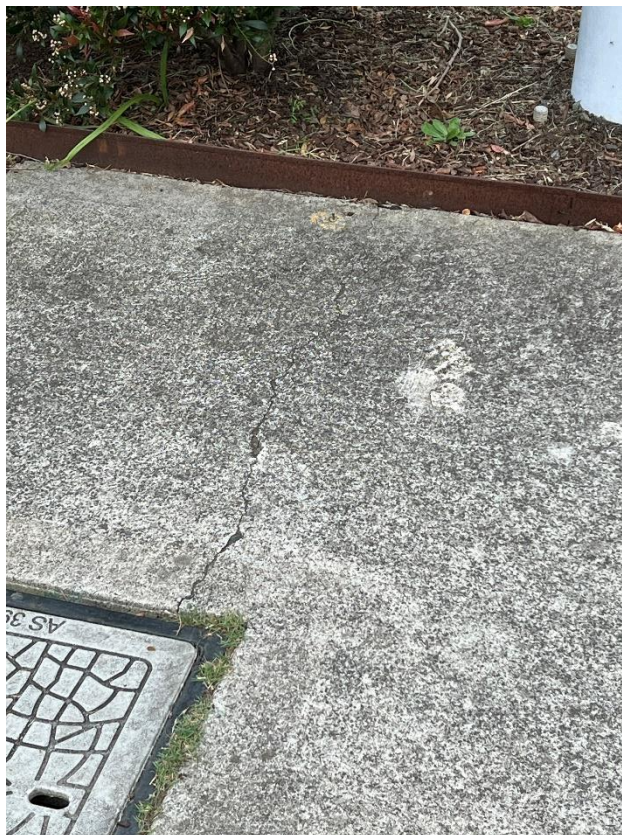
Figure 58 – Crack is evident to the footpath.

The council assets were found to be in a fair condition with evidence of crack to the driveway, kerb and footpath.

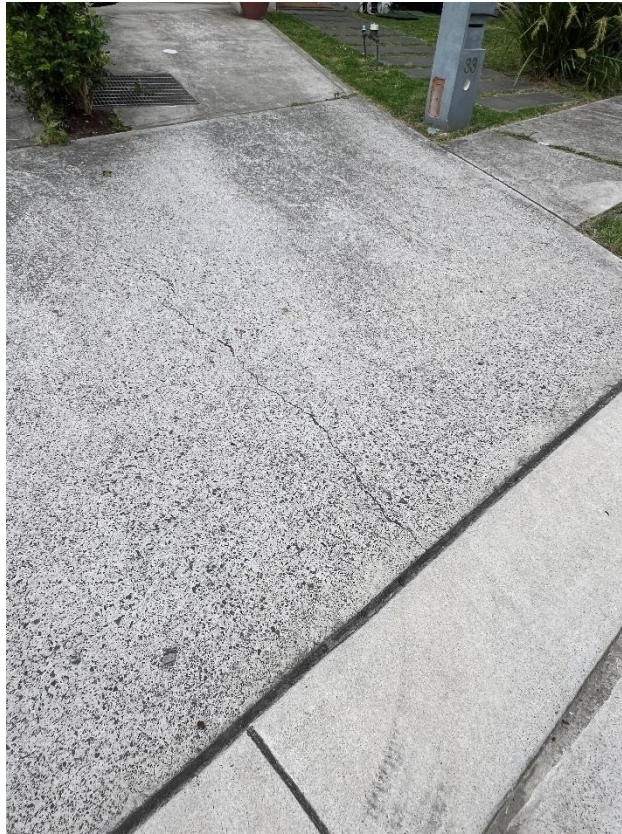
Figure 59 – Crack is evident to the driveway.

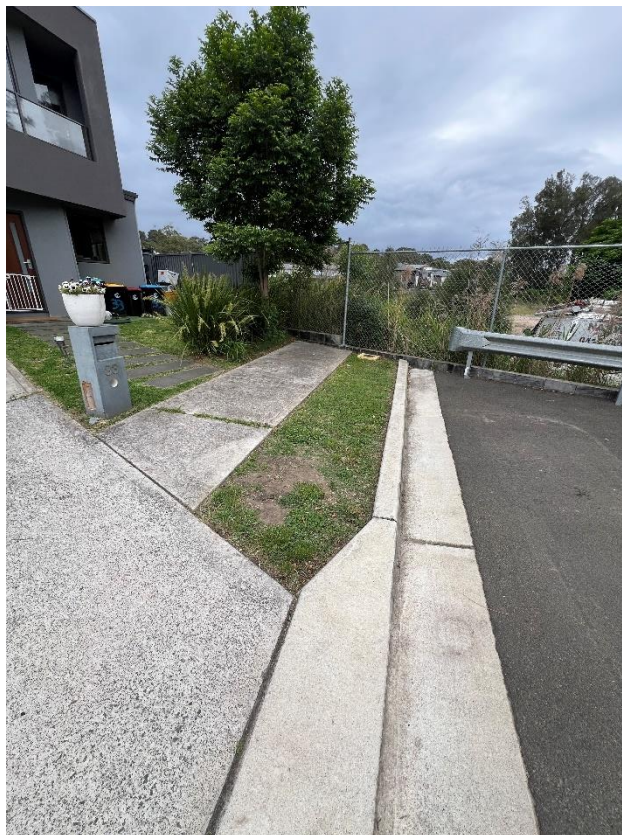
Figure 60 – General condition of the nature strip.

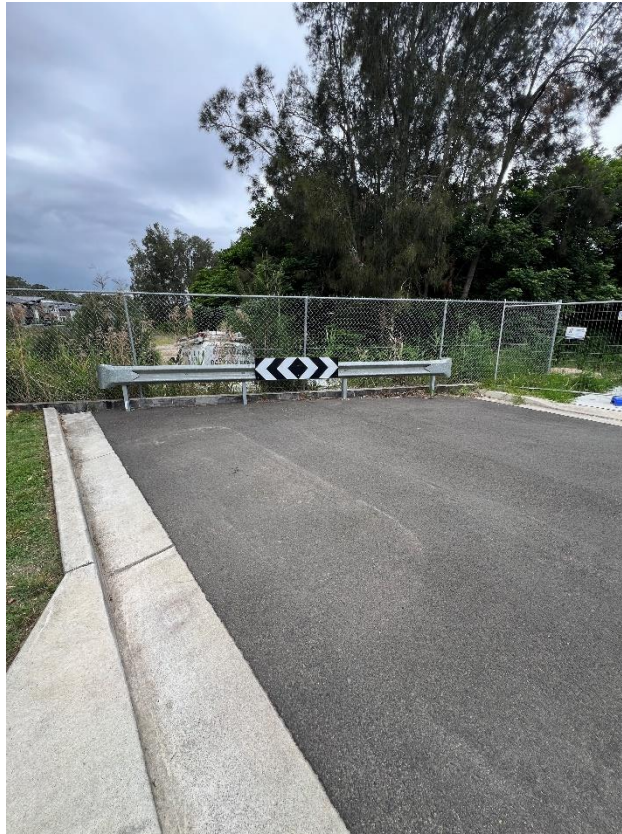
Figure 61 – General condition of the road.

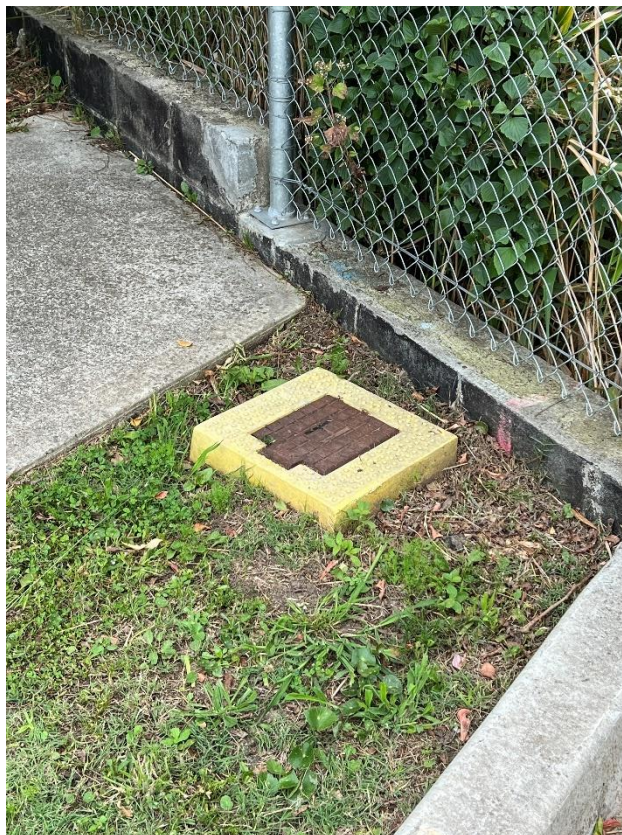
Figure 62 – General condition of the utility lid.

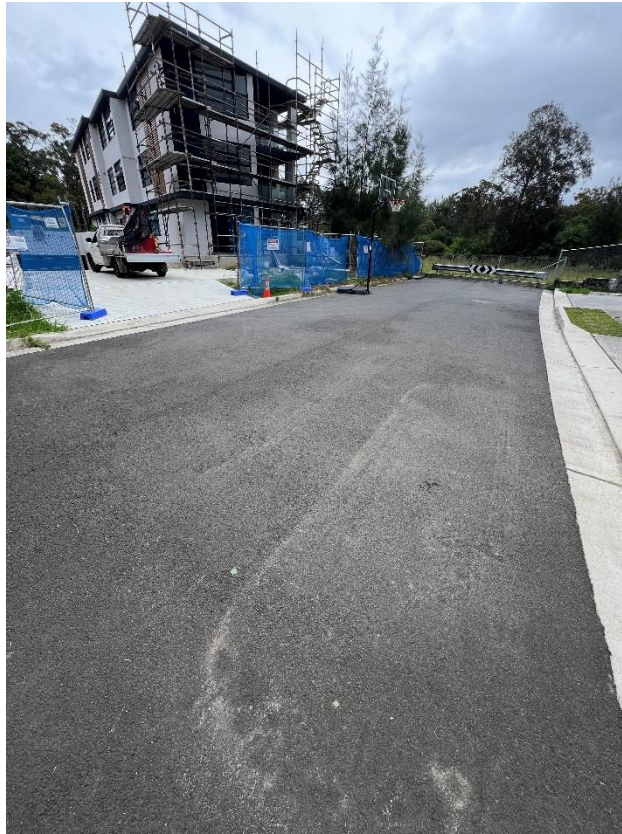
Figure 63 – General condition of the road.

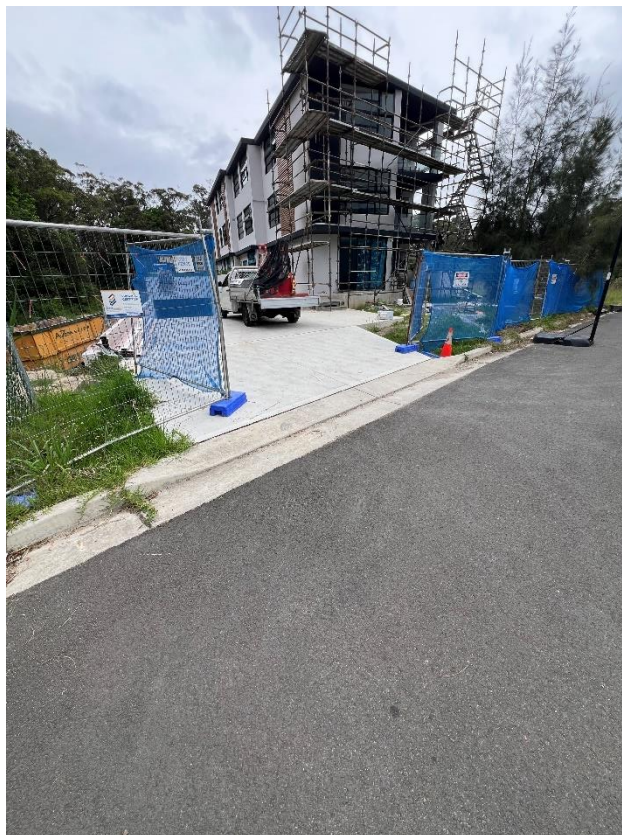
Figure 64 – General condition of the driveway.
