Date: 31st March 2020

Project No.: 2019-150

Geotechnical Assessment for Section 4.55 modification to approved works at
190 Barrenjoey Road, Newport

**RISK ANALYSIS & MANAGEMENT
FOR
PROPOSED NEW GARAGE AND ENTRANCE
AT
190 BARRENJOEY ROAD NEWPORT**

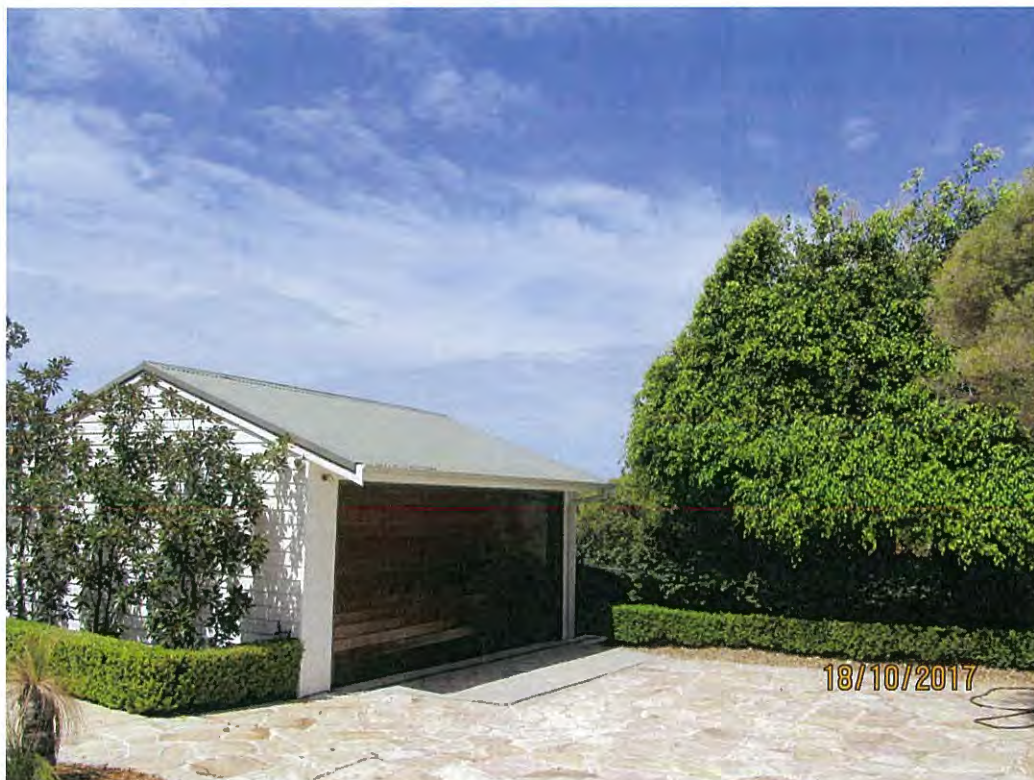
Photo 1

3.3 From the road frontage a sandstone paved driveway provides access to a garage (Photo 1). The natural slope is filled and terraced to the entrance of the house (Photo 2). The terraces are supported by well-constructed concrete block retaining walls (Photo 3). The uphill side of the house is cut into the slope and is supported by another of these walls. There are two walkways down either side of the house that provide access to the rear of the block and to tiled patio, level lawn area and a concrete inground swimming pool situated beyond the eastern side of the house (Photo 4). Immediately below the pool the site has been levelled into a lawn covered fill (Photo 5). The fill merges into the natural slope (Photo 6). The slope has been planted with natives shrubs. The average grade of the scarp is some 50 degrees with a bedrock face outcropping approximately halfway down. No evidence of significant slope instability was observed on the property.

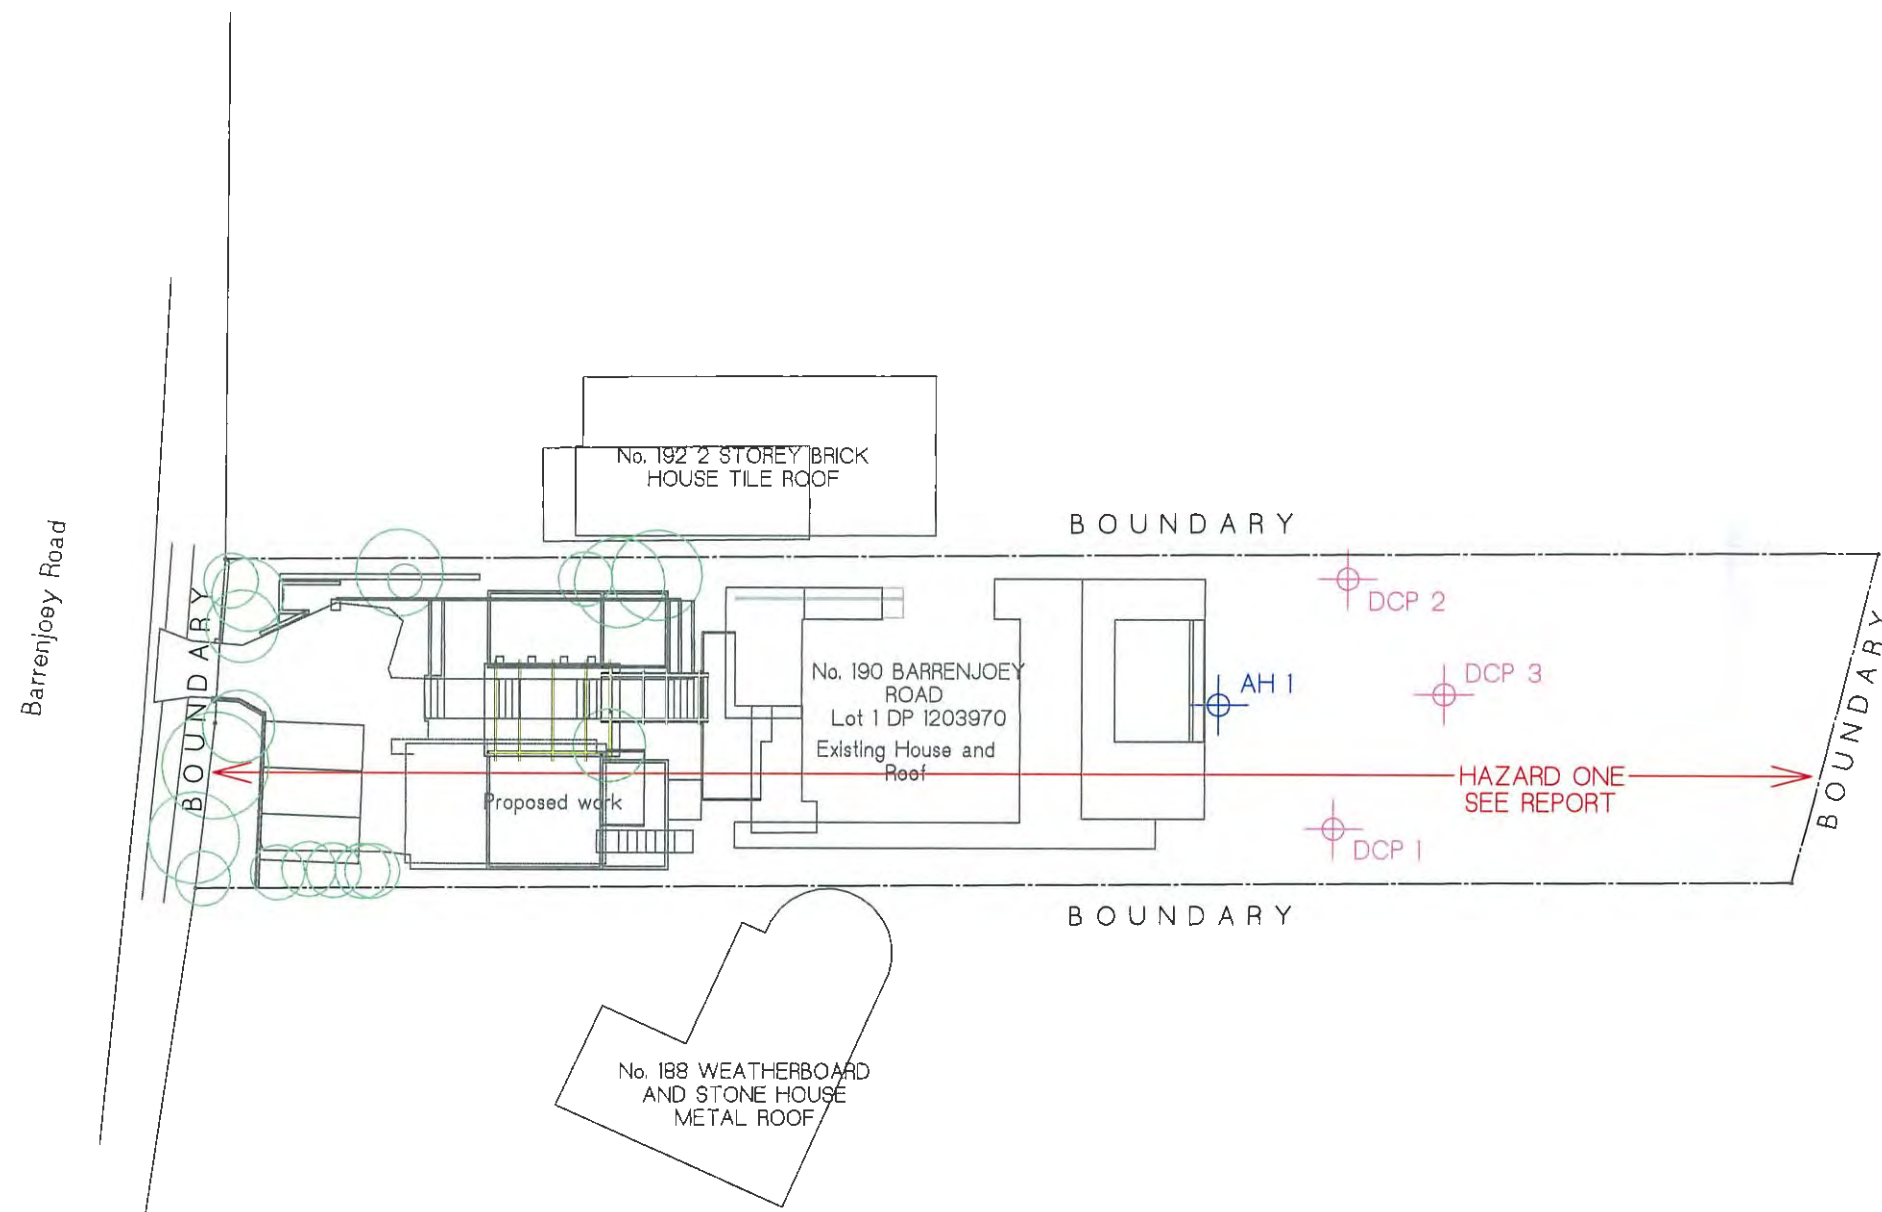
5.1 Three Dynamic Cone Penetrometer (DCP) tests were put down to determine the nature of the ground materials. The tests were conducted to the Australian Standard for ground testing: AS 1289.6.3.2 – 1997. The locations of these tests are shown on the site plan provided and the results of these tests are as follows:

One hand auger hole was put down in the approximate location shown on the Site Plan. The logs of this test is as follows:-

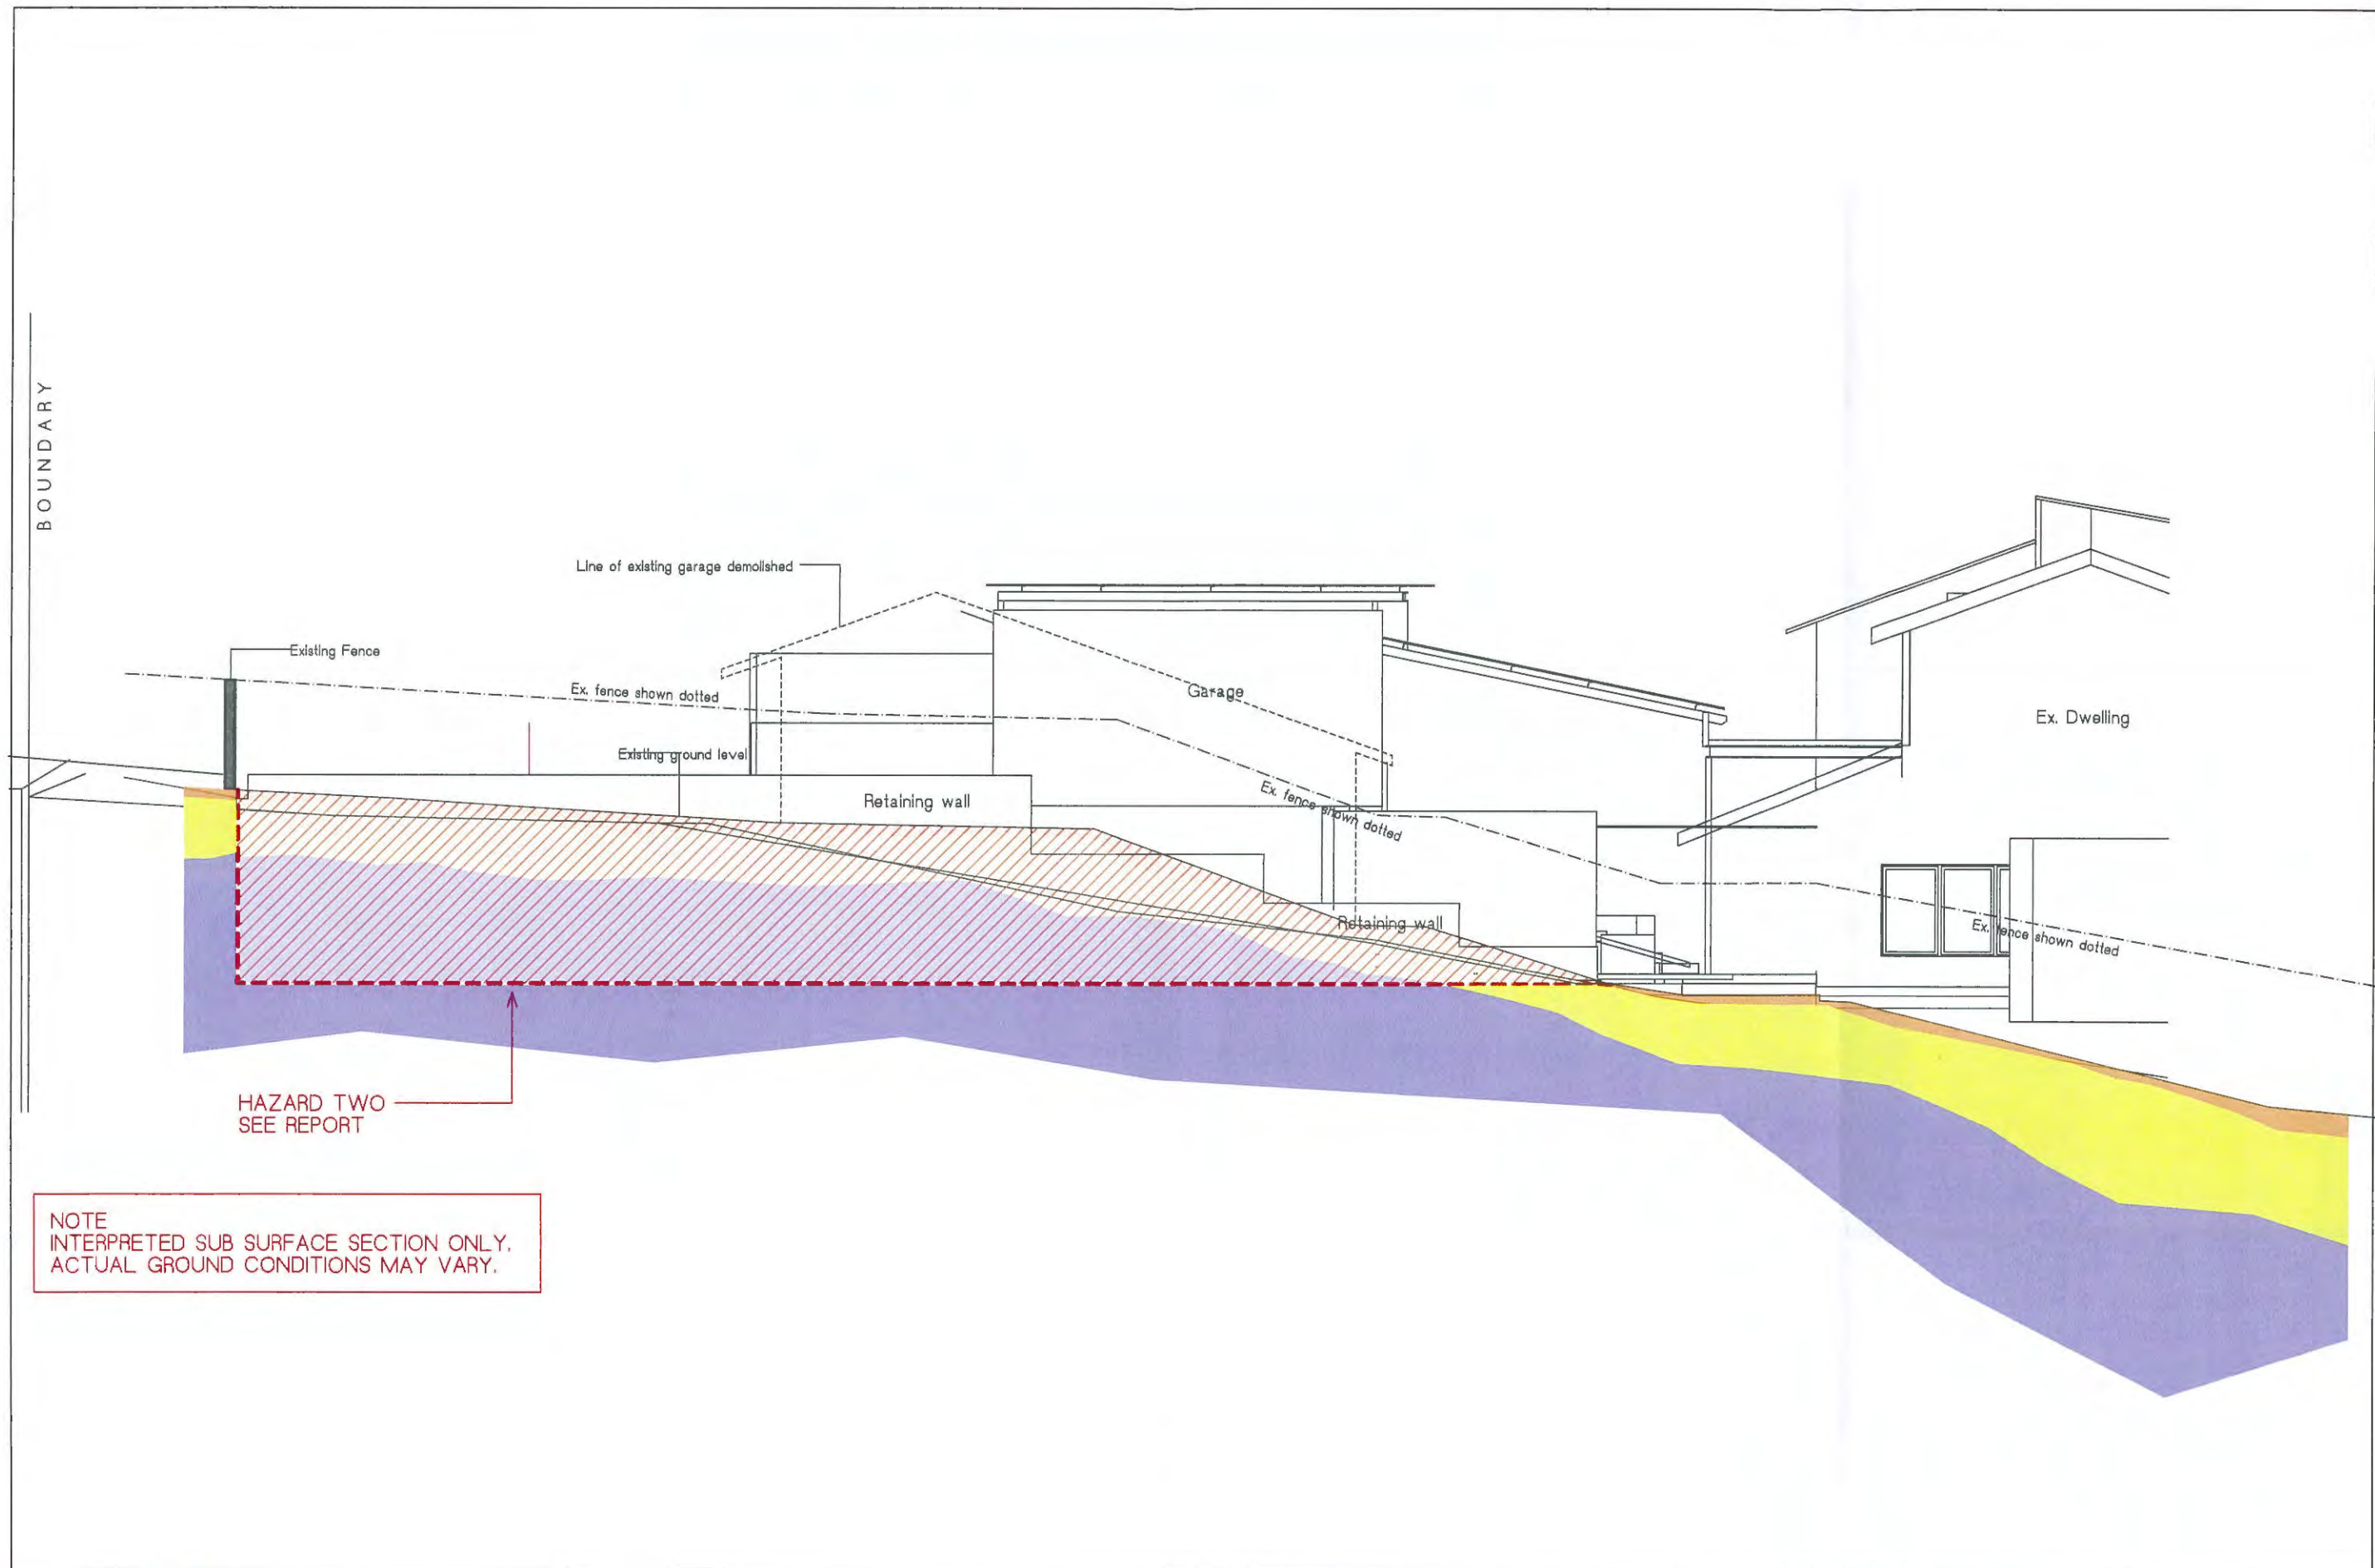
4.2 The slope materials are colluvial at the surface and residual at depth. They consist of sandy clays and clays with rock fragments and some floaters throughout the profile. The sandy clays and clays merge into the weathered zone of the under lying rocks at depths expected to be in the range 0.9 to 2.4 metres.
