## **REPORT ON GEOTECHNICAL SITE INVESTIGATION**

### **PROPOSED NEW RESIDENTIAL HOUSE**

**9 & 10 SURFSIDE AVENUE, AVALON BEACH, NSW**

**Project No.: 2020-033**

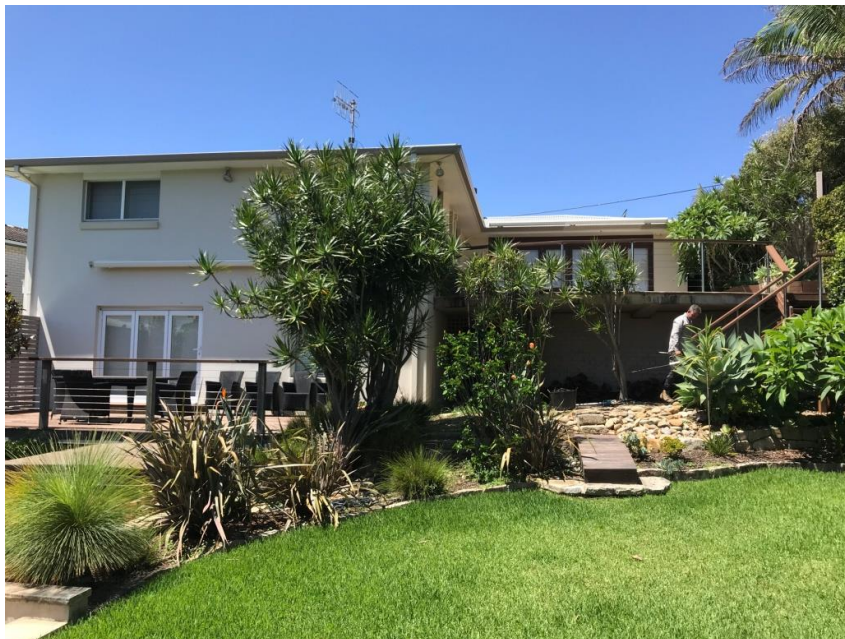
The site dwelling at No.9 Surfside Avenue comprises of a two storey rendered residence centrally positioned to the front of the site, with timber decking, retained grassed lawns and garden beds to the rear. Vehicular access to the site is provided via a moderate ( $-15^{\circ}$ ) sloping pebblecrete driveway leading from a concrete crossover to a dual garage under the existing residence. General views of the rear of the site are shown in Photograph 2.

*Photograph 2: Rear view of the site residence at No.9, looking east*

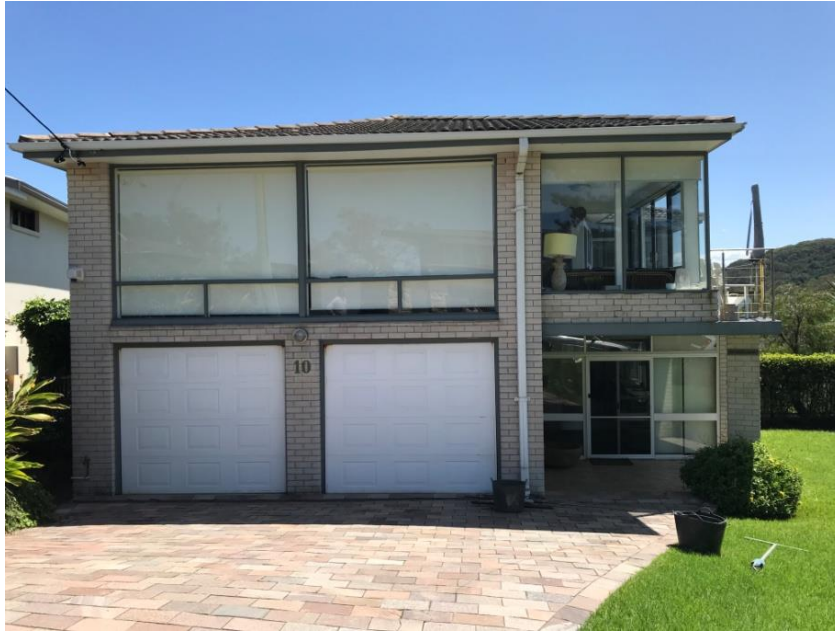
The site dwelling at No.10 Surfside Avenue comprises of a two storey brick residence centrally positioned to the front of the site. The rear of the site consists of a part in-ground swimming pool, tennis court and retained grassed lawns. General views of the front of the site are shown in Photograph 3.

*Photograph 3: Front view of the property at No.10, looking west*

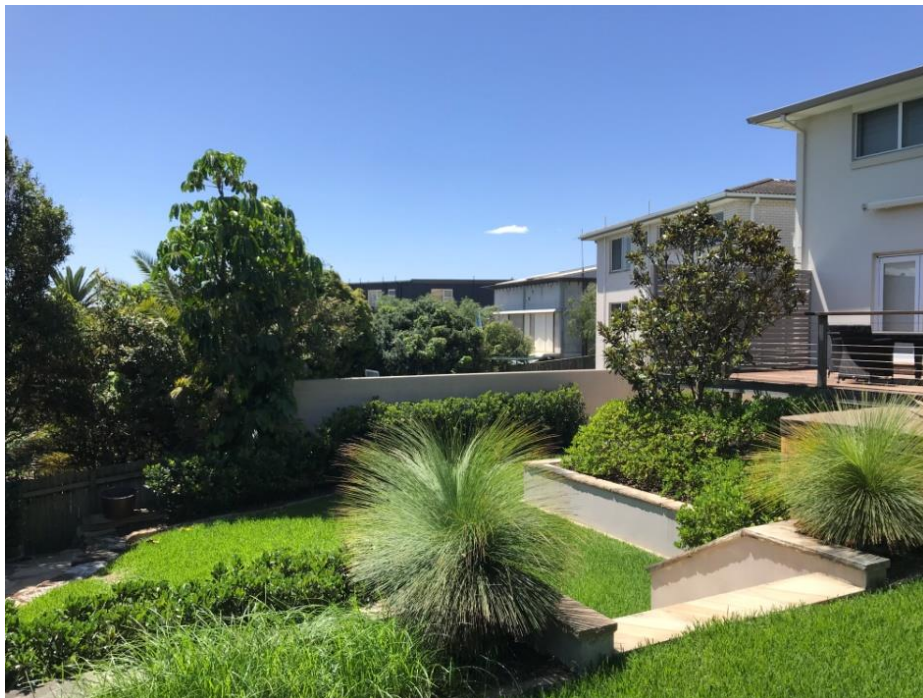
The rear of the property at No.9 is accessed via a sandstone paver pathway along the southern boundary, which leads to a timber staircase extending from the first floor balcony to a timber deck at the rear. The rear yard contains terraced grassed yards and multiple retained garden beds. The rear yard has been retained along the rear boundary by up to 1.50m from the neighbouring properties. The retaining walls throughout the site appear to be in good condition with no signs of excessive cracking or deformation. General views of the rear of the site are shown in Photograph 4.

*Photograph 4: Retained gardens at the rear of No.9*

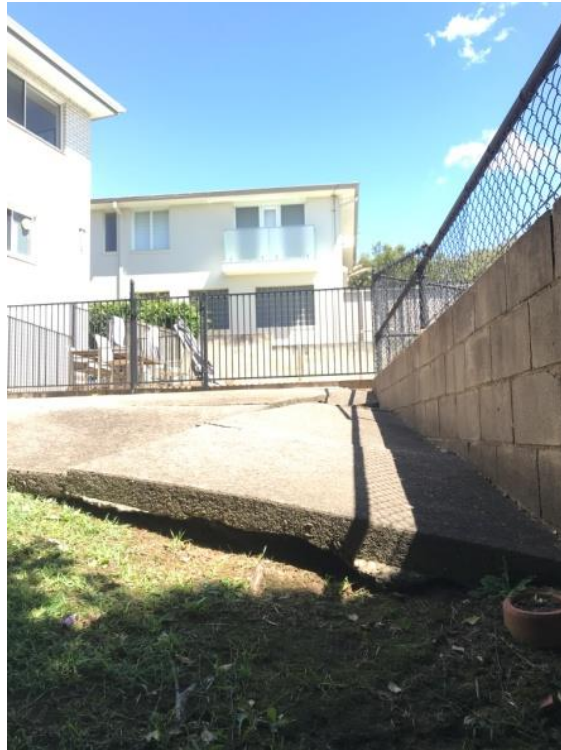
The rear of the property at No.10 is accessed via a pathway along the southern boundary which leads to the rear area, comprising of a part in-ground swimming pool to the south, tennis court to the north-west and grassed lawn to the north-east with segmented concrete slabs for pedestrian access. The front and rear grassed lawns along the northern boundary are separated by a 1.4m high besser block retaining wall whilst the tennis court is retained below the adjacent ground level by a 1.0m high besser block retaining wall. It was observed that the concrete slab between the grassed lawn and tennis court has experienced subsidence and has resulted in significant cracking and deformation, as shown in Photograph 4.

*Photograph 4: Subsidence of the concrete slab at No.10*
