## GEOTECHNICAL REPORT

### PROPOSED ALTERATIONS AND ADDITIONS

**74 ELANORA ROAD, ELANORA HEIGHTS, NSW**

**Project No.: 2024-205**

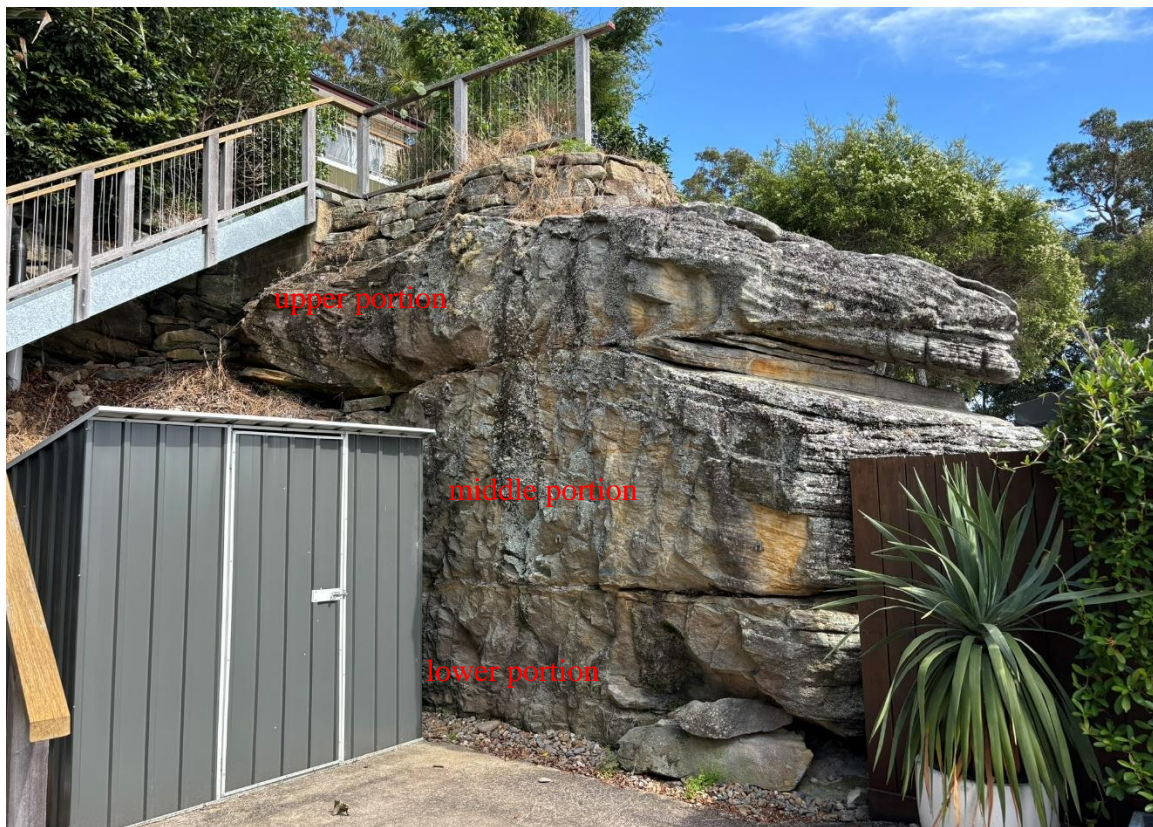
This bedrock outcrop comprises medium to coarse grained sandstone which has been vertically cut in places by apparent rock hammering techniques. Defects were identified in the unit along the southern face which comprised a 20 – 80mm thick, clean, bedding defect at 1.5m depth and a 50mm thick, clay infilled bedding defect at 2.9m depth, these defects form an upper, middle and lower portion to the southern face of the outcrop. The upper portion of the outcrop appears to be partially detached with the eastern end gently dipping ( $\approx 10^\circ$ ) east, laminations and undercutting of the sandstone were also identified within this upper eastern portion. Detached boulders were identified adjacent to the lower eastern portion of the outcrop but are associated with the excavation process. An image of this outcrop is shown in Photograph 1.

*Photograph 1: View of the sandstone bedrock outcrop adjacent to the site parking space, facing northwest*

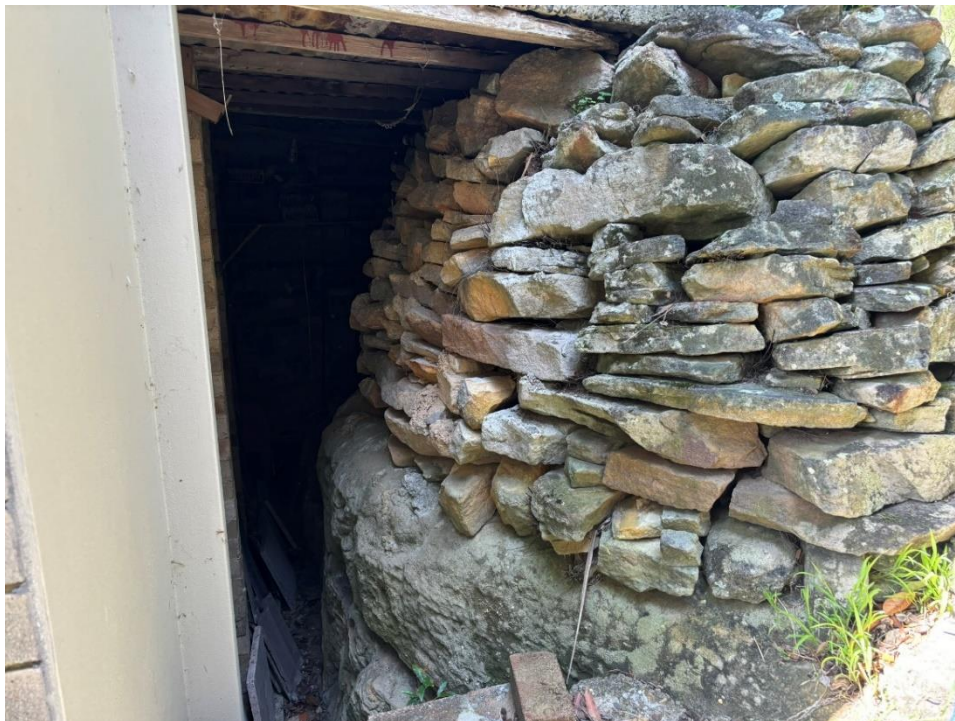
Sandstone bedrock is exposed between 0.30m and 0.90m from the rear of the ground floor of the main structure. It appears that this bedrock has been cut sub-vertically with lower portions extending closer to the structure in more southern portions. A battered, dry stack sandstone block retaining wall bears onto the top of the sandstone bedrock unit. It also appears that the overlying patio extends to bear onto this retaining wall along with the adjacent grassed lawn. Photograph 2 shows this area of the site.

*Photograph 2: View of the exposed sandstone bedrock and overlying retaining wall adjacent to the rear wall of the main structure, facing south*

New footings should extend through any fill or colluvial material to bear onto sandstone bedrock to avoid potential for differential settlement. This is inclusive of the northwestern extension as it will overlie an existing dry stack sandstone block retaining wall. This retaining wall is considered unsuitable to support additional loading, therefore new footings must extend to bear directly onto the bedrock unit below.

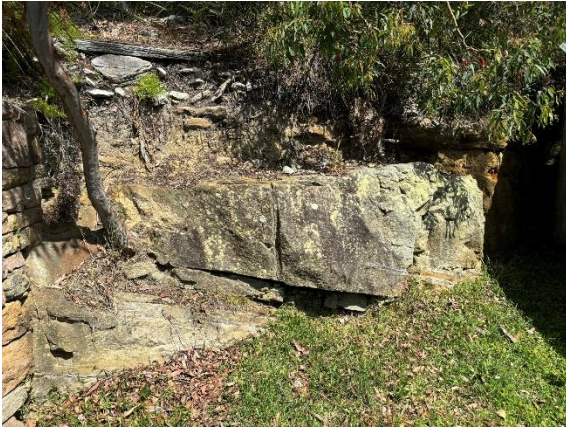
The rear boundary of the site comprises steeply dipping terrain of outcropping bedrock, boulders, residual and colluvial soils across a maximum height of approximately 2.0m. A steeply dipping ( $\approx 60^\circ$ ), 80mm wide, clean joint was identified in the outcropping bedrock at the rear boundary of the site, as shown in Photographs 3 and 4.

*Photograph 3: View of exposed bedrock at the rear of the site facing west*

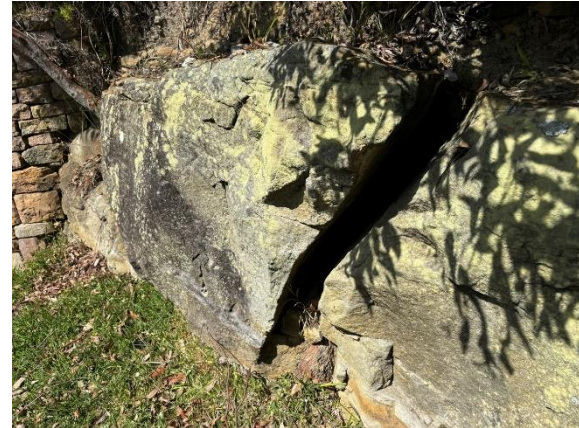
*Photograph 4: Joint within exposed bedrock at the rear of the site facing southwest*

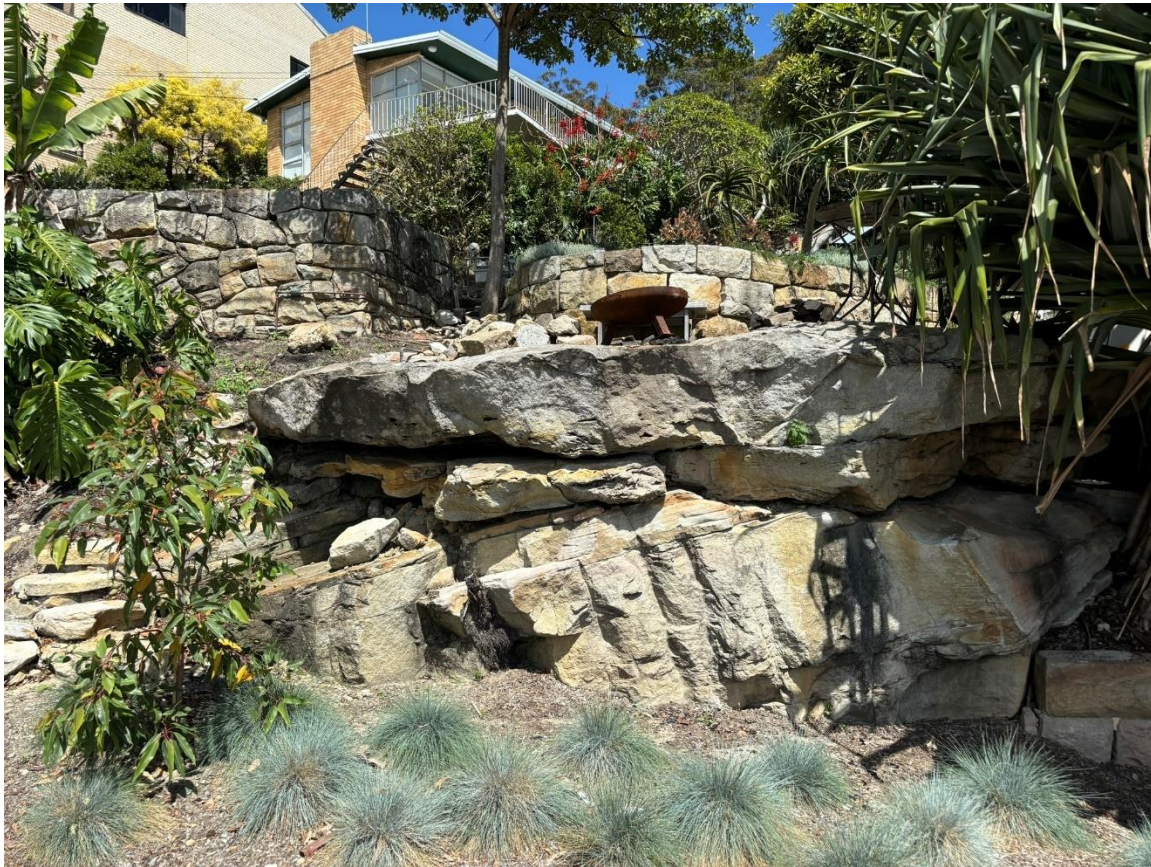
The neighbouring property to the east (No.74a) contains a recently constructed one and two storey clad building accessed via the concrete driveway shared with the site. The main structure appeared to be in a stable condition with no signs of instability. Exposed bedrock outcrops within the front southeastern corner of the property and comprises 2.0m high fractured sandstone with honeycombing and horizontal to sub-horizontal undercutting to  $\leq 0.5\text{m}$ . A sub-horizontal ( $\approx 20^\circ$ ) bedding defect was also identified within southern portions of the outcrop as shown in Photograph 5. Sandstone bedrock/boulders also outcrop within the rear of the property as an approximate 3.0m high cliff extends along the shared boundary of No.74a and the site, however limited inspection of this region was undertaken due to access restrictions.

*Photograph 5: View of outcropping fractured bedrock within the southeastern corner of No.74*
