# Arboricultural Impact Assessment Statement

**Prepared for:** Jill Hunter c/o Mr Tony McLain

**Date:** 12/05/2020

**Prepared by:** Vicki Beecher

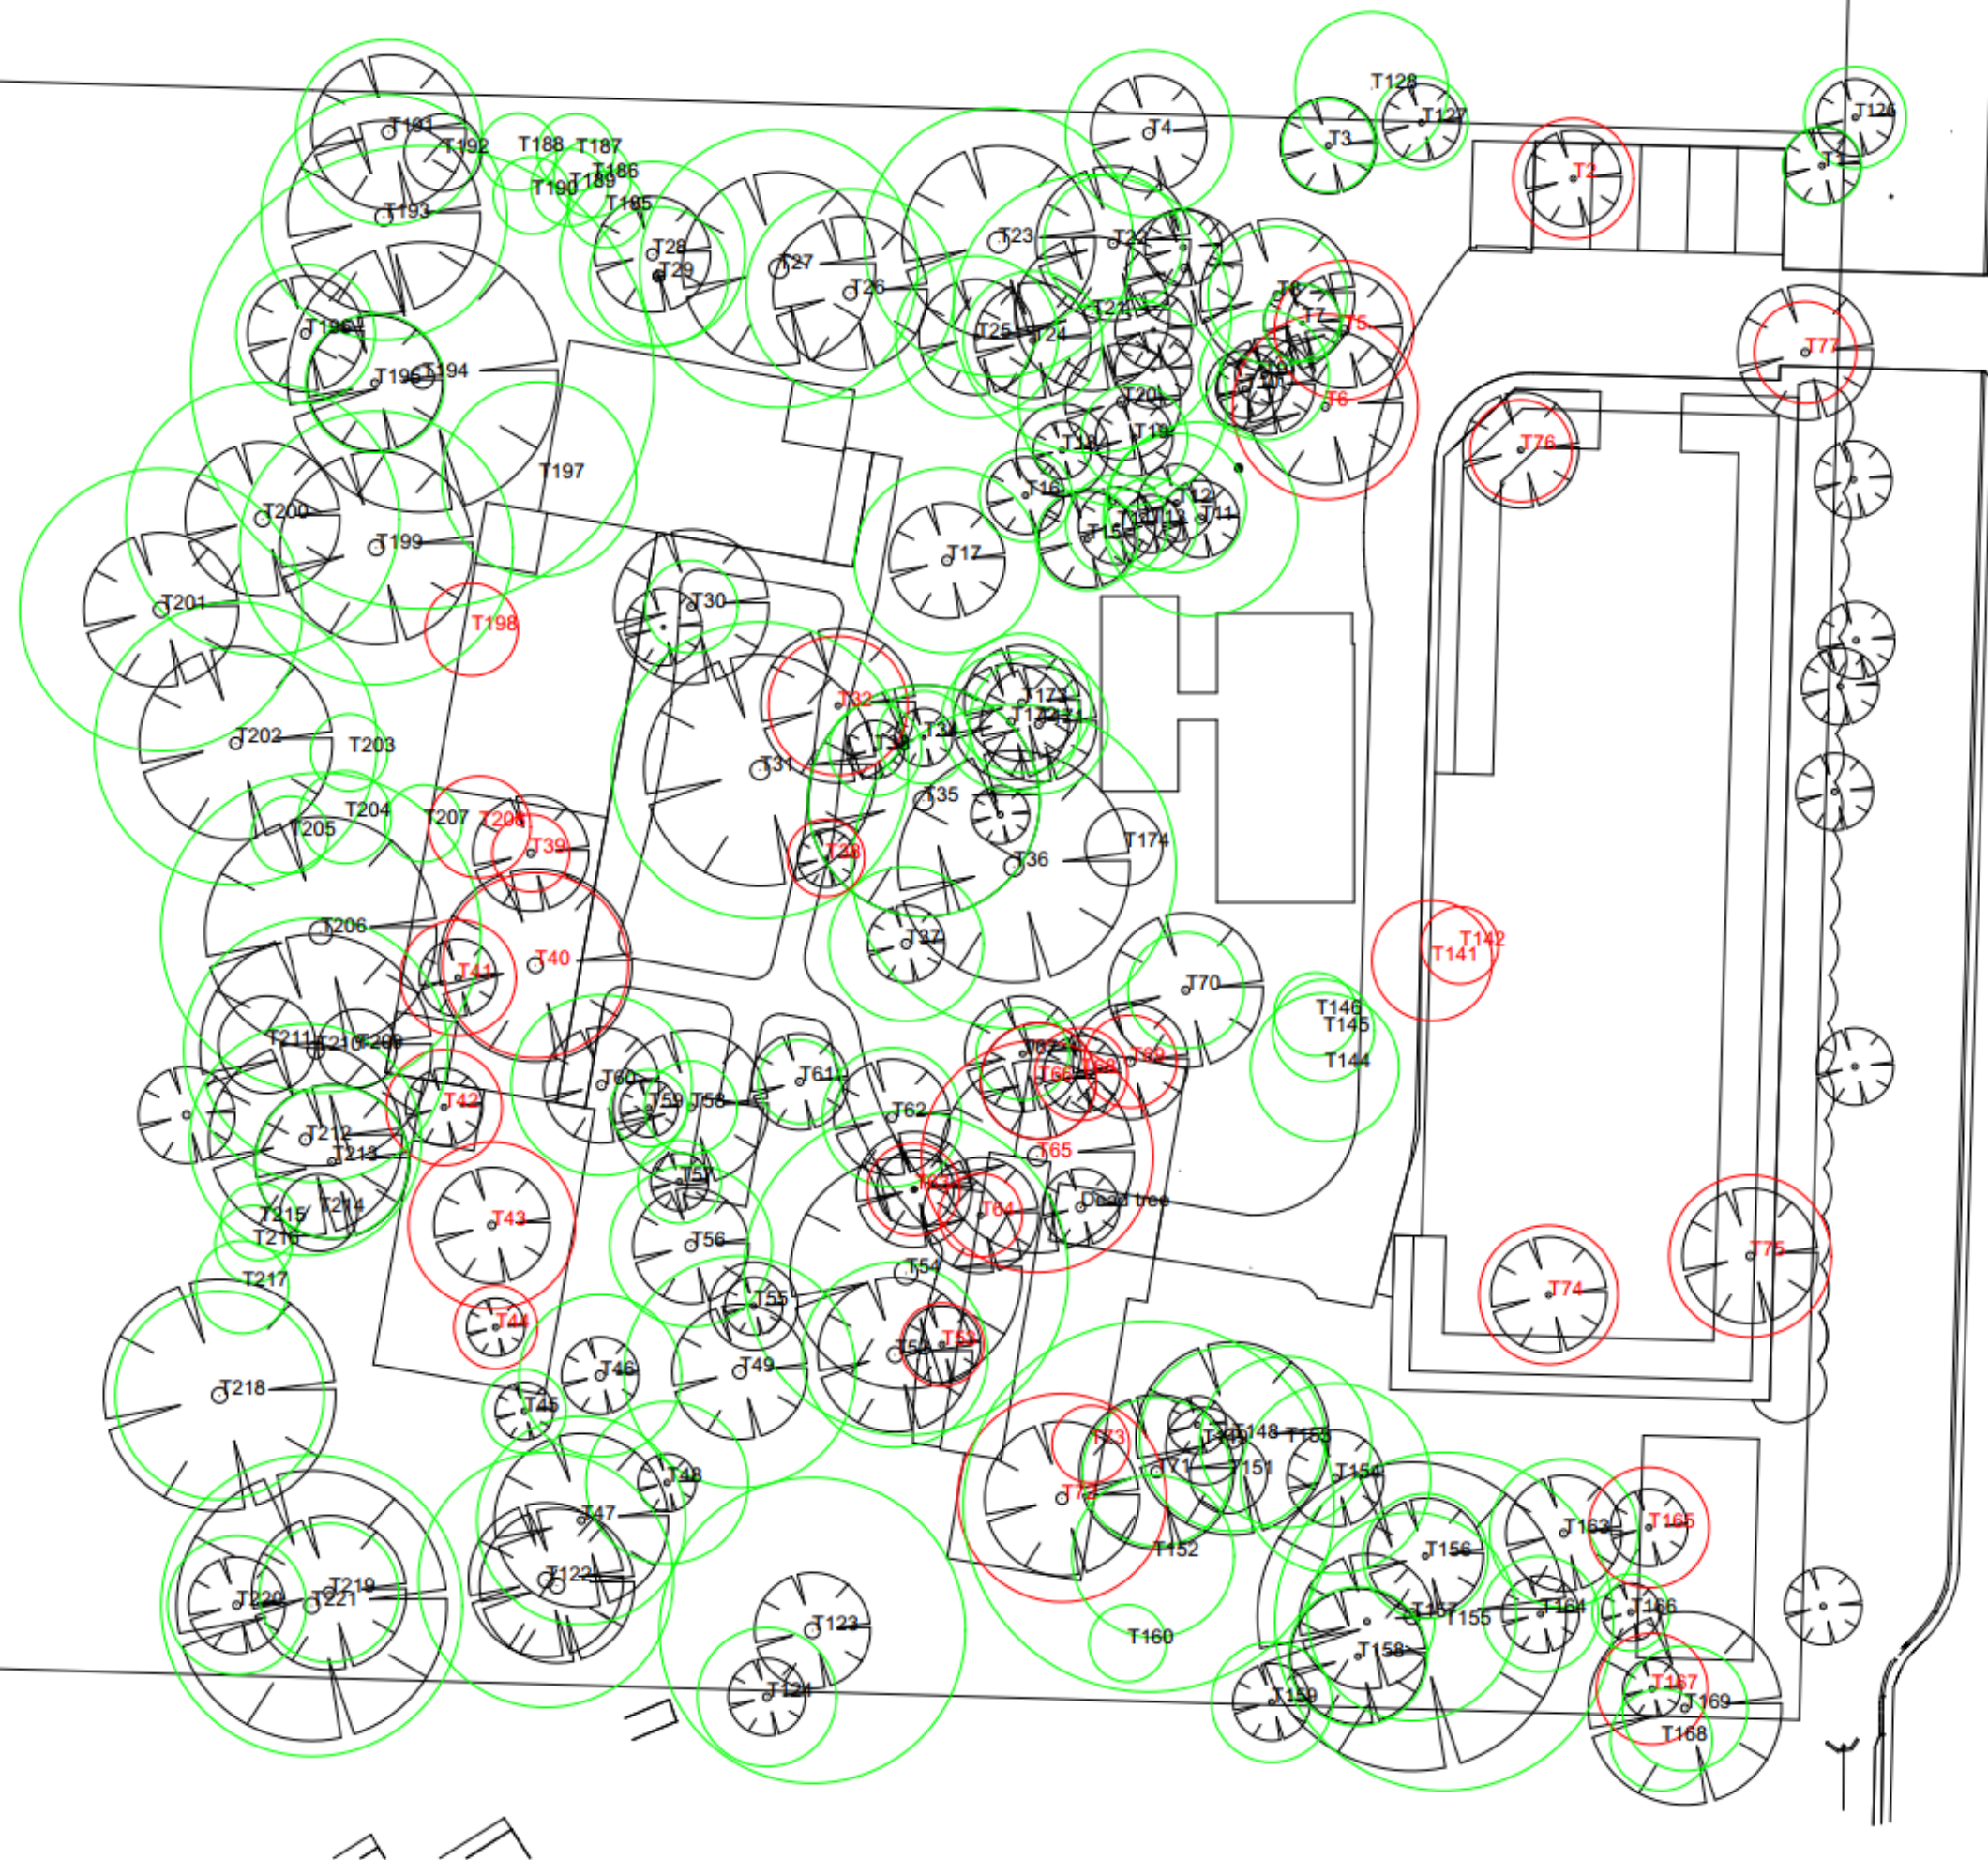
- 4.1 Based on plans provided the following trees cannot be retained due to development encroachments or poor health and condition 2, 5, 6, 32, 38, 39, 40, 41, 42, 43, 44, 53, 63, 64, 65, 66, 68, 69, 72, 73, 74, 75, 76, 77, 141, 142, 165, 167, 198, 208.

- 4.2 Excavation for the proposed absorption pit within the protection zones of trees 166 and 169 is to be undertaken using methods that do not damage tree roots. This work is to be supervised by the project arborist.

- 4.3 Based on plans provided where it is found that a minor encroachment applies no significant impact upon the tree is anticipated.
- 4.4 Screw piles located within the TPZ of trees 52, 54, 56, 57, 67, 150 are to be manually excavated using hand tools to their fullest extent. Where this is not deemed possible, they are to be manually excavated to a minimum depth of 600mm. Any further excavation that is then to be undertaken mechanically is to be of a diameter less than that excavated by hand. Appropriate ground protection measures are to be implemented to stand and operate excavation equipment within a tree protection zone. A degree of flexibility should be built into the design to allow for the pile locations to be moved if structural or significant roots are found. Tree roots less than 30mm diameter exposed by the excavations can be pruned to allow the sighting of piles. A minimum clearance of 100mm is to be left around significant roots.
