Report Title: Geotechnical Report 40 Bilwara Avenue Bilgola Plateau

Report Date: 3/7/20

GEOTECHNICAL INVESTIGATION:

Alterations and Additions at **40 Bilwara Avenue, Bilgola Plateau.**

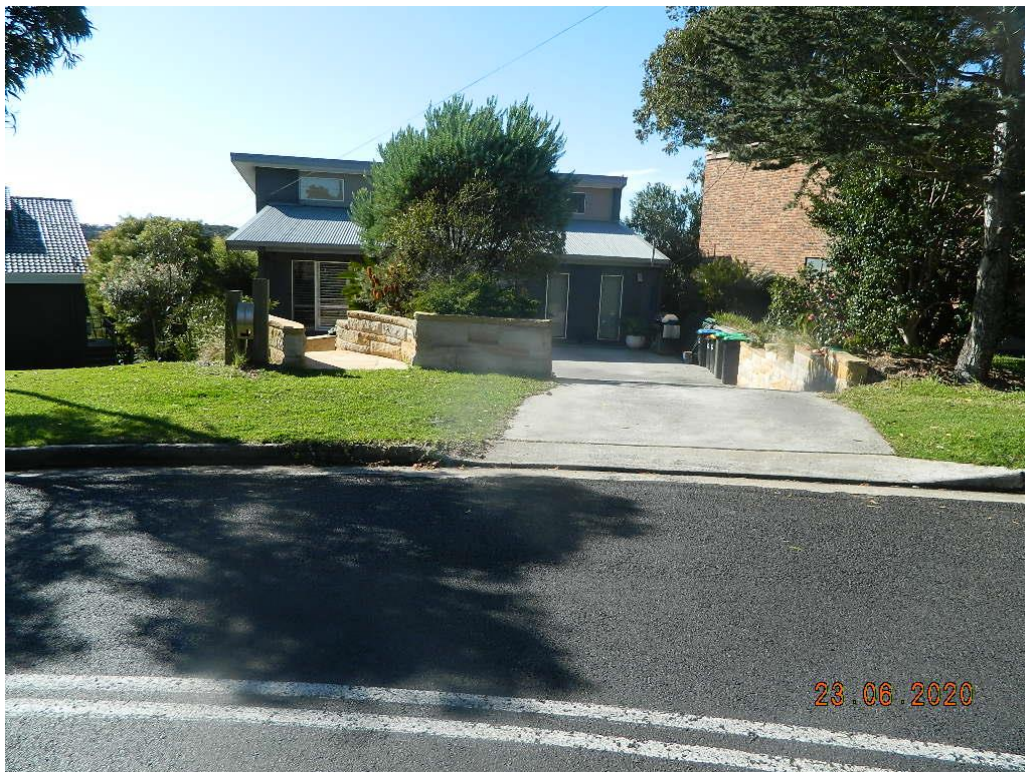
Photo 1

- 2.3** At the road frontage a concrete driveway runs to the existing house (Photo 1). The cut for the driveway and house is supported by stable low sandstone block and concrete block retaining walls. The two storey rendered brick house is supported by brick walls and brick piers (Photos 1 & 2). The supporting walls and piers stand vertical and show no significant signs of movement (Photo 3). A timber deck extends off the downhill side of the house and will be replaced as part of the proposed works (Photo 2). Fill provides level lawn areas on the downhill side of the house (Photos 4 & 5). The fill is supported by stable low sandstone block and sandstone stack

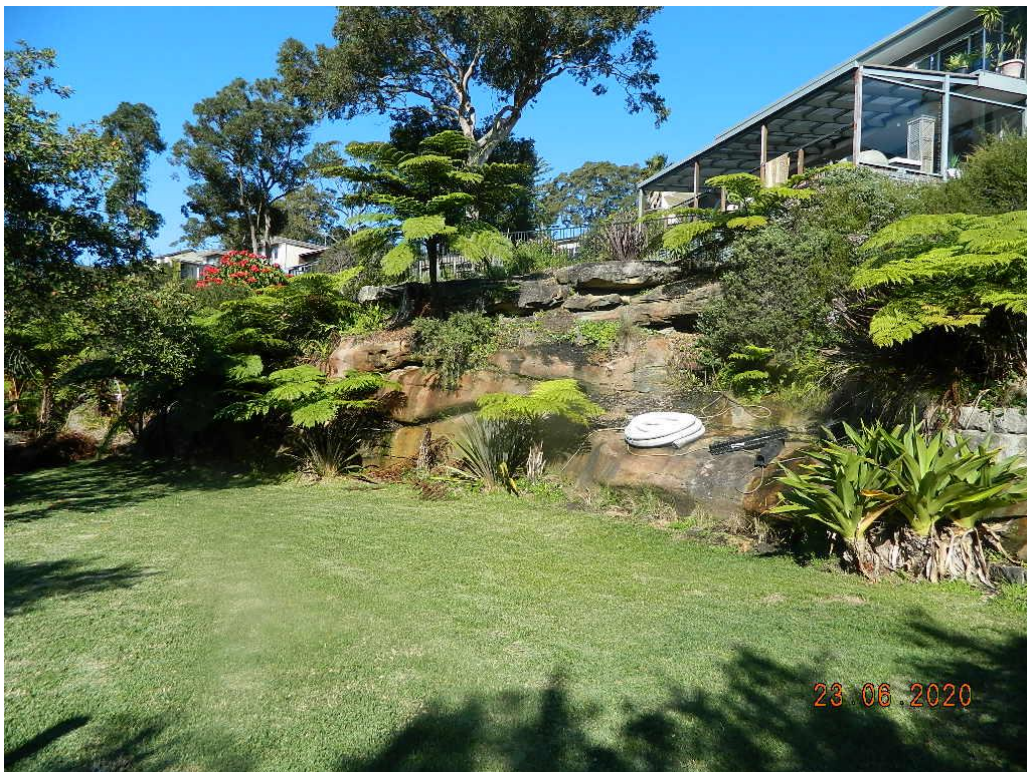
Photo 6

rock retaining walls. Medium Strength Sandstone bedrock outcrops between the upper and lower lawn (Photo 6). The rock face is ~2m high and is in good condition. No signs of slope instability were observed on the property. The adjoining neighbouring properties were observed to be in good order as seen from the street and subject property

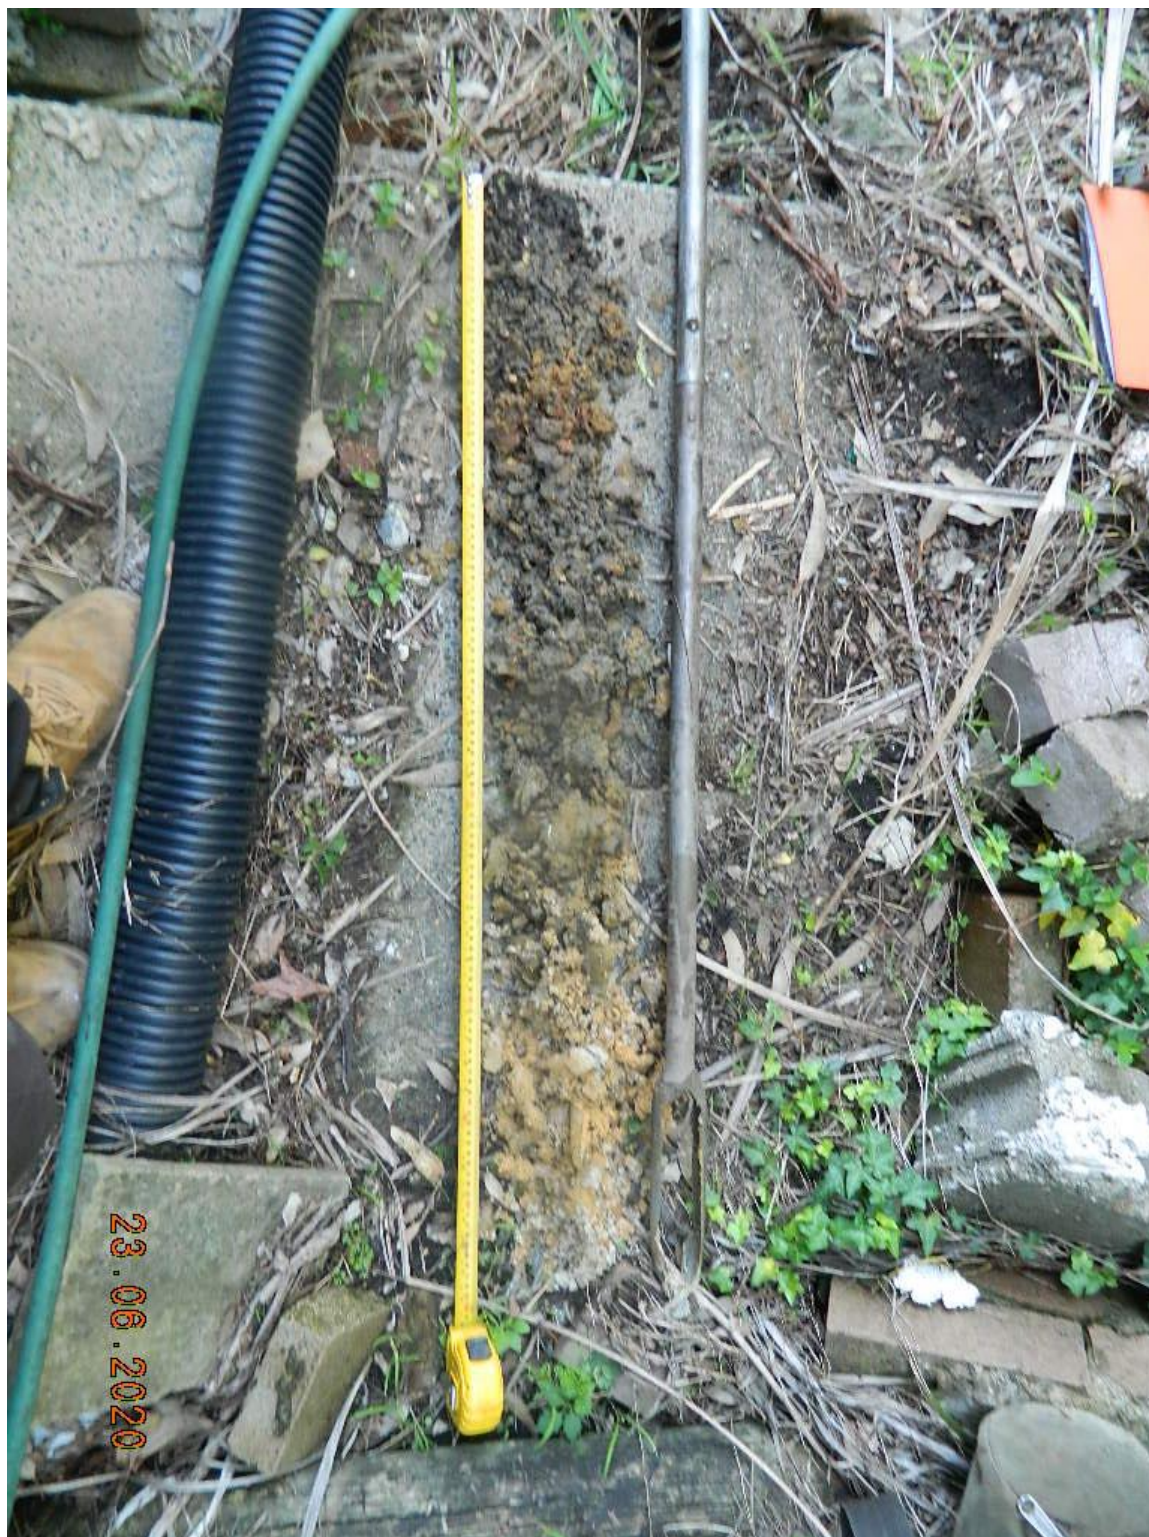
Photo 7: Downhole is from top to bottom

AUGER HOLE 1 (~RL108.4) – AH1 (photo 7)

Depth (m)	Material Encountered
0.0 to 0.1	TOPSOIL , sandy soil, dark brown, fine to medium grained, damp with fine trace organic matter.
0.1 to 0.7	SAND , grey and orange, medium grained, damp.
0.7 to 1.1	CLAYEY SAND , derived from very low strength sandstone, orange brown and light grey, medium to coarse grained, damp.

Refusal @ 1.1m auger grinding on rock. No watertable encountered.

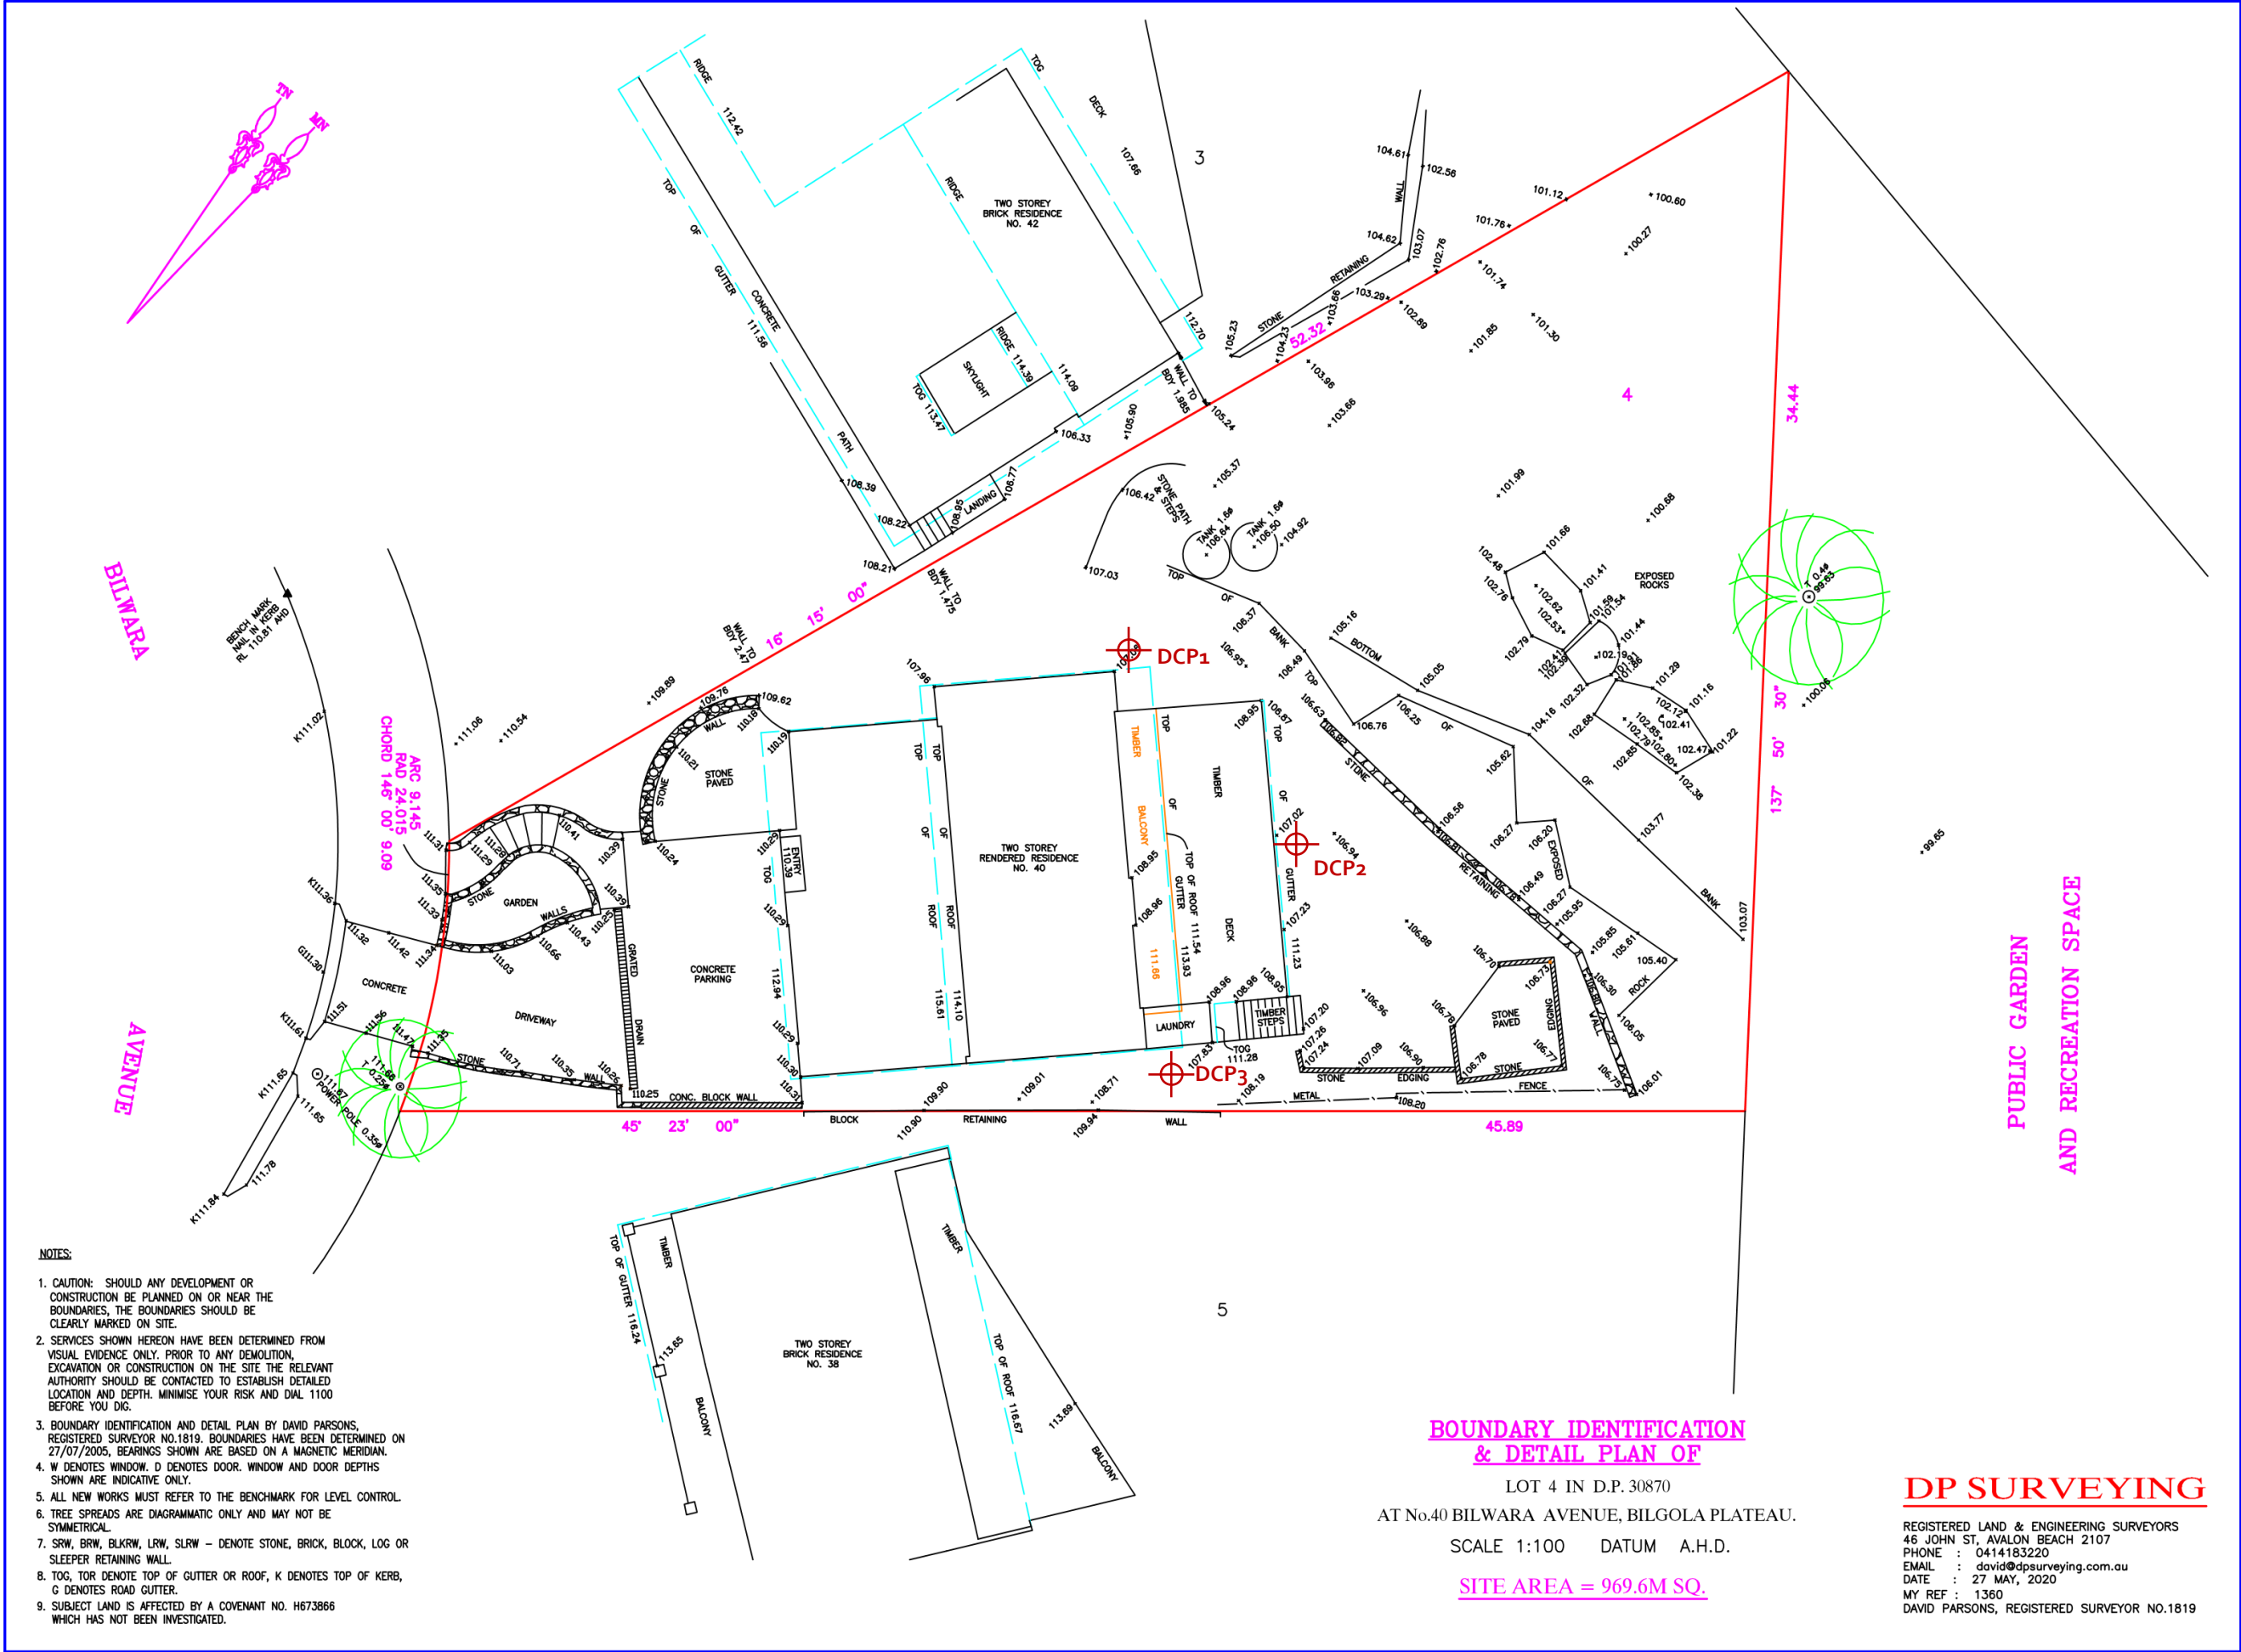
SITE PLAN – showing test locations

One auger hole was put down to identify the soil materials. Three Dynamic Cone Penetrometer (DCP) tests were put down to determine the relative density of the overlying soil and the depth to weathered rock. The locations of the tests are shown on the site plan. It should be noted that a level of caution should be applied when interpreting DCP test results. The test will not pass through hard buried objects so in some instances it can be difficult to determine whether refusal has occurred on an obstruction in the profile or on the natural rock surface. This is not expected to be an issue for the testing on this site. But due to the possibility that the actual ground conditions vary from our interpretation there should be allowances in the excavation and foundation budget to account for this. We refer to the appended "Important Information about Your Report" to further clarify. The results are as follows:

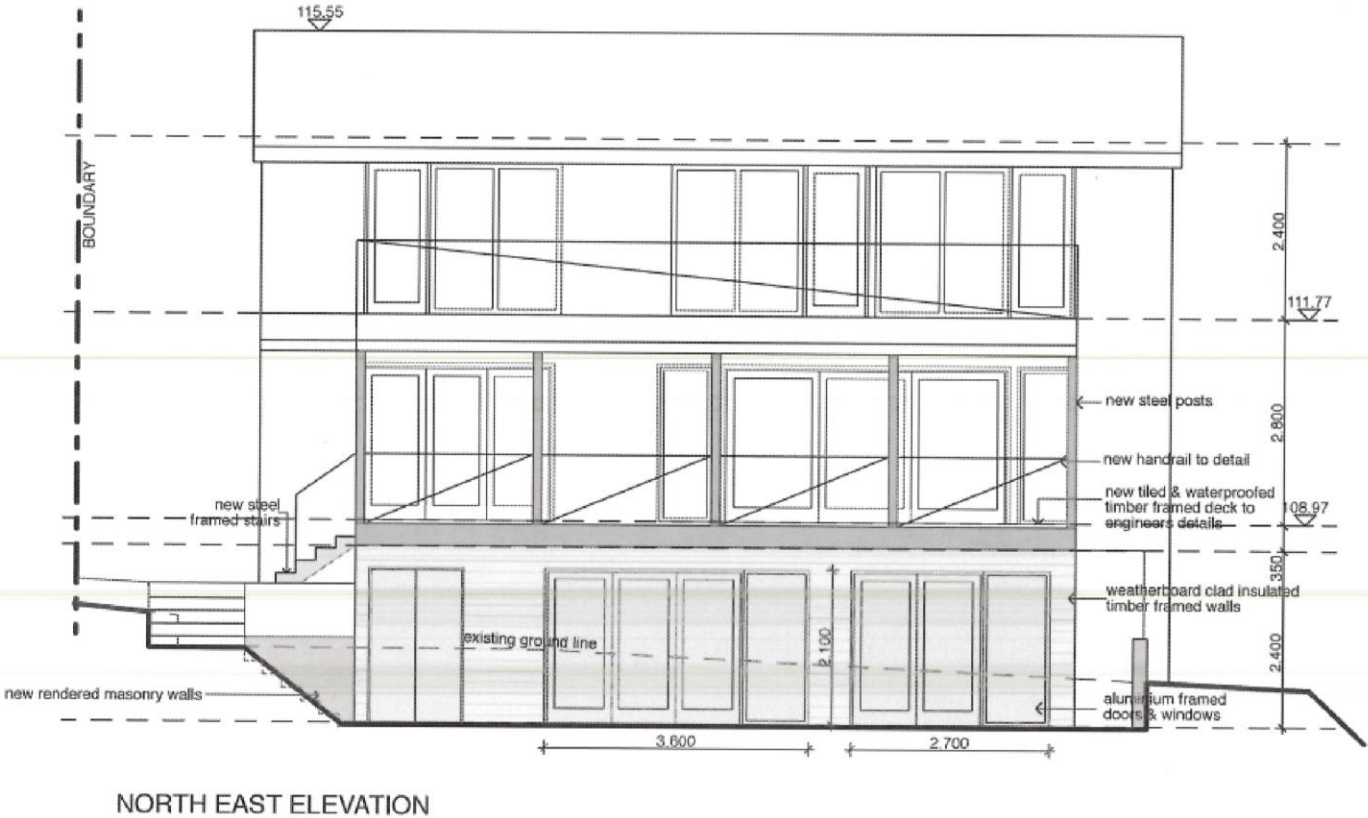
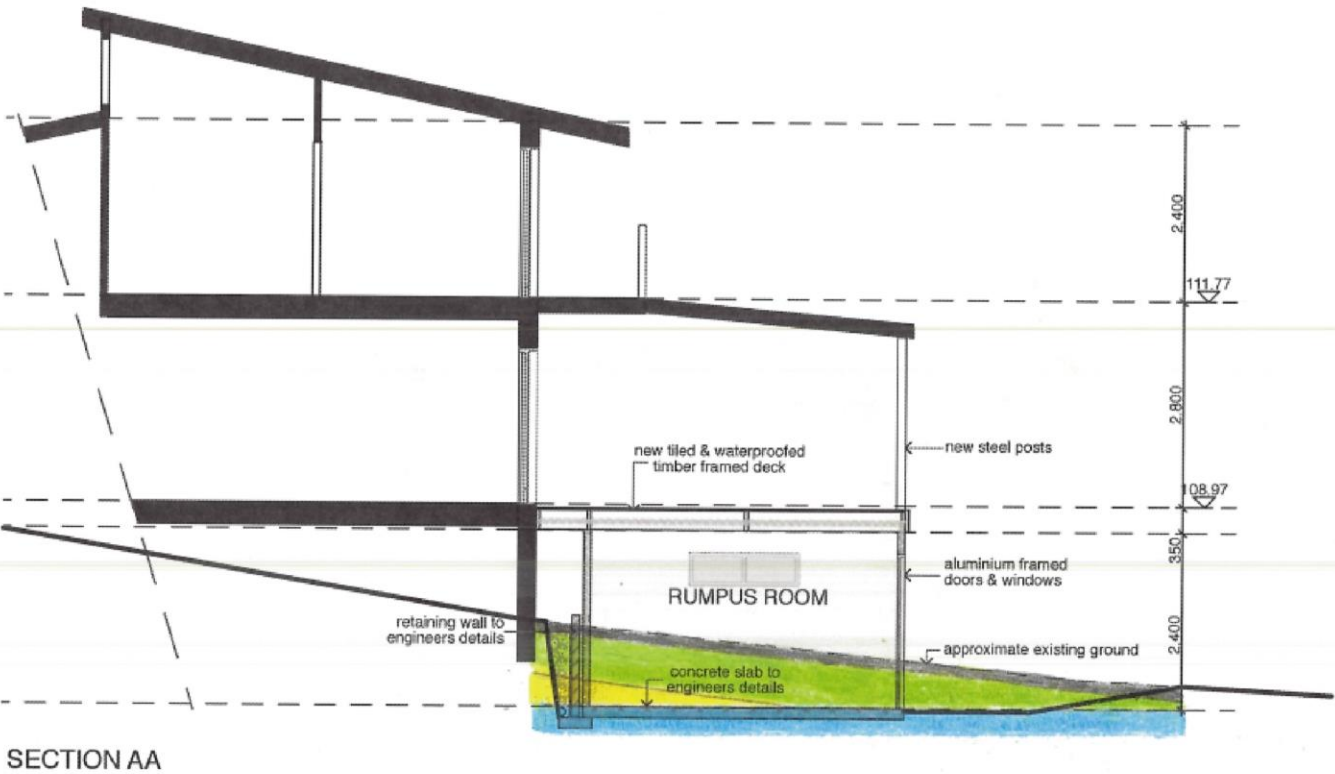
TYPE SECTION – Diagrammatical Interpretation of expected Ground Materials

The surface features of the block are controlled by the underlying sandstone bedrock that steps down the property forming sub-horizontal benches between the steps. Where the

grade is steeper, the steps are larger and the benches narrower. Where the slope eases, the opposite is true. The rock is overlain by fill, sandy soil, sand and clayey sand that fills the bench step formation. Fill provides level lawn areas on the downhill side of the property. In the test locations, the depth to rock ranged to depths of between ~0.4 to ~1.4m below the current surface. The sandstone underlying the property is estimated to be Medium Strength or better. See Type Section attached for a diagrammatical representation of the expected ground materials.
