Report Title: Geotechnical Report 61B Wandeen Road, Clareville
Report Date: 15/12/21

GEOTECHNICAL INVESTIGATION:

Alterations and Additions and New Pool at 61B Wandeen Road, Clareville

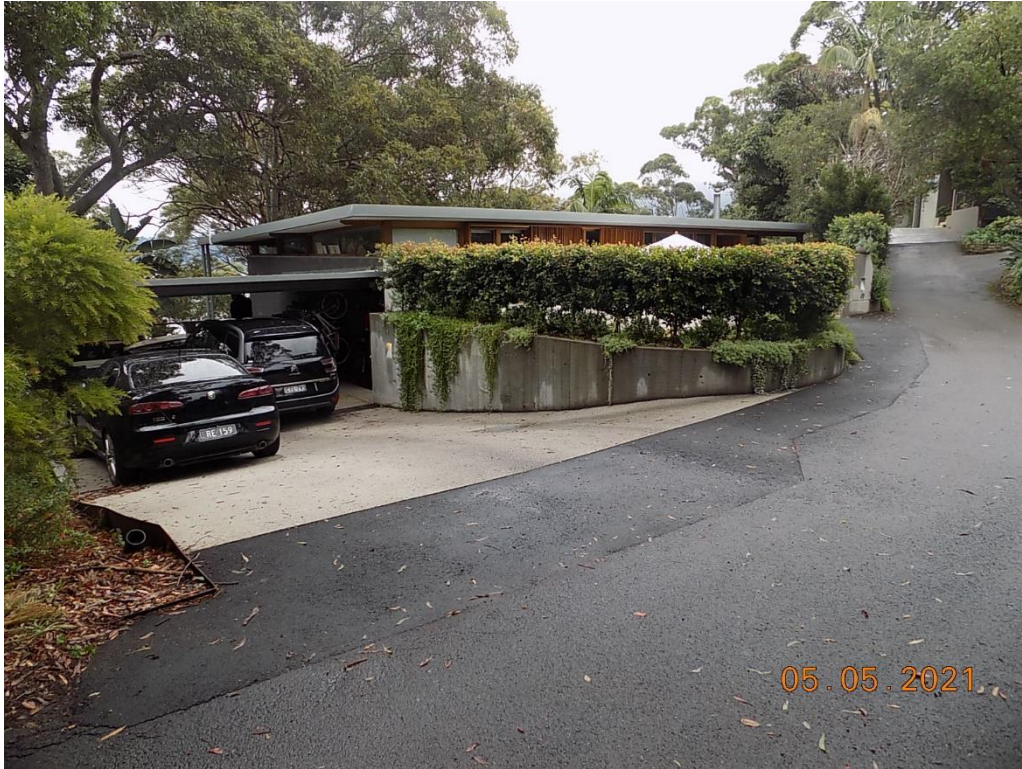
Photo 1

2.3 At the road frontage to Wandeen Road, a concrete and bitumen ROW runs past the uphill side of the property (Photo 1). A concrete driveway diverts off the ROW and runs to a carport attached to the SW side of the house (Photo 2). The carport will be demolished as part of the proposed works. An excavation has been made in the slope between the ROW and the house for a lawn area (Photo 3). The cut is supported by a stable brick and formed concrete retaining wall reaching ~1.0m. Competent Medium Strength Sandstone outcrops through this lawn. The part two-storey brick house is supported on brick walls, brick piers, and steel posts (Photo 4). No significant signs of movement were observed in the supporting brick walls and the supporting brick piers and steel posts stand vertical. Some of the supporting walls, posts, and piers were observed to be supported directly off outcropping sandstone. The outcropping sandstone that falls below the NW side of the house displays no significant geological defects and is considered stable (Photo 5). The outcropping sandstone that falls below the SE side of the house is undercut in two locations (Photos 6 & 7). See **Section 14** for recommendations regarding these undercut joint blocks. A steep, well-vegetated slope falls from the base of the outcrops to the uphill side of a bitumen ROW off Georgia Lee Place (Photo 8).

No evidence of surface flows were observed on the property during the inspection. The ROW above will provide only limited drainage diversion from surface flows as the road is not guttered above the subject property (Photo 1). It is expected that normal sheet wash will move onto the site from above the property during heavy down pours.

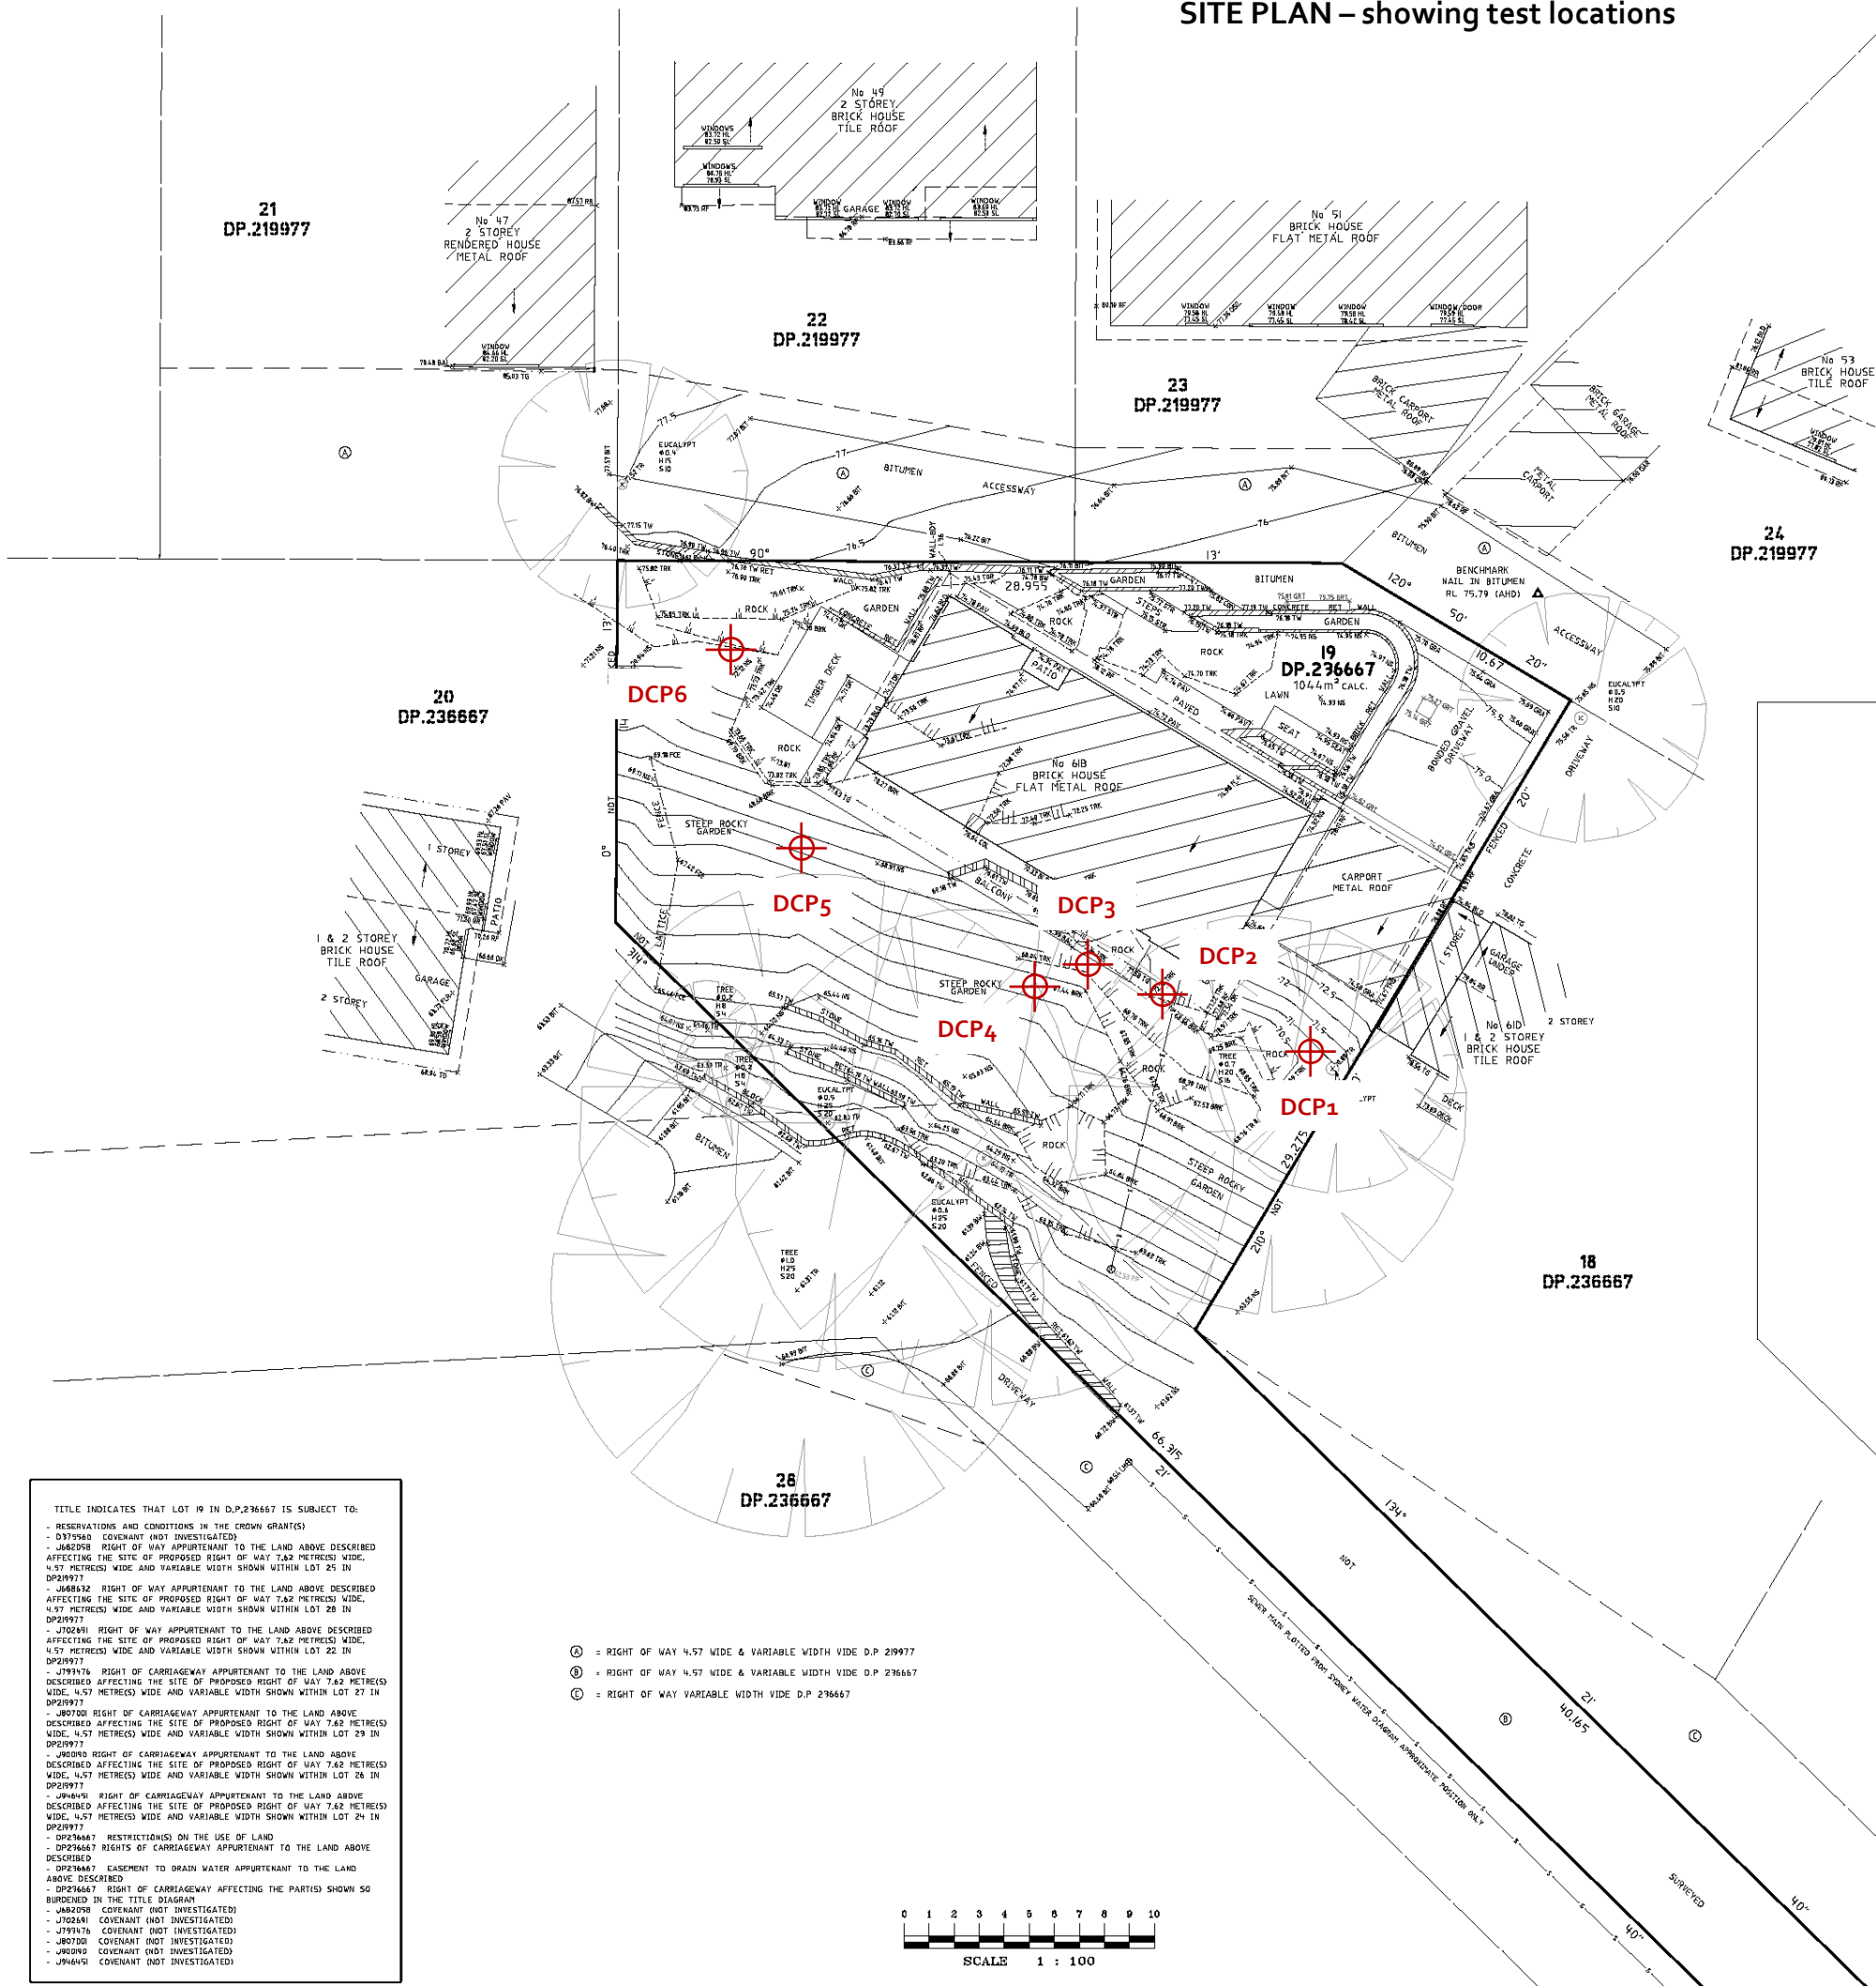
SITE PLAN – showing test locations

Six DCP (Dynamic Cone Penetrometer) tests were put down to determine the relative density of the overlying soil and the depth to bedrock. The locations of the tests are shown on the site plan attached. It should be noted that a level of caution should be applied when interpreting DCP test results. The test will not pass through hard buried objects so in some instances it can be difficult to determine whether refusal has occurred on an obstruction in
