Report Title: Geotechnical Report 314 Hudson Parade, Clareville  
Report Date: 16/12/19  
Author: BEN WHITE  
Author's Company/Organisation: WHITE GEOTECHNICAL GROUP PTY LTD

## **GEOTECHNICAL INVESTIGATION:**

### **Alterations and Additions at 314 Hudson Parade, Clareville**

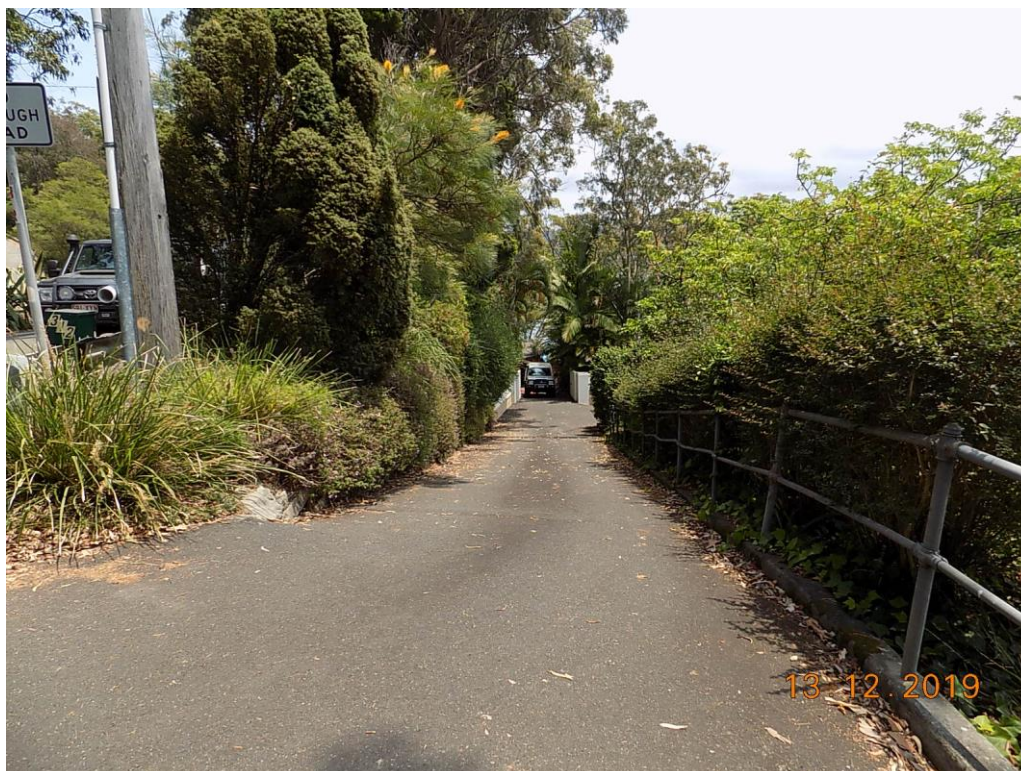
Photo 1

- 2.3** The property is accessed by a bitumen Right of Carriageway (ROW) off Hudson Parade (Photo 1). A bitumen driveway diverts off the ROW and runs down and across the slope to a stable brick garage on the uphill side of the house and to a parking area on the uphill side of the garage (Photo 2). The cut for the parking area is supported by a stable ~1.0m high brick retaining wall. A steep, well-vegetated slope falls from the road frontage (Photo 3). A cut and fill has been made in this slope for a level lawn area (Photo 4). The cut is supported by a stable ~1.8m high stack rock retaining wall

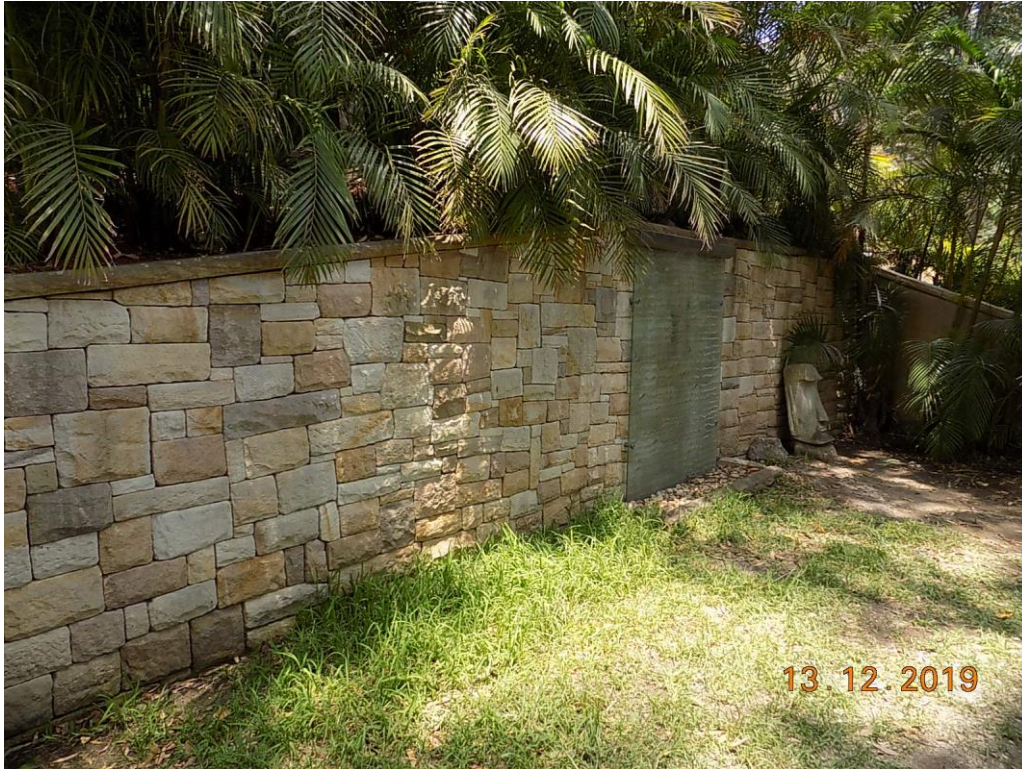
Photo 5

(Photo 5). The fill is supported by a stable ~1.2m high brick retaining wall (Photo 6). The existing two-storey brick house is supported on brick walls (Photo 7). No significant signs of movement were observed in the supporting brick walls. The house was undergoing remediation at the time of the site visit. The builder on site informed us that the remediation works were due to a termite infestation in the timber supports and frame of the upper floor and internal walls. A cut and fill has been made in the slope to create a level platform for the house. The cut for the house is supported by a stable brick retaining wall reaching ~2.7m high (Photo 8). The fill is lawn-covered, battered to stable angles, and merges into the natural slope. The slope below the house is terraced with a series of stable treated timber retaining walls (Photo 9). A steep well-vegetated slope falls from the lowest of these walls to the waterfront (Photo 10). Competent Medium Strength Sandstone outcrops through this slope in places (Photo 11).
