**Date:** 2<sup>nd</sup> March 2022

**Project No.:** 2022-025

Mr T. John Baker & Mrs Sheila Scott  
2/73 Lauderdale Avenue,  
Fairlight, NSW

### **Preliminary Landslip Assessment for 2/73 Lauderdale Avenue, Fairlight**

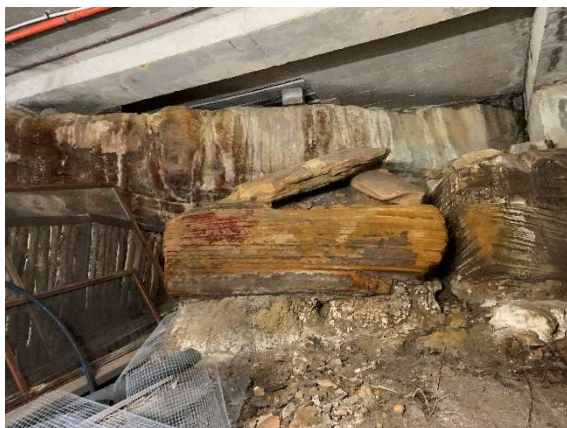
seepage flowing over the bedrock surface was also noted. Interpreted sandstone boulders are positioned to the south of the sub-vertical bedrock face, as shown in Photograph 1, these boulders are embedded into the surficial soils and appeared to be in a stable condition.

*Photograph: 1 – Sandstone bedrock and boulders within undercroft region of No.2/73, facing north*

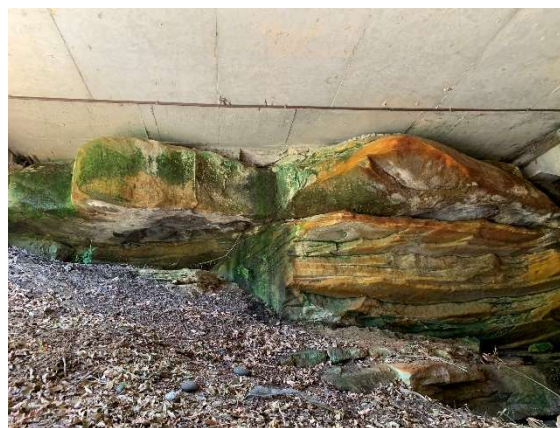
*Photograph: 2 – Undercutting within sandstone bedrock within undercroft of No.1/73, facing north*

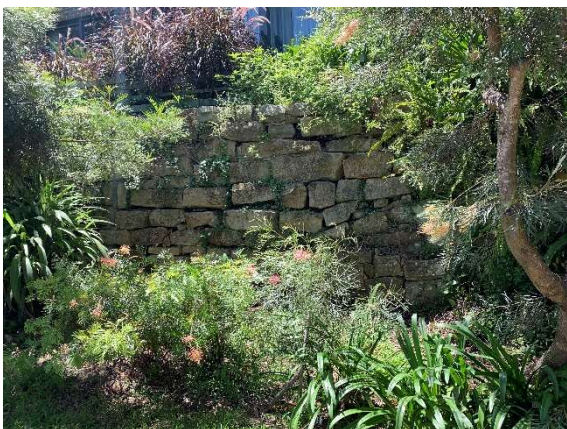
*Photograph 3 – Dry stack sandstone block retaining wall along southern boundary of site, facing north*

The wall appeared to be in a relatively stable condition however large separations between blocks and deflections in the wall were identified. A 0.2m to 0.3m outward bow/bulge in the wall was also identified within the central portion of the wall. It is understood that a large Norfolk Pine tree planted in 1928 had been recently removed within the retained garden, it is possible that the root system of the tree had impacted the retaining wall, leading to outward bowing.

It is considered likely that the bowing and deflections in the rear sandstone block retaining wall are due to stresses induced by the large Norfolk Pine tree root system. The tree has now been removed however it is anticipated that the existing root system remains within the retained garden area. The wall is considered stable at present pending no additional loadings within the retained soils are induced. However, due to the over-vertical state of the wall in portions it is anticipated that it will suffer from creep movement. The Structural Drawings indicate that the footings for the deck extension are to extend to bear onto sandstone bedrock which should impose negligible stresses into the surrounding retained soils.

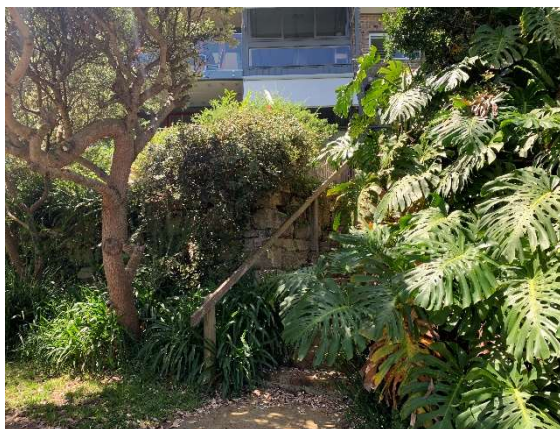
*Photograph 4 – View of the rear of No.2 facing north-west*
