REPORT ON GEOTECHNICAL SITE INVESTIGATION

EXISTING SITE CONDITIONS

98 OLD PITTWATER ROAD, BROOKVALE, NSW

Project No.: 2019-228 July, 2020

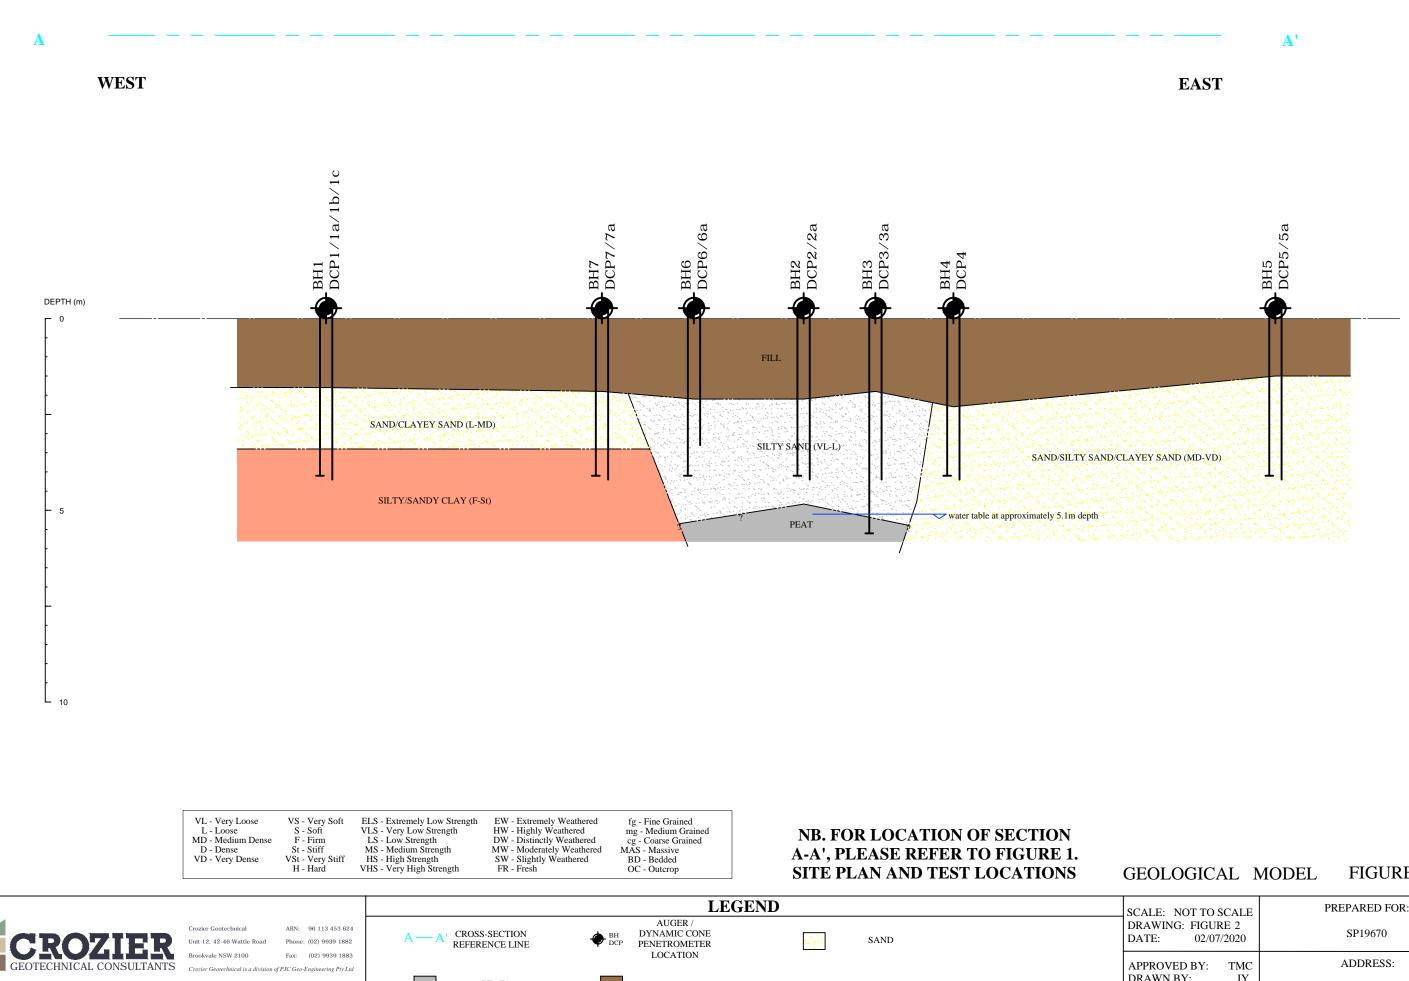
SCALE: NOT TO SCALE	PREPARED FOR:
DRAWING: FIGURE 2 DATE: 02/07/2020	SP19670
APPROVED BY: TMC	ADDRESS:
DRAWN BY: JY PROJECT: 2019-228	98 Old Pittwater Road, Brookvale

4.20m depth. A layer of highly compressible organic clay/peat was encountered below the superficial soils to the south of the wall, from varying depths between 2.50m (BH107) and 3.70m (BH101) to maximum investigation depth at 5.50m, and also below the very loose silty sand in BH3.

Considering that the settlement and cracking is occurring mostly in the centre north of the building and that relatively shallow bedrock was interpreted underlying the south of the building, it is expected that differential settlement between the very loose wet silty sand and organic clay/peat and shallow soil above bedrock is the primary cause of the excess cracking. This could also explain why the previous attempts to lift slabs and footings by injection system at the north end of the site have been unsuccessful.

The investigation identified that a significant layer of soft and highly compressible material underlies the centre northern part of the site and is considered to be the most likely cause to the depression and settlement identified in the existing building.

Remediation is likely to be achieved through extending footings to below the very loose to loose sand and organic clay/peat, however, any footing in soil will still be subject to settlement under loading. Therefore, it is recommended to extend/construct footings to found off bedrock.

Based on the site conditions, it is expected that pile footings are required. Due to the saturated, very loose silty sand and organic clay/peat as well as the water level at 1.30m depth, the most suitable method for concrete pile footings will be CFA piles. However, significant cost should be allowed for, and existing building walls are expected to require some demolition to accommodate this style of rig. Alternatively, screw piles could be utilised. However, the success of these pile systems depends on defining bedrock surface levels.
