Geotechnical

Assessment

Address: 12 Bubalo Street, Warriewood

Job No: 43014

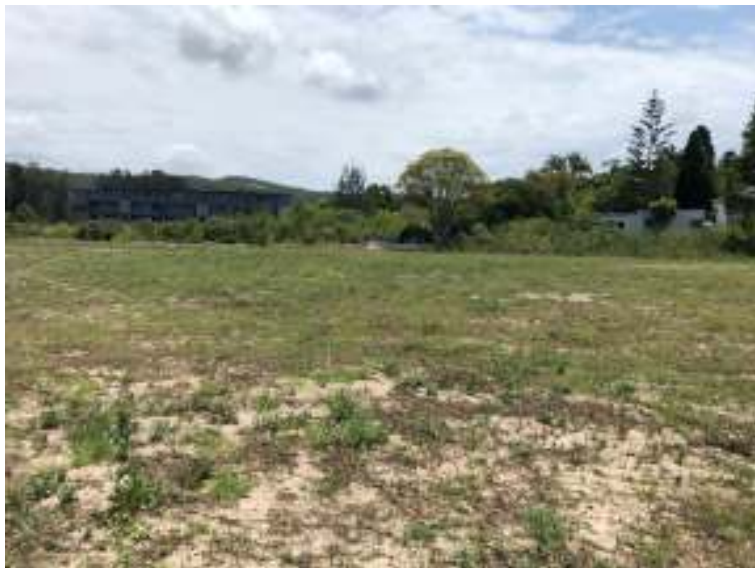
The site is rectangular in shape with a total area of approximately 314m². The site is bound by Bubalo Street to the south east and by vacant residential lots on all other sides. The site is currently vacant with a 1.5m high retaining wall running along the north western boundary. Vegetation consist of some grass cover and the site slopes downwards towards the south at approximately 2-3°.

Photograph 1: Looking at the site from Bubalo Street

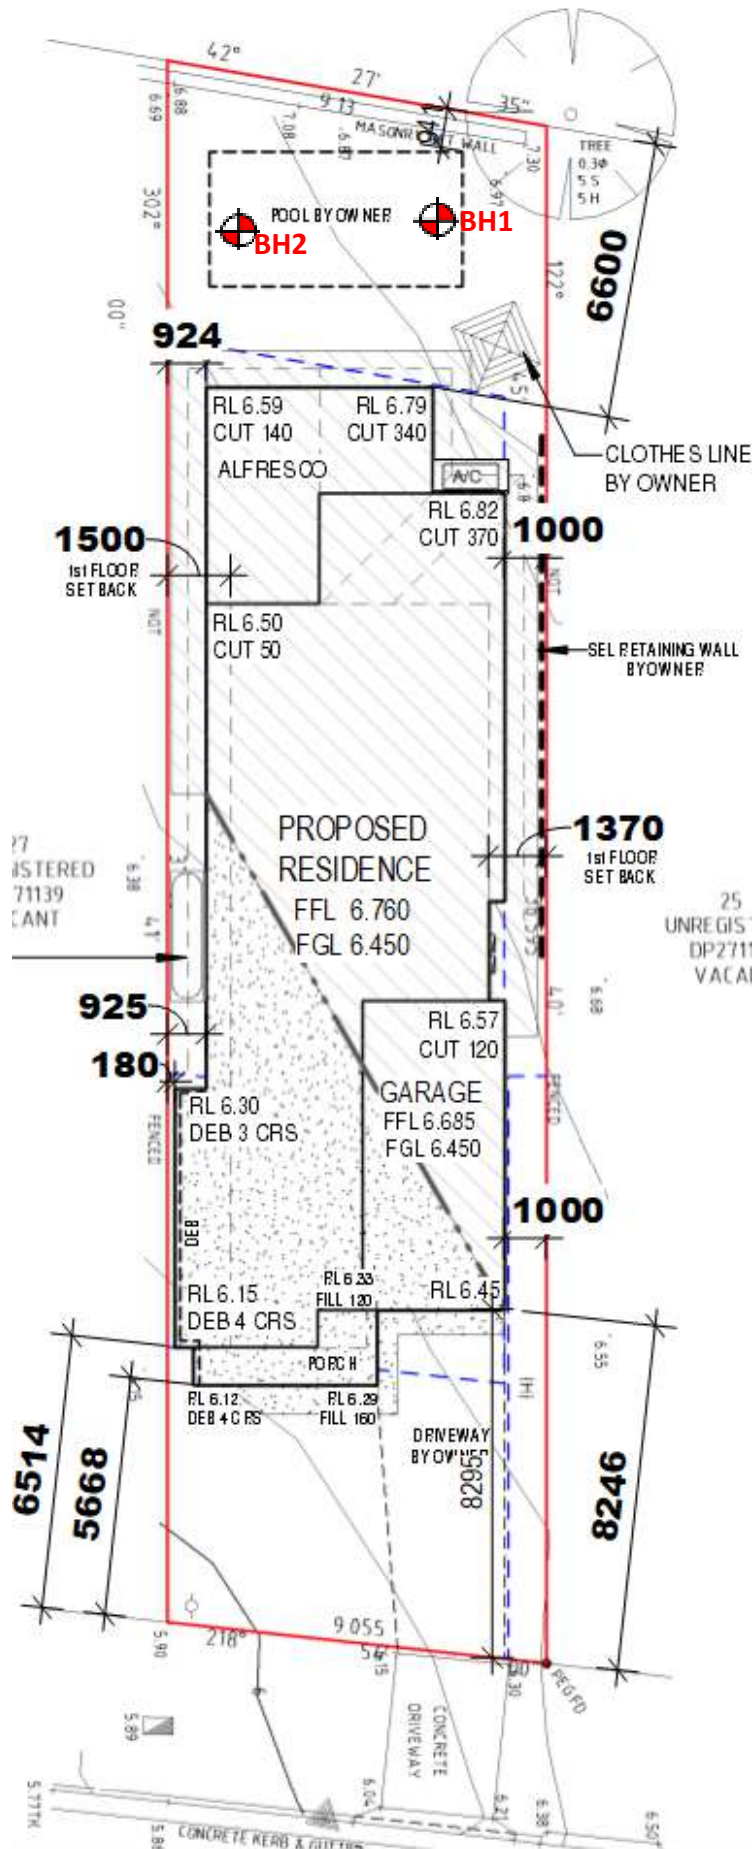
Figure 1 – Borehole Location Plan

Fieldwork was undertaken on 13 January 2020. The geotechnical investigation included drilling two boreholes (BH1-BH2) using a 4wd mounted drilling rig equipped with continuous flight augers, at the location shown on Figure 1, attached in Appendix A. The Boreholes were supplemented with Pocket Penetrometer tests for the measurement of soil strength properties. The boreholes were terminated at 4.5m.
