Report Title: Geotechnical Report 7 Crane Lodge Place, Palm Beach
Report Date: 12/6/24

GEOTECHNICAL INVESTIGATION:

Alterations and Additions at 7 Crane Lodge Place, Palm Beach

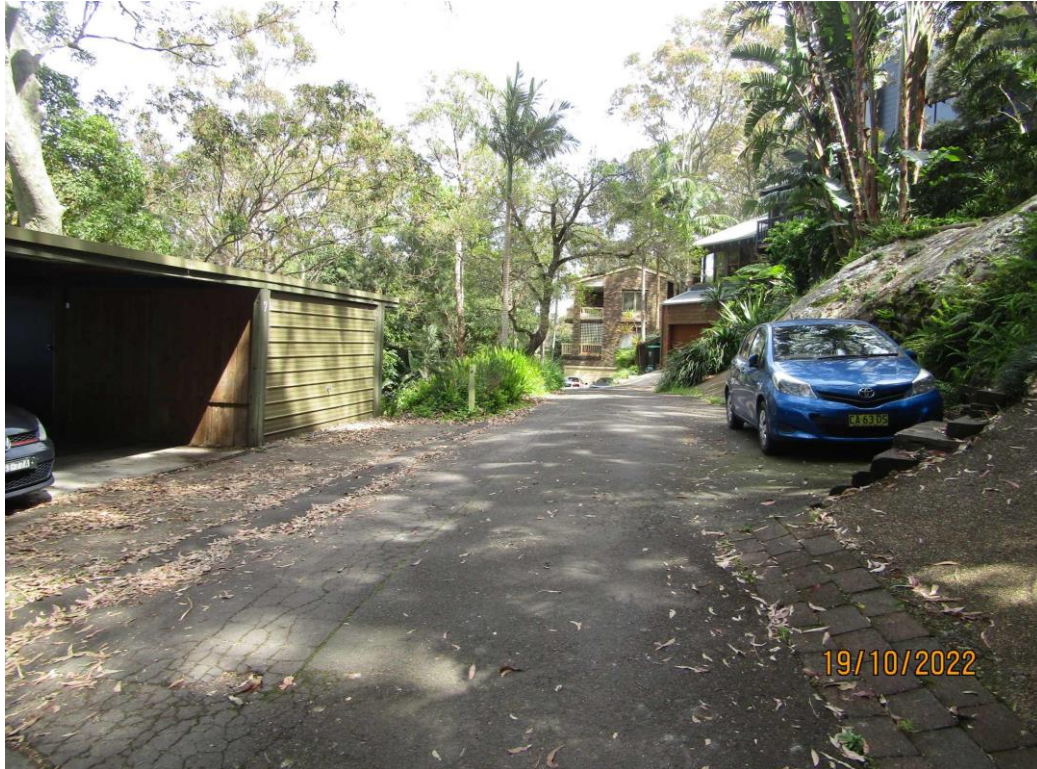
Photo 1

estimated to be ~2m deep. A suspended carport and garage is located on the downhill side of the ROW (Photo 1) and another garage is located on the uphill side (Photo 3). A detached sandstone joint block is located in a stable position beside the upper garage (Photo 4). A concrete driveway runs up the slope to a parking area above the rock (Photos 4 & 5). A cut and fill provides a level platform for the driveway and parking area. The cut and fill is supported by stable timber retaining walls up to ~2.0m high.

A suspended timber balcony extends off the downhill side of the house (Photo 1). One of the supporting posts is supported off a stable detached sandstone joint block (Photo 6). This post and the other supporting posts stand vertical. The part two storey brick and timber clad house is supported by brick walls and brick piers (Photos 6 & 7). The supporting walls and piers stand vertical and show no significant signs of movement (Photo 8). A cut provides a level platform on the uphill side of the house. The cut is supported by concrete block and timber retaining walls ~2.2m high (Photo 9). The concrete block retaining wall is stable. The timber retaining wall displays minor bulging and the timber posts supporting the wall are tilting downslope slightly (Photo 10). A new block retaining wall will be built in front of this wall as part of the proposed works. The steep slope on the uphill side of the retaining walls is well vegetated (Photo 11). Detached sandstone joint blocks are scattered across the slope.

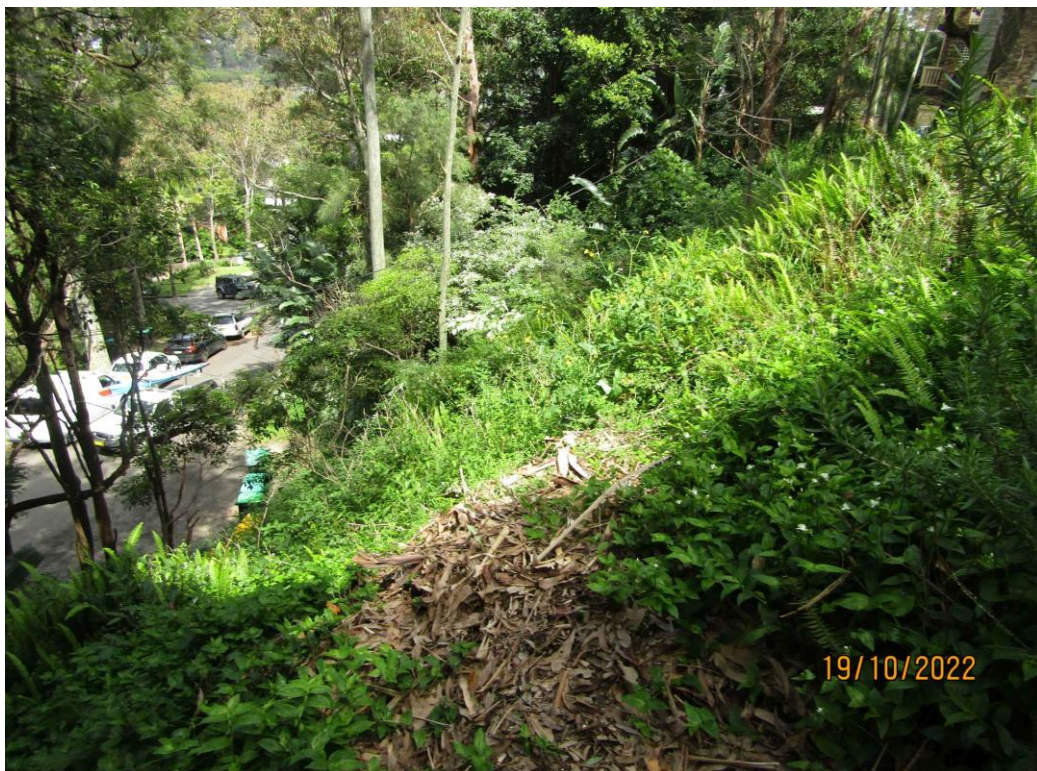
Photo 2

- 2.1** The site was inspected on the 19th October, 2022.
- 2.2** This residential property is on the high side of the road and has a S aspect. It is located on the steeply graded middle reaches of a hillslope. The natural slope rises across the property at an average angle of ~27°. The slope above the property continues at steep angles for some 140m before reaching the crest of the hill. The slope below the property gradually decreases in grade.
- 2.3** The property is accessed from a bitumen right of carriageway (ROW). Fill provides a level platform for the ROW (Photo 1). The fill merges into a densely vegetated natural steep slope (Photo 2). The depth of the fill is unknown but is

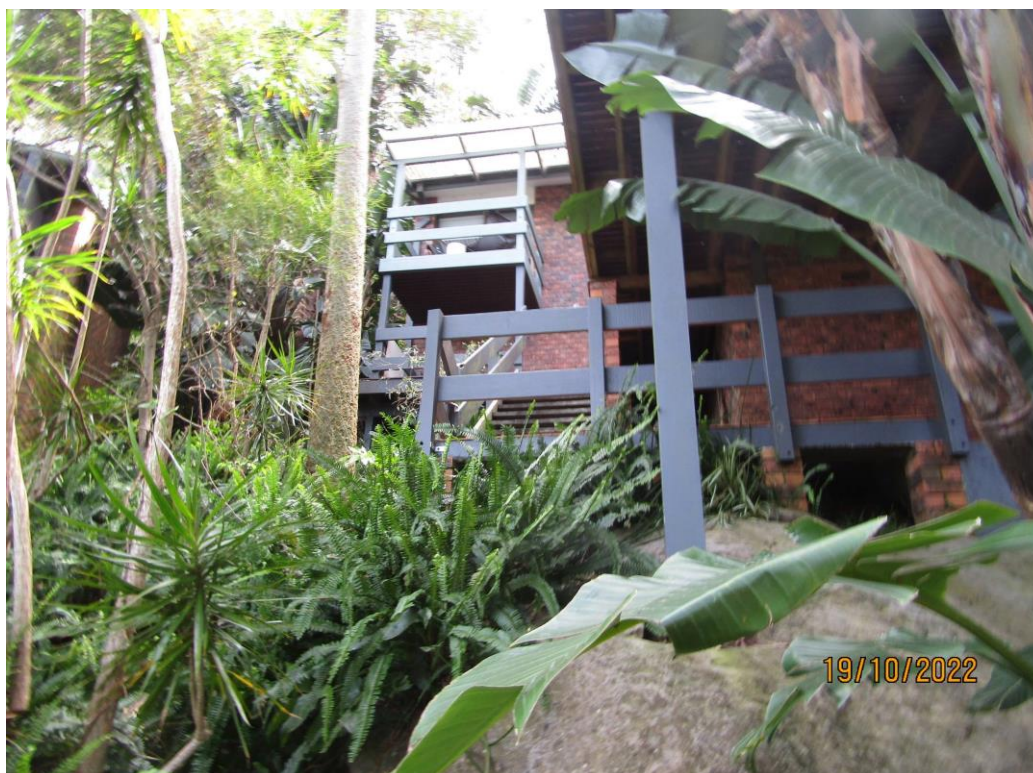
Photo 6

The detached sandstone joint block (Photo 6), existing house and W common boundary will be within the zone of influence of the excavation. In this instance, the zone of influence is the area above a theoretical 30° line (from horizontal) through fill/soil and a 45° line through clay / weathered rock from the base of the excavation towards the surrounding structures and boundaries.

The large detached sandstone joint block (Photo 6) and E supporting brick wall of the existing house may extend to below the base of the excavation. However, to be sure, exploration pits along the joint block and wall will need to be put down by the builder to determine the depth of the joint block and the foundation depth and material that supports the existing house wall. These are to be inspected by the geotechnical consultant. If the base of the joint block and existing house wall foundations are confirmed to extend below the base of the excavation, the excavation may commence. If they are not, the sandstone joint block and existing house wall are to be underpinned to below the base of the excavation, prior to the excavation commencing. The extent of the area of the required exploration pits/underpinning are shown in orange on the attached Level 0 and Level 1 Plans.

- The geotechnical consultant is to inspect any exploration pits required to expose the foundation materials of the existing house and to expose the base of the large sandstone joint block (Photo 6).
- All footings are to be inspected and approved by the geotechnical consultant while the excavation equipment and contractors are still onsite and before steel reinforcing is placed or concrete is poured.

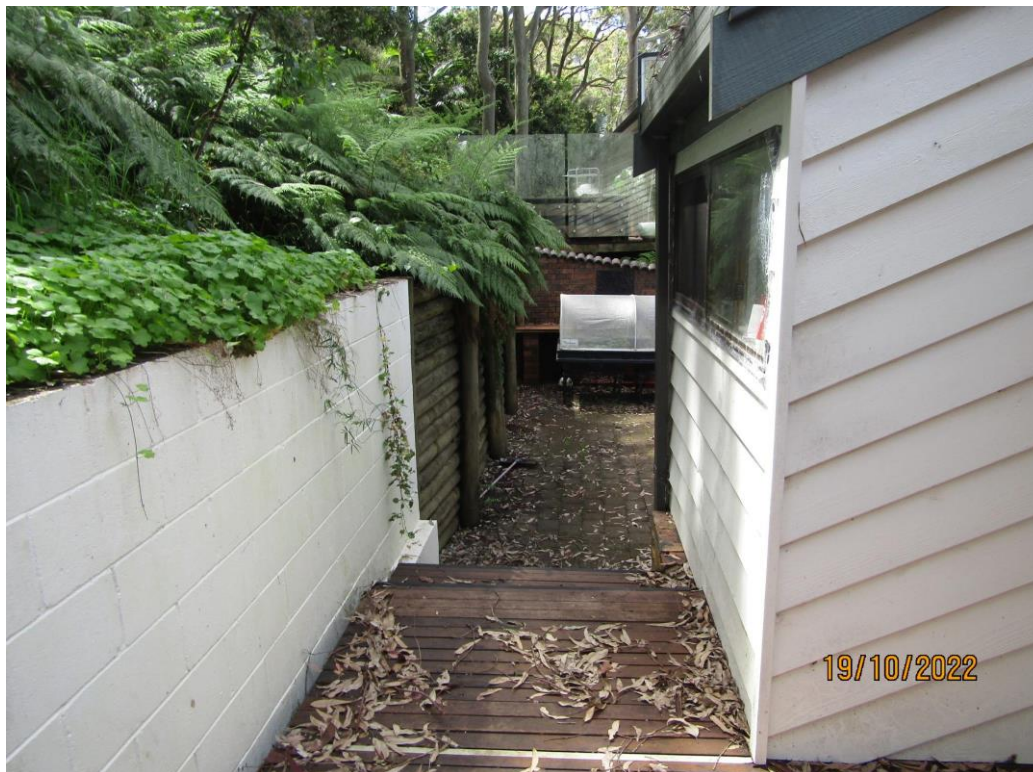
Photo 9

No evidence of surface flows were observed on the property during the inspection. It is recommended as part of the development a cut off drain be installed across the upper reaches of the site to catch surface flows from the slope above. Ideally, the drain is to be installed near the uphill property boundary to capture flows before they enter the property. If the drain is to be installed close to the uphill property boundary, the location of the drain will require the approval of the geotechnical consultant. Alternatively, the drain can be installed on the uphill side of the existing concrete block and timber retaining walls (Photo 9).

The captured flows from this drain should be piped to the street. All drains, pits and associated plumbing are to be oversized and designed to cope with extreme prolonged rainfall events. The drain is to be the first thing constructed on the site as part of the development. It is a condition of the slope stability assessment in Section 8 (**Hazard One**) that this be done.

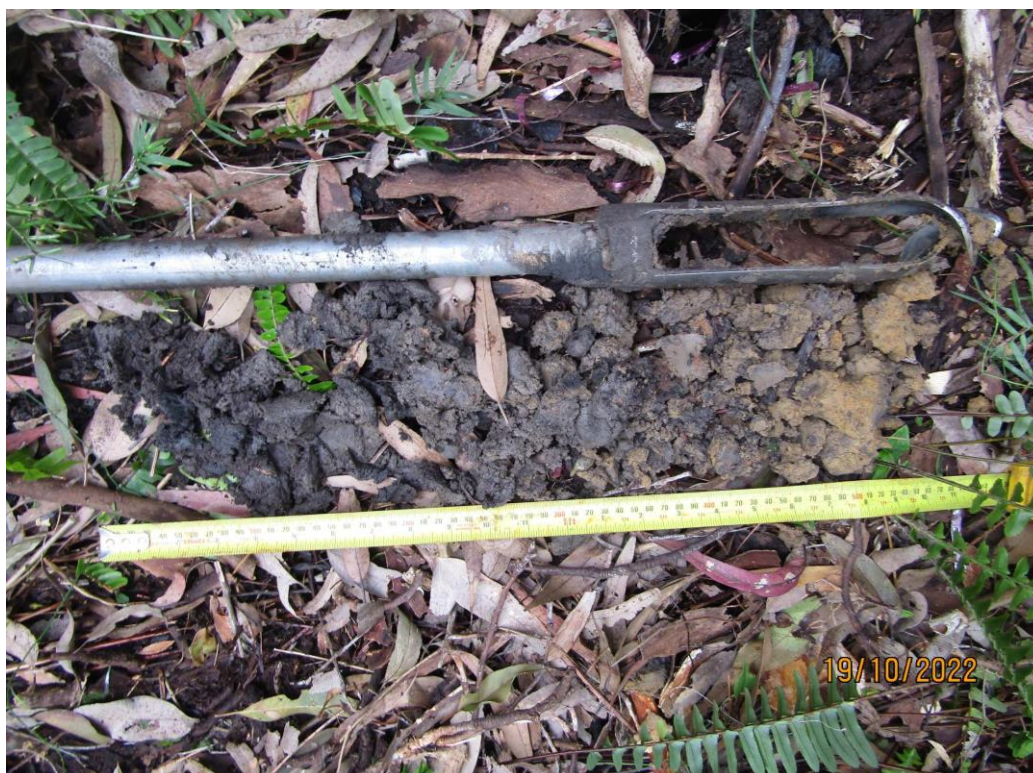
Depth (m)	Material Encountered
0.0 to 0.4	TOPSOIL , sandy soil, dark brown/grey, damp, fine to medium grained.
0.4 to 0.6	SANDY CLAY , light brown orange, damp, firm.

End of hole @ 0.6m in firm sandy clay. No watertable encountered.

Photo 12: AH1 – Downhole is from left to right.
