## PRELIMINARY GEOTECHNICAL ASSESSMENT:

### 323 McCarrs Creek Road, Terrey Hills

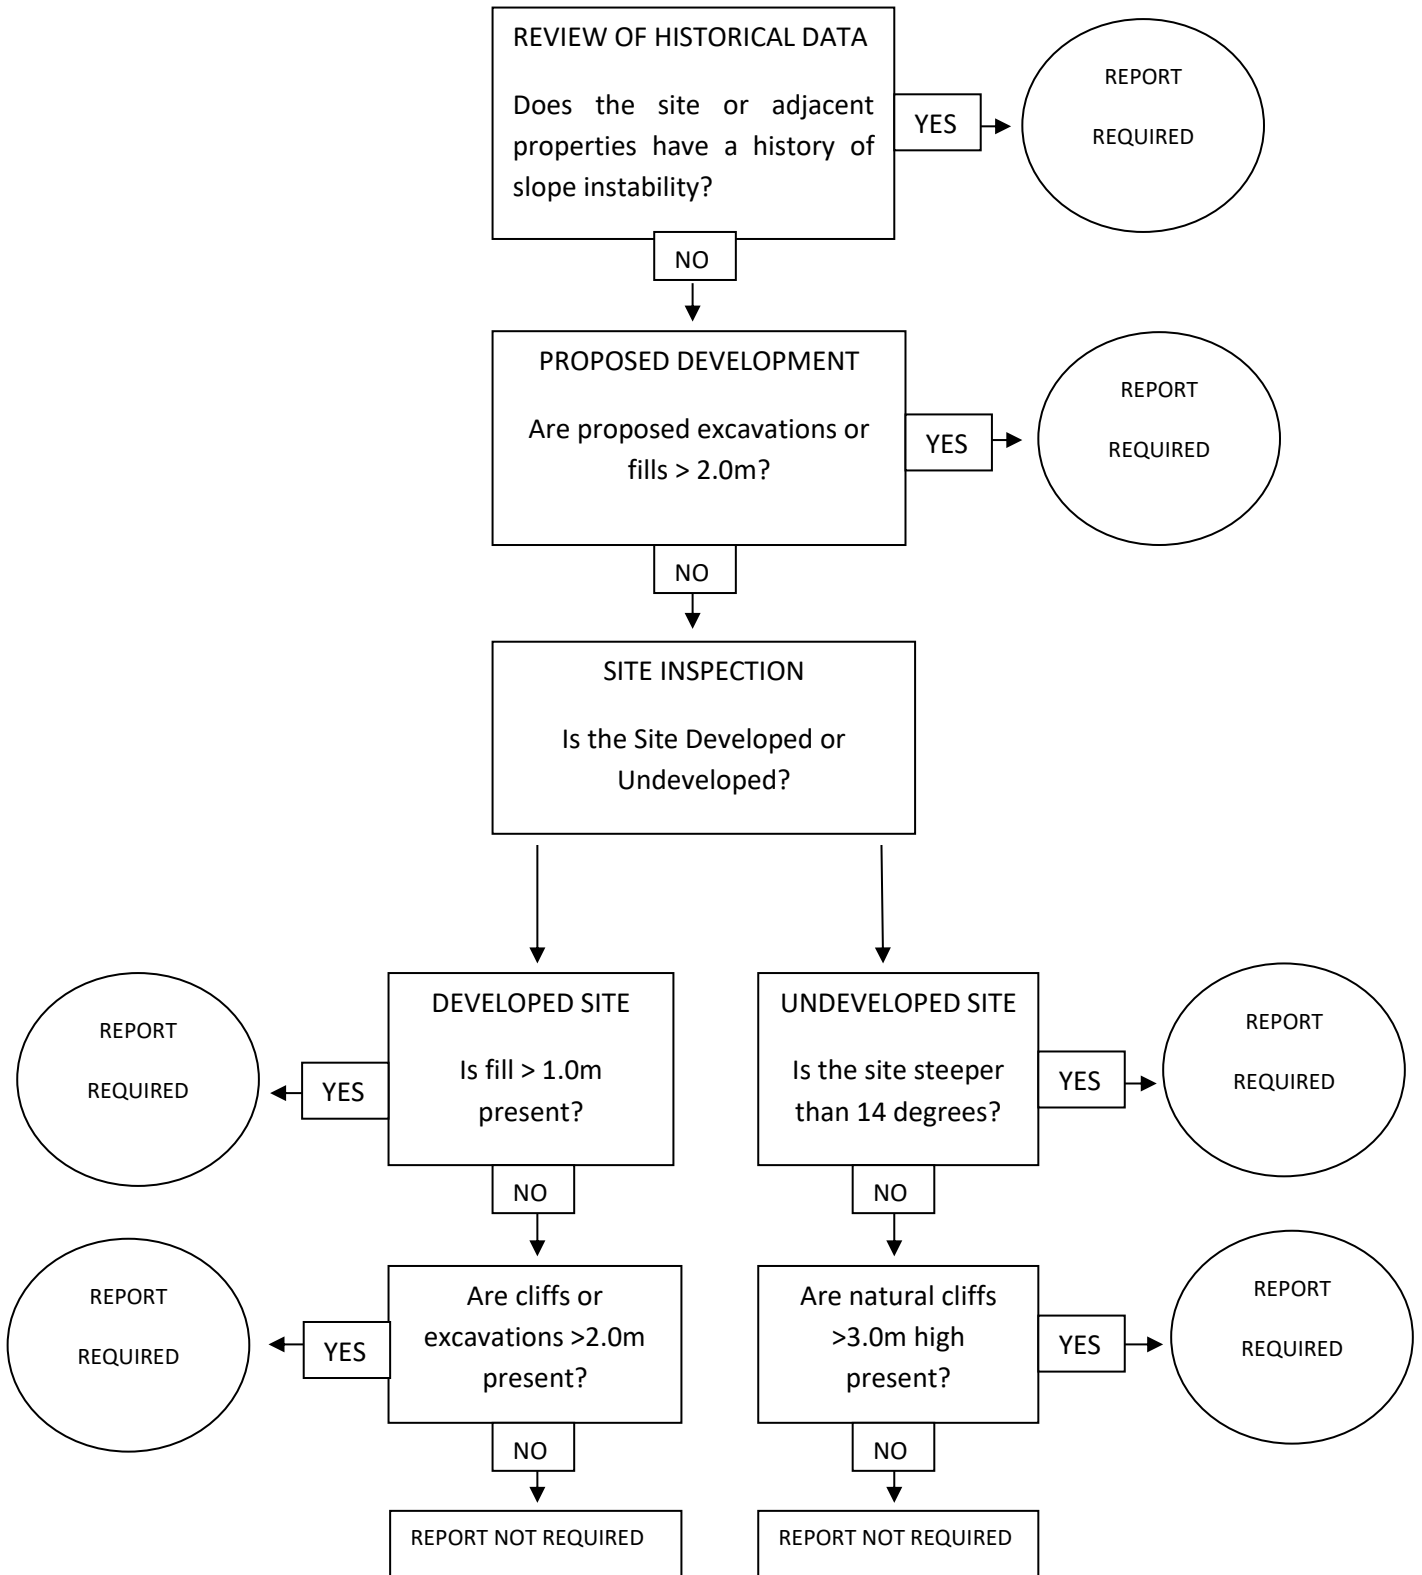
## Preliminary Assessment Flow Chart – Norther Beaches Council (Warringah)

The proposed development and site conditions were considered and applied to the Council Flow Chart.

Provided good engineering and building practice are followed, no further Geotechnical assessment is recommended for the proposed development.
