Report Title: Geotechnical Report 7 PACIFIC ROAD, PALM BEACH
Report Date: 1/12/16
Author : BEN WHITE
Author's Company/Organisation : WHITE GEOTECHNICAL GROUP PTY LTD

GEOTECHNICAL INVESTIGATION:

Alterations & Additions at 7 Pacific Road, Palm Beach.

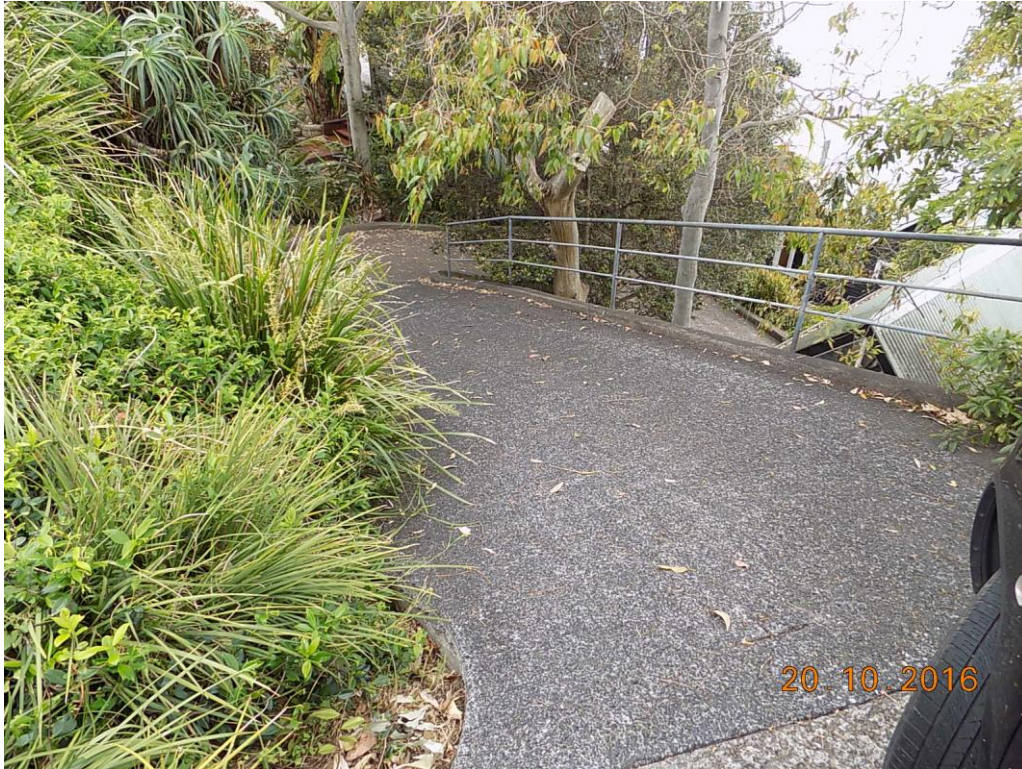
Photo 1

- 2.3 At the road frontage a suspended concrete driveway runs down and across the slope then cuts back 180° to a timber framed and clad garage (Photos 1 & 2). The driveway is supported by concrete piers, some of which can be seen to be founded directly onto medium strength sandstone bedrock (Photo 3). Below the driveway is a steep, densely vegetated slope that has been terraced with three retaining walls (Photo 4). The upper wall is a concrete block wall and the middle wall is a brick wall. Both walls are $\sim 1.0\text{m}$ high and from what could be seen of them through the dense vegetation, they appear stable. The lower wall is a concrete block wall $\sim 1.4\text{m}$ high. It also appears stable and is supported directly onto medium strength sandstone. Below the garage is a densely vegetated slope that falls to the top of a cut made to accommodate the house. The cut is through medium strength sandstone, is $\sim 2.0\text{m}$ high and is considered to be stable (Photo 5). The part three storey brick and timber framed and clad house is in good condition (Photo 6). No significant cracking or movement was observed in its external supporting walls and its supporting concrete piers stand vertical. A tiled patio area extends off the downhill side of the house and around a pool that displays no signs of movement. A lawn covered fill below the house is supported by a timber

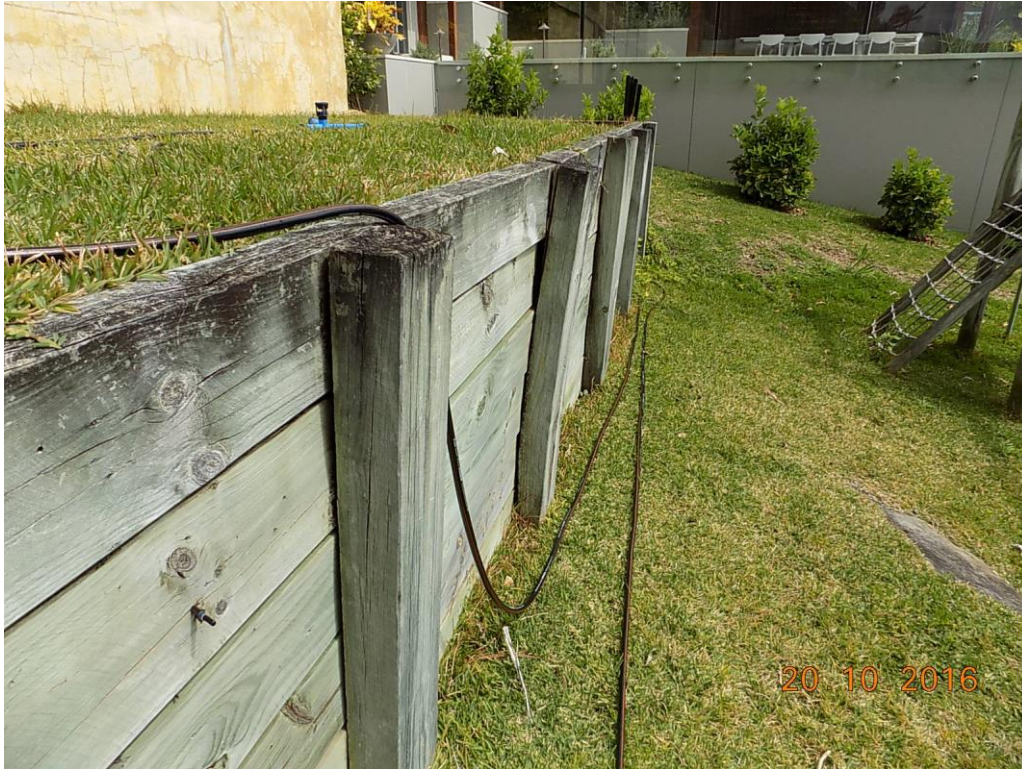
Photo 7

retaining wall reaching ~1.2m high. The wall is tilting to ~8° (Photo 7). The movement in the retaining wall appears to be partly due to bowing of the soldier posts and partly due to the inadequate embedment. Below the wall, a large fill provides a level platform for a lawn that is supported by a timber crib wall ~2.0m high at its SE end (Photo 8), and by a timber soldier pile wall at its NW end. The crib wall displays some minor movement but is currently considered stable. See **section 15** for recommended maintenance. The height of the soldier pile wall could not be accurately determined due to the dense exotic vegetation below it but was observed to be tilting to a maximum of ~5°. See **section 15** for recommended maintenance. Below these walls is a very steep slope with a dense covering of exotic vegetation that continues to the lower boundary (Photo 9).

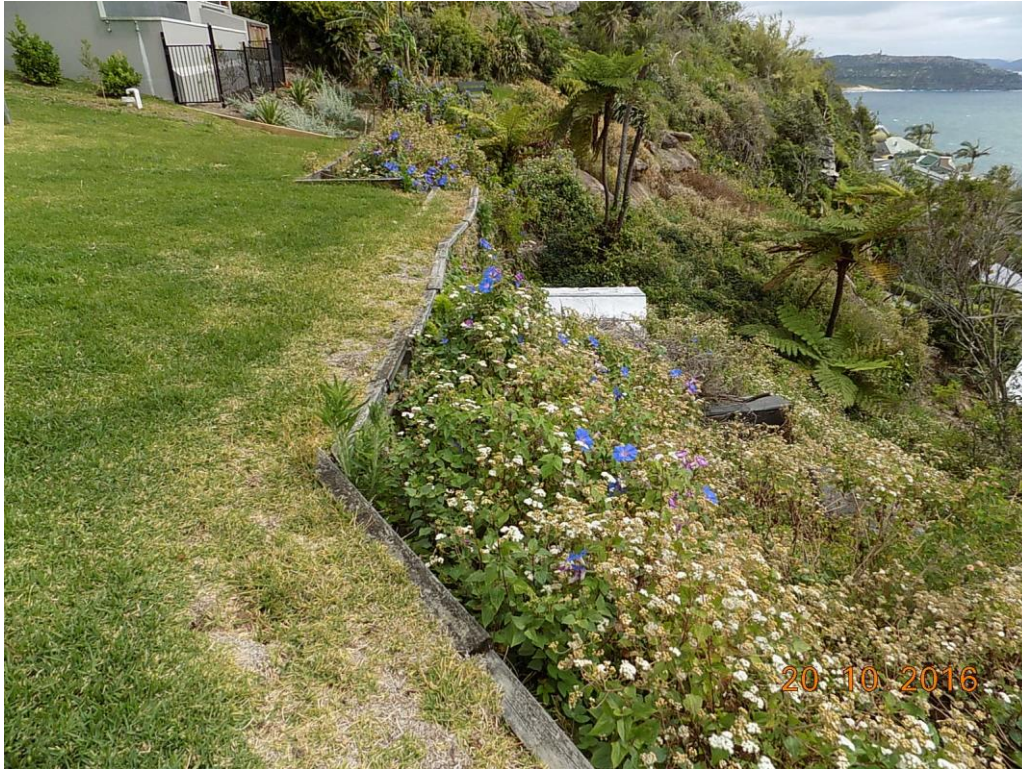
Photo 9

HAZARDS	Hazard One	Hazard Two
TYPE	The steep slope that falls from below the house to the lower boundary and continues beyond failing and impacting on the existing house and proposed works (Photo 9).	The timber crib retaining wall near the lower boundary failing and impacting on the property below (Photo 8).
LIKELIHOOD	'Unlikely' (10^{-4})	'Possible' (10^{-3})
CONSEQUENCES TO PROPERTY	'Medium' (15%)	'Medium' (20%)
RISK TO PROPERTY	'Low' (2×10^{-5})	'Moderate' (5×10^{-5})
RISK TO LIFE	5.5×10^{-7} /annum	2.5×10^{-6} /annum
COMMENTS	This level of risk is 'ACCEPTABLE'.	This level of risk is 'TOLERABLE'. Risk will move to acceptable provided the wall is monitored by the owners on an ongoing biannual basis. See section 15 for maintenance.

All retaining walls on the property are to be inspected for new movement on a biannual basis or after prolonged heavy rainfall, whichever occurs first by the owners of the subject property (Photo 8 & 9). A photographic record of those inspections is to be kept as a record and for future reference. Should further movement be observed a geotechnical professional is to be engaged to assess the movement and provide a plan for remediation should it be required.

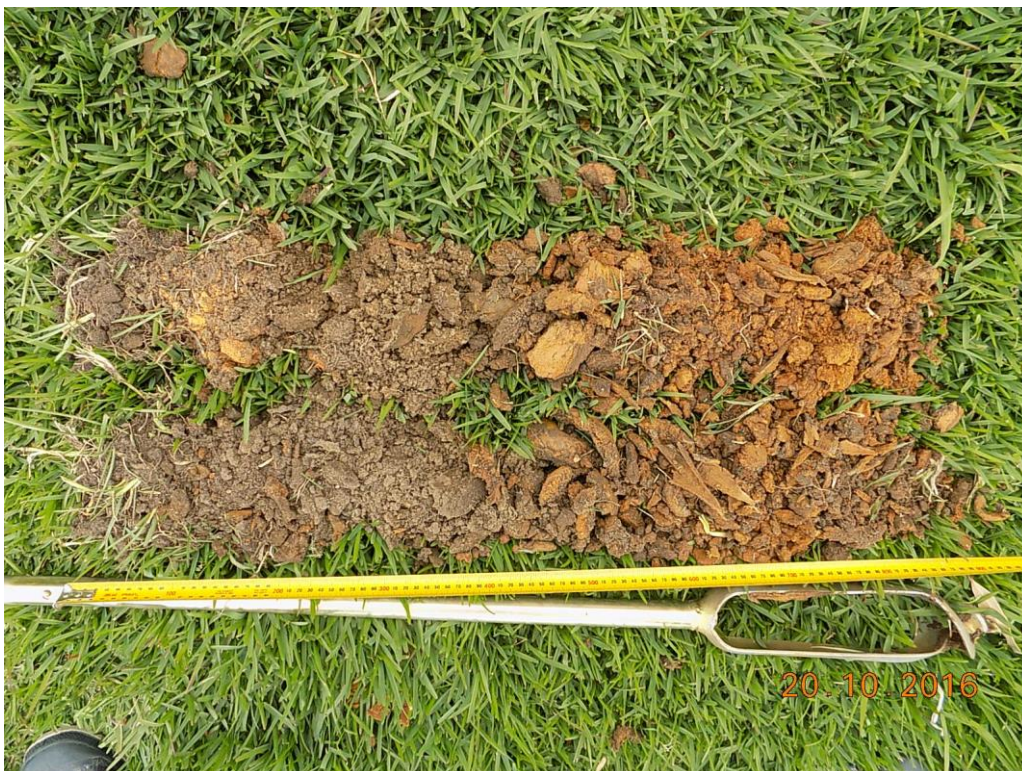
AUGER HOLE 1 (~RL75.1) – AH1 (Photo 10)

Depth	Material Encountered
0.0 to 0.4	SANDY SOIL , dark brown, medium to coarse grained with fine trace organic matter.
0.4 to 0.9	CLAY , brown and mottled orange, firm, fine grained.
Refusal @ 0.9m, auger grinding on rock surface. No water table encountered.

Photo 10: AH1 – Downhole is from left to right.

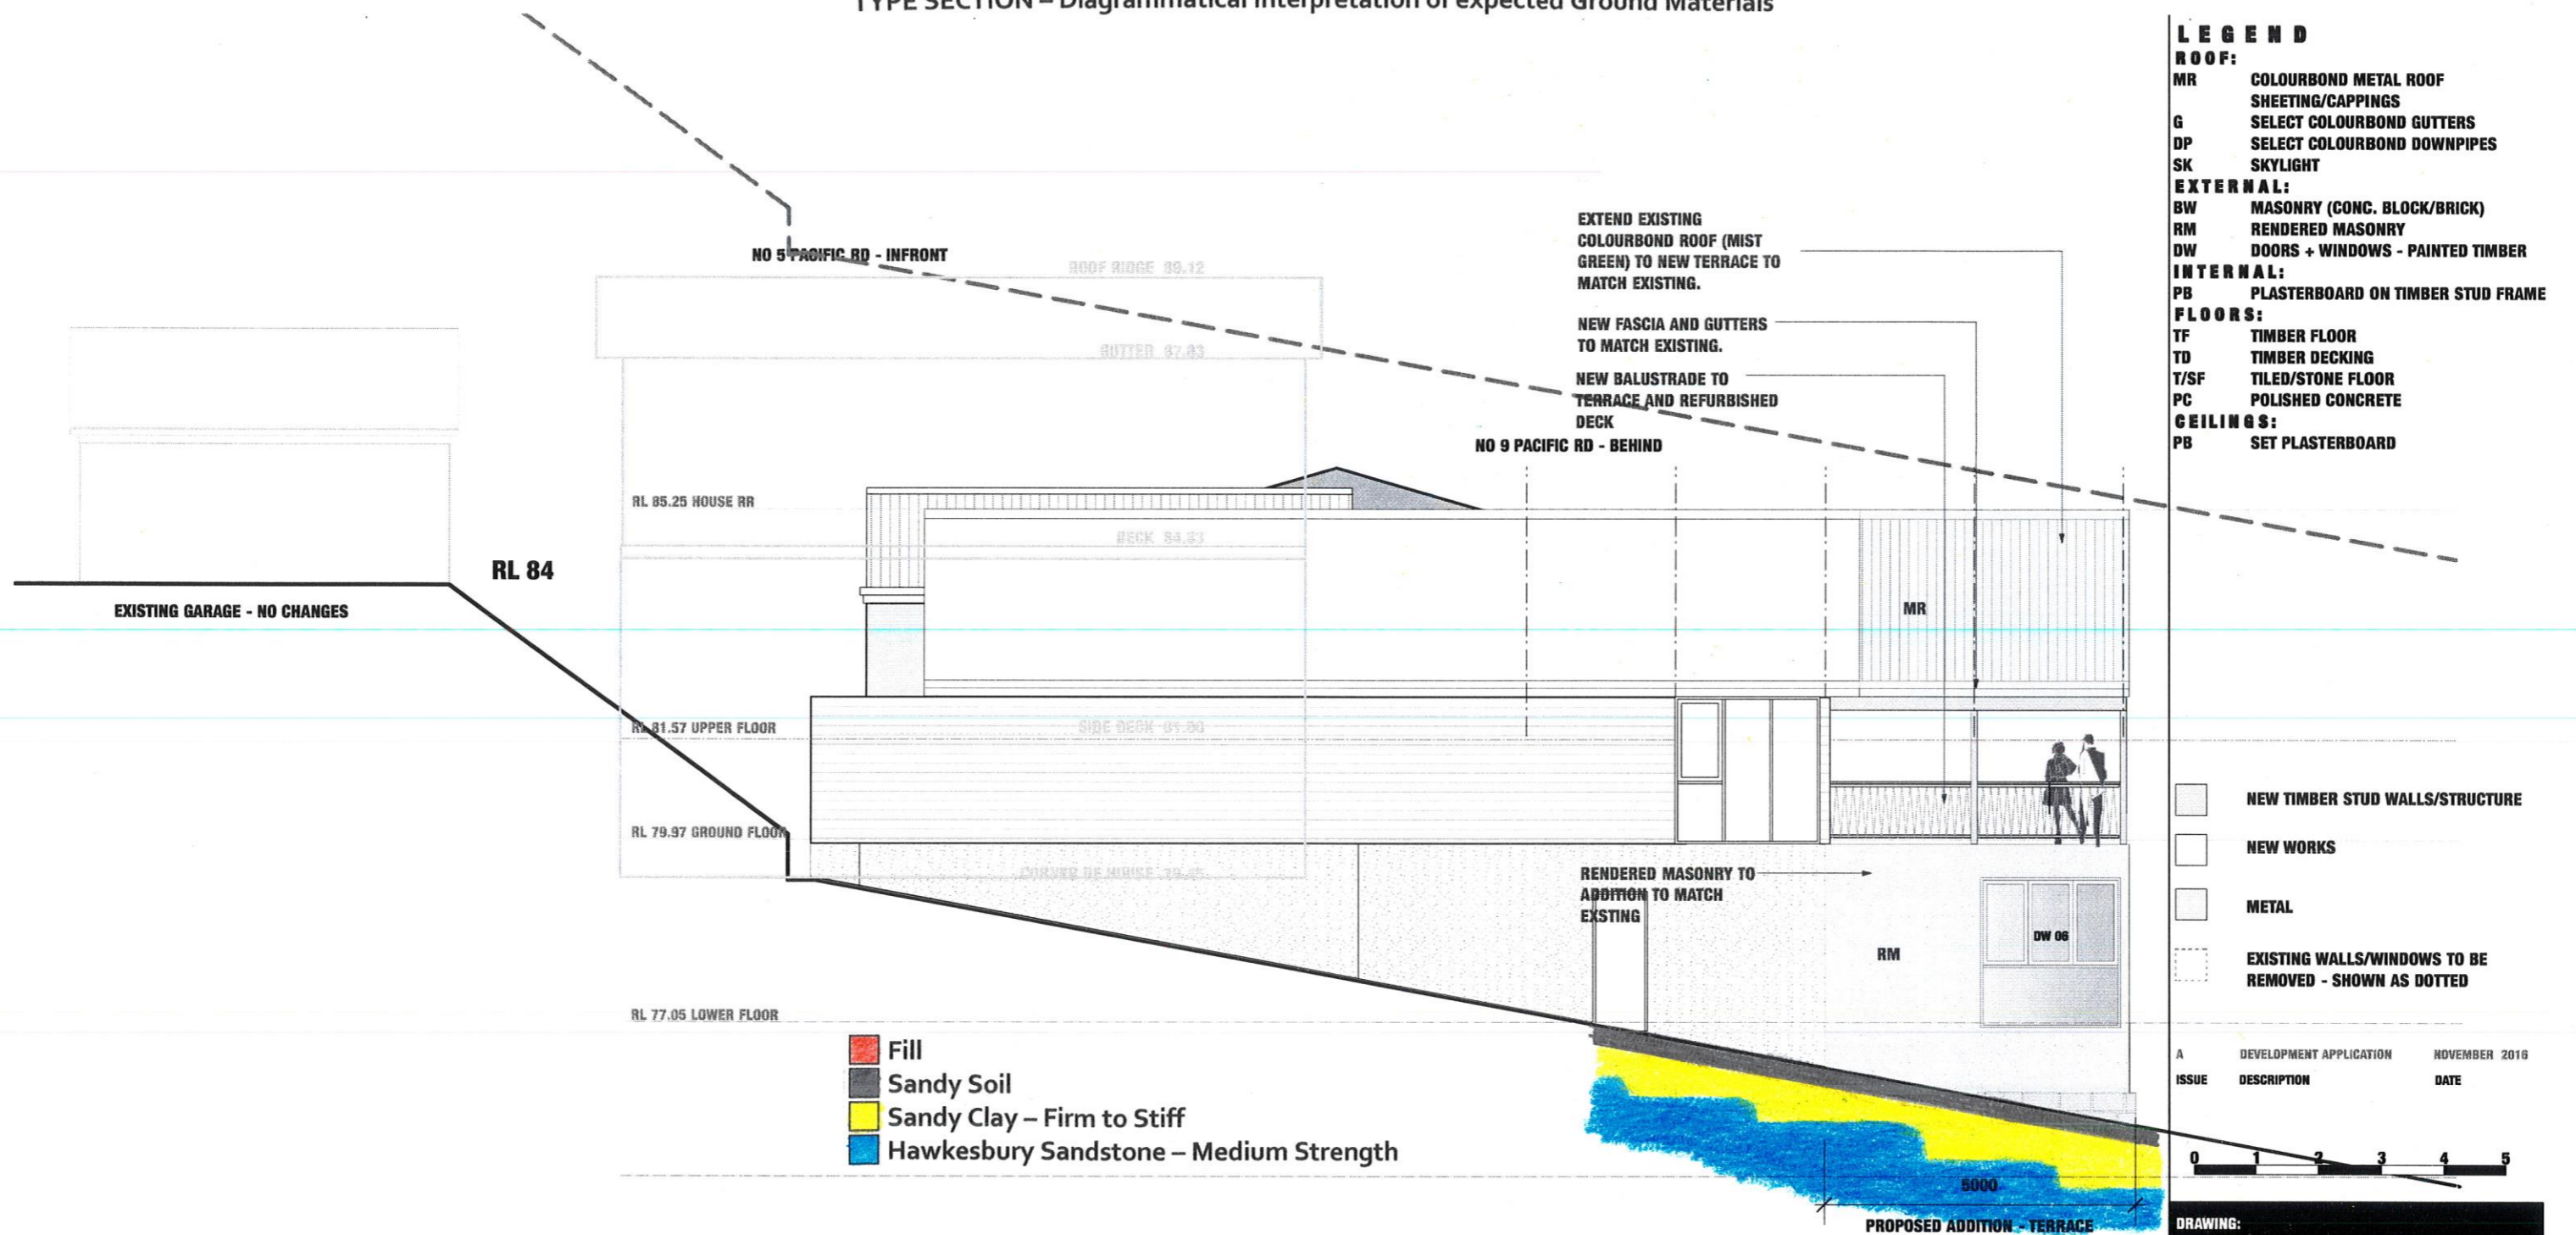
TYPE SECTION – Diagrammatical Interpretation of expected Ground Materials

The surface features of the block are controlled by the outcropping and underlying sandstone bedrock that steps down the property forming sub horizontal benches between the steps. Where the grade is steeper the steps are larger and the benches narrower. Where the slope eases the opposite is true. Where the rock is not exposed it is overlain by natural sandy soils over sandy clays that cover the bench step formation. In the test locations the depth to rock ranged between 0.0 to 1.0m below the current surface, being deeper due to filling placed on the lower side of the house. The outcropping sandstone on the property is estimated to be medium strength or better and similar strength rock is expected to underlie the entire site. See the Type Section attached for a diagrammatical representation of the expected ground materials.
