Report Title: Geotechnical Report 110 Woorarra Avenue, North Narrabeen  
Report Date: 28/2/22

## **GEOTECHNICAL INVESTIGATION:**

Alterations and Additions at **110 Woorarra Avenue, North Narrabeen**

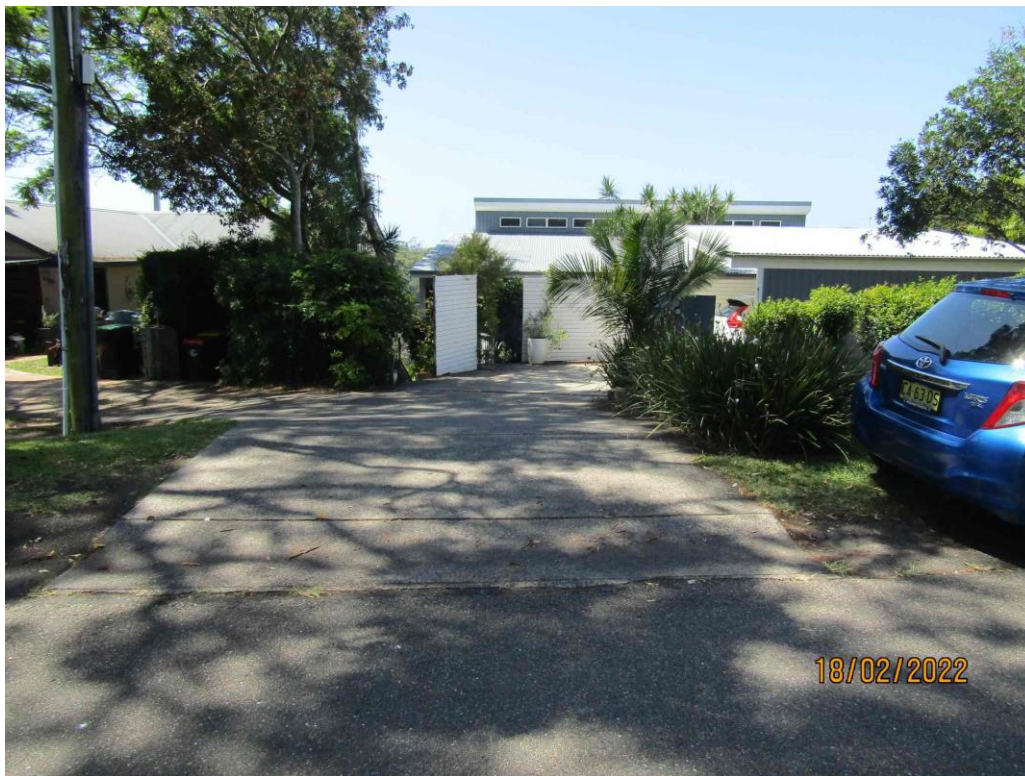
Photo 1

**2.3** At the road frontage, a concrete driveway runs to a carport on the uphill side of the house (Photos 1 & 2). The part two storey brick and timber clad house is supported by brick walls, brick piers, concrete piers and timber posts (Photos 1 & 3). The supporting walls, piers and posts stand vertical and show no significant signs of movement (Photo 4). A level lawn area extends off the downhill side of the house. Stable stack rock retaining walls up to ~1.5m high support the fill for the lawn (Photo 5). Medium Strength Hawkesbury Sandstone bedrock outcrops on the downhill side of the retaining wall and further downslope (Photos 6 & 7). A large detached joint block is located at the downhill property boundary (Photos 8 & 9). The rock is undercut by up to ~2.0m. The undercut rock is bridged at either side and is overlain by thick sandstone beds. It is considered to be stable. A sandstone rock face ~3.5m high is located beside the detached joint block (Photo 10). No signs of slope instability were observed on the property that could have occurred since the property was developed. The adjoining neighbouring properties were observed to be in good order as seen from the street and subject property.

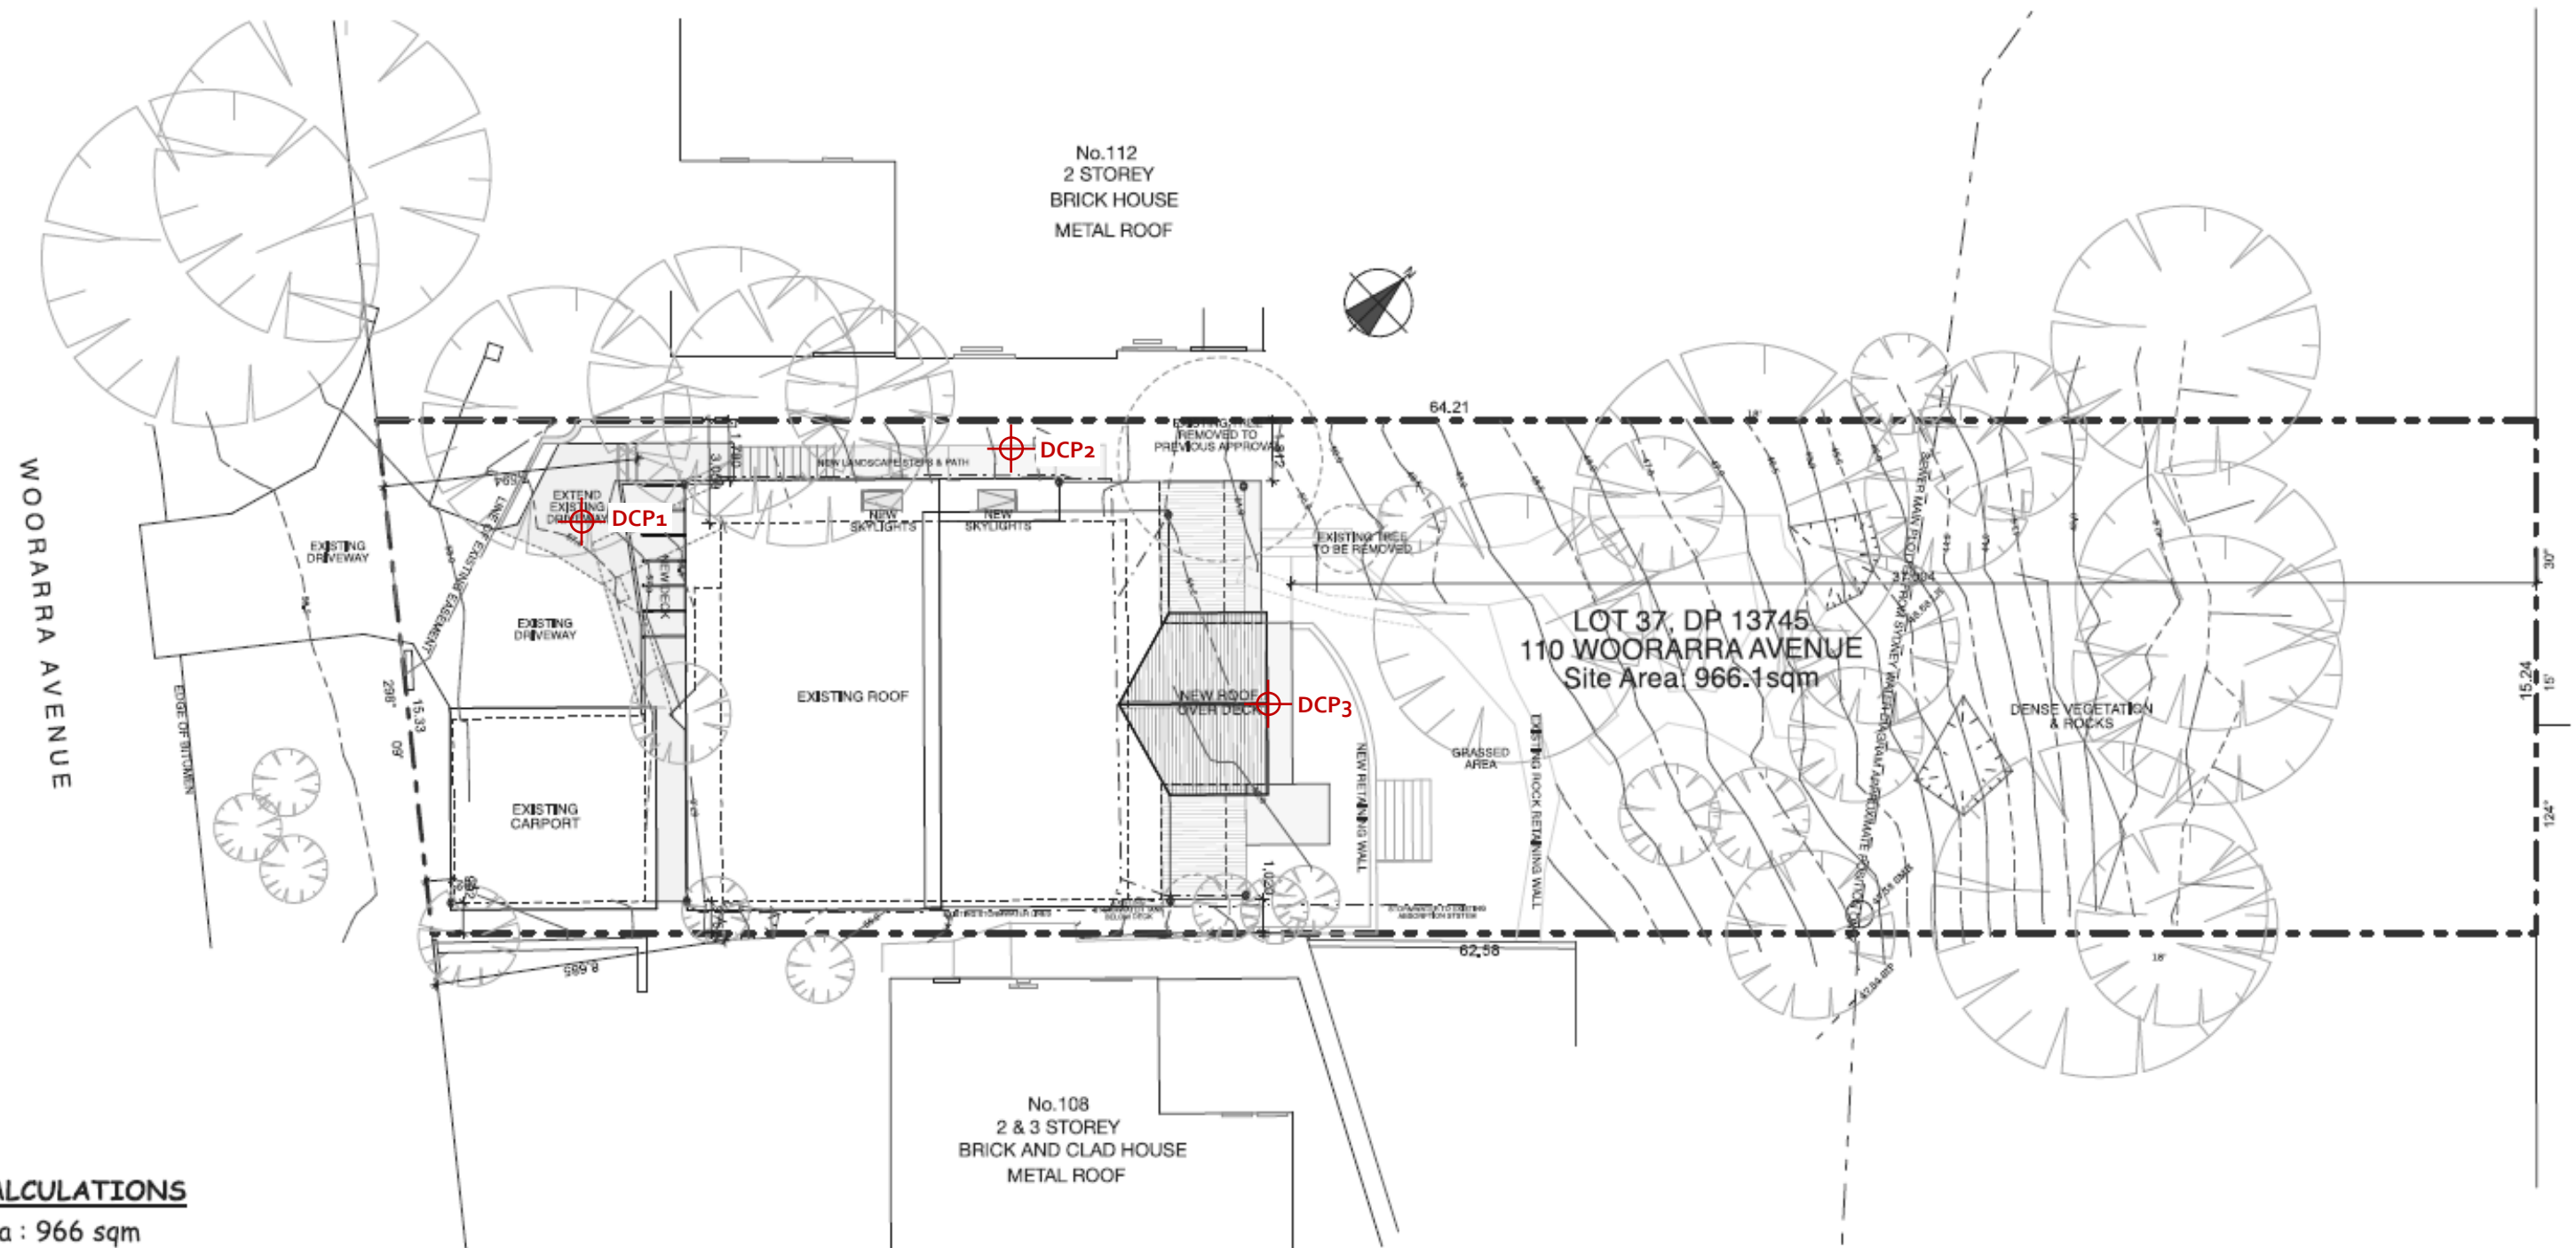
### SITE PLAN – showing test locations

Three Dynamic Cone Penetrometer (DCP) tests were put down to determine the relative density of the overlying soil and the depth to bedrock. The locations of the tests are shown on the site plan. It should be noted that a level of caution should be applied when interpreting DCP test results. The test will not pass through hard buried objects so in some instances it can be difficult to determine whether refusal has occurred on an obstruction in the profile or on the natural rock surface. This is not expected to have been an issue for this site. But due to the possibility that the actual ground conditions vary from our interpretation there should be

<b>DCP TEST RESULTS – Dynamic Cone Penetrometer</b>			
Equipment: 9kg hammer, 510mm drop, conical tip.		Standard: AS1289.6.3.2 - 1997	
<b>Depth(m) Blows/0.3m</b>	<b>DCP 1 (~RL57.3)</b>	<b>DCP 2 (~RL52.5)</b>	<b>DCP 3 (~RL51.3)</b>
0.0 to 0.3	4	5	7
0.3 to 0.6	6	5	3F
0.6 to 0.9	10	9	5
0.9 to 1.2	#	24	10
1.2 to 1.5		#	#
	Refusal on rock @ 0.8m	Refusal on rock @ 1.2m	Refusal on rock @ 1.1m

DCP1 – Refusal on rock @ 0.8m, DCP bouncing off rock surface, white sandstone fragments and brown orange impact dust on dry tip.

DCP2 – Refusal on rock @ 1.2m, DCP bouncing off rock surface, white sandstone fragments on dry tip.

DCP3 – Refusal on rock @ 1.1m, DCP bouncing off rock surface, light brown sandy soil on muddy wet tip.

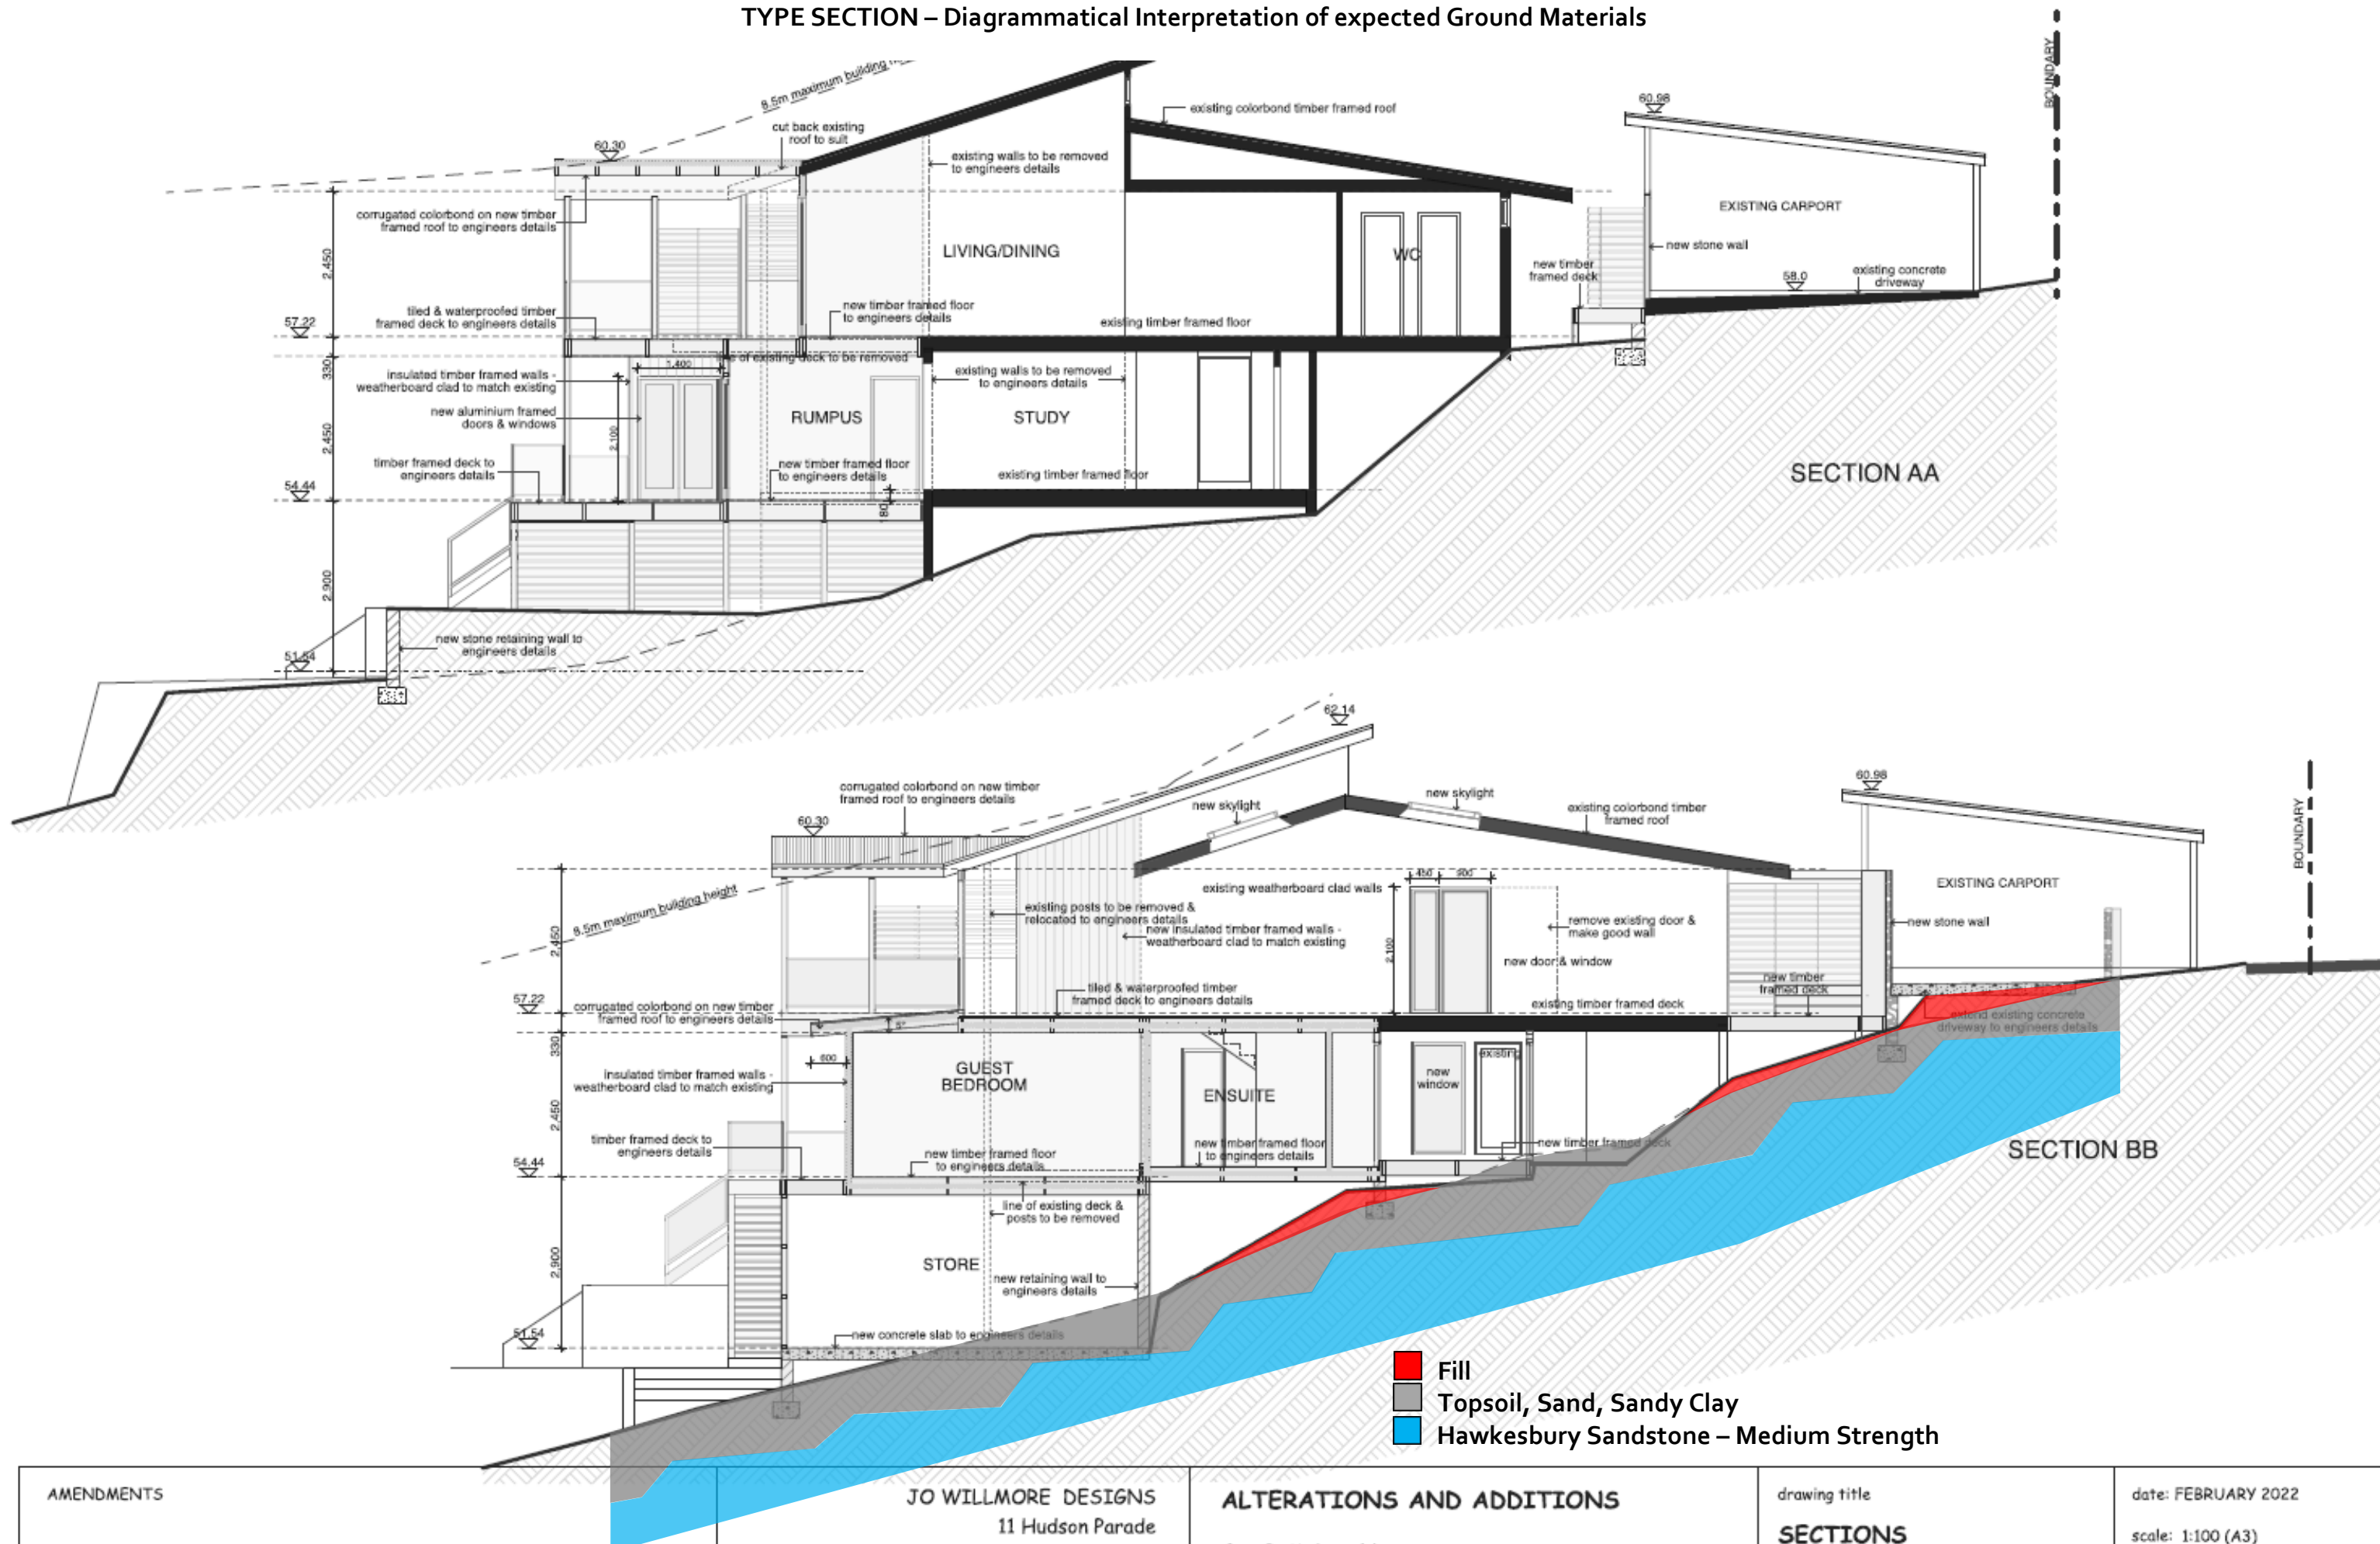
# TYPE SECTION – Diagrammatical Interpretation of expected Ground Materials

The surface features of the block are controlled by the underlying sandstone bedrock that steps down the property forming sub-horizontal benches between the steps. Where the grade is steeper, the steps are larger and the benches narrower. Where the slope eases, the opposite is true. The rock is overlain by fill, a sandy topsoil, sand and sandy clay that fills the bench step formation. Fill to a maximum depth of ~1.5m provides level platforms for lawn and garden areas across the property. In the test locations, the depth to rock ranged from ~0.8m to ~1.2m below the current surface. The sandstone underlying the property is

estimated to be Medium Strength or better. See Type Section attached for a diagrammatical representation of the expected ground materials.
