**GEOTECHNICAL RISK MANAGEMENT POLICY FOR PITTWATER  
FORM NO. 1 – To be submitted with Development Application**

Report Title: Geotechnical Report <b>29 Calvert Parade, Newport</b>
Report Date: <b>8/1/25</b>
Author: <b>BEN WHITE</b>
Author's Company/Organisation: <b>White Geotechnical Group Pty Ltd</b>

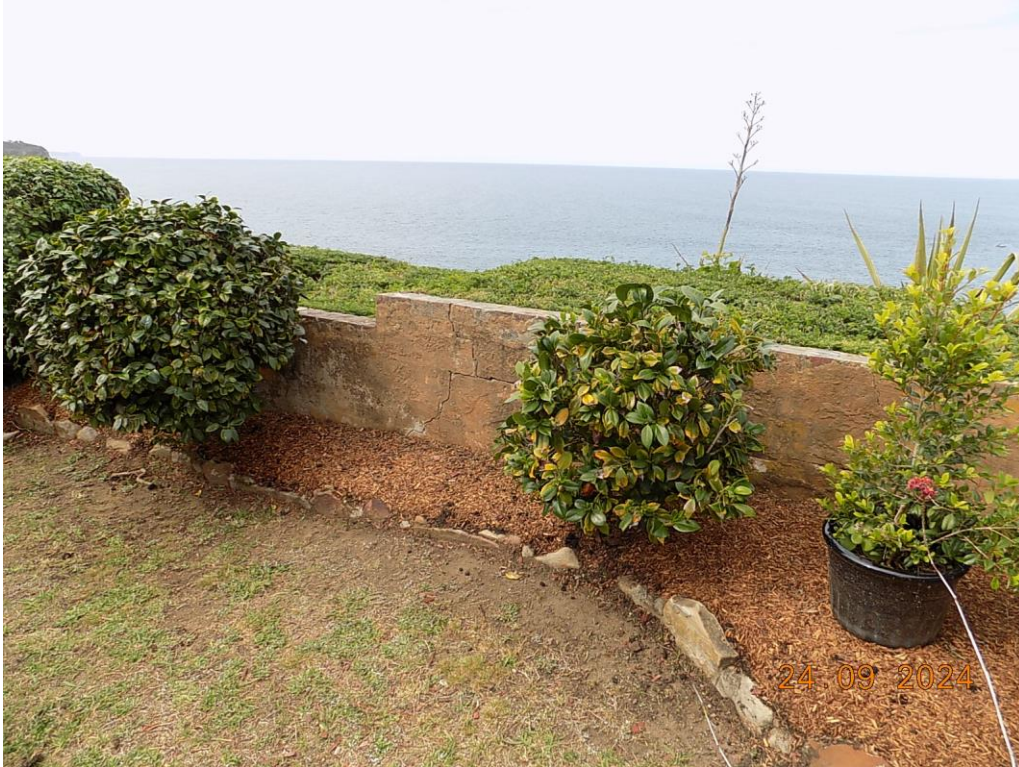
Photo 3

The excavation for the proposed pool will reach a maximum depth of ~1.2m and will come close to flush with a low brick retaining wall (Photo 3) that is shown on the plans to remain. If this is the case and the wall is found to not be supported on Medium Strength sandstone or better, it will need to be propped or underpinned or otherwise supported in a suitable manner until the pool structure is in place.

During the excavation process, the geotechnical consultant is to inspect the excavations as they approach no less than 0.5m horizontally from the foundations of the wall/underpins to confirm the stability of the cut to go flush with the footings.

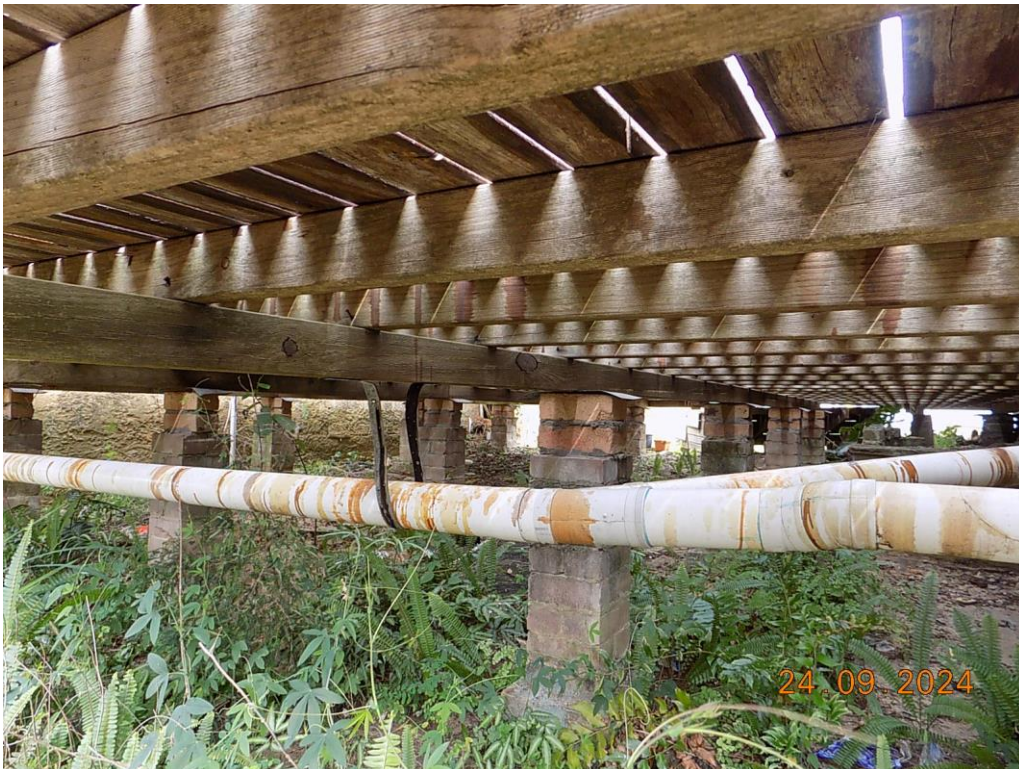
Photo 4

road frontage and the house is supported by stable low mortared sandstone retaining walls. The part two-story rendered brick house is supported on brick walls. A cut for the lower floor of the house is supported by a ~1.5m high mortared sandstone retaining wall (Photo 2) as well as the brick walls of the house. Thin cracking was visible in the supporting walls of the house as well as in the mortared sandstone wall. This cracking is typical in houses of this age and construction. The house walls and the sandstone retaining wall are considered stable. A low brick wall (Photo 3) supports a cut for a level area on the uphill side of the house. The wall was measured to be cracked up to ~4mm in width. However, no deflection was observed and the wall is considered stable. A timber deck has been constructed in this location. The brick piers for the deck stand vertical (Photo 4).

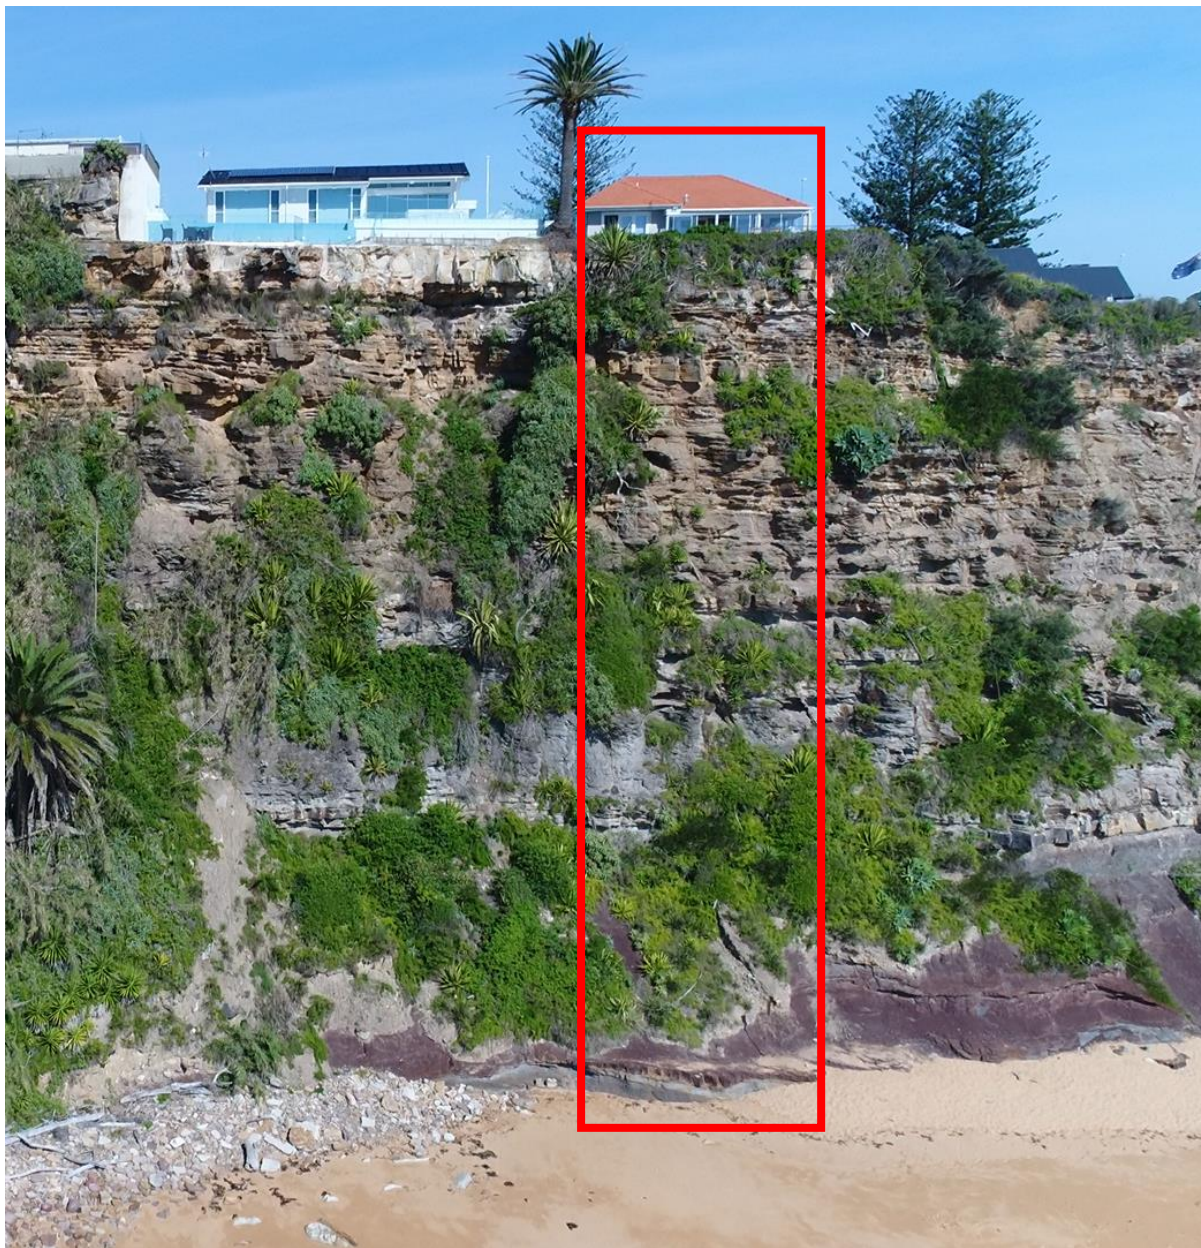
**2.4** A ~40m high sea cliff (Photo 5) falls from the top of the property ~2.3m E of the low retaining wall to the rock platform below. The cliff was observed from the rock platform below as well as from drone footage taken previously. The top section of the cliff immediately below the property consists of highly weathered sandstone. This section of cliff contains little undercutting over the top 3.0m and only minor undercutting below that to ~26m. The average grade is ~ 82° from horizontal. This overlies the central portion of the cliff that consists of interbedded siltstone and sandstone that extend 30m. Some instances of undercutting are present, but nothing critical, with the slope at an average grade of 70° from horizontal. The lower 10m of the cliff consists of Bald Hill Claystone that slopes at an average grade of 44° to the rock platform. We refer to the attached Coastal Engineering Report by Horton noting that cliff grades mentioned above are from this report. He nominates a conservative maximum erosion rate accounting for sea level rise of 1.7m/ 100 years. The following advice accounts for this erosion rate but also considers it against the localised cliff geology, joint spacing and potential failure mechanisms within the properties extent.

*Photo 5 – approximate portion of cliff within property boundaries in red*

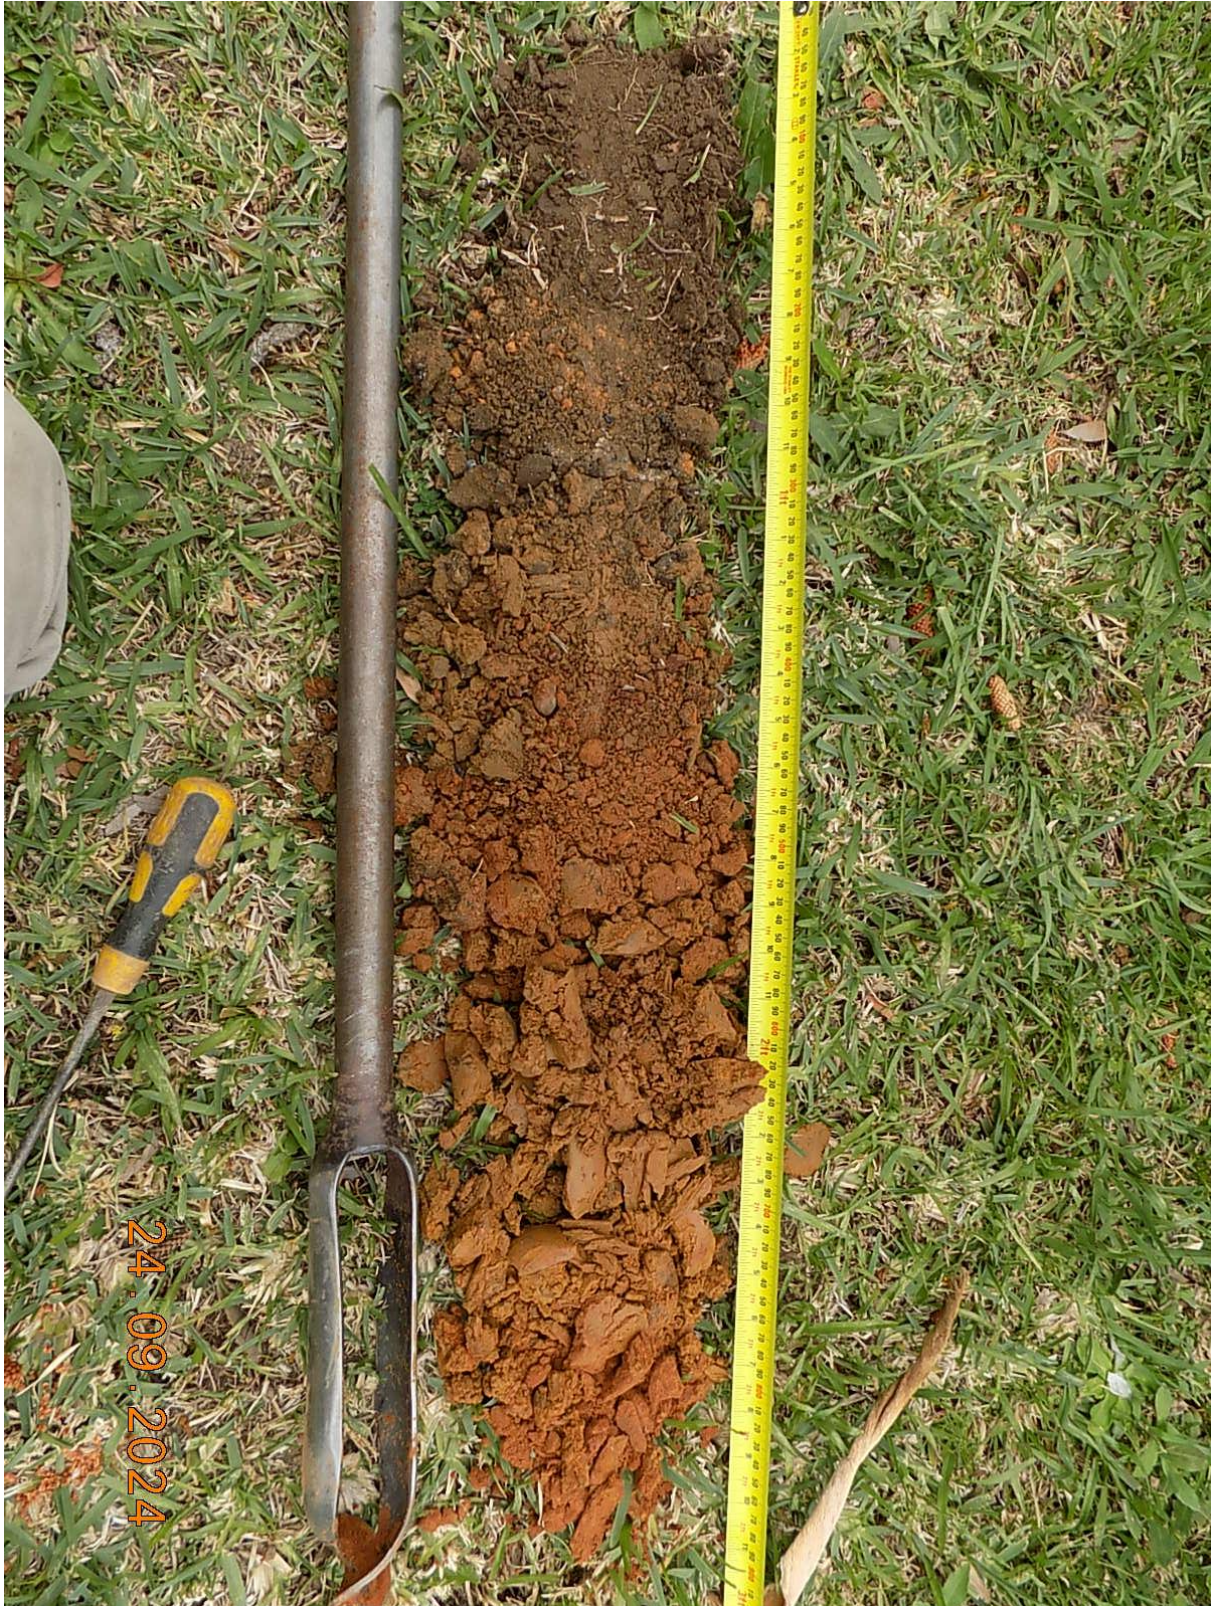
Photo 6 – downhole is top to bottom

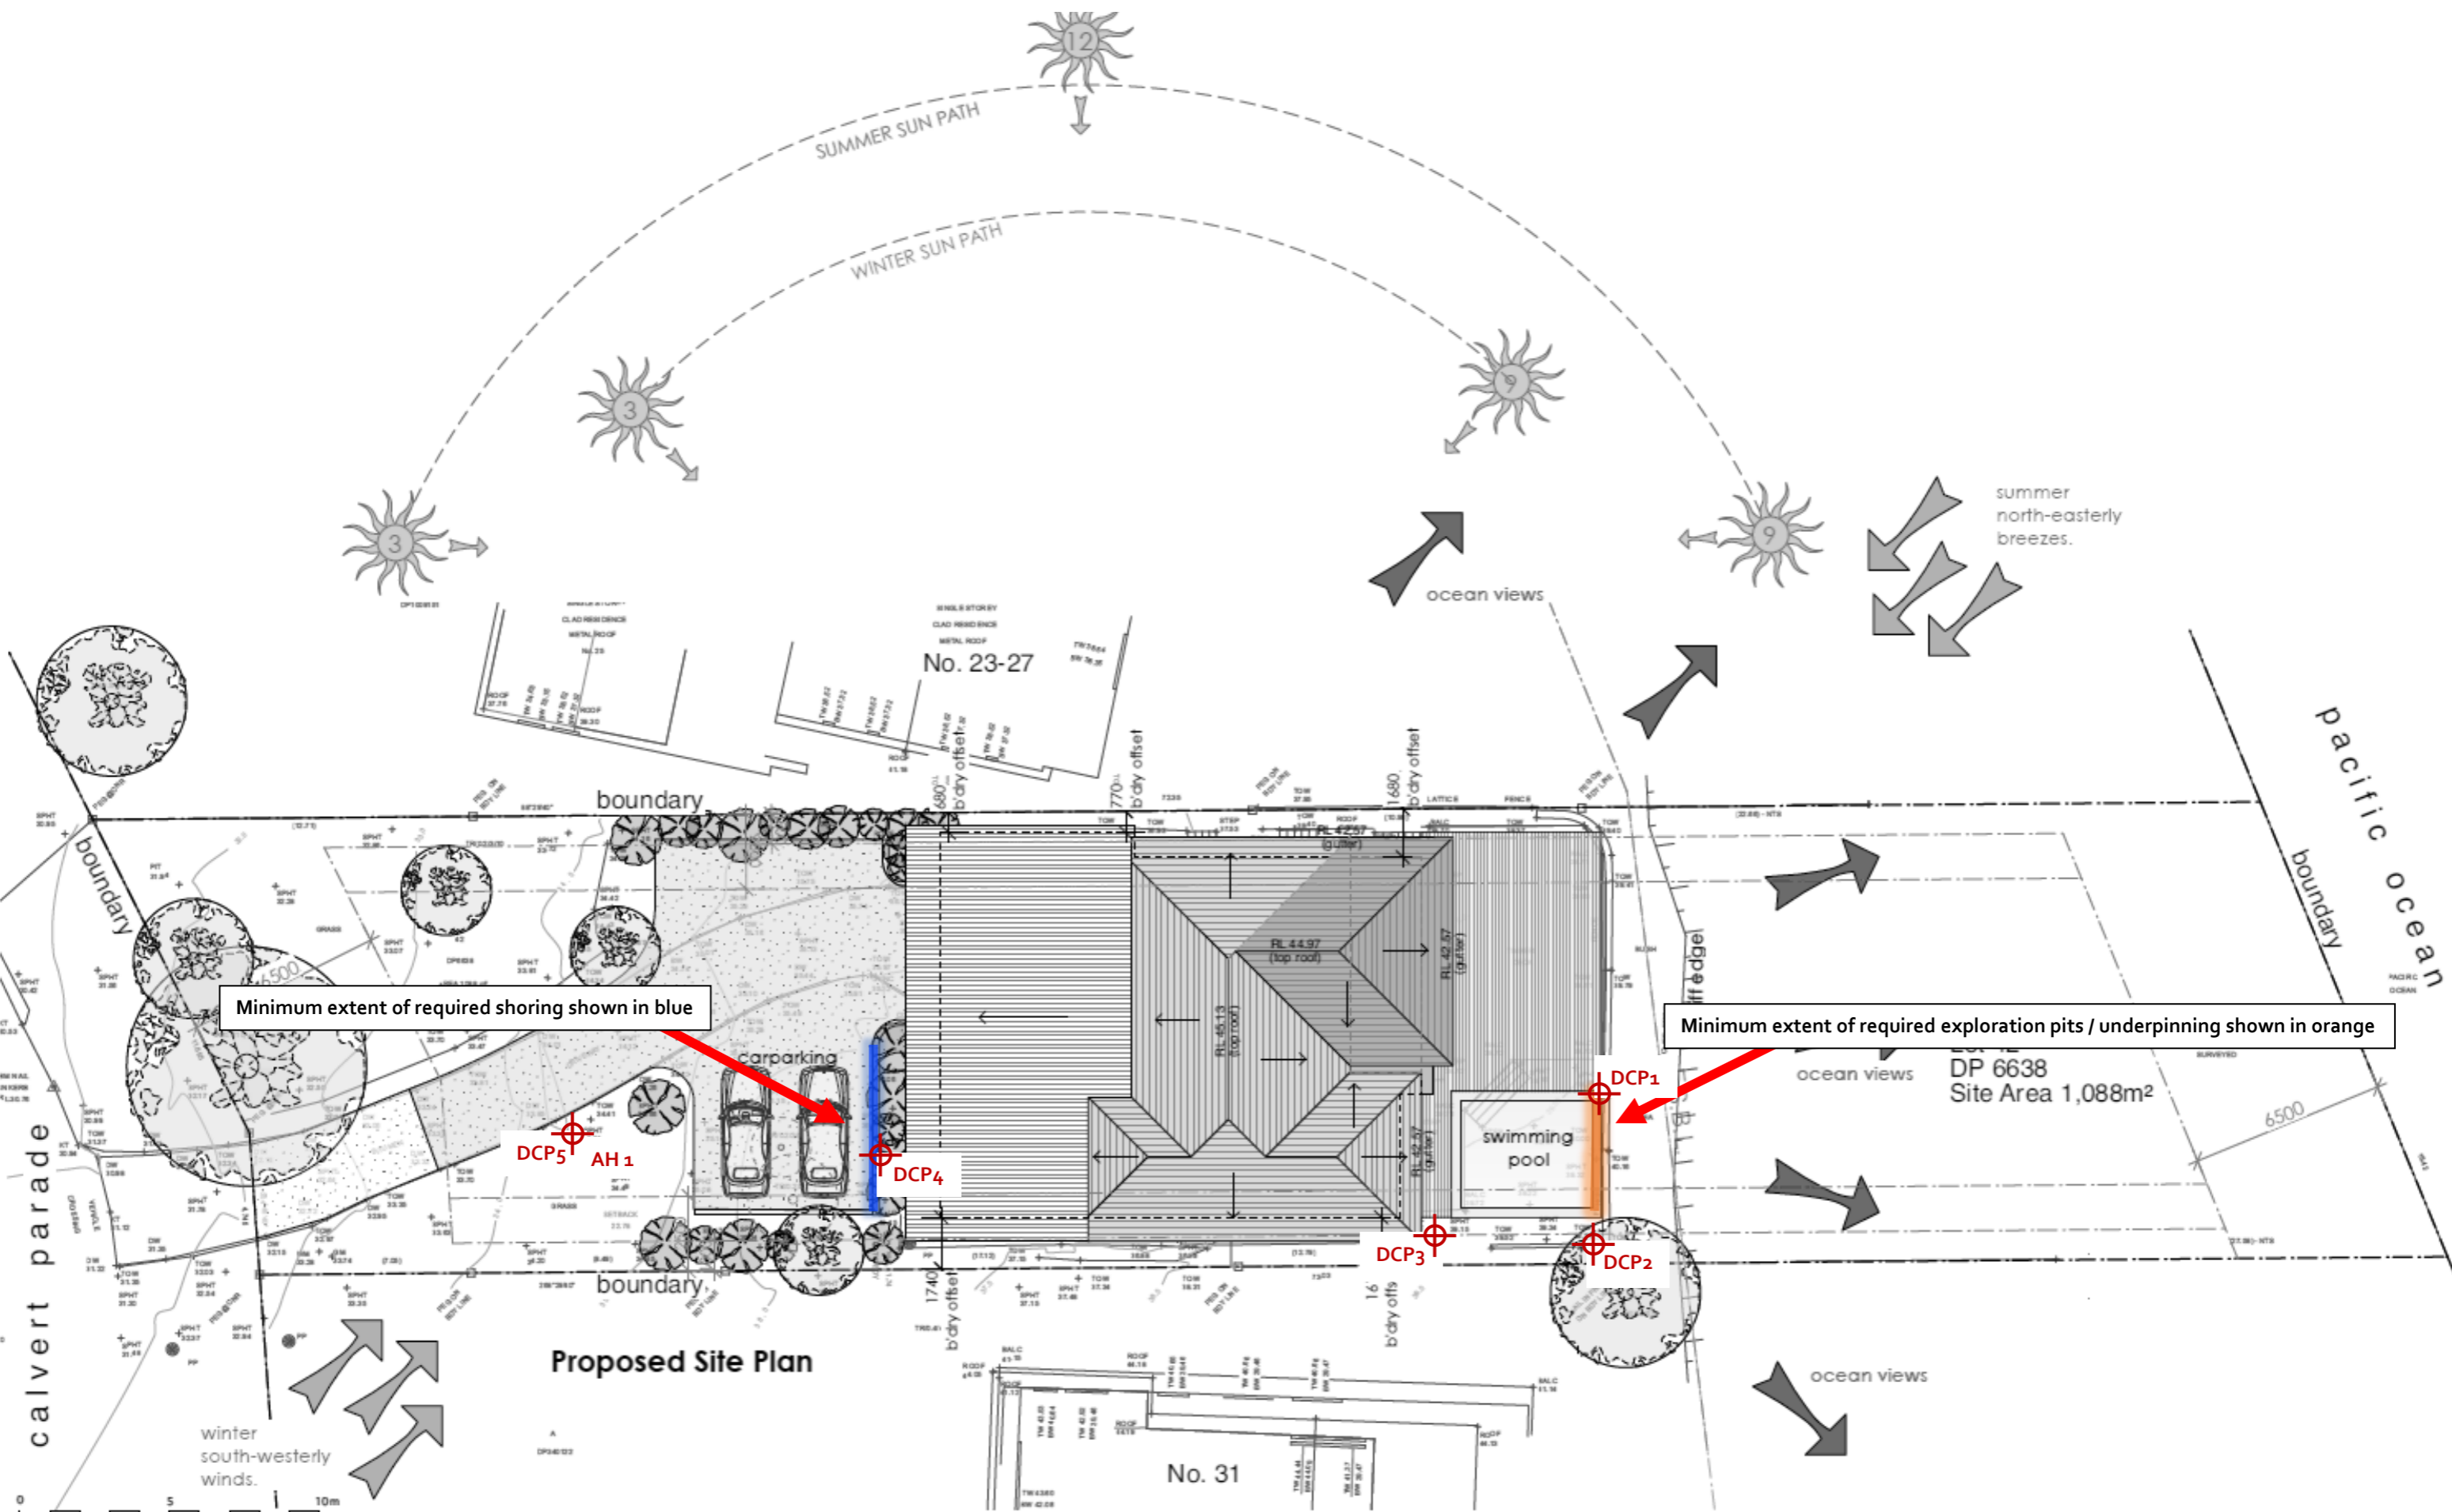
SITE PLAN – showing test locations and minimum extent of required shoring

Minimum extent of required shoring shown in blue

Minimum extent of required exploration pits / underpinning shown in orange

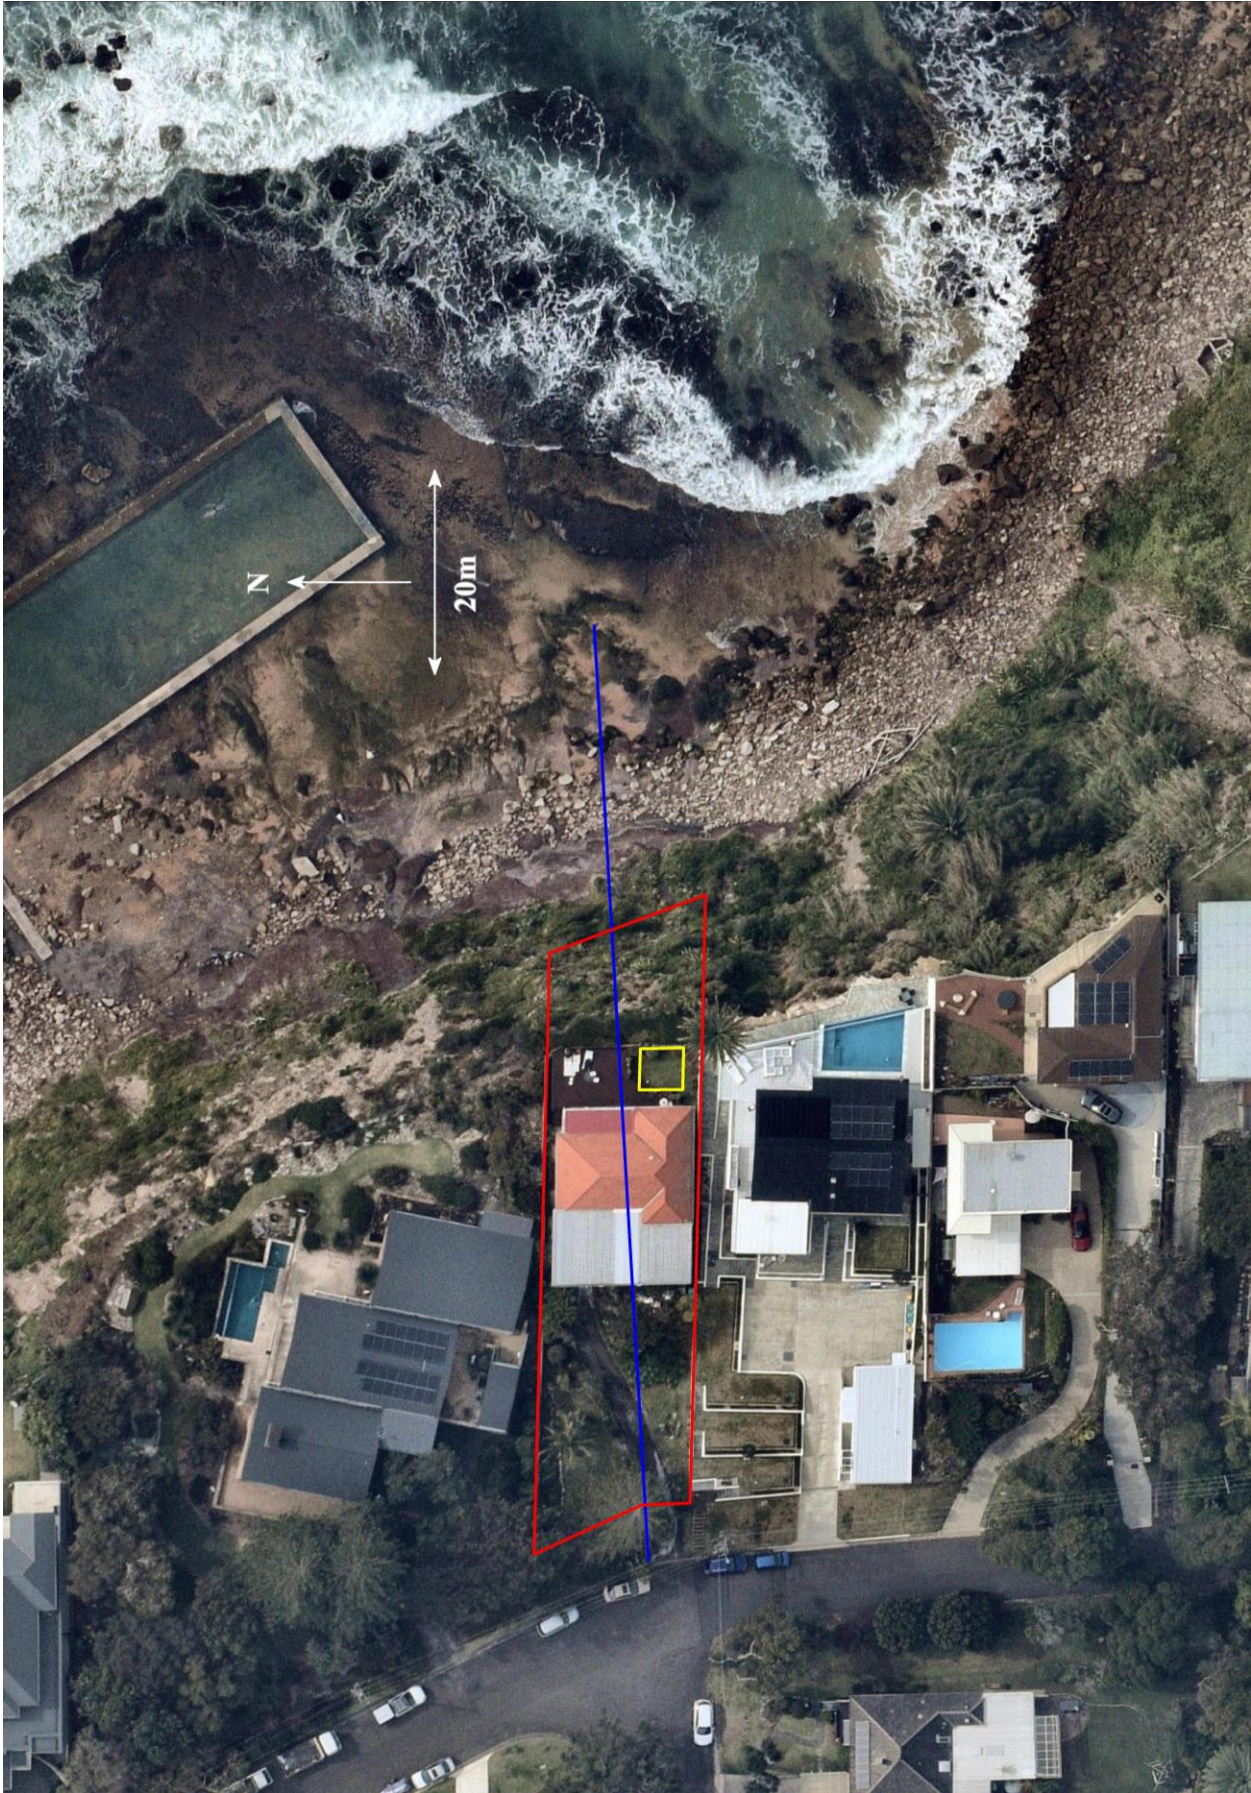
A relatively flat rock platform is located seaward of the cliff, and is about 50m wide at low tide, and about 70m wide at the ocean pool to the NE of the site. The rock platform cycles between being covered in sand and having the underlying rock exposed (the latter applying in Figure 1).

**Figure 1: Aerial view of site (approximate red outline), with Section A in blue, approximate proposed pool location in yellow, and aerial photograph taken 4 August 2024**

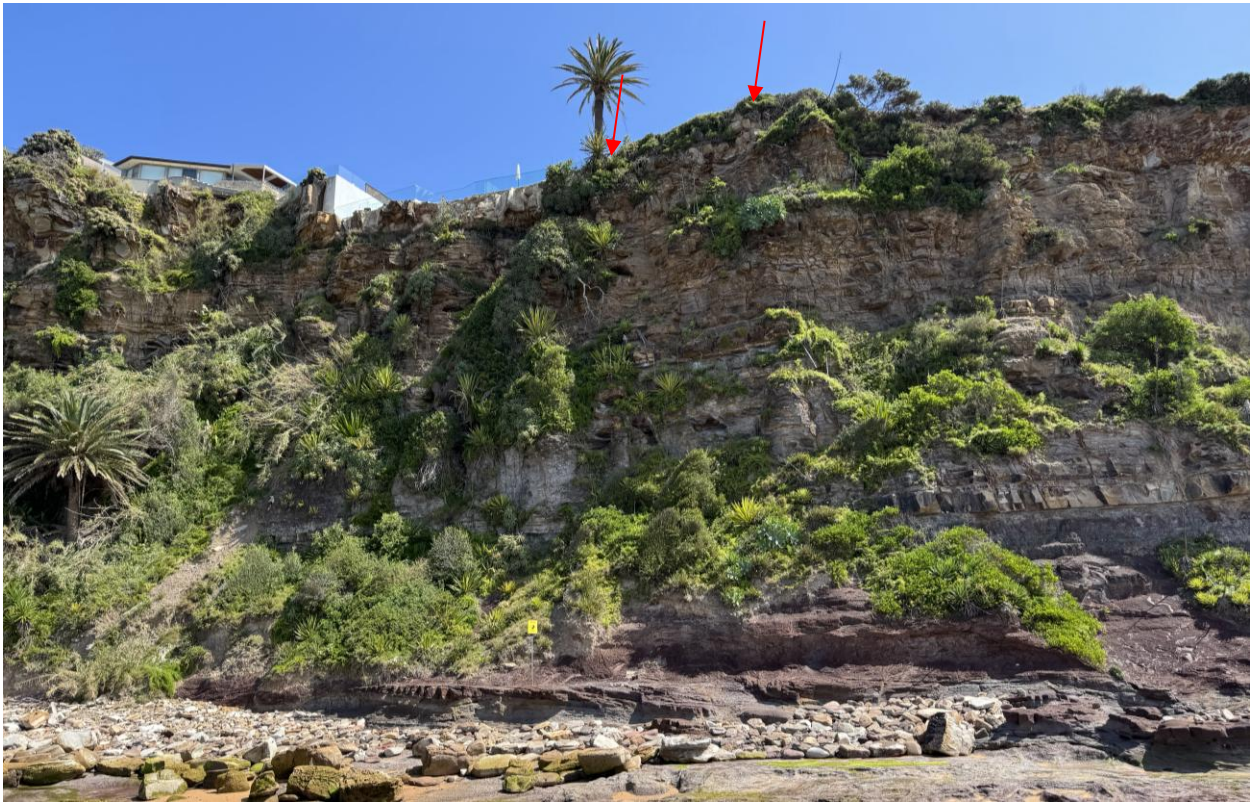
**Figure 3: View of cliff face at site (approximately between arrows) from rock platform on 3 October 2024, facing SW to WSW**

Weathering may induce undercutting and toppling failure of overhanging blocks if the rate of weathering is highest near the base of the cliff or at other levels below the top of the cliff. Overhangs are currently evident in the cliff face, as visible in Figure 3. Erosion of steep slopes tends to occur suddenly in association with heavy rainfall or changes to drainage patterns, slope undercutting, and increases in load on the slope.

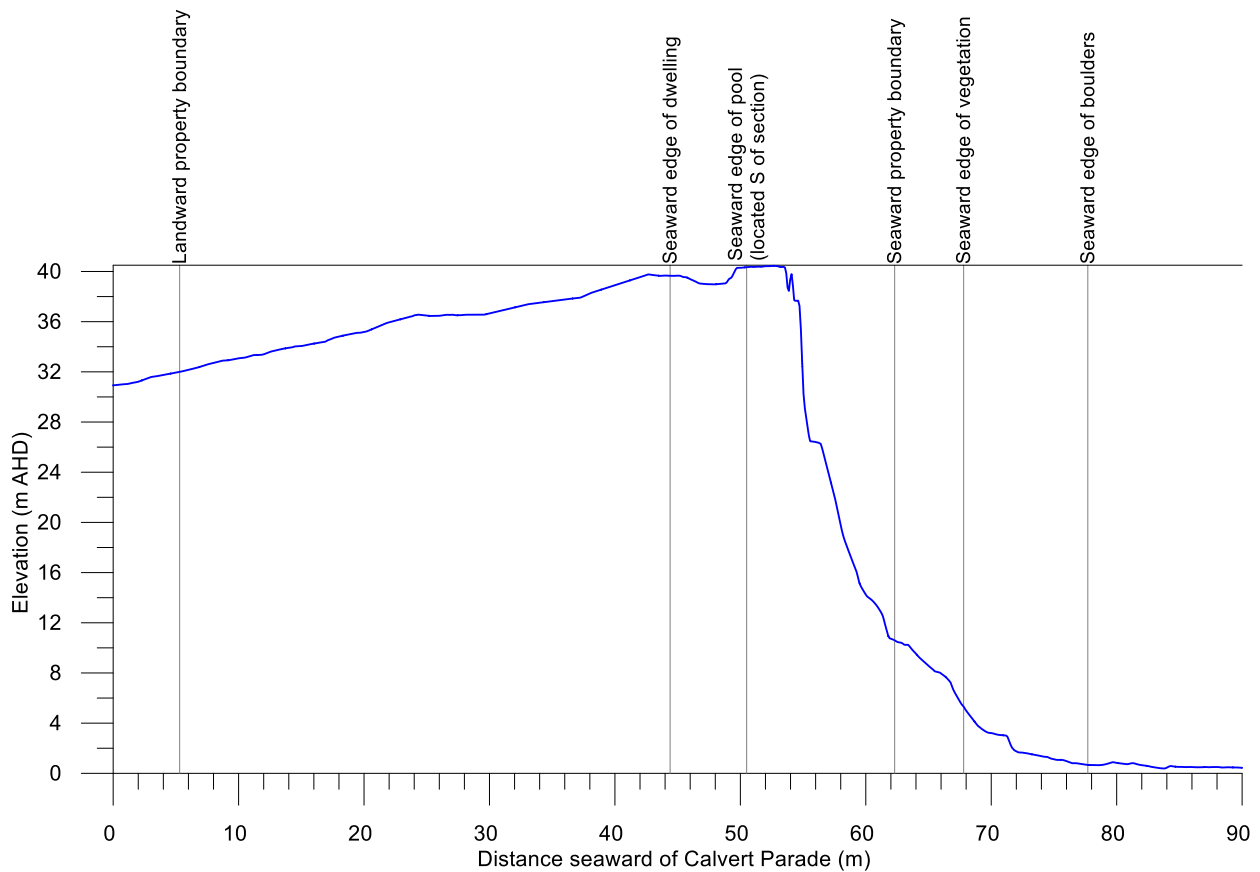
**Figure 4: Section A through site (including cliff face) and down to adjacent rock platform**
