Report Title: Geotechnical Report 100A Wakehurst Parkway, Elanora Heights
Report Date: 31/8/20

GEOTECHNICAL INVESTIGATION:

New Inclined lift at **100A Wakehurst Parkway, Elanora Heights**

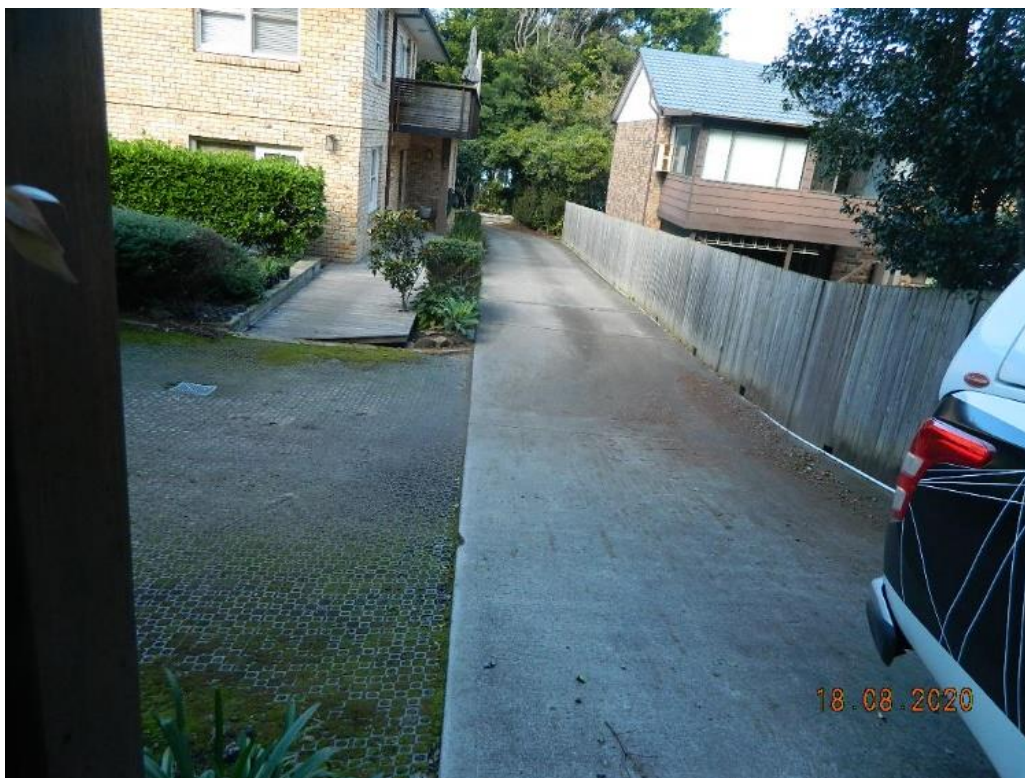
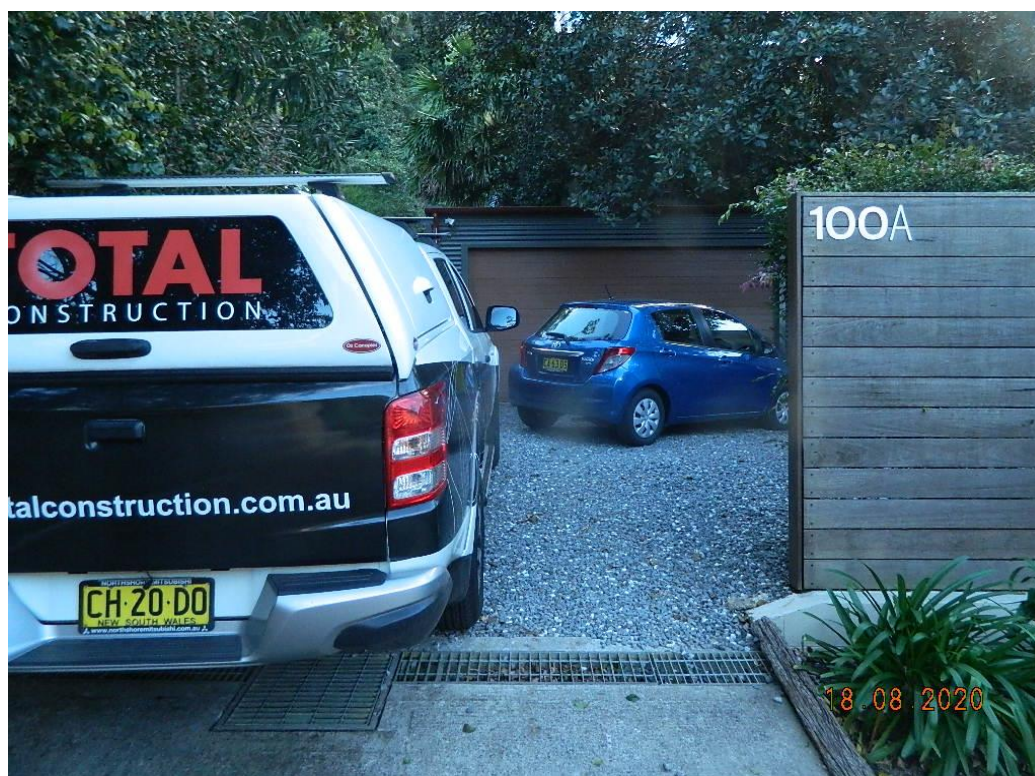
- 2.3** The property is accessed by a concrete right of carriageway (ROW) which runs up the slope to a parking area and garage (Photos 1 & 2). Uphill of the garage is a large sandstone boulder in a stable position (Photo 3). The part three storey concrete and steel clad house is supported by concrete block walls, formed concrete walls and steel posts (Photos 4 & 5). The supporting walls and posts stand vertical and show no significant signs of movement. Each level of the house has been cut into the slope on the uphill side (Photo 6). The cuts are supported by formed concrete retaining walls up to $\sim 2.3\text{m}$ high and in good condition. A suspended timber deck in good condition extends off the E side of the house. Medium Strength Hawkesbury Sandstone bedrock

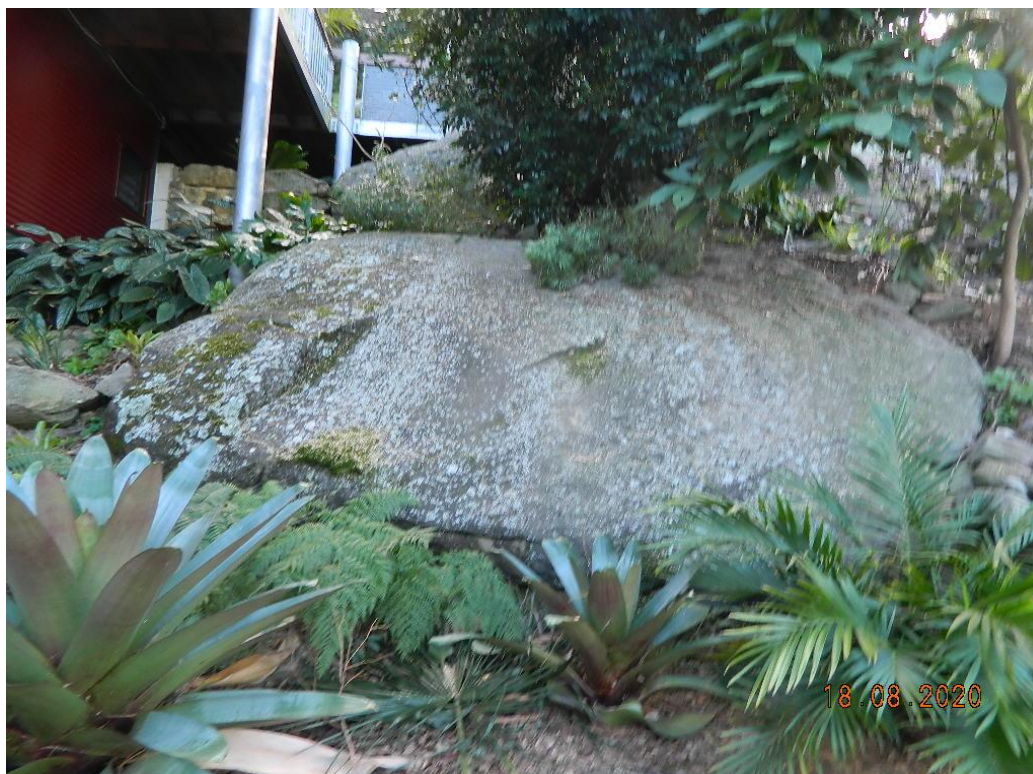
Photo 7

steps up the slope beside the house (Photo 7). Another timber deck is located uphill of the house (Photo 8). Large dislodged sandstone joint blocks are sitting in stable positions on the slope next the deck. Uphill of the deck is sandstone cliff face that is estimated to be at least ~8m high (Photos 8 to 10). No significant geological defects were observed on the exposed rock face that could affect its stability. No signs of slope instability that could have occurred since the site was developed were observed on the property. The adjoining neighbouring properties were observed to be in good order as seen from the street and subject property.

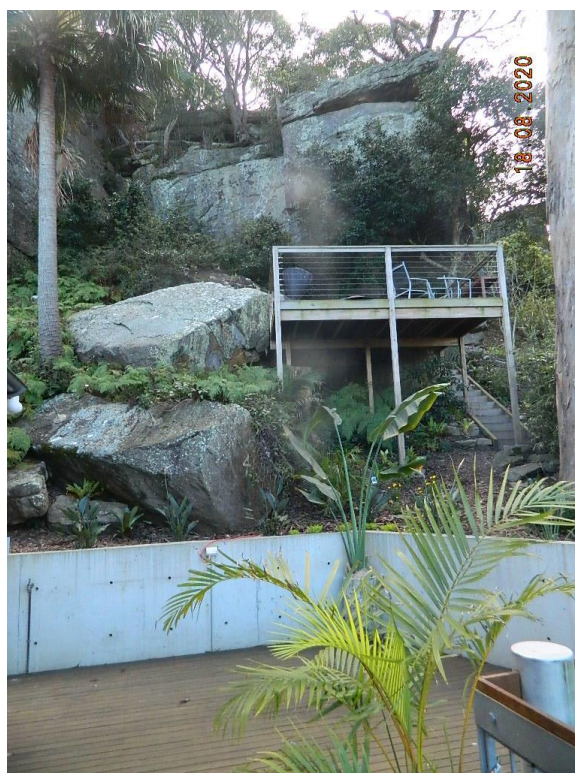
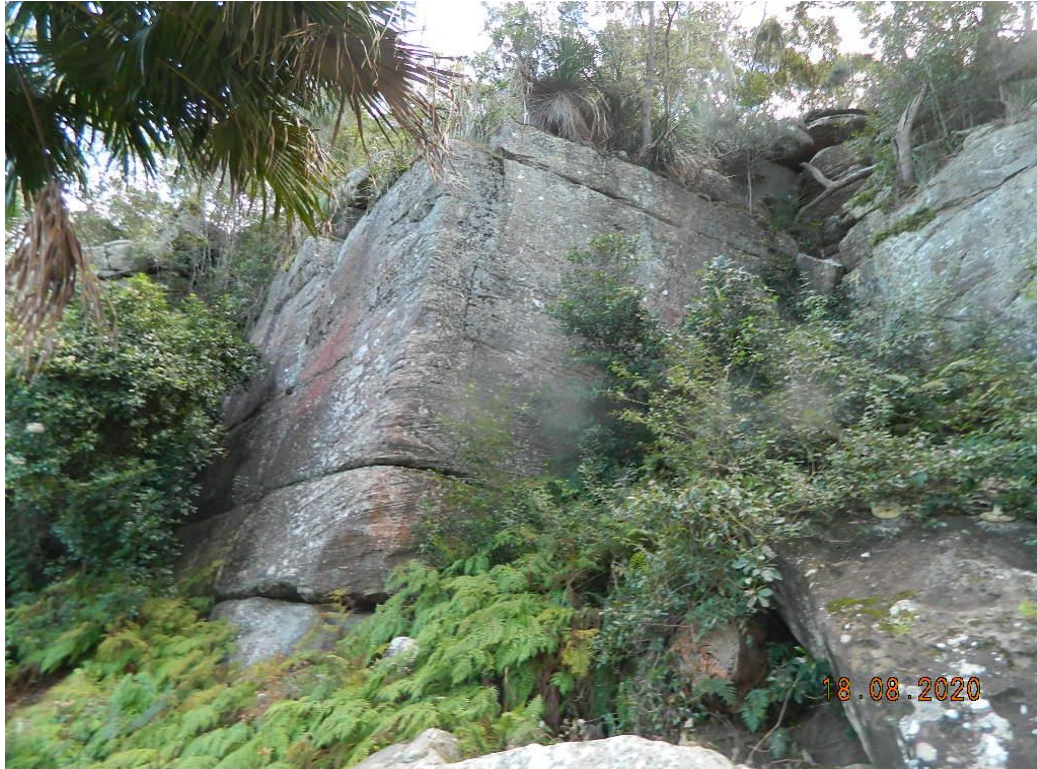
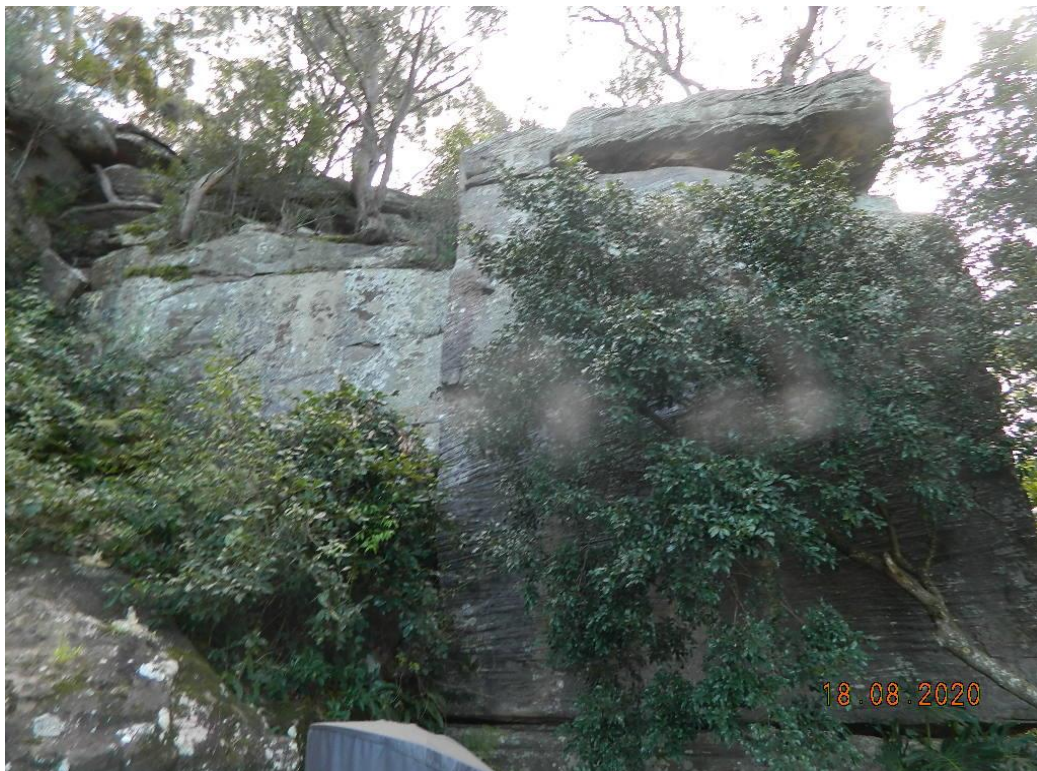
No geotechnical hazards were observed beside the property that could impact the subject property. The moderate to steep slope that falls across the property and continues above is a potential hazard (**Hazard One**). The sandstone cliff face that rises above the property is a potential hazard (**Hazard Two**).

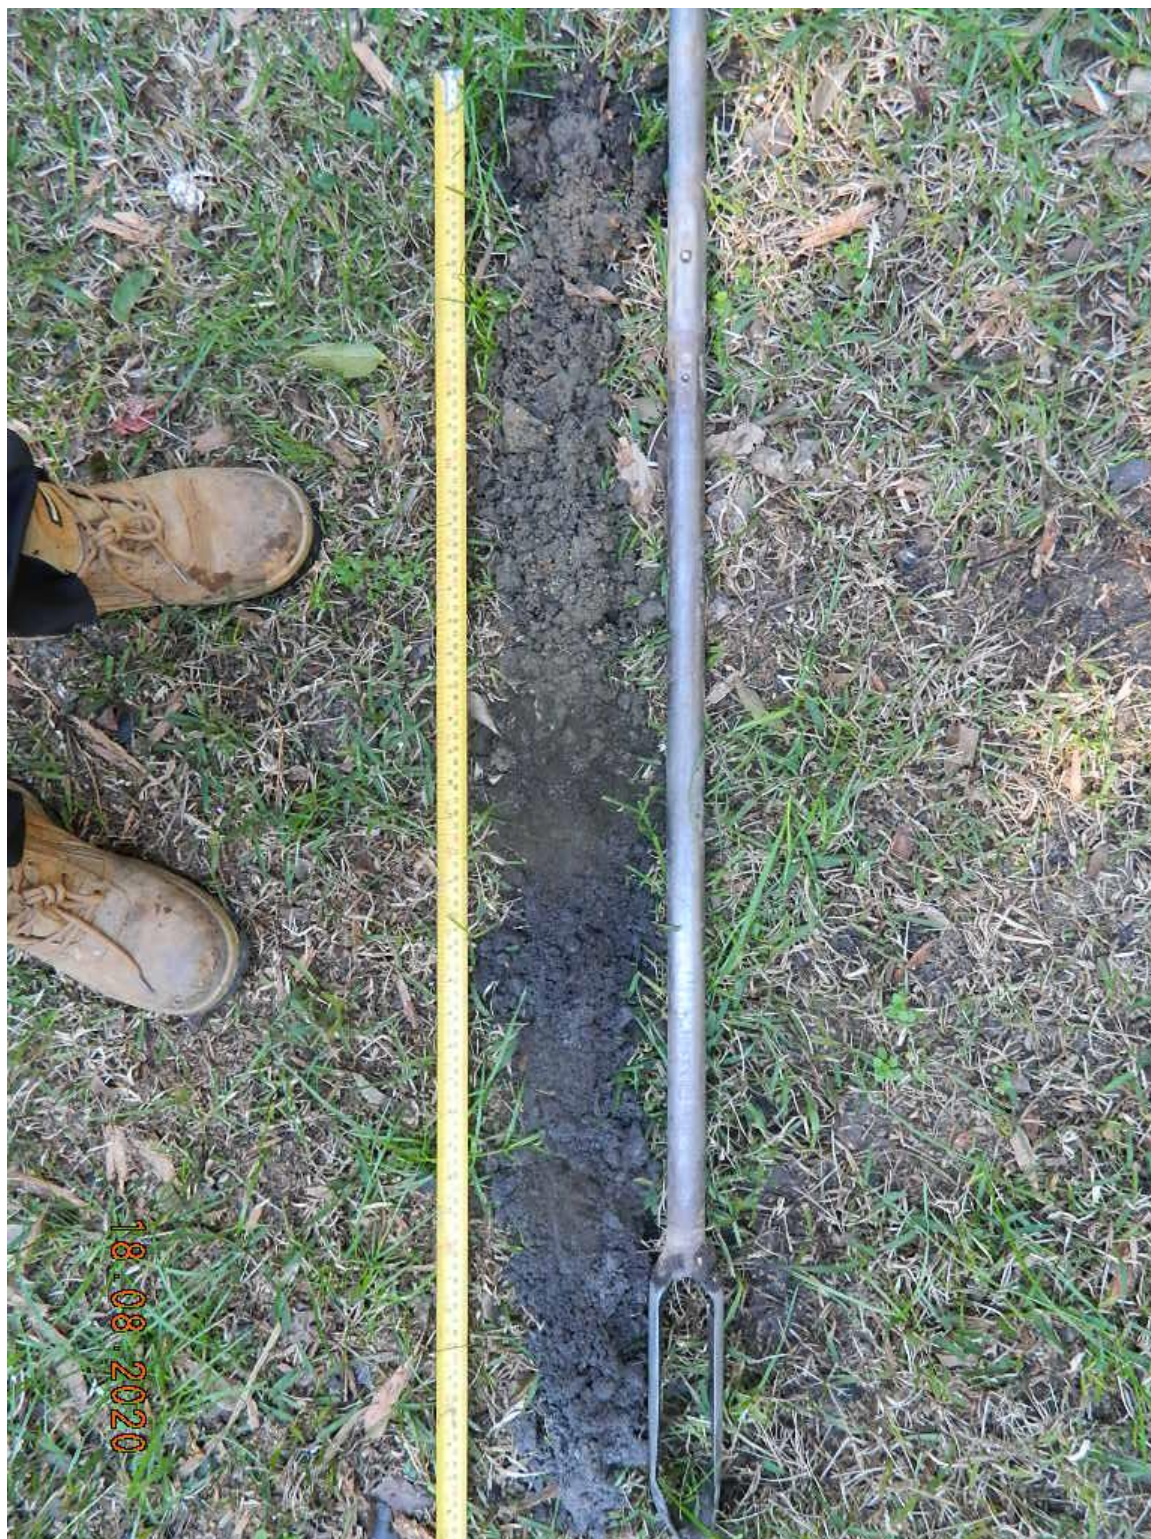
Photo 11: AH1 – Downhole is from top to bottom

AUGER HOLE 1 (~RL12.1) – AH1 (photo 11)

Depth (m)	Material Encountered
0.0 to 0.1	FILL , sandy soil, dark brown, fine to medium grained, damp.
0.1 to 0.5	FILL , sand, grey, damp, medium grained.
0.5 to 1.1	SILTY SAND , dark brown and grey, moist, fine to medium grained.

Refusal @ 1.1m, auger grinding on rock. No watertable encountered.
