Geotechnical Assessment

Project: Alterations & Additions
19 Wandearah Avenue, Avalon Beach NSW

Prepared for:
Arclab Pty Ltd

Ref: AG 24534
6 December 2024

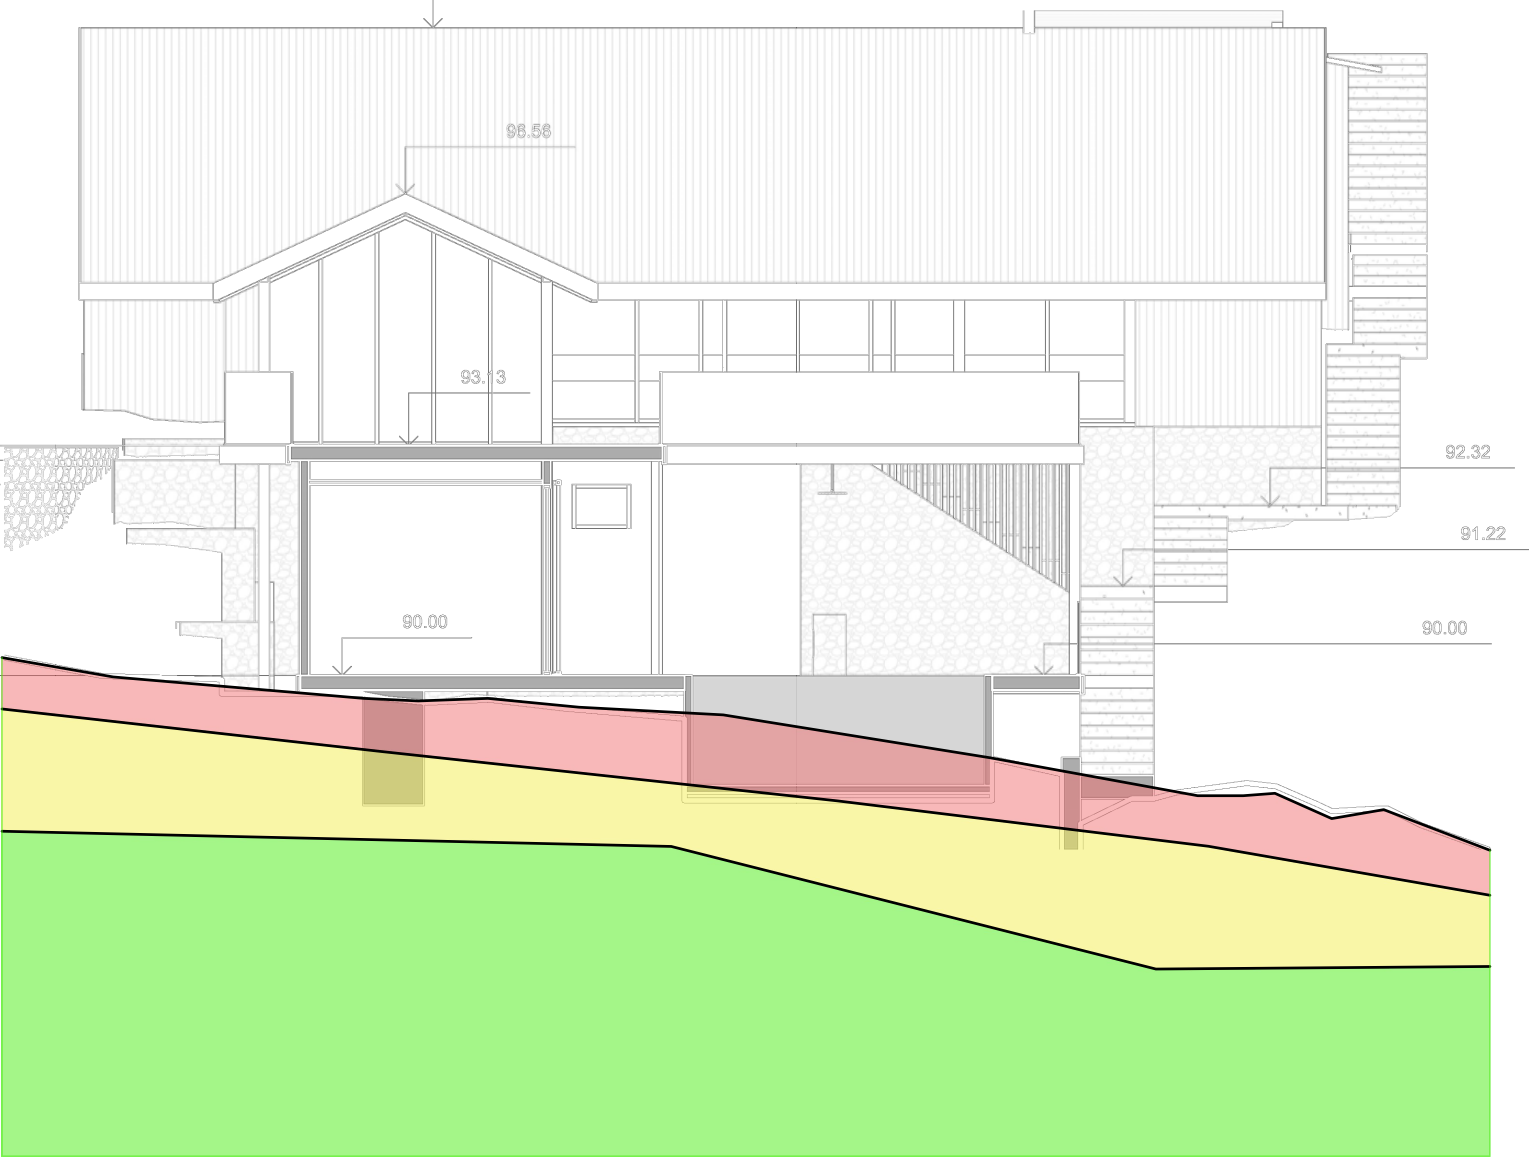
INFERRED GEOLOGICAL SECTION
SCALE NTS

INTERPRETED SUBSURFACE SECTION ONLY.
ACTUAL GROUND CONDITIONS MAY VARY.

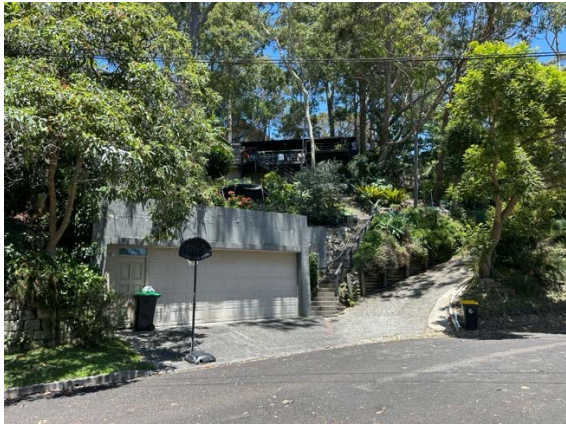
Photo 1: Site frontage, looking southwest.

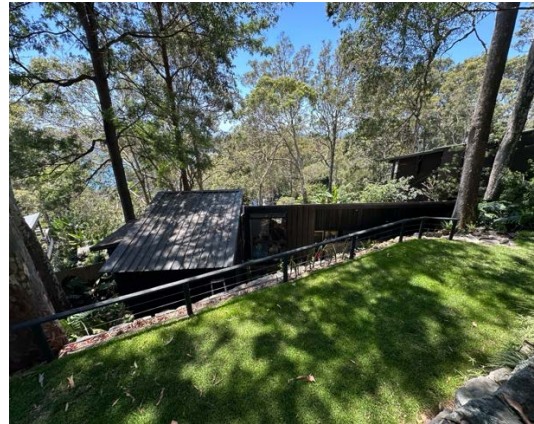
Photo 2: Southwestern boundary of site looking northeast.

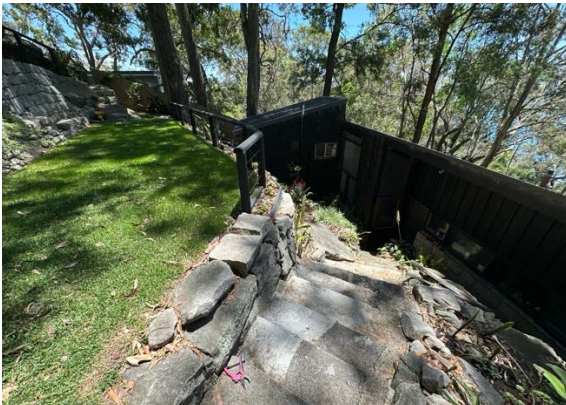
Photo 3: Southern corner of site, showing typical slope aspect on site, looking northwest.

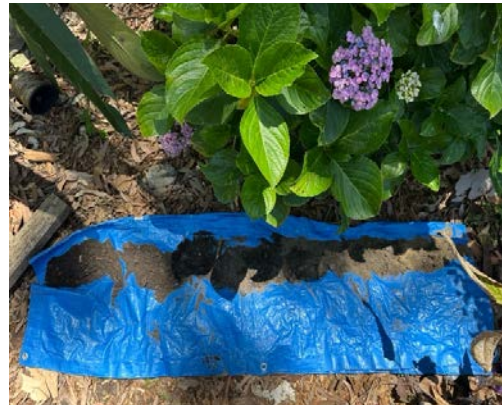
Photo 4: Subsurface soil profile of BH02.
