Report Title: Geotechnical Report 21 Palm Beach Road, Palm Beach

Report Date: 9/4/19

GEOTECHNICAL INVESTIGATION:

Proposed New Garage at 21 Palm Beach Road, Palm Beach

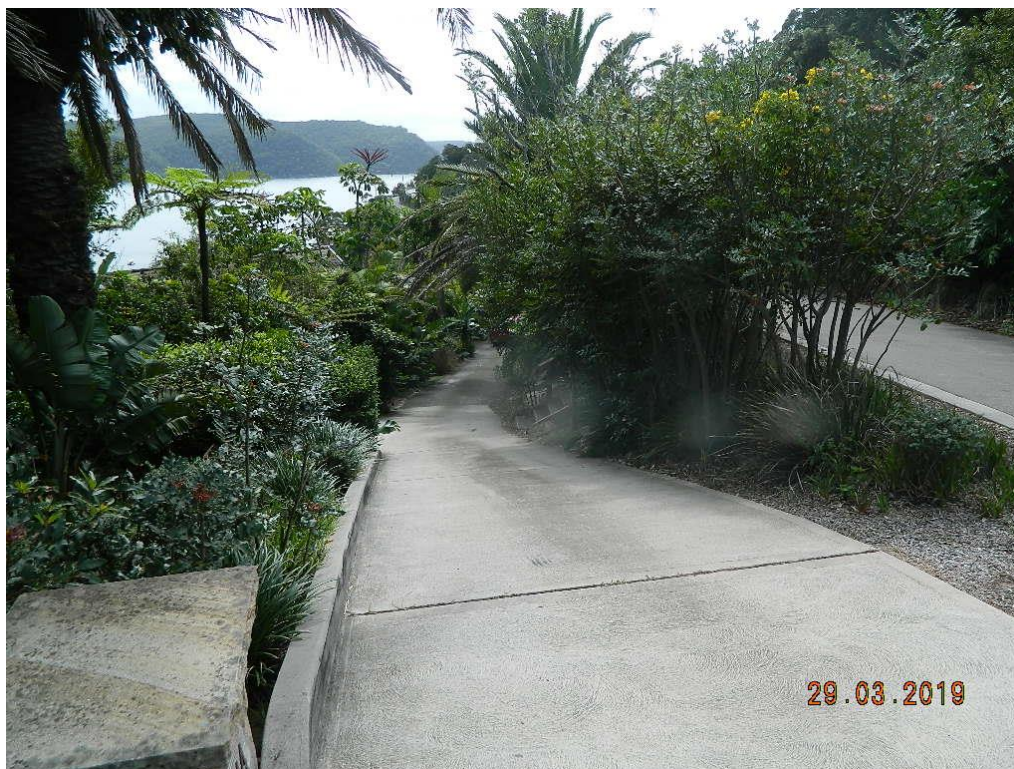
Photo 1

- 2.3** At the road frontage a concrete driveway runs down and across the slope to a garage and gravel parking area on the N side of the property (Photos 1 & 2). The garage will be demolished as part of the proposed works. Fill has been placed on the slope to level an area for a lawn to the N of the gravel parking area (Photo 3). The fill is battered at stable angles and has been planted with native vegetation to stabilise the slope (Photo 4). A moderately sloping garden encompasses the area between the road frontage and the house (Photo 5). An excavation to a maximum depth of ~1.2m has been made on the uphill side of the house to level an area for the house and for a paved patio (Photo 6). The cut is supported by a stable dimensioned sandstone block wall. The part two storey sandstone block, timber framed and clad house is supported

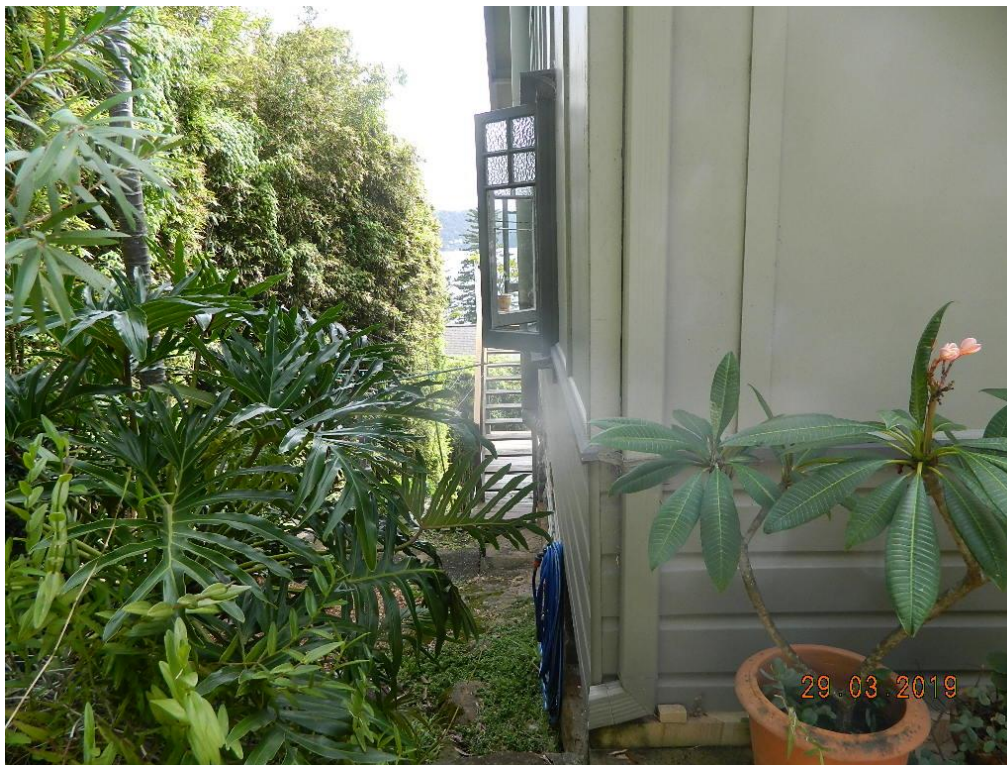
Photo 7

on sandstone block walls and sandstone block piers (Photo 7). No significant signs of movement or cracking were observed in the external supporting walls of the house and the supporting sandstone block piers stand vertical. The slope on either side of the house has been terraced with stable, rough sandstone block retaining walls that reach a maximum height of ~0.5m (Photo 8). Some of the walls have been constructed over sandstone boulders that are sitting in stable positions. Sandstone boulders and smaller joint blocks scatter the slope across the site (Photo 9). The boulders and joint blocks appear to have been in place for some time and are in stable positions. A bed of Medium Strength Sandstone outcrops in the NW corner of the property (Photo 10). The remains of a mortared sandstone block building sit upon the sandstone bed. A narrow lawn extends along the downhill boundary. The garage will be demolished as part of the proposed works.

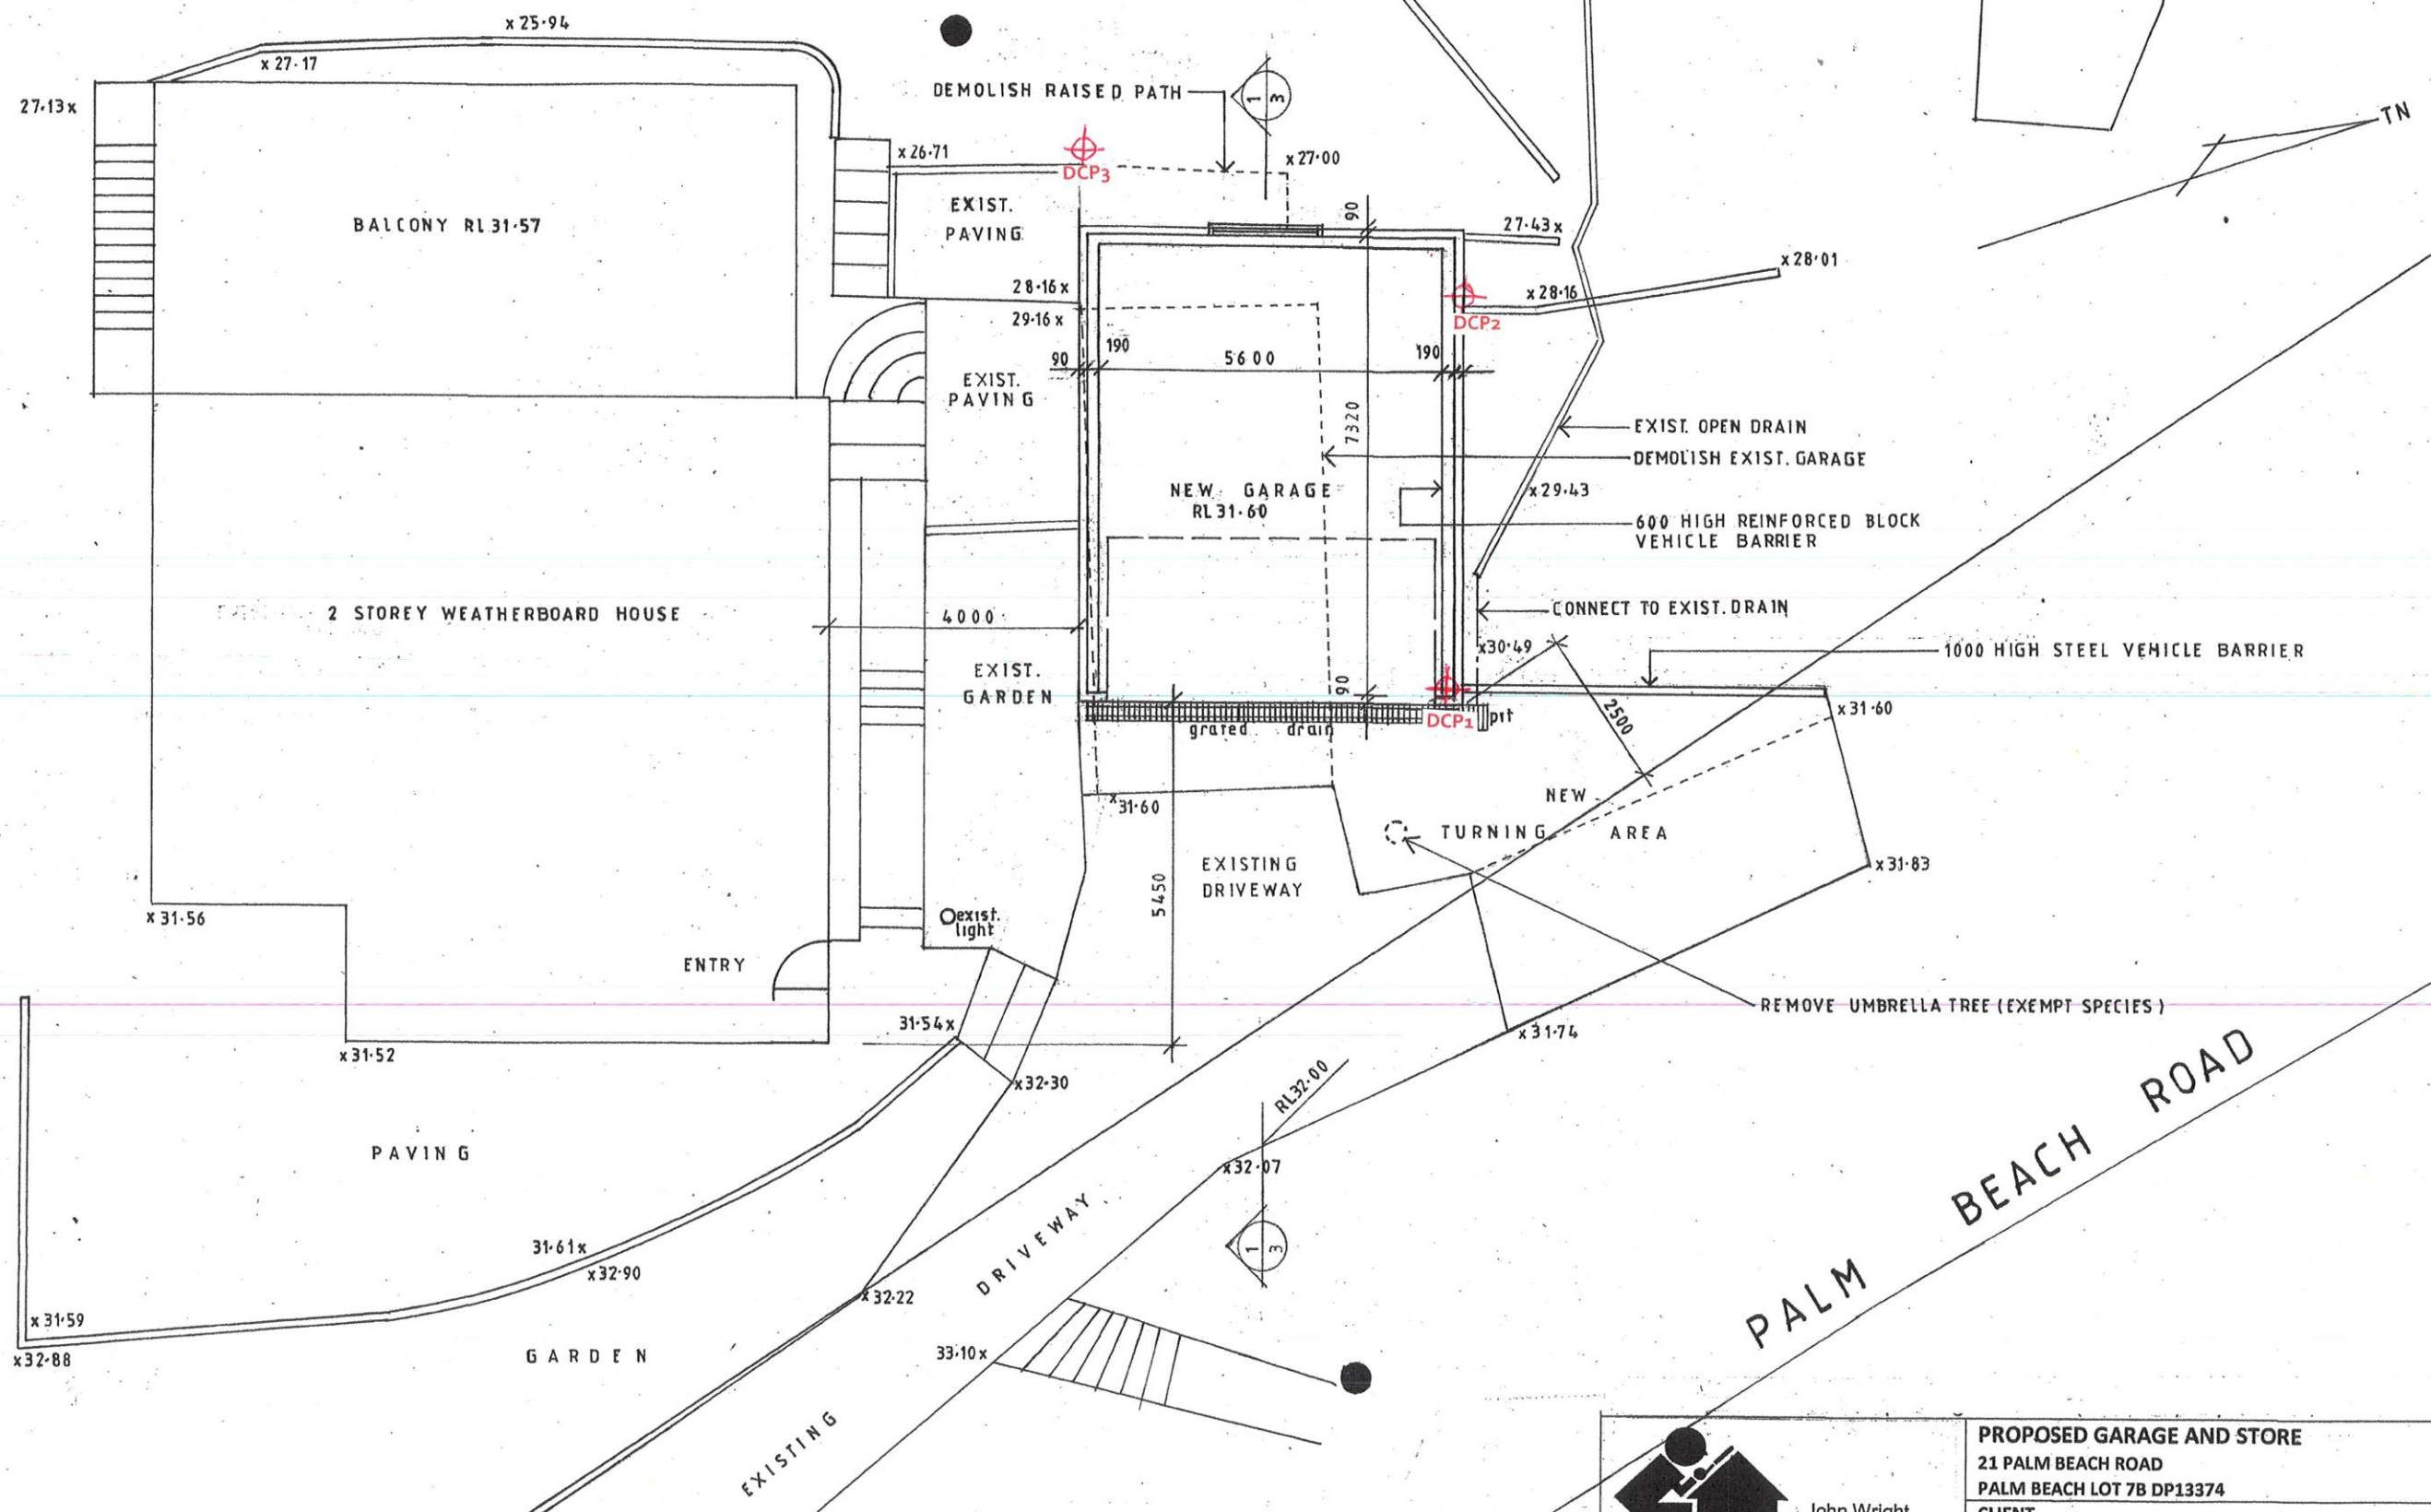
SITE PLAN – showing test locations

Three Dynamic Cone Penetrometer (DCP) tests were put down to determine the relative density of the overlying soil and the depth to bedrock. The locations of the tests are shown on the site plan. It should be noted that a level of caution should be applied to interpreting DCP test results. The test will not pass through hard buried objects so in some instances it can be difficult to determine whether refusal has occurred on an obstruction in the profile or on the natural rock surface. This is not expected to be an issue for the testing on this site and the results are as follows:

DCP TEST RESULTS – Dynamic Cone Penetrometer			
Equipment: 9kg hammer, 510mm drop, conical tip.		Standard: AS1289.6.3.2- 1997	
Depth(m) Blows/0.3m	DCP 1 (~RL30.7)	DCP 2 (~RL28.1)	DCP 3 (~RL26.7)
0.0 to 0.3	4	6	1F
0.3 to 0.6	4	4	13
0.6 to 0.9	15	8	29
0.9 to 1.2	15	18	#
1.2 to 1.5	10F	12	
1.5 to 1.8	8	#	
1.8 to 2.1	13		
2.1 to 2.4	24		
2.4 to 2.7	40		
2.7 to 3.0	#		
	End of Test @ 2.7m	Refusal on Rock @ 1.4m	Refusal on Rock @ 0.9m

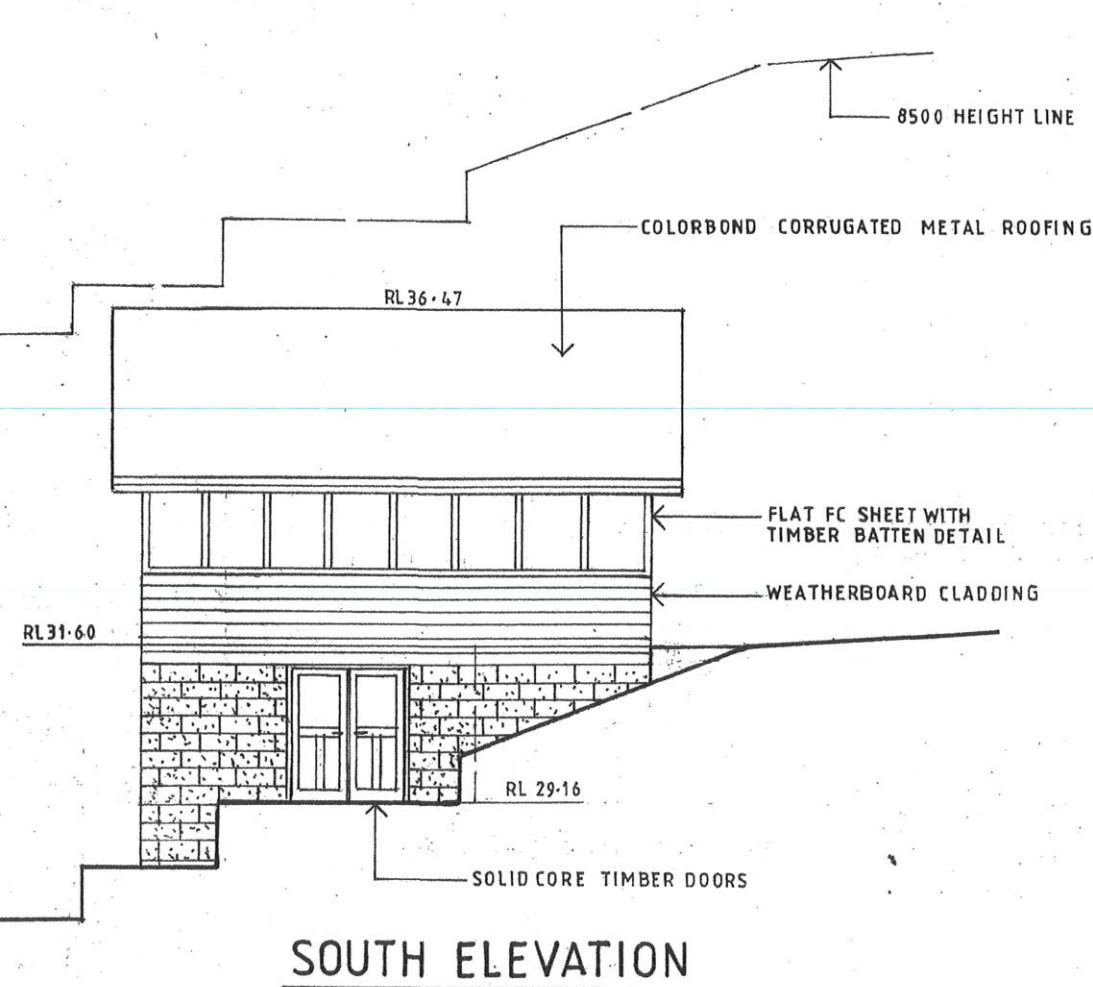
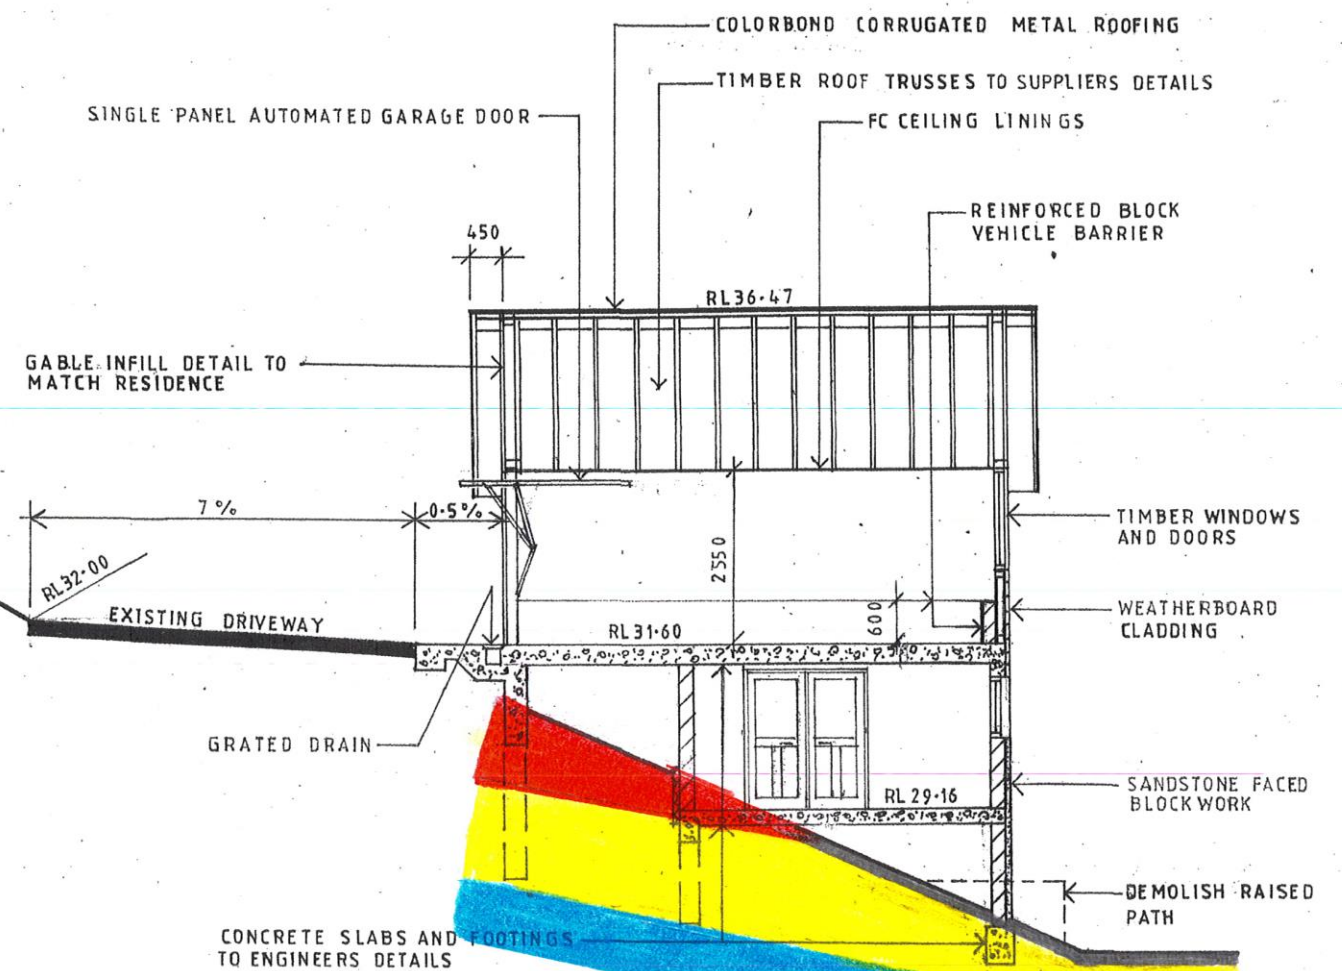
TYPE SECTION – Diagrammatical Interpretation of expected Ground Materials

The natural slope materials are colluvial at the near surface and residual at depth. In the test locations, the ground materials consist of a sandy topsoil over firm to stiff clays to depths of between ~0.6 to 2.2m below the current ground surface. Fill to a maximum depth of ~1.5m has been paced on the slope to level an area for the gravel parking space. No other fills were encountered or observed during the testing on the site. The test results on the high side of the proposed garage show a weathered rock profile (DCP1) while the results on the downhill side (DCP 2 and 3) are typical of a Medium Strength Sandstone profile. To account for this

variability in terms of bearing pressure we consider the rock to be very low strength. It is to be noted that this material can appear as a mottled stiff clay when it is cut up by excavation equipment. See Type Section attached for a diagrammatical representation of the expected ground materials.
