Development Application for <u>Reform Projects Pty Ltd</u>	Name of Applicant
Address of site <u>1102-1106 Barrenjoey Road, Palm Beach, NSW</u>

REPORT TO
REFORM PROJECTS PTY LTD

ON
**SEEPAGE ANALYSIS AND GEOTECHNICAL
ASSESSMENT**
(In Accordance with Pittwater Council Risk
Management Policy)

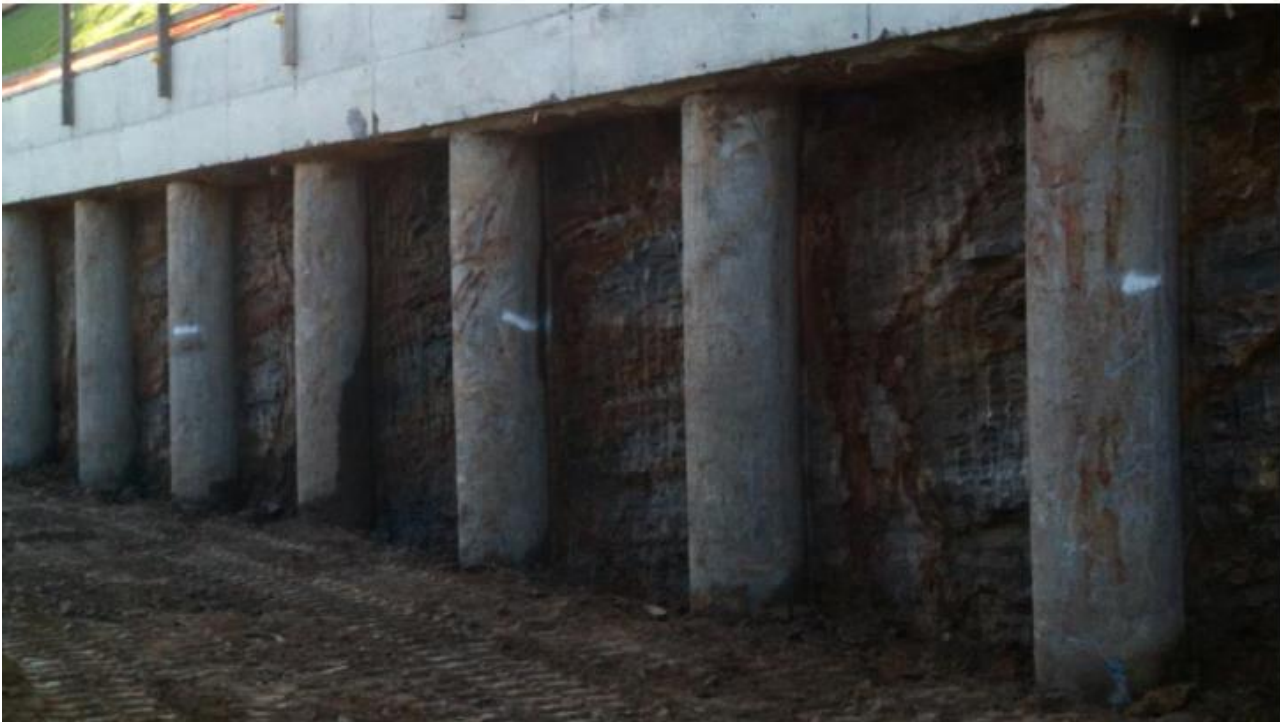
The soldier pile wall comprised 0.6m diameter piles spaced at about 2.5m, with mesh and shotcrete infill panels between piles. Over the lower about 0.8m to 0.9m mesh and shotcrete has not been placed and here the materials exposed were assessed to comprise moderately weathered siltstone of low to medium strength. Water seepage was observed in this face, both over the siltstone cut face and through the shotcrete panels. Some cracks varying from 'hairline' to 2mm in width were observed in the shotcrete panels but overall, the soldier pile wall appeared to be in good condition. There was a concrete section about 1.1m high above the piles, which appeared to be the capping beam. Above the capping beam was about a 1m high mesh fence. The architectural section drawing by Mills Architecture & Interiors (Ref: Drawing No. DA.01) details the base of the soldier piles at RL-0.25m. We have extracted a photograph from the Witt geotechnical investigation report, as shown below in Plate 1, of the soldier pile wall prior to being shotcreted. It appears the portion below the capping beam comprises weathered rock.

Plate 1: Photograph of Soldier Pile Wall Prior to being Shotcreted (Figure 3 from Witt Report)

Near the southern boundary, water seepage was observed below the boulder. Along the soldier pile wall, water seepage was observed both through the shotcrete and mesh panels and over the lower siltstone bedrock exposed in the cut face below the shotcrete and mesh.

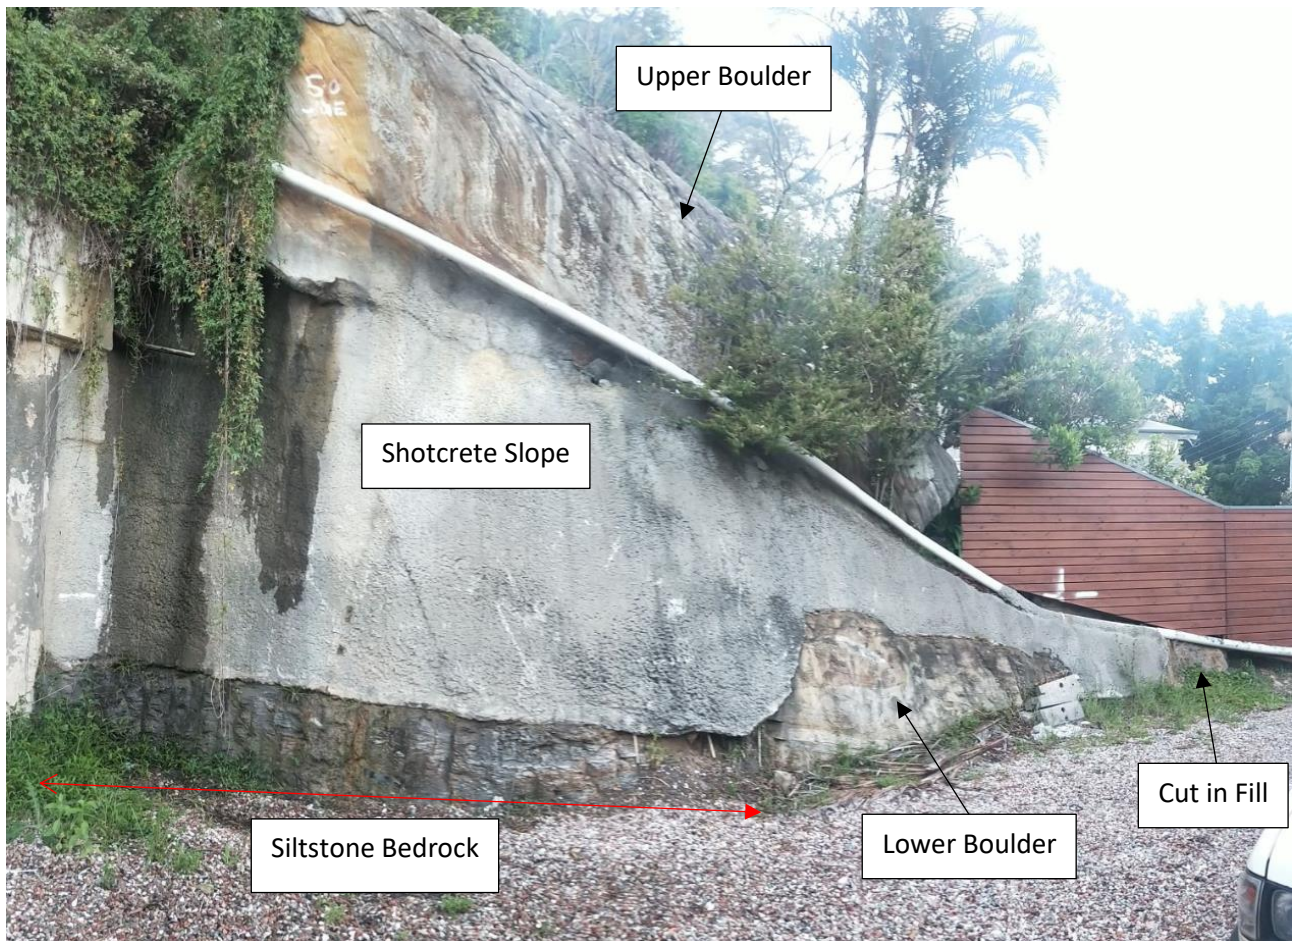
The below site description should be read in conjunction with Plate 2, which includes a photograph of the southern boundary area. Extending into the site near the southern boundary is a large sandstone boulder. This boulder is located in the upper portion of the profile and where excavation has extended below it the cut face has been protected with shotcrete. The boulder is approximately 2m to 3m high and extends for a length of about 7.5m. The shotcreted cut has a maximum height of approximately 3.5m and extends for a length of about 10.5m. The boulder overhangs the eastern end of the cut by about 1m to 1.5m over a length of 1.5m. Water seepage was observed below the boulder along the eastern 2m length of the shotcrete facing. A second sandstone boulder is exposed below the western end of the upper boulder. This boulder extends for a length of about 2.5m over the lower 0.7m to 1.3m of the cut. Between the eastern soldier pile wall and this lower boulder, siltstone bedrock was exposed below the shotcrete for a length of about 6m to 7m over the lower 0.8m of the cut. The siltstone bedrock was assessed to be moderately weathered and of low to medium strength. A 0.8m high vertical cut in fill was observed over a length 1m at the westernmost end of the southern cut.

Plate 2: Photograph 1 of Large Boulders and Shotcreted Cut Face At/Near Southern Boundary (Facing South)

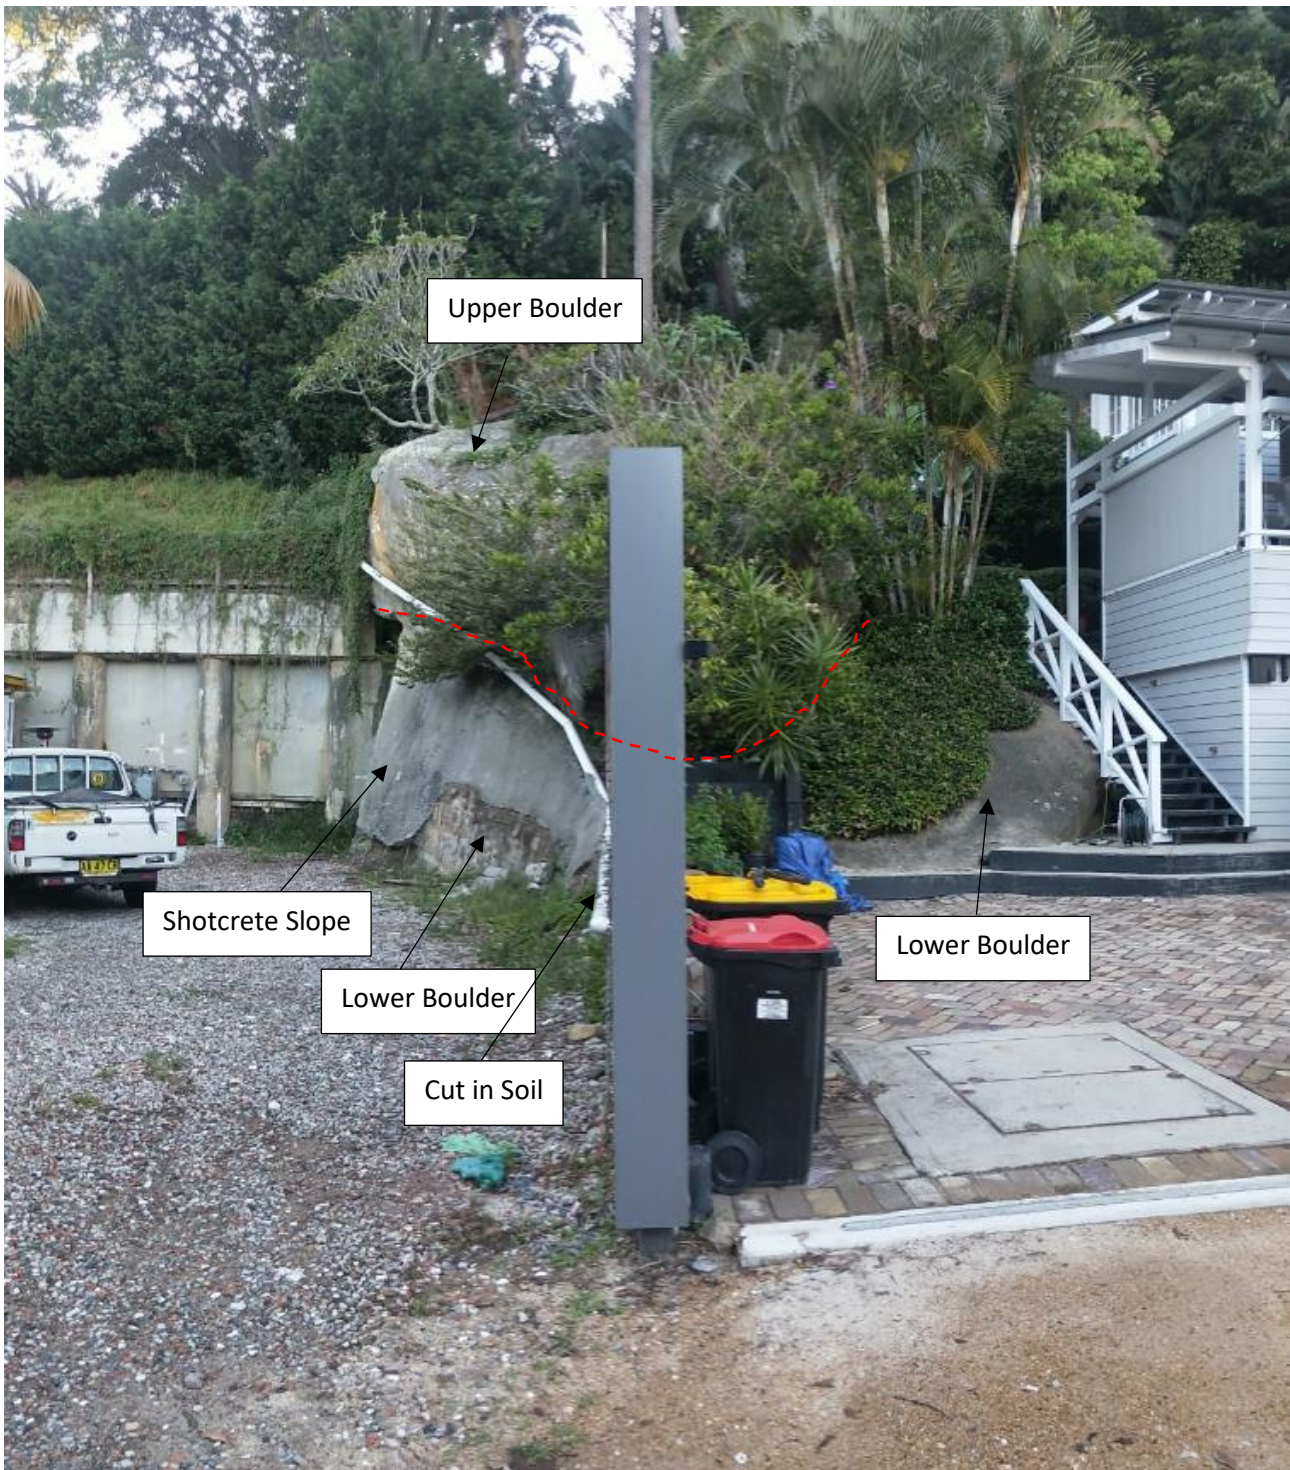
The site is bound by residential development to the south, 1100 Barrenjoey Road, beyond the boundary. It appears that the upper boulder visible in the southern cut face extends an additional 2.5m to the south and overlies another large boulder that extended further to the south. This can be seen below in Plate 3. Beyond these boulders is a two-storey timber clad house. To the east of the site is a flat grass area (driveway) and then a single-storey shed. To the north is a one and two storey rendered building ('Barrenjoey House', which is heritage listed) while Barrenjoey Road bounds the site to the west. All adjoining structures appeared in good condition when viewed from the site.

Plate 3: Photograph 2 of Large Boulders and Shotcreted Cut Face At/Near Southern Boundary (Facing East)

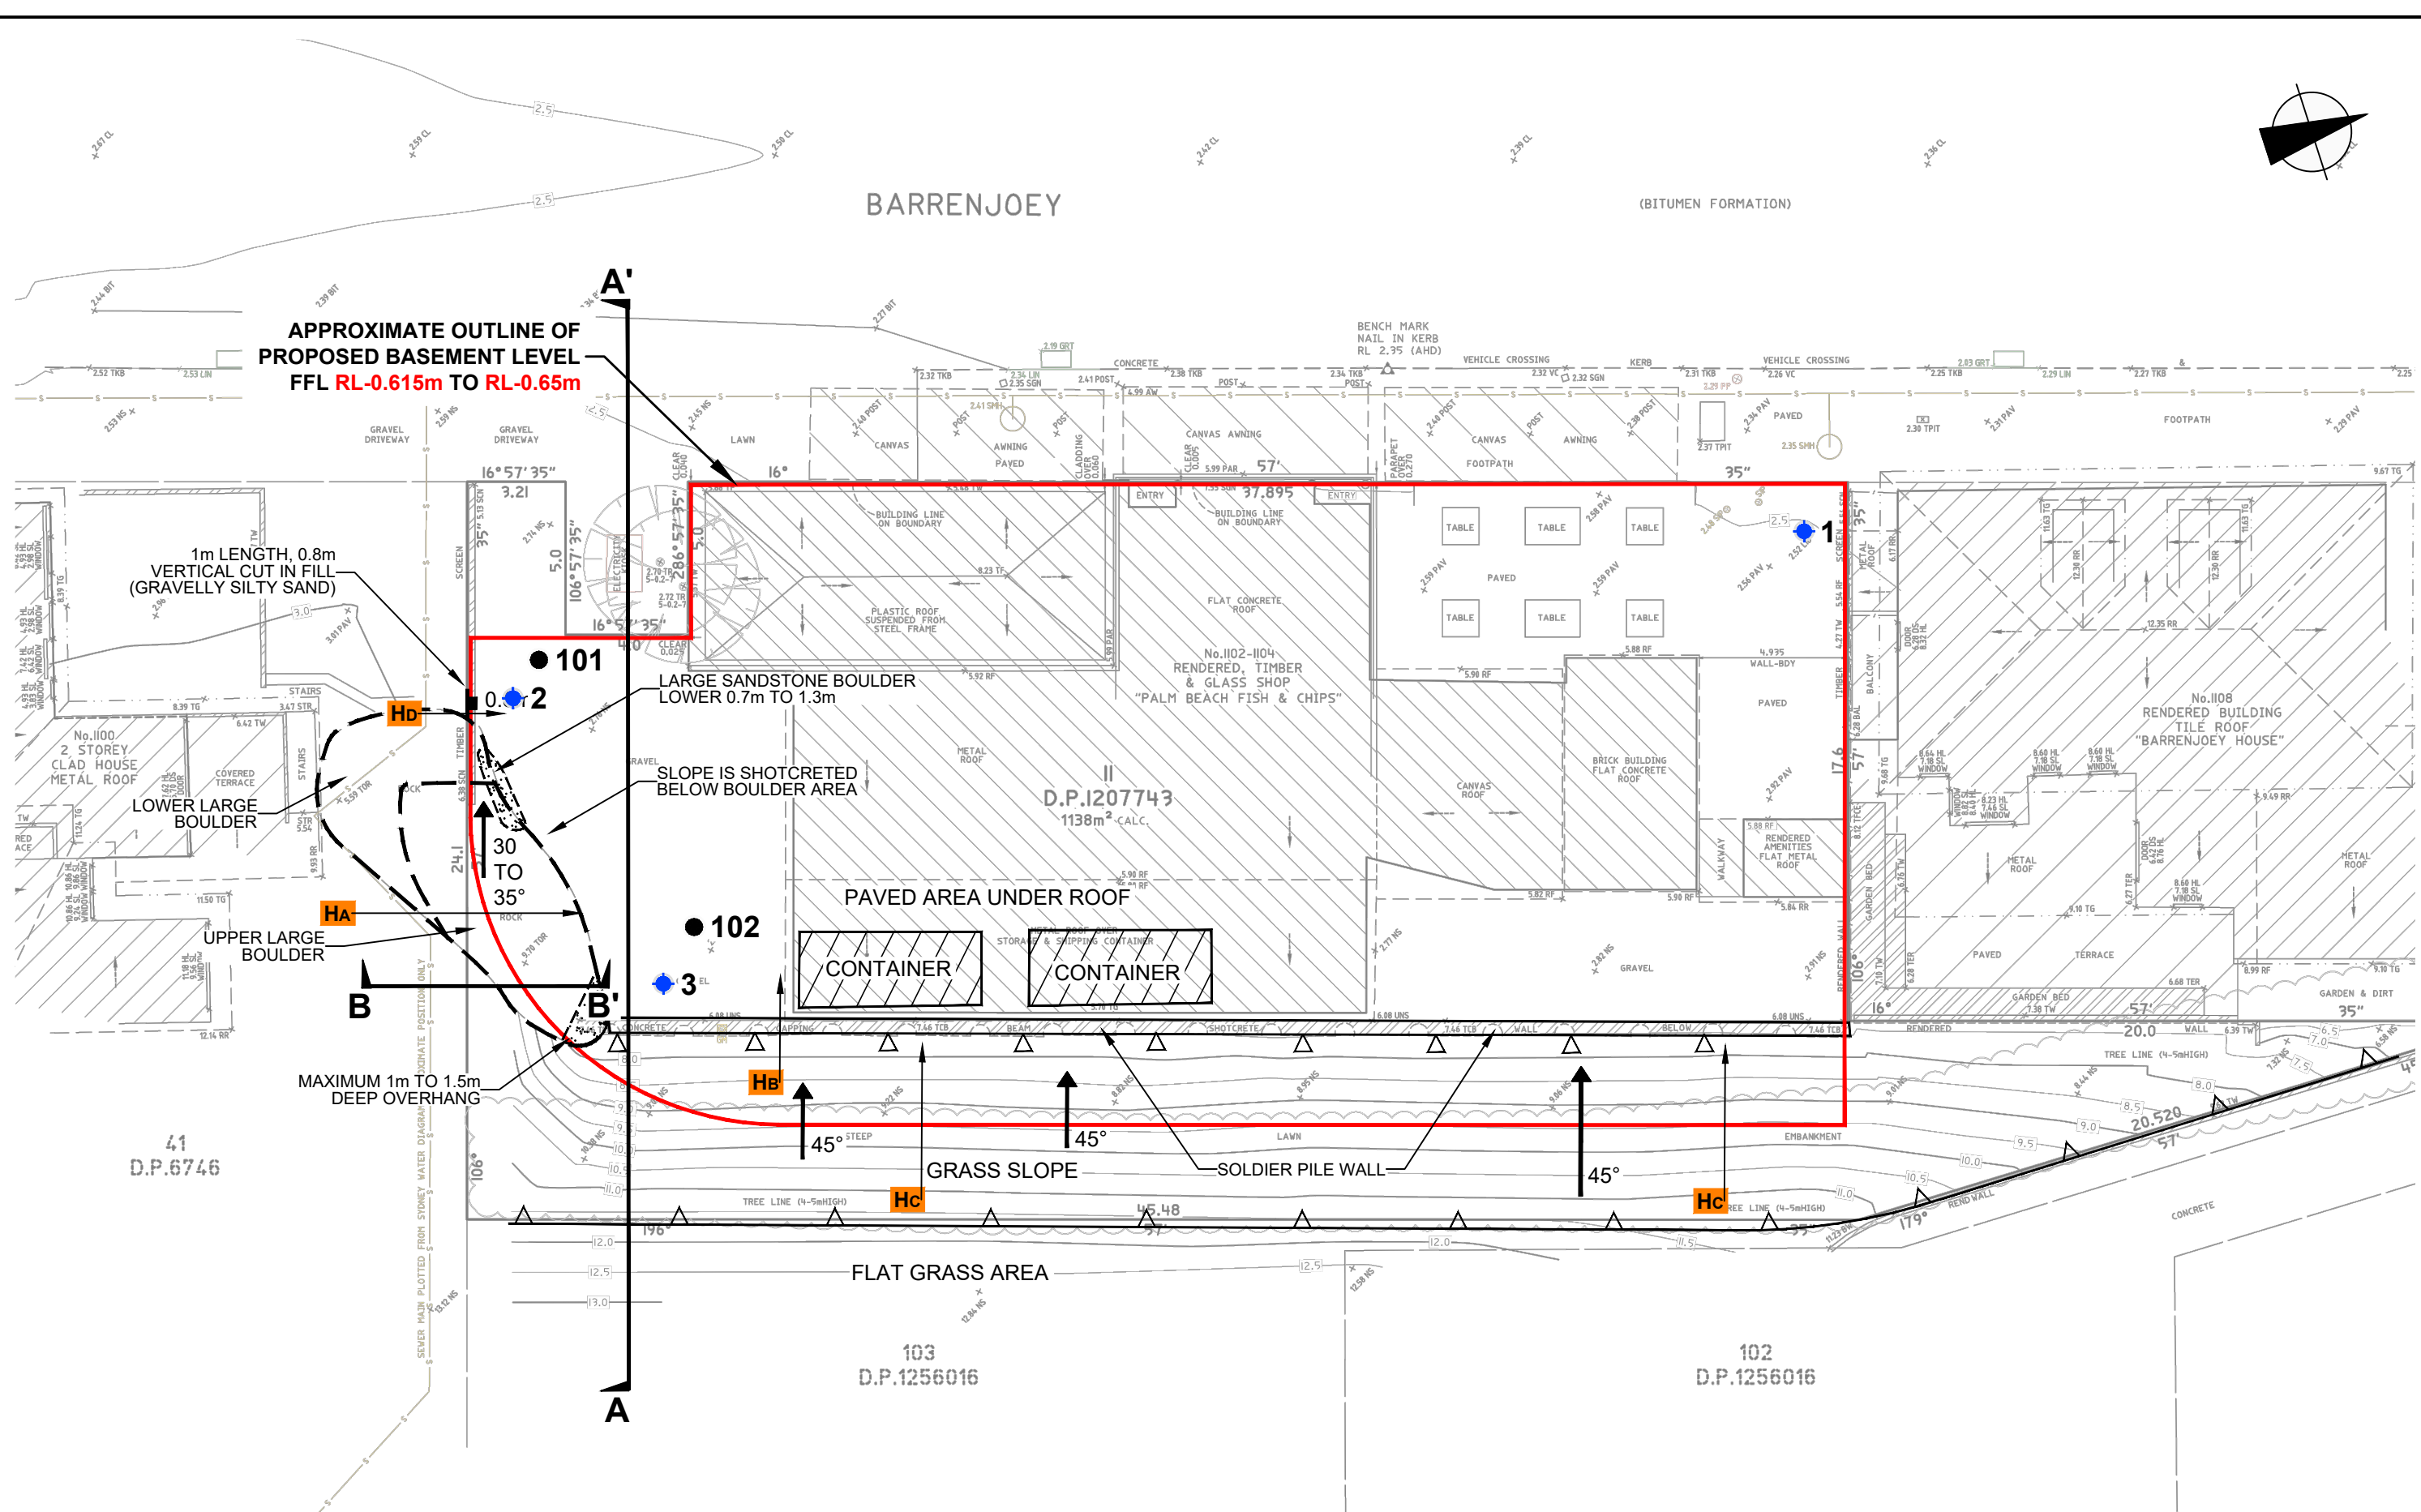
Figure 3: Plan of Notable Geotechnical Features and Geotechnical Hazards

- A Stability of existing large boulder near/at the southern boundary (requires shotcrete slope below to fail, assumed as engineered);
- B Stability of the soldier pile wall to the east of the buildings (assumed as engineered);
- C Stability of the reinforced hillside upslope (east) of the soldier pile wall (assumed as engineered);
- D Stability of the localised 0.8m high vertical cut in fill along a 1m length at the southern boundary; and,
- E Stability of new engineered retaining walls

These potential hazards are indicated in schematic form on the attached Figure 3.
