## **5 Kooloora Avenue, Freshwater**

### Comments on updates to Plans

## **GEOTECHNICAL INVESTIGATION:**

Alterations and Additions at **5 Koolooro Avenue, Freshwater**

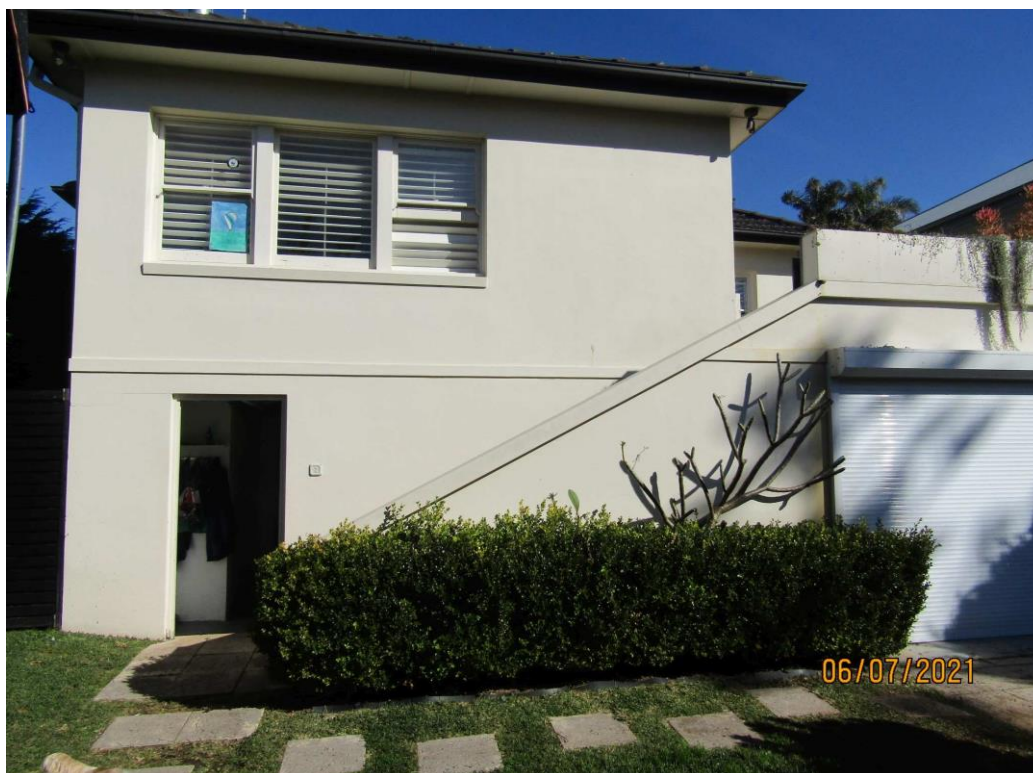
Photo 2

two storey rendered brick house is supported by brick walls, brick piers and steel posts (Photos 2 & 3). The supporting walls, piers and posts stand vertical and show no significant signs of movement (Photo 4). A near level lawn and paved area extends off the uphill side of the house (Photo 3). No signs of slope instability were observed on the property. The adjoining neighbouring properties were observed to be in good order as seen from the street and subject property.

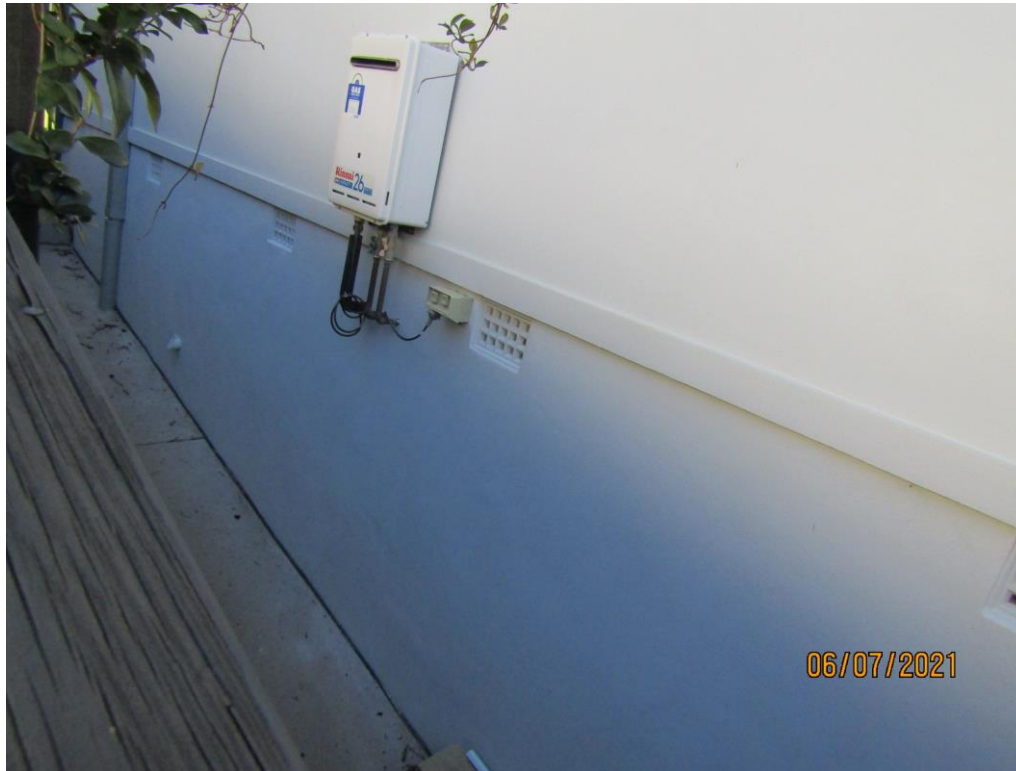
Photo 5

retaining walls are in place (**Hazard One**). The proposed lower ground floor excavation undercutting the subject house, NW neighbouring concrete pathway (Photo 5) and NW neighbouring house (Photo 5) is a potential hazard (**Hazard Two**). The proposed excavation for the pool undercutting the existing low rendered masonry retaining wall (Photo 6), Rendered masonry boundary fence/retaining wall (Photo 7) and SW neighbouring pathway (Photo 8) is a potential hazard (**Hazard Three**).

- ~2.0m from the NW neighbouring house and ~0.6m from the NW neighbouring concrete pathway (Photo 5).

The subject house, NW neighbouring house and NW neighbouring pathway will be within the zone of influence of the excavation. In this instance, the zone of influence is the area above a theoretical 30° line through soil/sand and a 45° line through clay/weathered rock from the base of the excavation towards the surrounding structures and boundaries.

The structures supporting the existing house (within the zone of influence of the excavation) are to be propped or underpinned to beyond the zone of influence of the excavation, prior to the excavation commencing.

Where underpinning is not required (outside of the footprint of the existing house) heavy ground support is recommended due to the presence of deep sand and the proximity to the neighbouring structures.

It is recommended a secant or contiguous pile wall be constructed along the NW side and SW side of the excavation where underpinning is not required before the excavation commences. See the Lower Floor Plan attached for the minimum extent of the required shoring shown in blue. Secant piers are the preferred option but if contiguous piers are used, the gaps between the piers are to be grouted closed as the excavation is lowered so no material moves through the wall. The piers can be temporarily supported by bracing and/or embedment below the base of the excavation but are to be tied into the house structure during construction.

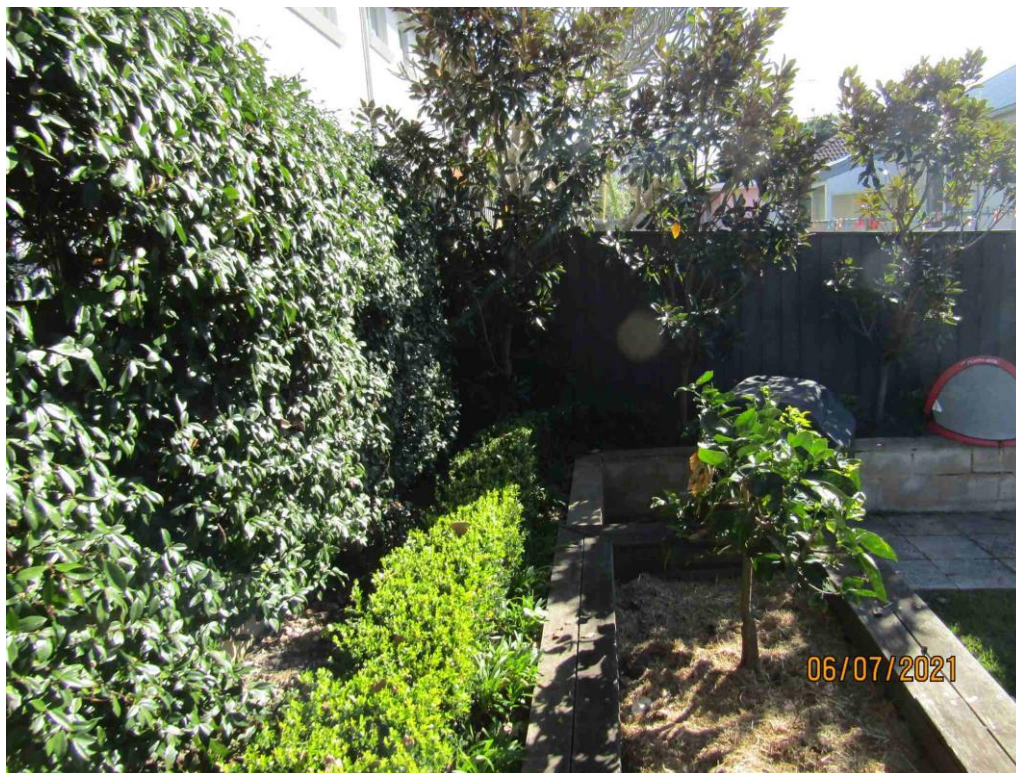
Photo 6

- Flush with a low rendered masonry retaining wall on the subject property (Photo 6).
- ~1.3m from the SW rendered masonry boundary fence/retaining wall (Photo 7) and ~1.5m from the SW neighbouring pathway (Photo 8).
- ~1.0m from the NW common boundary.

1. If the low rendered masonry retaining (Photo 6) is to remain, it is to be underpinned to the base of the excavation, prior to the excavation commencing.
2. If the low rendered masonry retaining is to be demolished, ground support will be required for the SW cut and temporary pool shoring will be required for the NW cut. A secant or contiguous pile wall is recommended for the SW cut as per the recommendations for the lower ground floor excavation. For ease of design and construction it may be considered desirable to pile the entire excavation perimeter.

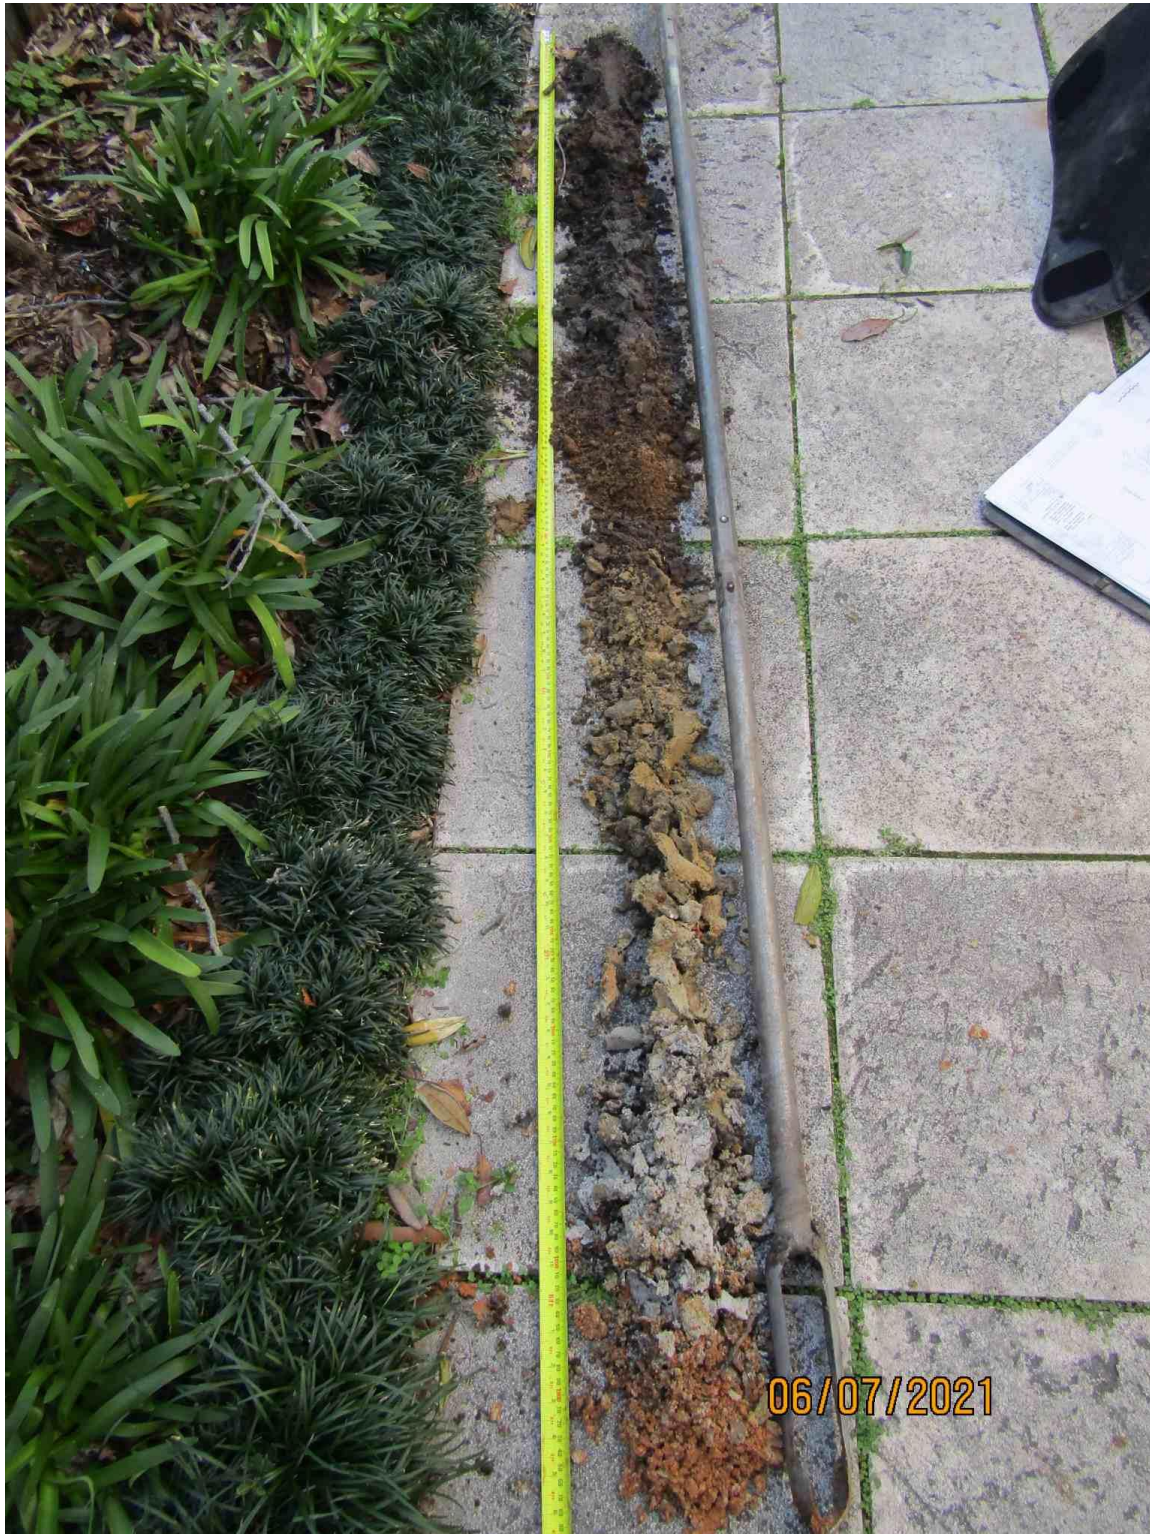
Photo 9: AH1 – Downhole is from top to bottom.

## AUGER HOLE 1 (~RL8.4) – AH1 (Photo 9)

Depth (m)	Material Encountered
0.0 to 0.4	<b>TOPSOIL</b> , sandy soil, dark brown, damp, fine to medium grained with fine trace organic matter.
0.4 to 1.0	<b>SILTY SAND</b> , dark grey and brown, moist, loose to medium dense, fine to medium grained.
1.0 to 1.4	<b>SAND</b> , light orange brown, damp, medium dense, medium grained.
1.4 to 1.8	<b>SANDY CLAY</b> , light brown and light grey, firm, moist to damp.
1.8 to 2.0	<b>SANDY CLAY</b> , derived from Very Low Strength Sandstone, orange, moist, sugary texture.

End of Hole @ 2.0m in sandy clay. No watertable encountered.
