35 Robertson Road, Scotland Island, NSW

ARBORICULTURAL RISK ASSESSMENT REPORT – REVISION A

22nd August 2018

**Prepared for Far East Land and Housing Development Company Pte.
Ltd**

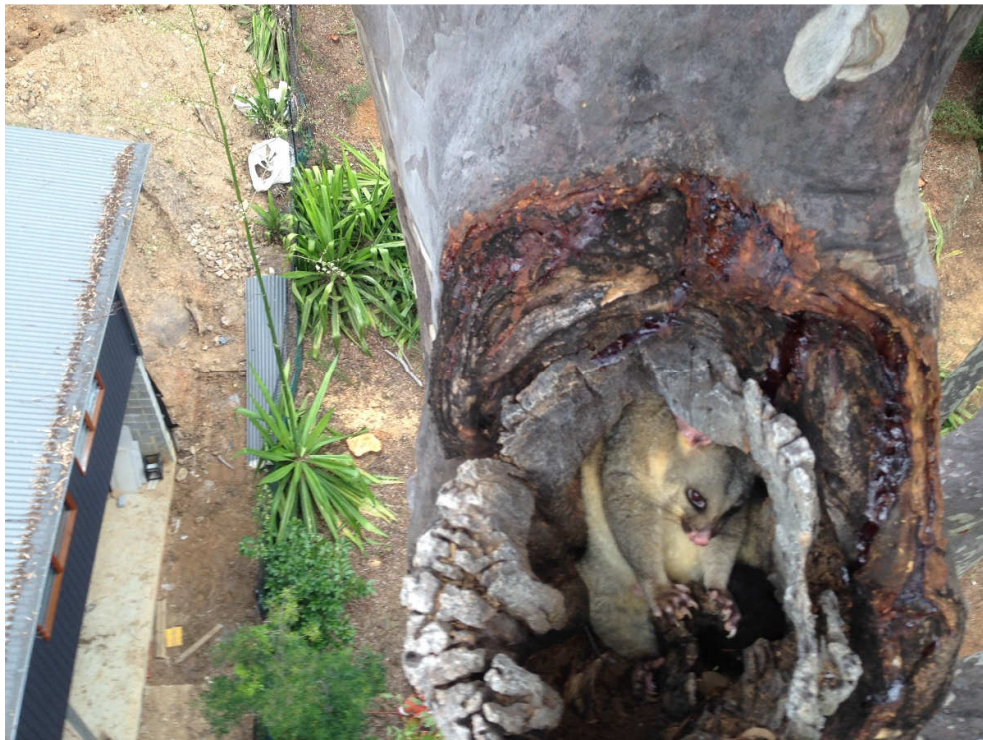
This tree has three co-dominant trunks from a point between 6-10m from the base. One of the co-dominant trunks has been topped in order to remove structural defects and limbs overhanging the neighbouring property and yet retain fauna habitat. This removal is in accordance with guidelines in Birds Tree Consultancy Arboricultural Assessment Report Revision A dated 7 April 2017. Both of the remaining co-dominant trunks have significant defects present. The central co dominant trunk has a cavity present from a previous failure with possums living in it. The most western co dominant trunk has two points of decay where previous failures have occurred.

Figure 1- Cavity in Tree 32

The subject tree has a number of structural defects within the canopy of this tree. There are three co dominant trunks, one of which has been topped. The other two co dominant trunks both have points of decay and cavity within them. This places these co dominant trunks at increased risk of failure at these points.

This risk has been assessed as outlined within 4.0 Risk Assessment and the residual risk has been found to be moderate to high. Due to the compromised form of the canopy, further remedial pruning to mitigate this risk is not possible. It is also not possible to move the targets from within the zone of the tree. As a result, in order to remove the hazard posed by this moderate to high risk, we recommend the removal of this tree.

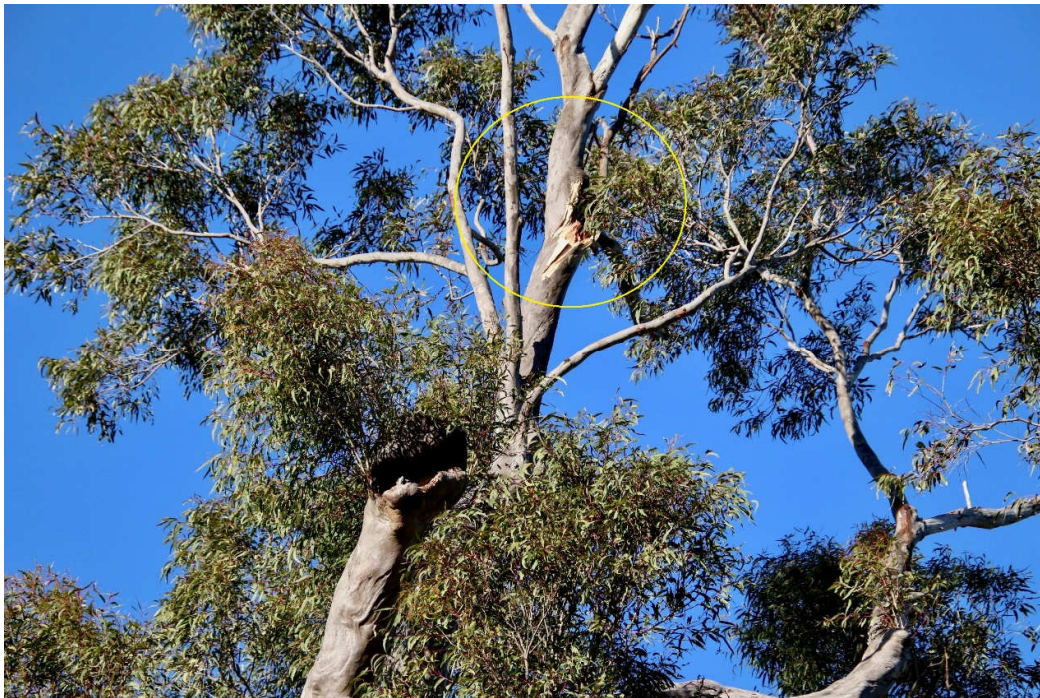
Since our last inspection for this tree for the above mentioned report, there has been a large limb fail from the upper canopy which has torn out at a collar. This failed limb landed on the roof of the neighbouring property, puncturing the roof and damaging solar power panels. This failed limb was not overhanging the neighbouring dwelling.

Figure 2 - Point of recent limb failure

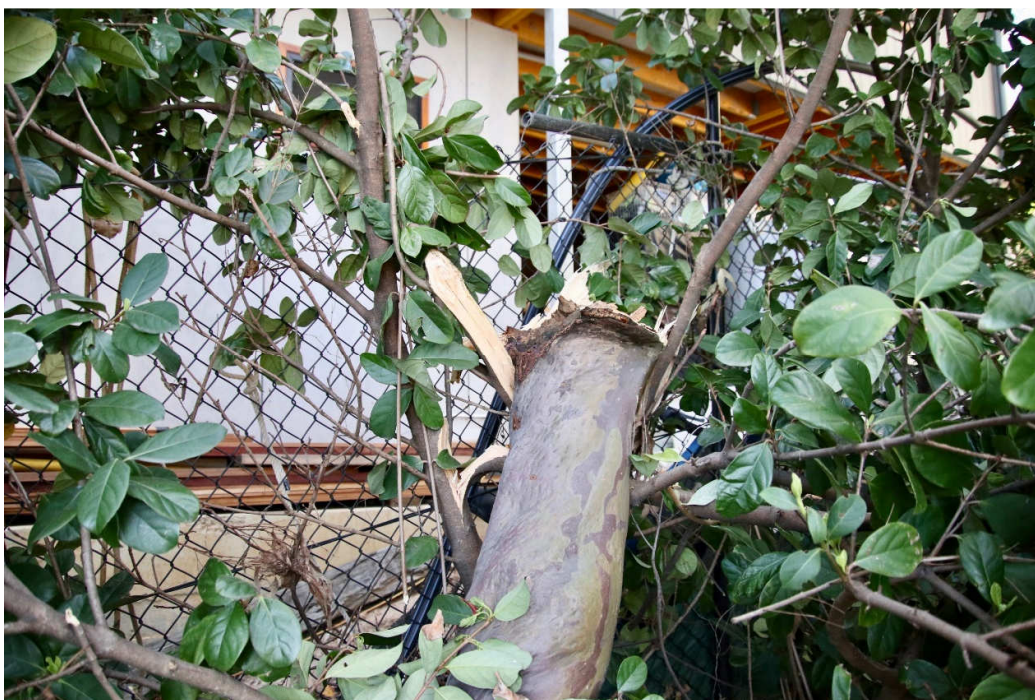
Figure 3 - Base of failed limb

In addition, this tree has a history of frequent limb failures. The most recent failure which damaged the neighbouring property failed at the collar during a period of high winds, however there is a large amount of evidence of other limb failures away from the collar in a manner that is typical of Sudden Limb Drop (SLD).

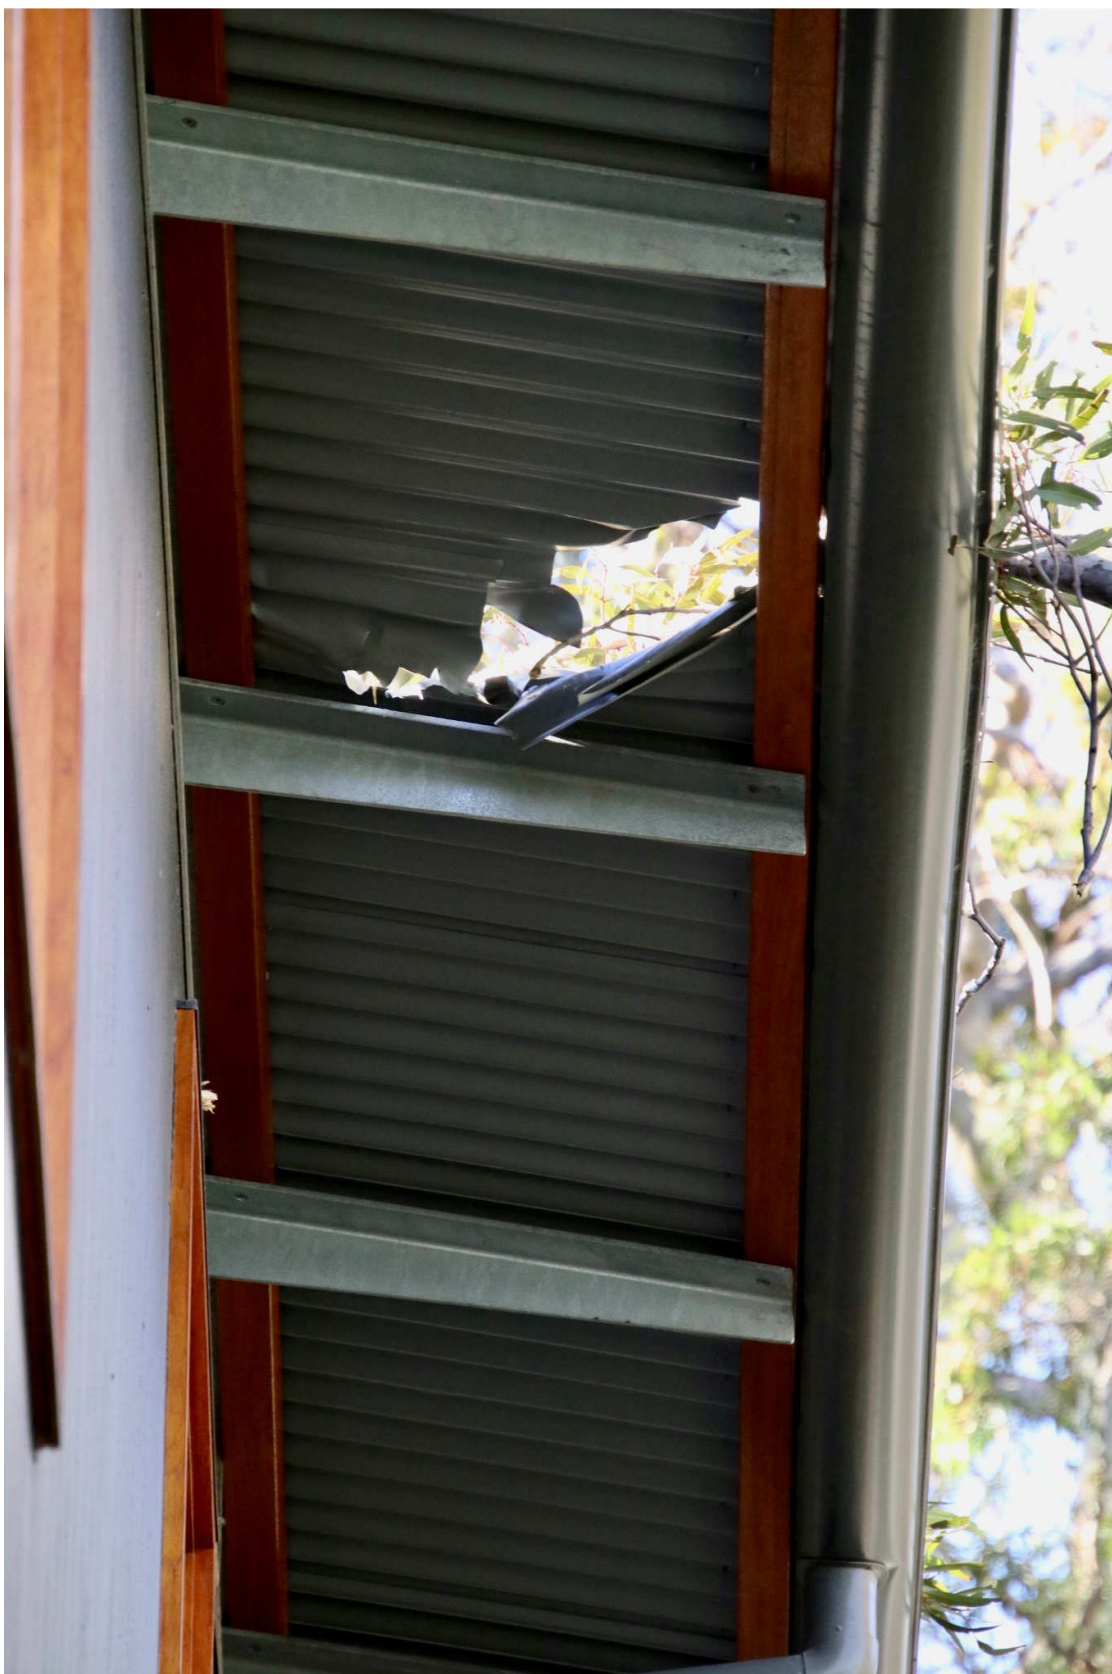
Figure 4 - Damage to neighbouring roof

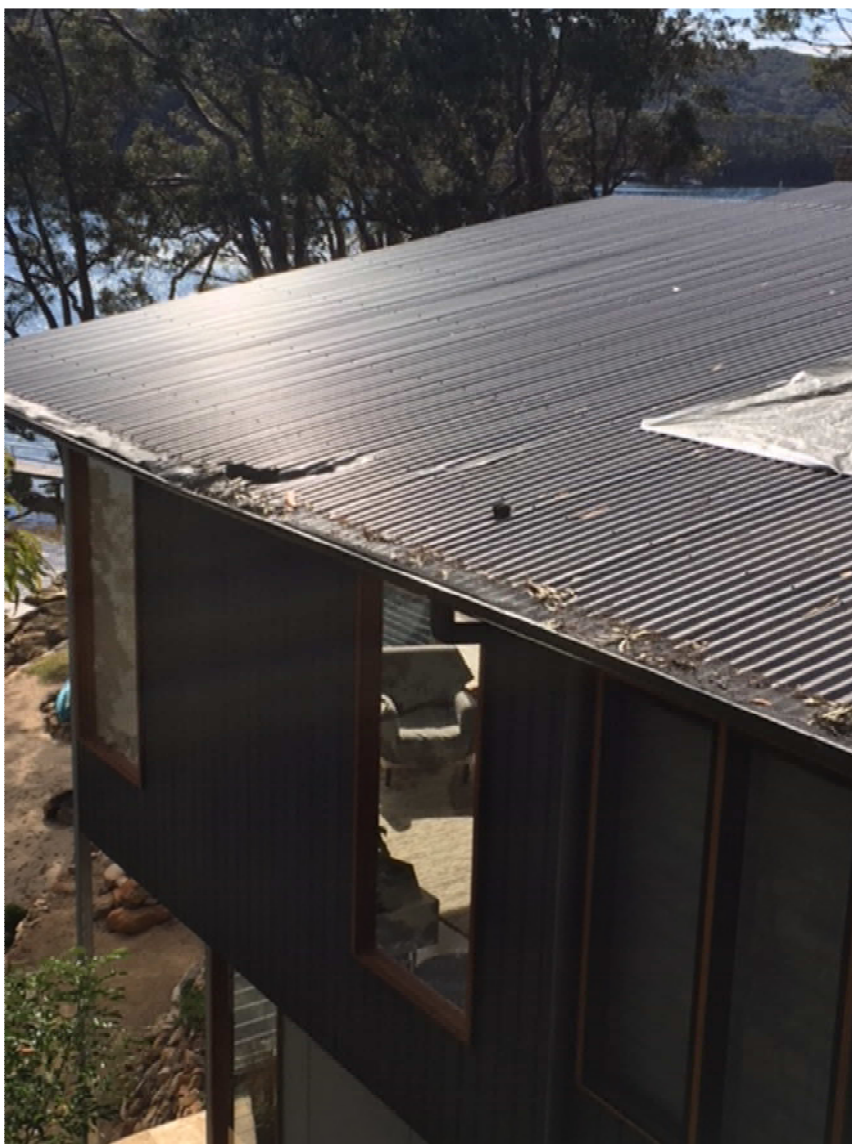
Figure 5 - Damage to neighbouring roof

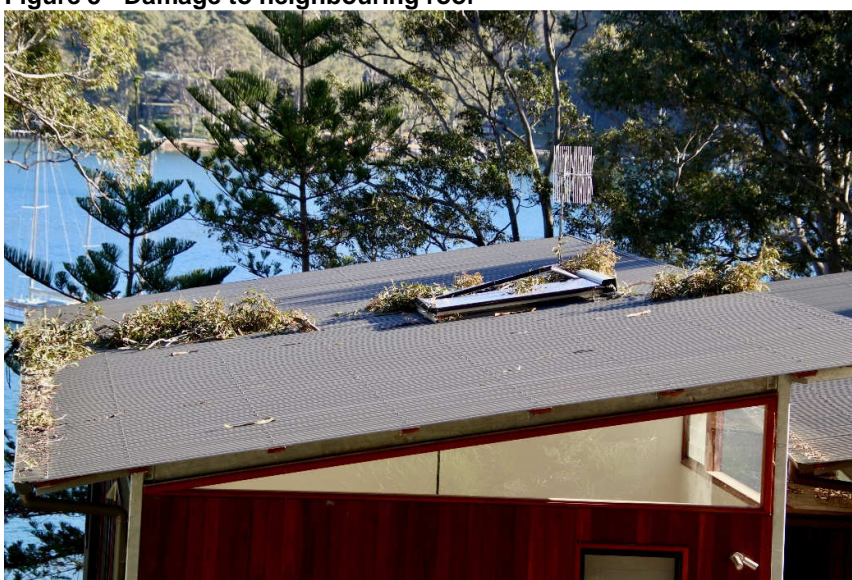
Figure 6 - Damage to Solar Panel

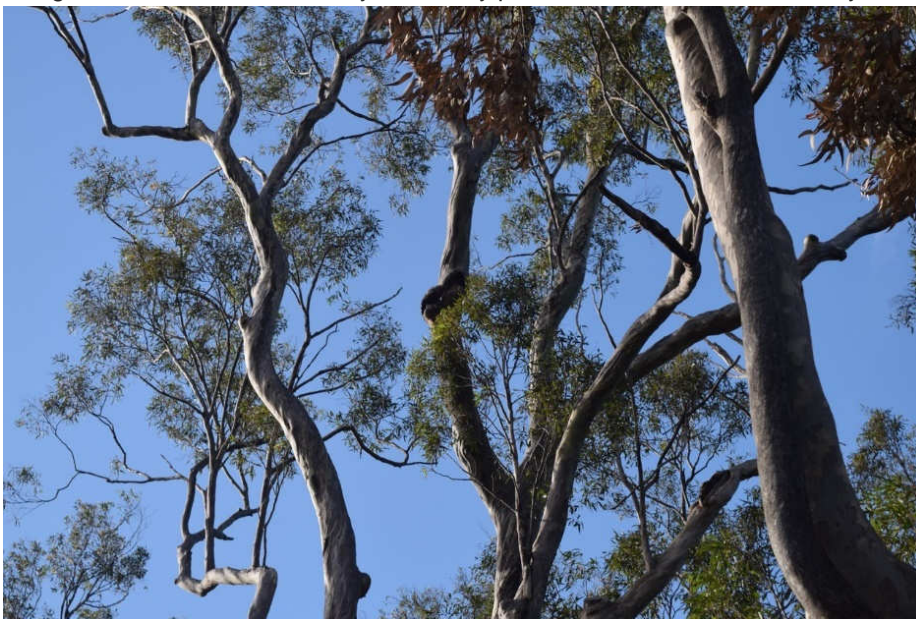
This tree is a mature *Corymbia maculata* and is approximately 30m tall with canopy spread of 16m. The tree is in good health and condition with moderate deadwood and minimal epicormic growth. This tree has a single trunk with a diameter at breast height (DBH) of 740mm. There is evidence of limb failure away from collar. There is a large wound with evident decay and cavity present in one central secondary limb.

Figure 1 - Decay and cavity in Tree 1

Remove the secondary limb on Tree 1 where the existing cavity is present back at the lower primary junction.

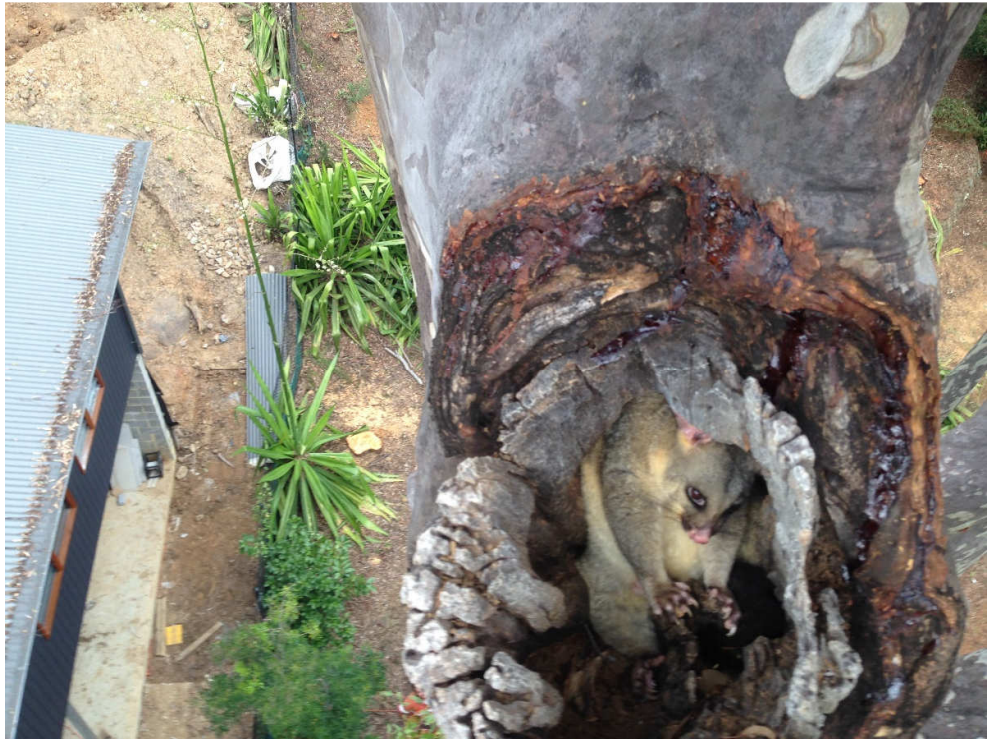
This tree is a mature *Corymbia maculata* and is approximately 27m tall with canopy spread of 22m. The tree is in fair health and condition with moderate deadwood and minimal epicormic growth. This tree has multiple (6) co-dominant trunks from 6m above the base with a diameter at breast height (DBH) of 1180mm. There is evidence of large number of failed limbs away from collar. There is a large cavity within a primary limb that is overhanging the adjacent neighbour's residence currently under construction. This cavity is visually determined to be greater than 60% of the diameter of the limb by means of aerial visual inspection. The cavity is currently housing possums. There is also a large wound on the central primary trunk that appears to be as a result of a previous limb failure leaving a "socket". Upon aerial inspection this wound appears to have compartmentalised with no evident cavity or swelling indicative of significant decay.

Figure 2- - Cavity in Tree 2

Both trees 1 and 2 require remedial pruning. Remove the secondary limb on Tree 2 with the large cavity present. Limb removal is to be carried out at the lower primary junction. Care must be taken that the cavity in tree 2 currently is habitat for possums and these possums and any other fauna are to be safely relocated.

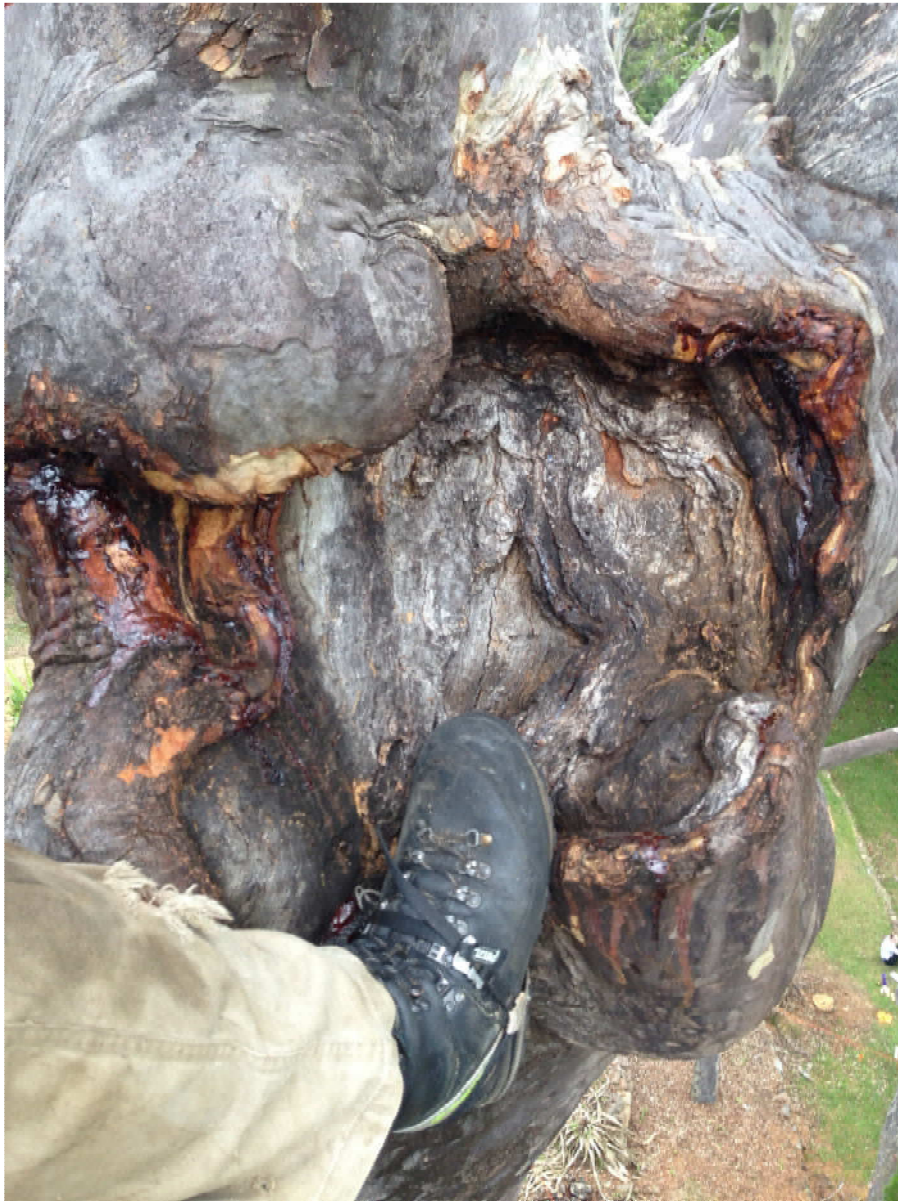
Figure 3 - Socket wound in Tree 2

Tree 2 has a number of wounds and potential decay sites within the canopy. Removal of all of these limbs would make this tree not viable to be retained. This tree will remain viable for retention in the medium term (5-10 years). Tree 2 is to be monitored regularly to investigate the extent of potential decay within the socket wound present in this tree.

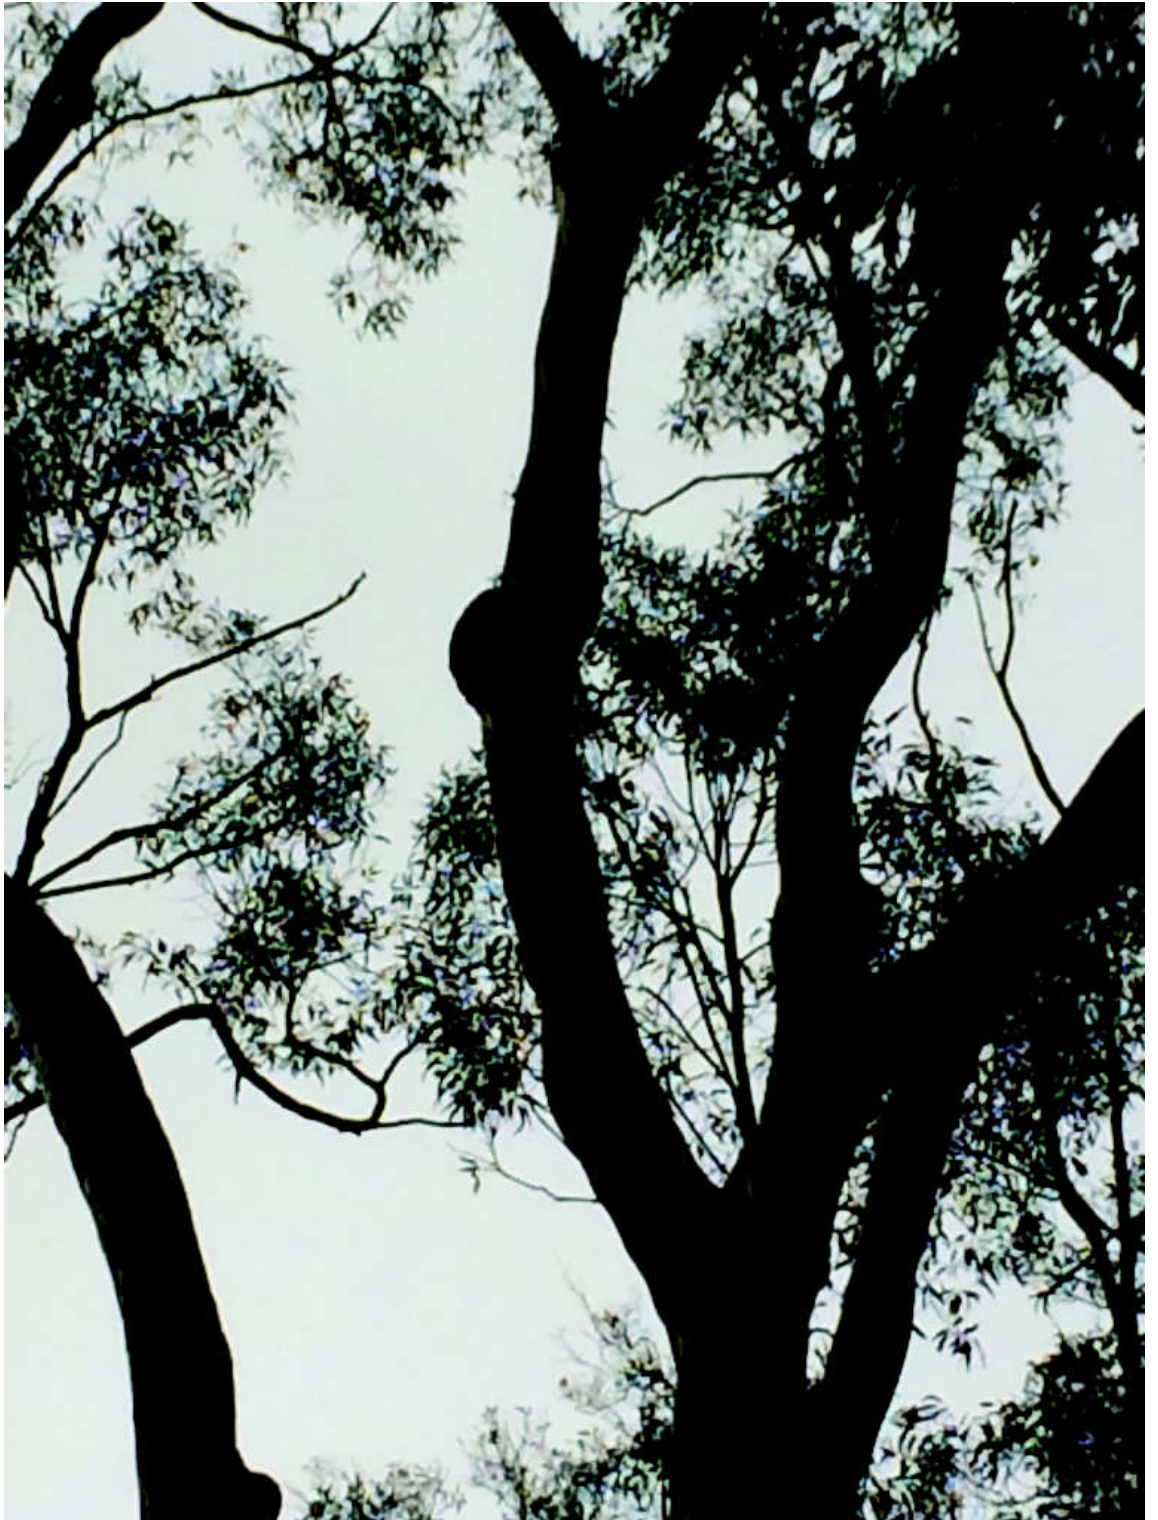
Figure 1 - Cavity in upper cavity of tree 32.

accordance with *AS4373-2007 Pruning of Amenity Trees*. It is recommended that All Arbor carry out this work whilst they are carrying out other pruning works in this tree.

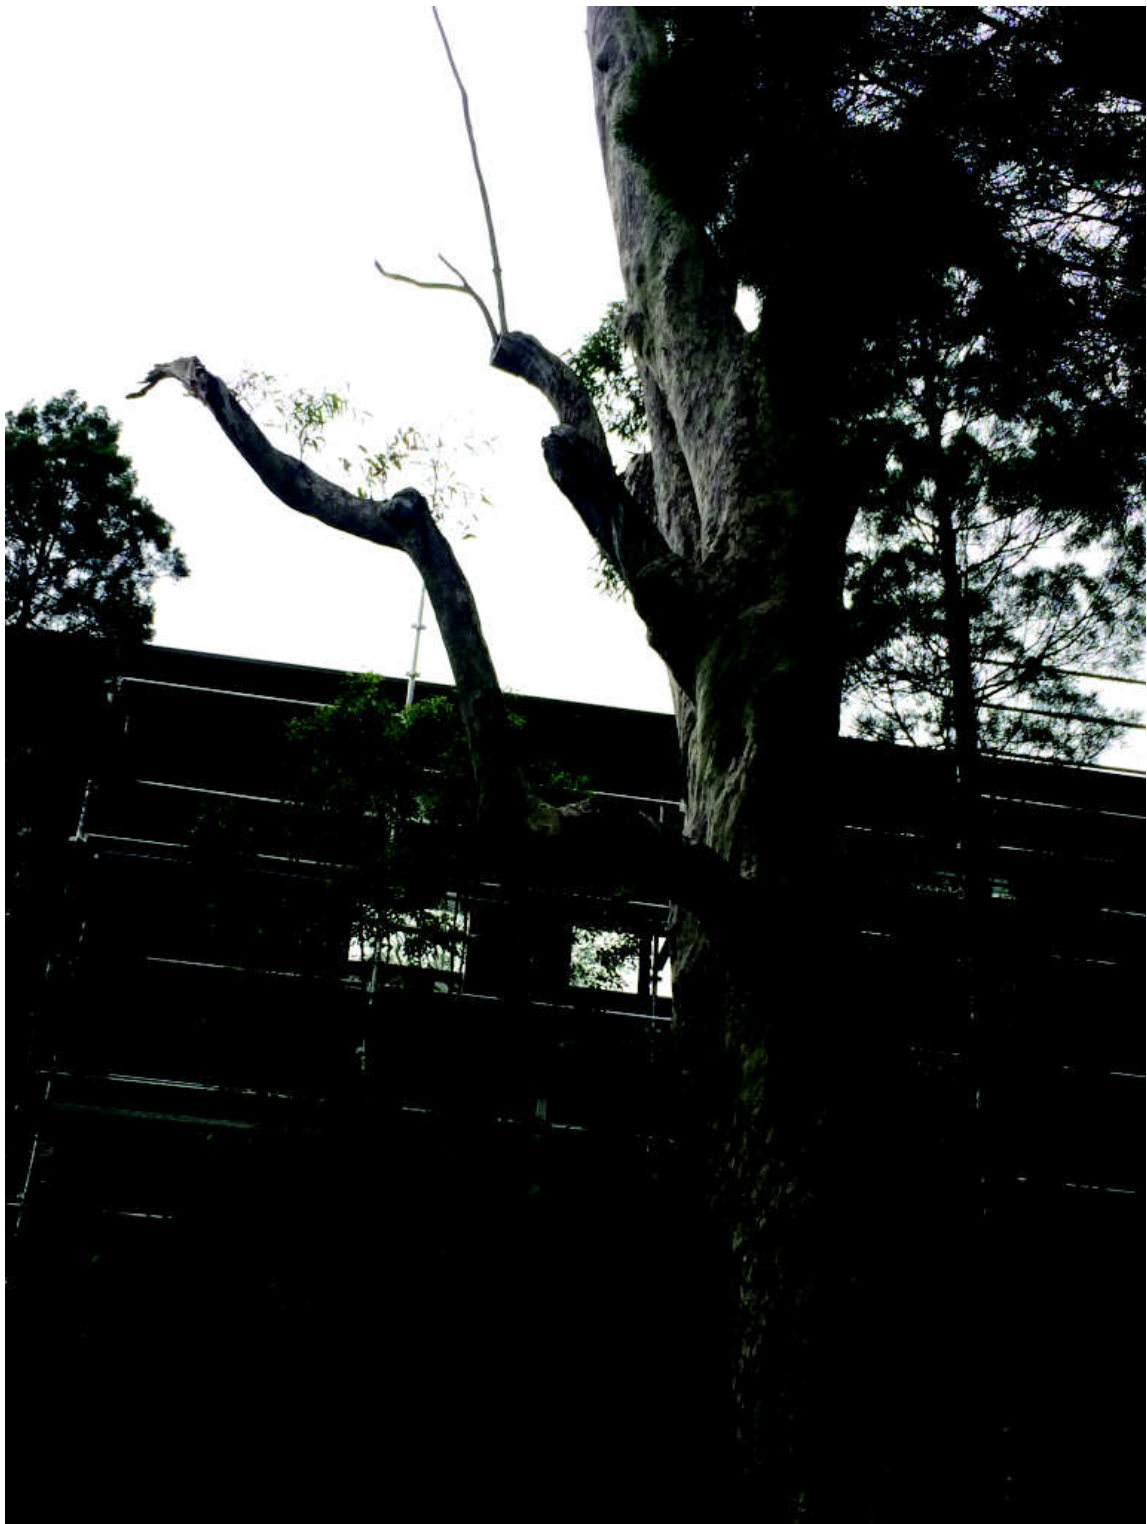
Figure 2 - Tree 32 failed limb requiring removal.
