GEOTECHNICAL ASSESSMENT

PROPOSED SECONDARY DWELLING

48 NAREEN PARADE, NORTH NARRABEEN

Project No.: 2019-116

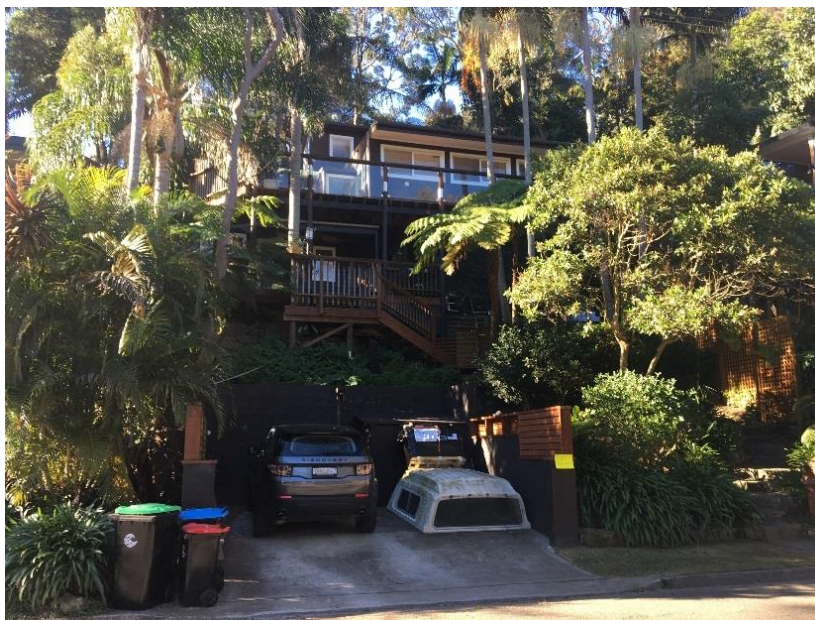
Photo: 2 – General view of front of site, facing north.

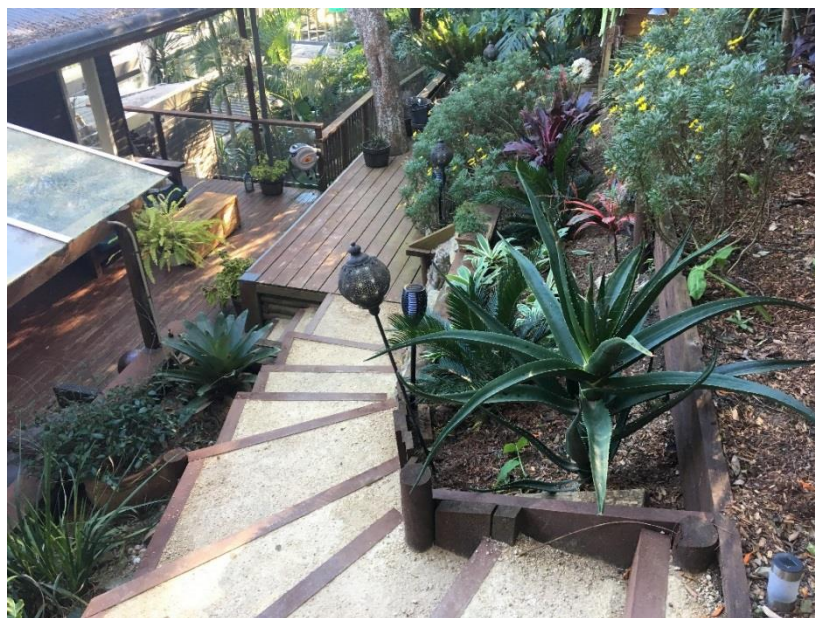
Photo: 3 – General view of landscaped gardens and decks at rear of house, facing west.

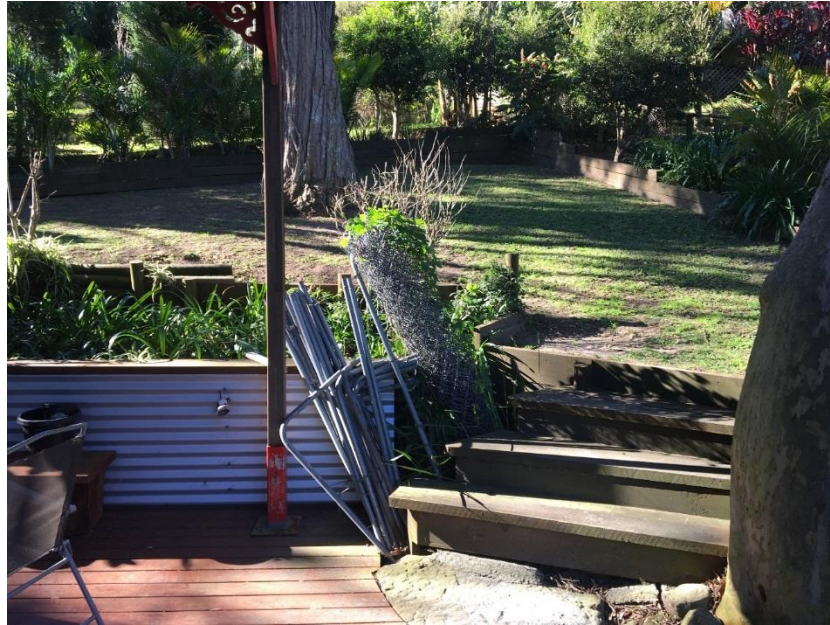
Photo: 4 – General view of rear upper portion of site, facing north-east.

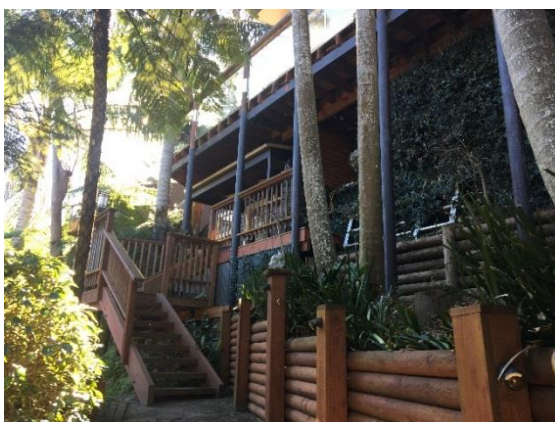
Photo: 5 – Front slope of site

The front of the site is then formed with a moderate ($\sim 18^\circ$), vegetated slope along with terraced gardens that are supported by timber log retaining walls up to 1.20m in height that extend upslope to the front edge of the existing house with a pathway and steps between, see Photo: 5. The vegetated slope becomes steep towards the western boundary, above the car parking bay retaining wall, with a low dry stacked rock retaining wall formed across part of the slope, see Photo: 6. There were signs of minor creep movement within the timber and sandstone rock retaining walls however there were no indications of significant movement, previous or impending landslip instability or excess surface stormwater flow/erosion.

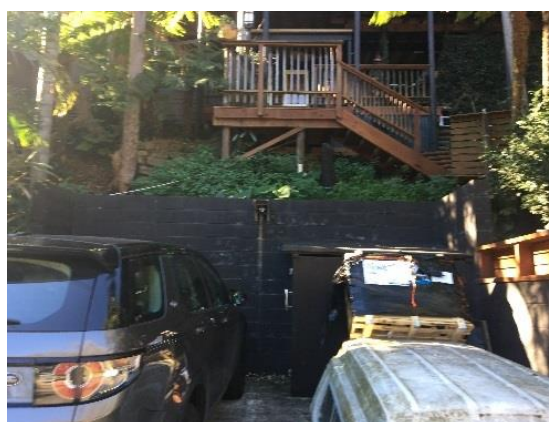
Photo: 6 - Parking bay at south-west corner

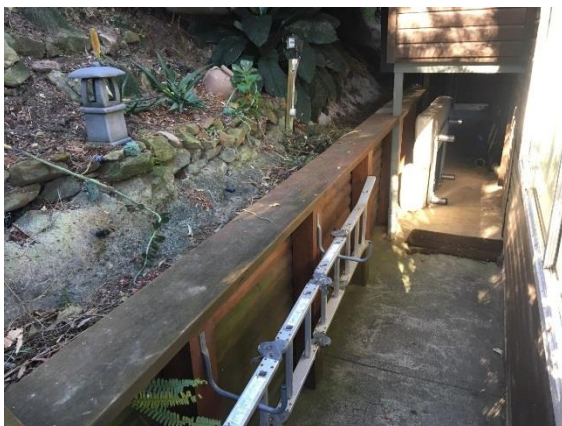
The existing house is a multi-level timber residential structure with a part brick lower level below the south-west corner. The house is supported above ground surface levels in part with a timber deck at the front supported off timber posts whilst a deck at the rear spans across from the house to the crest of a retaining wall to the north. The middle level of the house appears partially excavated into the hillslope along its rear northern side (Photo: 7) with a series of timber retaining walls supporting sloping gardens rising up from this level towards the rear of the block (Photo: 8).

Photo: 7 6 Rear edge of house, middle level

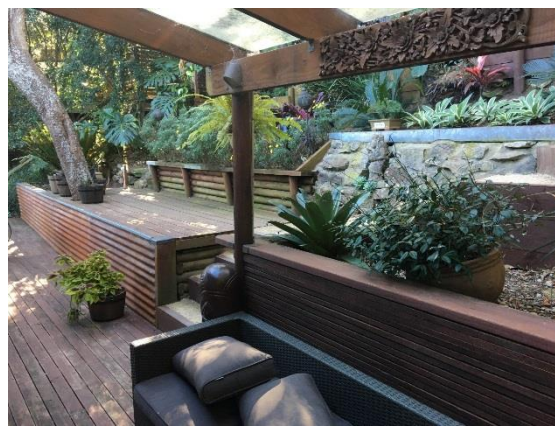
Photo: 8 6 Deck and retaining walls at rear of house

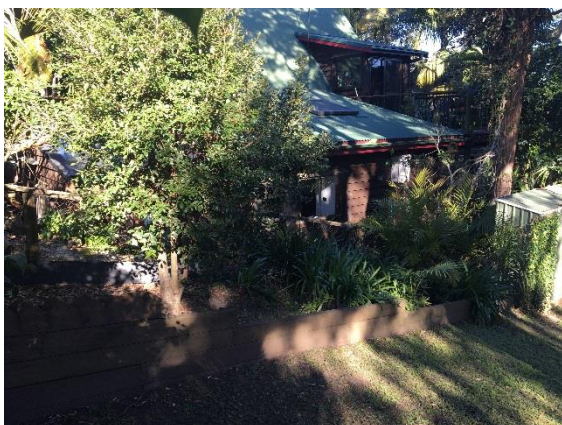
The rear of the site is gently sloping and contains gardens, a deck and low (<1.0m) timber retaining walls with a gently north-west dipping lawn occupying the rear edge with gardens around its perimeters, see Photo: 9 and 10.

Photo: 9 - NE corner of site, looking towards No. 46

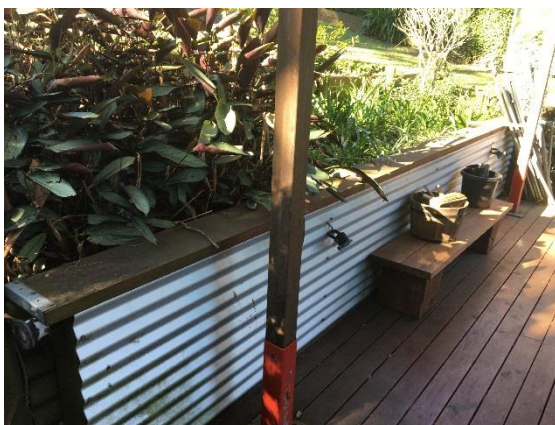
Photo: 10 6 Low timber retaining wall and deck
