## WSA assessment

| Date:<br><b>10/08/2022</b> | Asset owner's job ref.:<br><b>1</b> | Asset Owner:<br><b>Civil Scan</b> | Operator :<br><b>Terry Heron</b> | Section number:<br><b>1</b> | Pipe Asset Id:<br><b>SPI11867</b> |

| Town:<br>Suburb:<br>Street:<br>Asset Location | <b>Dee Why</b><br><b>Bix Road</b><br><b>Private property, industrial site</b> | Catchment:<br>Asset Owner:<br>Precipitation.:<br>Flow control | <b>Civil Scan</b><br><b>No</b><br><b>No measures</b> | US MH:<br>Survey Dir:<br>DS MH:<br>Inspect Length : | <b>SPP13738</b><br><b>downstream</b><br><b>SPP13737</b><br><b>17.29 m</b> |

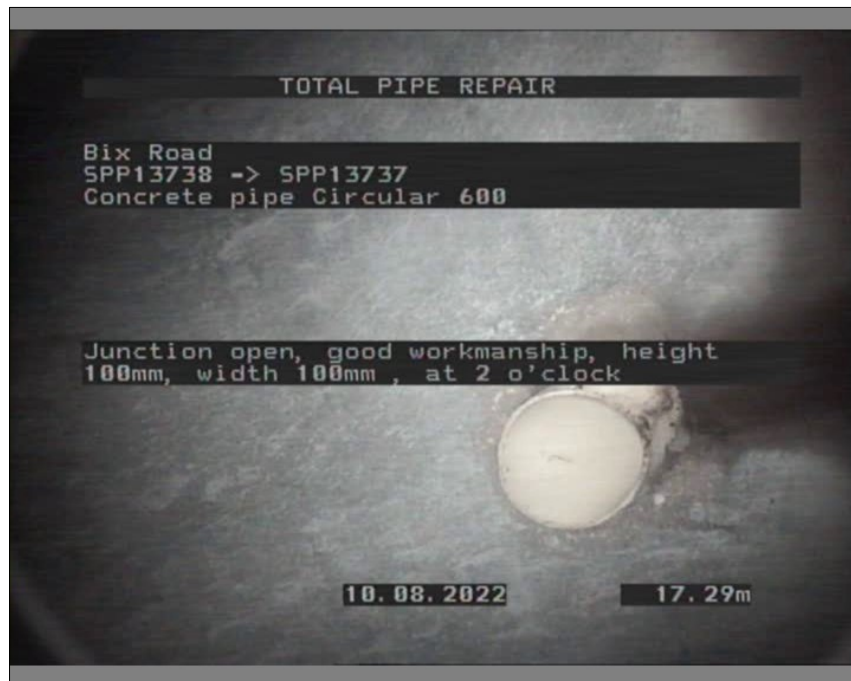
Photo: 122218SPI11867S\_SPARE5\_SPP13737703202114\_D.JPG  
17.29m, Junction open, good workmanship, height 100mm, width 100mm , at 2 o'clock
