**re: DA-STAGE GEOTECHNICAL INVESTIGATION / LANDSLIDE RISK APPRAISAL  
PROPOSED HORSE ARENA DEVELOPMENT, POOL & BUILDING ADDITIONS  
NO.113 [LOT 6 DP749791] ORCHARD STREET WARRIEWOOD NSW**

DA-STAGE GEOTECHNICAL INVESTIGATION / LANDSLIDE RISK APPRAISAL  
PROPOSED HORSE ARENA DEVELOPMENT, POOL & BUILDING ADDITIONS  
NO.113 [LOT 6 DP749791] ORCHARD STREET WARRIEWOOD NSW

report ref: R/18-023.A

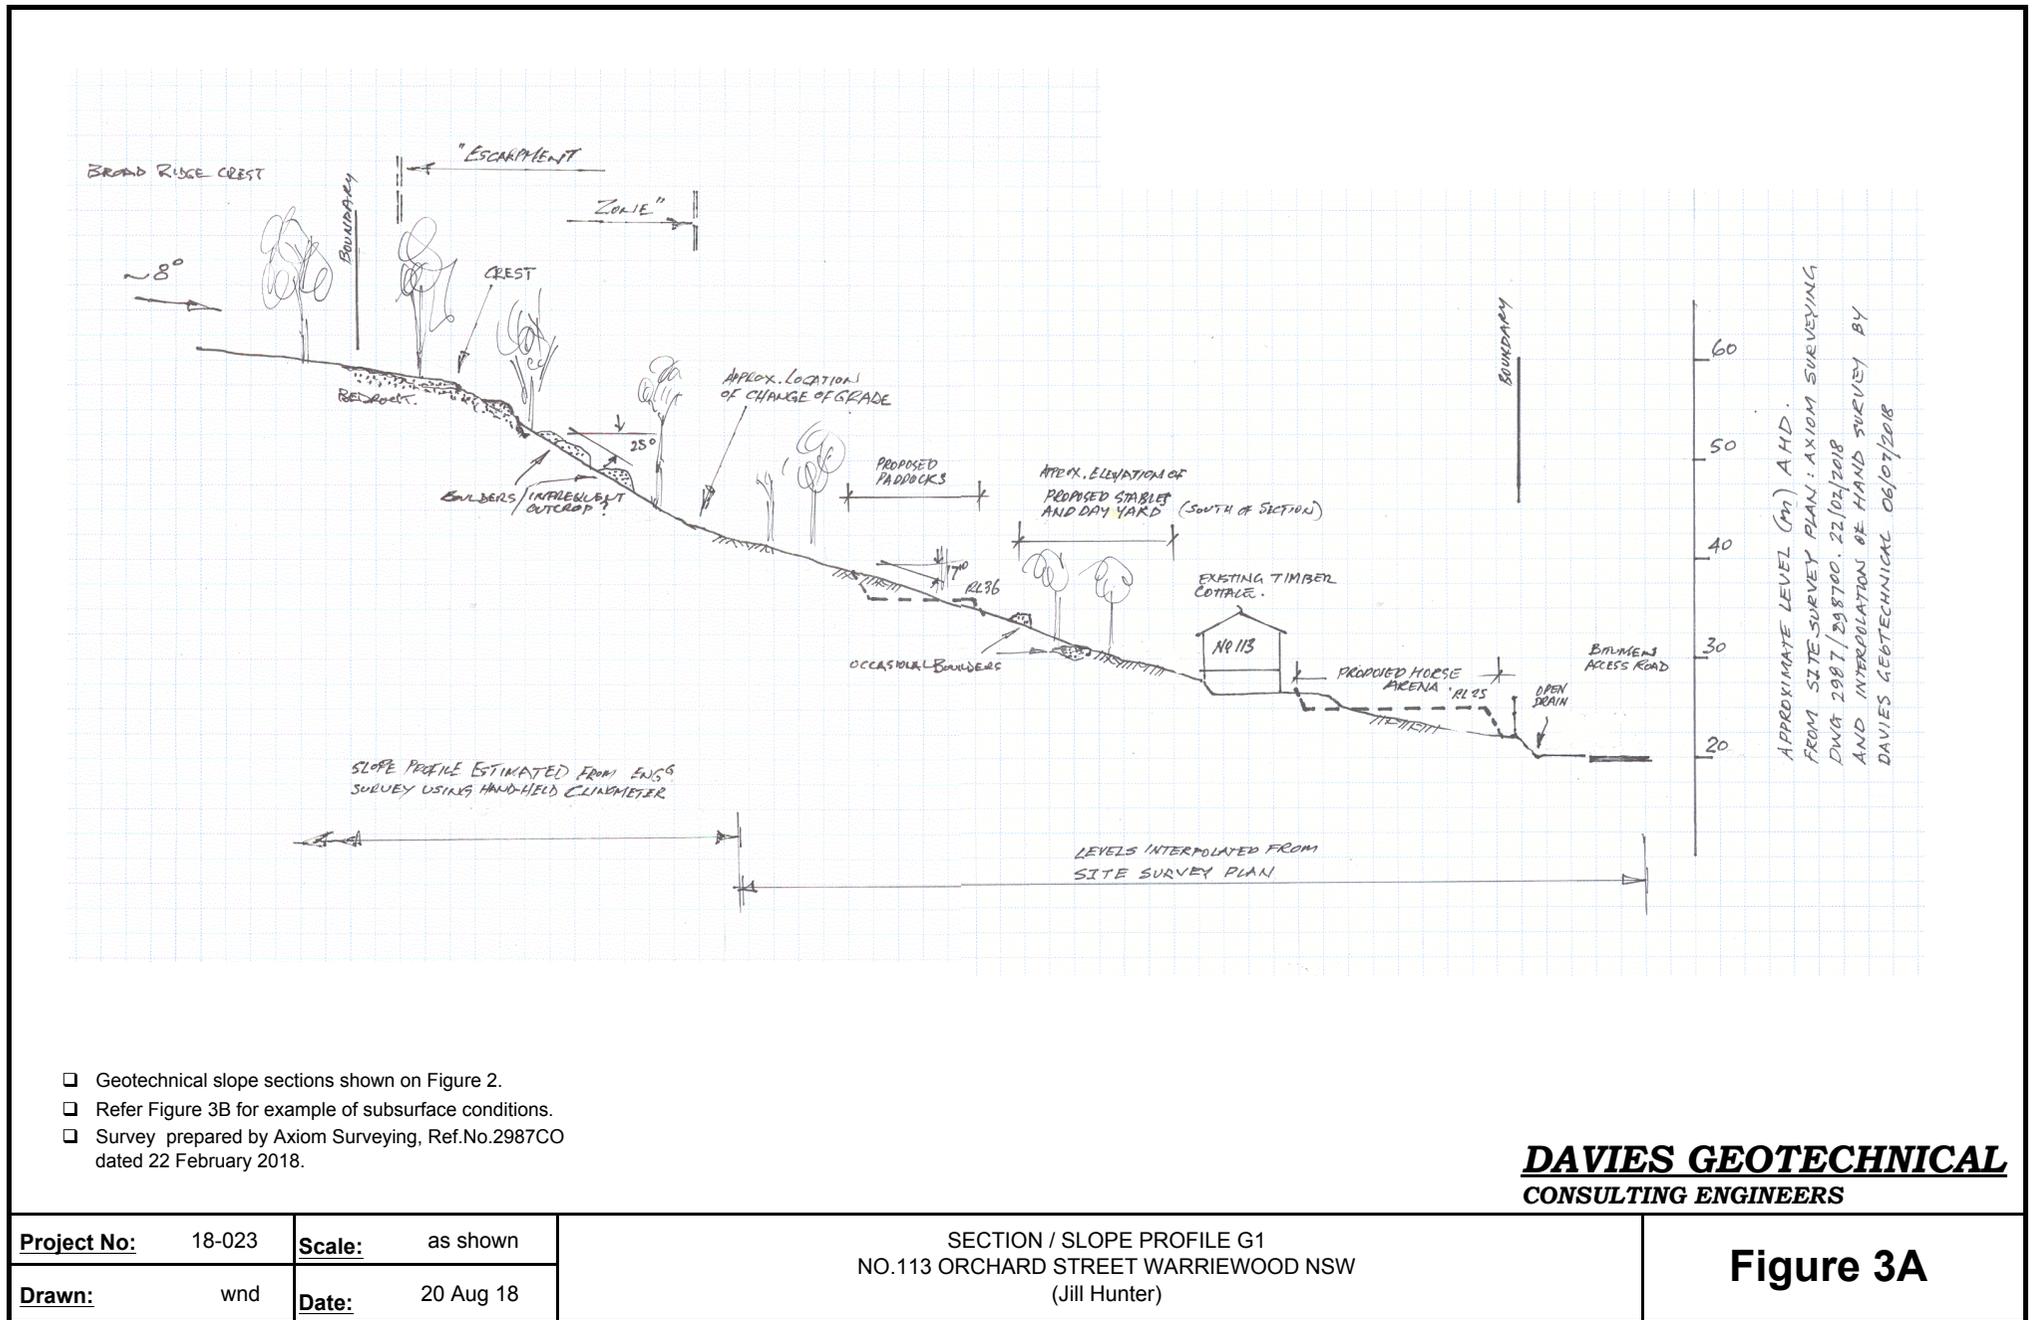
**Figure 3A**

The slope section G1 in Figure 3A and the photographs provided in Figure 3B indicate our interpretation of the geotechnical slope model and the anticipated subsurface conditions at the site, based on the mapped slope features and site geology.

SECTION / SLOPE PROFILE G1  
NO.113 ORCHARD STREET WARRIEWOOD NSW  
(Jill Hunter)

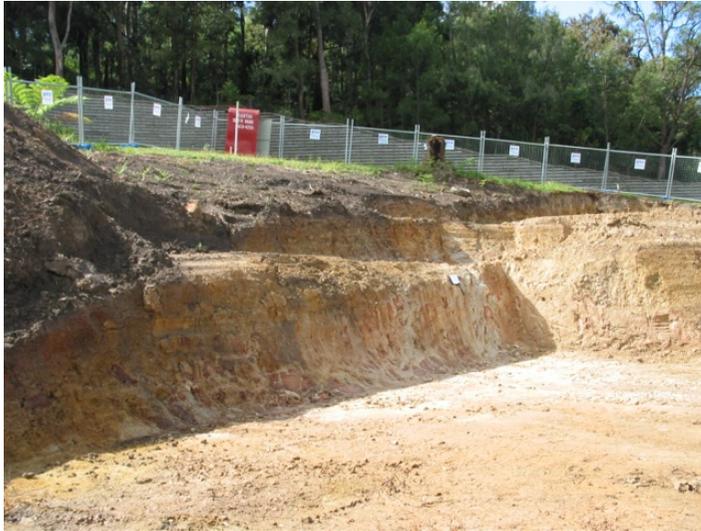
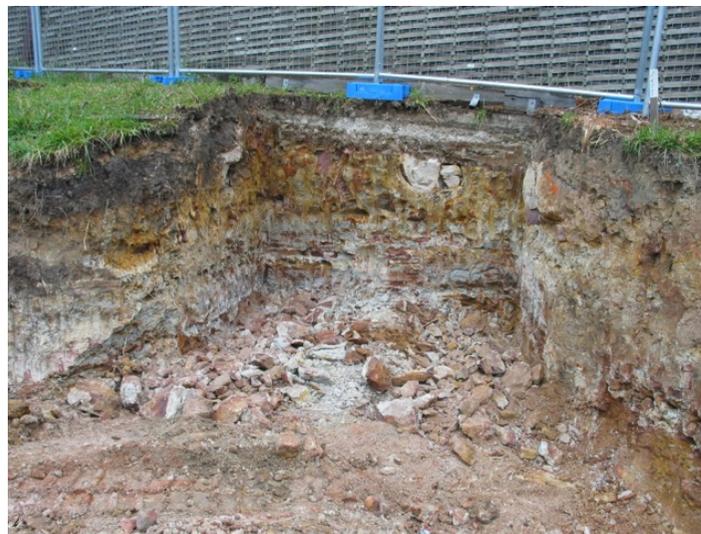
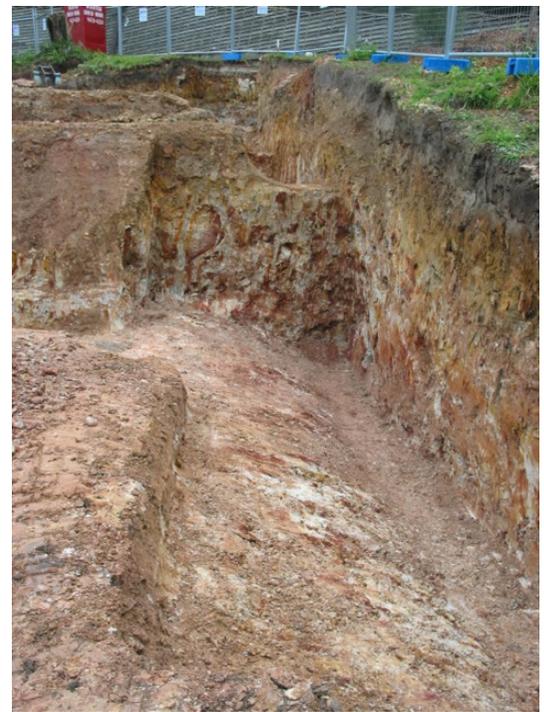
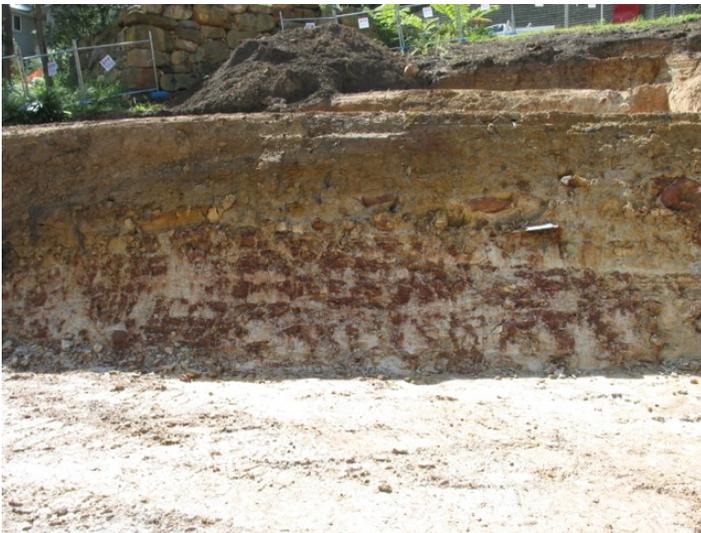
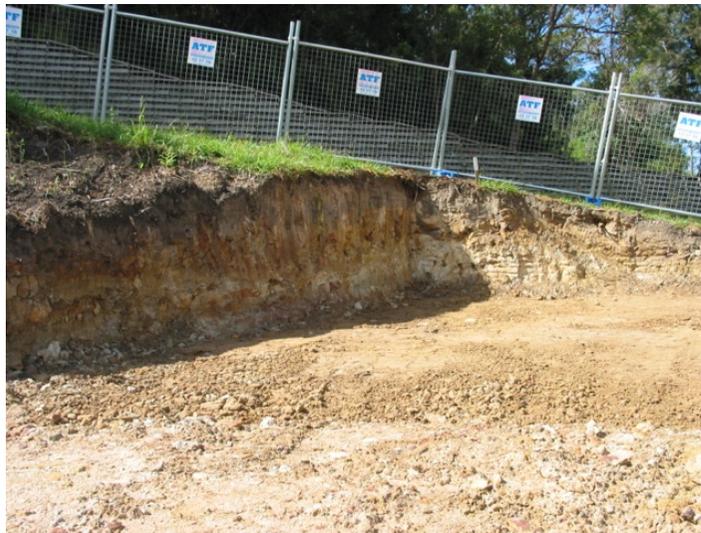
<b>Project No:</b> 18-023	<b>Scale:</b> NTS	ANTICIPATED SUB-SURFACE CONDITIONS NO.113 ORCHARD STREET WARRIEWOOD NSW (Jill Hunter)	<b>Figure 3B</b>
<b>Drawn:</b> wnd	<b>Date:</b> 20 Aug 18

- ❑ Photos by Davies Geotechnical Pty Ltd, Barkala Rd Bayview, April - July 2008.
- ❑ Subsurface conditions for Newport Formation. Sandstone/siltstone/claystone stratigraphy, RL range 22m - 32m AHD.

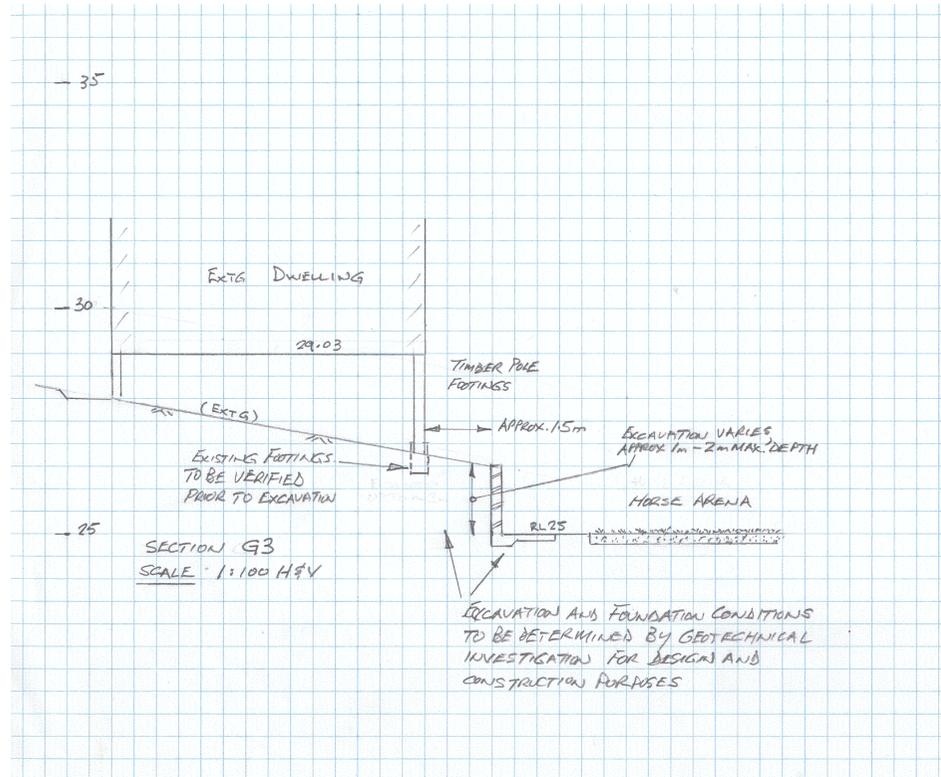
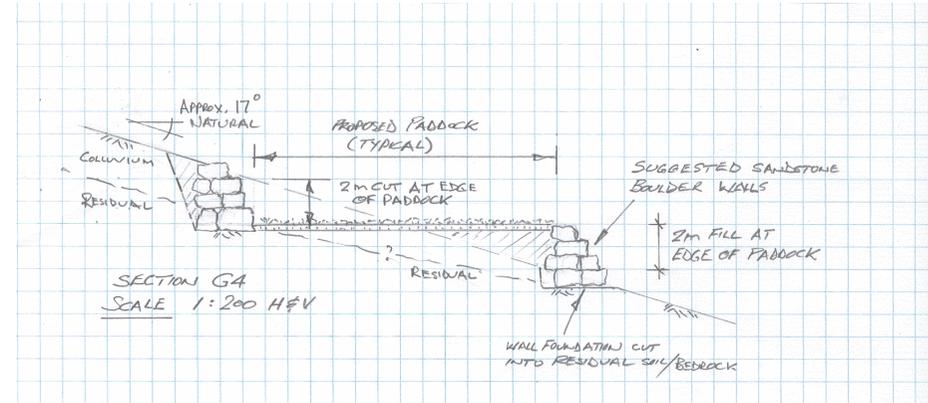
**Figure 4B**

GEOTECHNICAL SECTIONS G3 & G4  
NO.113 ORCHARD STREET WARRIEWOOD NSW  
(Jill Hunter)

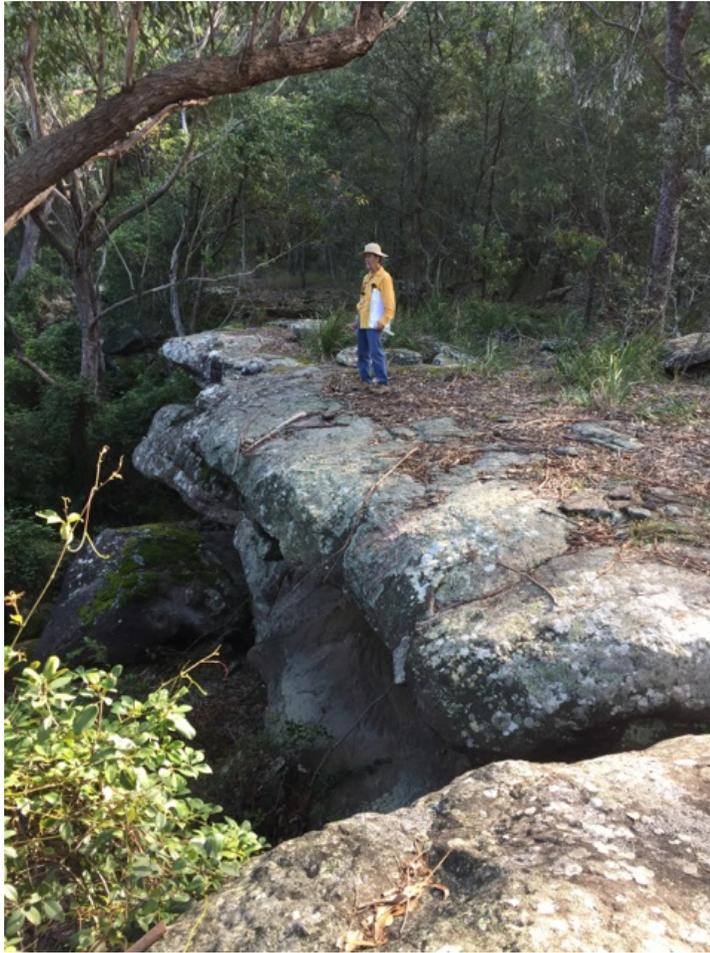
View west along escarpment cliff line from rear boundary of No.113

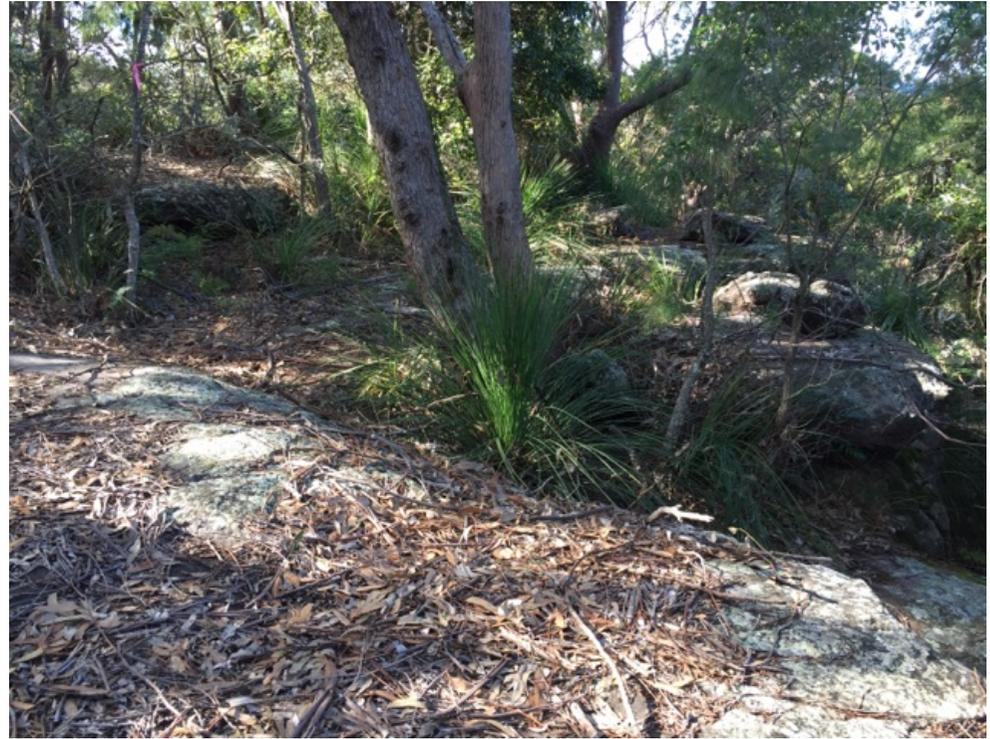
View north along western boundary of No.113, typical of broad ridge crest upslope from escarpment

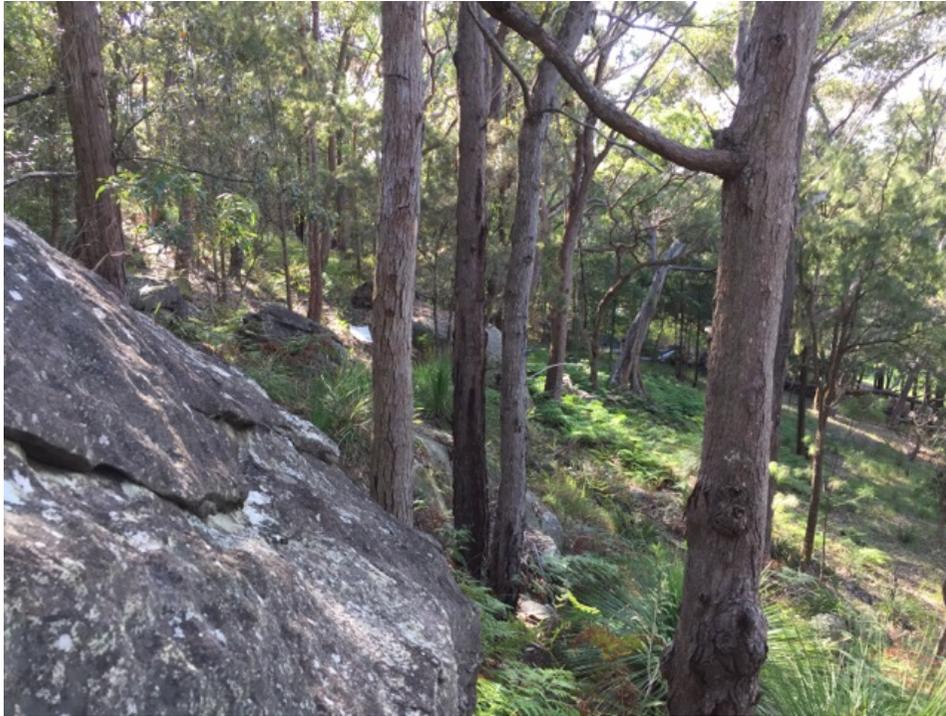
View north along escarpment zone

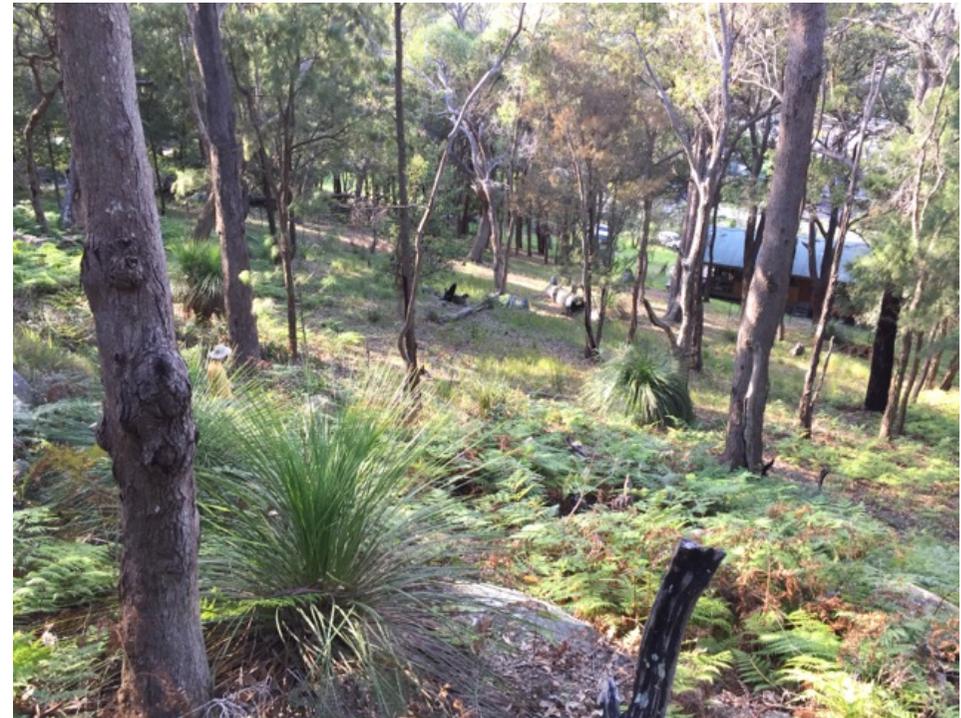
View ENE from escarpment, looking down the 17° hillslope, across paddock site, and towards dwelling

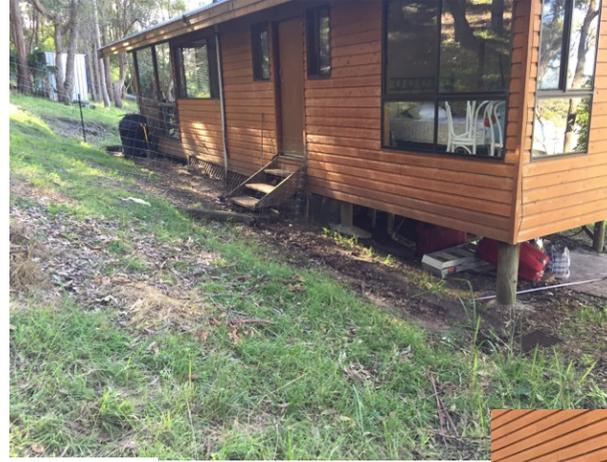
View NE to rear of dwelling.  
Isolated sandstone floater resting on slope surface

Excavated batters must not undercut or de-stabilise the foundation of any boulders or sandstone blocks/"floaters". Where necessary, modify the batter design or support to suit local circumstances.

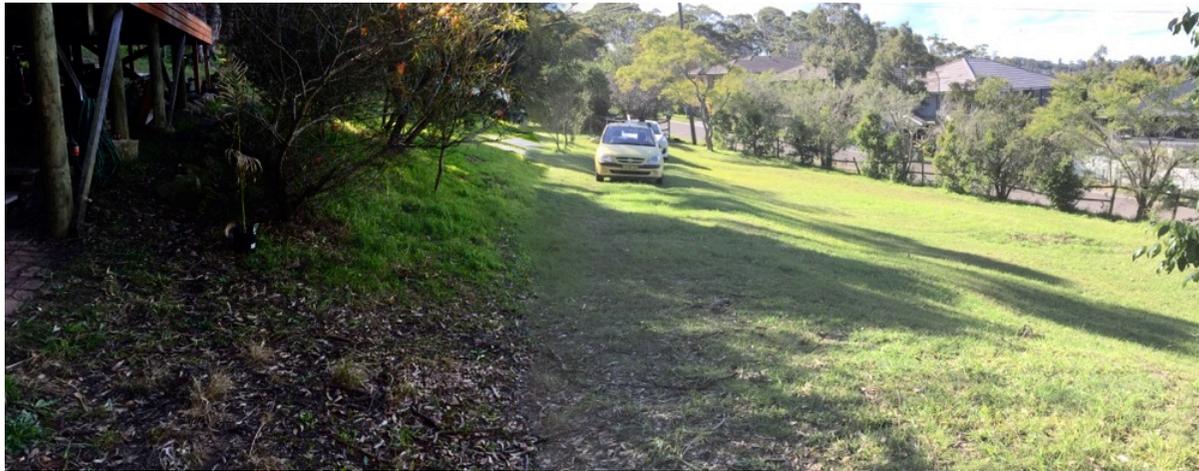
View NNE across front of dwelling and lower footslope area (site of proposed Horse Arena)

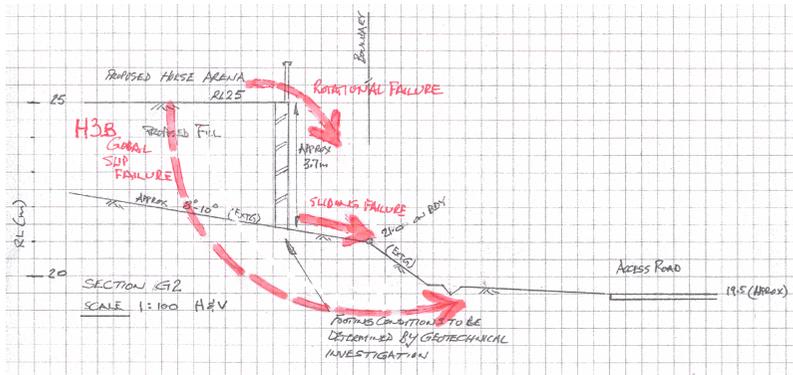
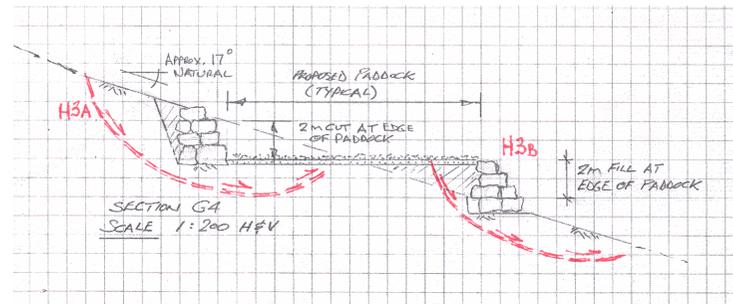
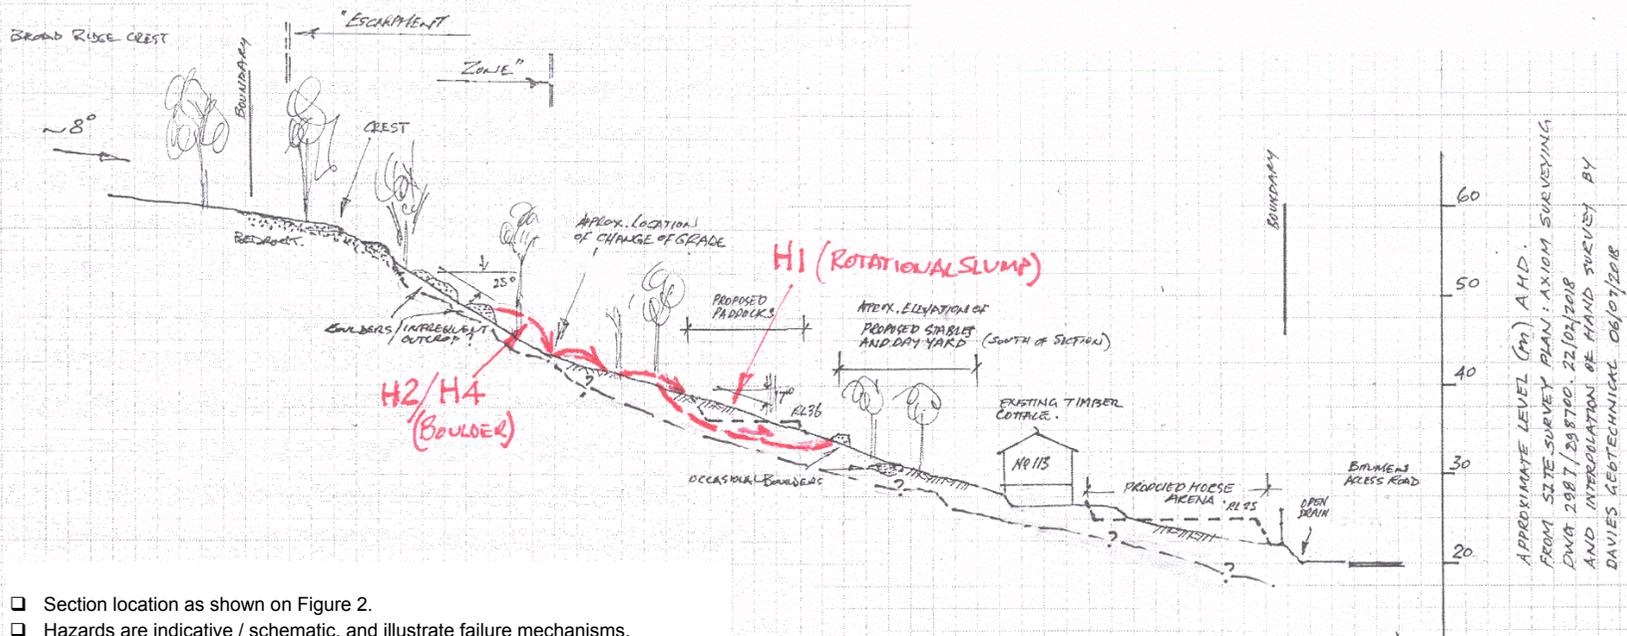
The hazards are described below and are illustrated schematically on Figure A1 below.

Obvious signs of slope instability were not observed at the time of our site mapping, however earth creep or earth slide movement are a potential hazard in this geomorphic environment. The assessed likelihood of failure for smaller to medium scale failures of this type is considered POSSIBLE.

The consequence for property damage from batter failure is assessed to be MINOR to MEDIUM, comprising soil and rock falling onto fencing, yards and stables plus debris clean-up and removal from site.

- Section location as shown on Figure 2.
- Hazards are indicative / schematic, and illustrate failure mechanisms.
- Scales / magnitude of failures may vary according to local slope conditions
- Refer to Appendix A of report for discussion / explanation of failure mechanisms and associated risk issues
