Preliminary Geotechnical Assessment

For Alterations and Additions at

76 Sir Thomas Mitchell Drive, Davidson NSW

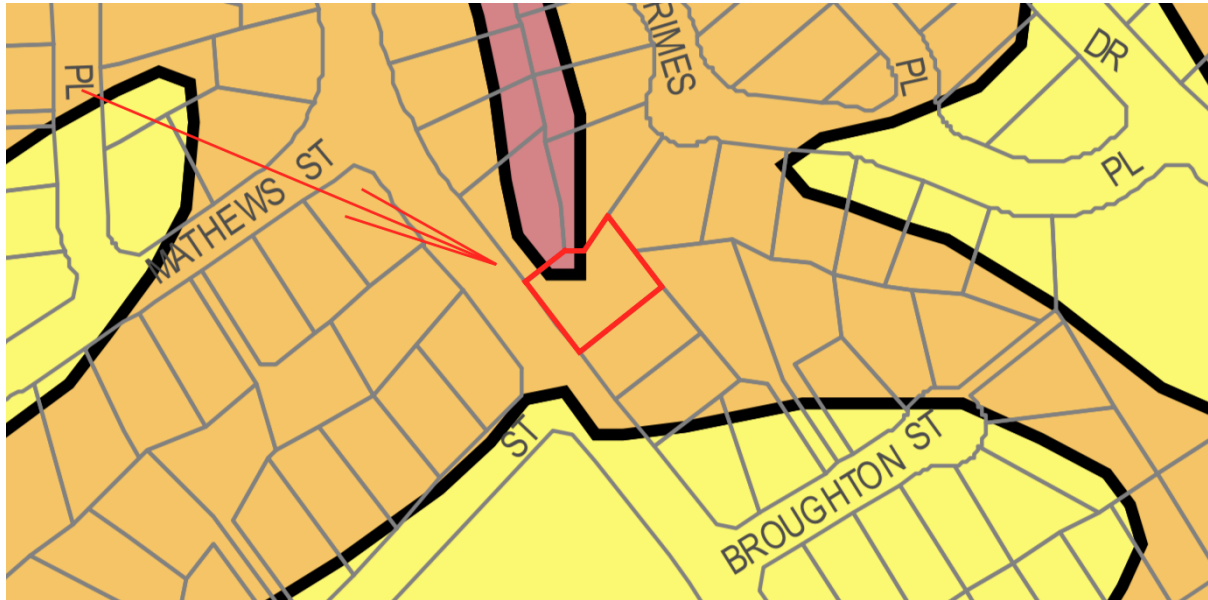
WARRINGAH LANDSLIP RISK MAP

The site is mapped as **Areas B & C** on the Landslip Risk Map LSR_003 (**Image 1**, below).
