## **REPORT ON GEOTECHNICAL INVESTIGATION**

### **PROPOSED SWIMMING POOL**

**47 CUTLER ROAD, CLONTARF**

**Project No.: 2020-235**

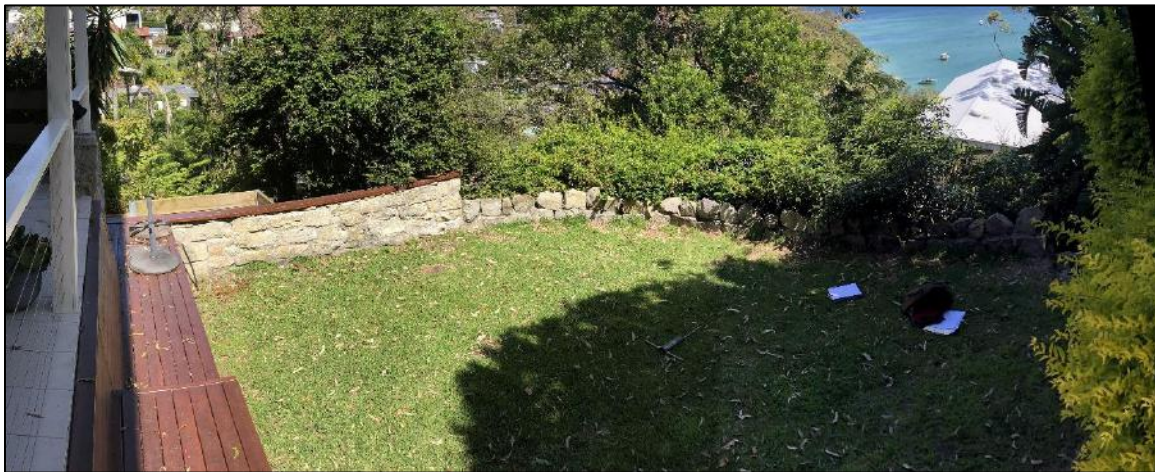
The rear garden is supported by a sandstone block retaining wall which reaches a maximum height of approximately 1.5m. A series of sandstone steps lead down from the west side of the retaining wall to a rockery within the south of the site.

*Photograph 2: View of the rear garden of the property looking broadly south east.*

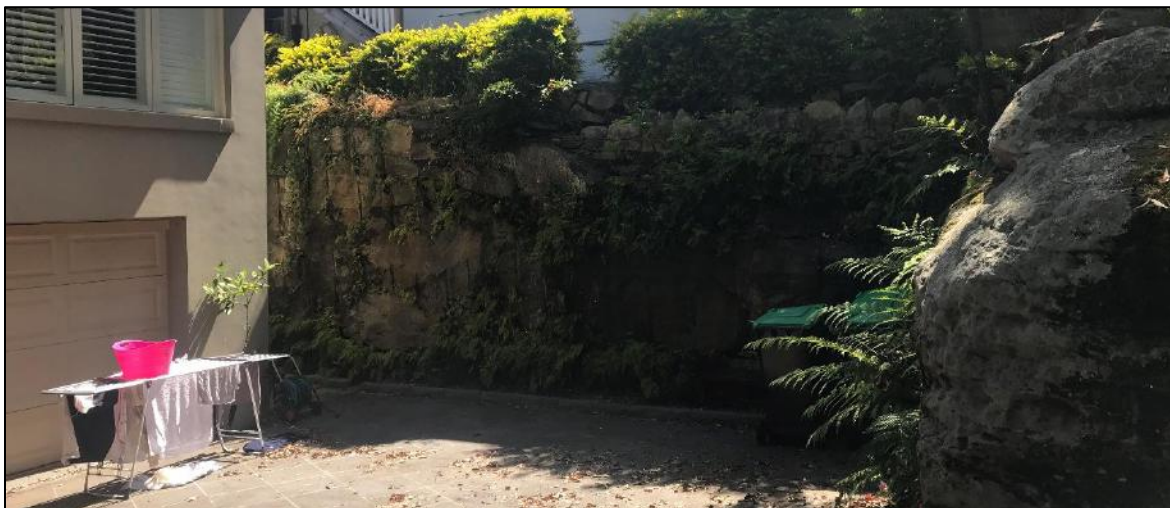
*Photograph 3: View of the front courtyard and cliff line near the western shared boundary*

The front of the site contains a vertical cliff face up to approximately 4.0m above the level of the courtyard and comprises sandstone bedrock of low to medium strength. Within the site, signs of detachment or potential instability were not observed in the cliff exposure. It was noticeable that the upper surface of the cliff contained vertical defects up to approximately 0.3m in depth and areas of the upper surface of the sandstone outcrop appear to have been mortared to maintain stability.

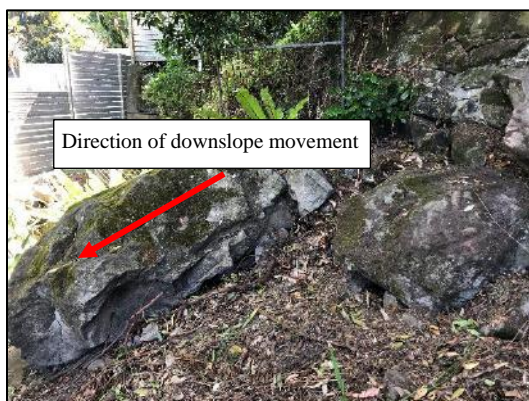
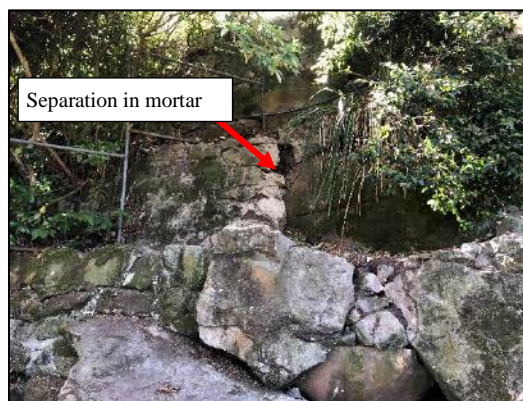
The area immediately adjacent to the south and below the proposed pool within the rear of the property comprised a combination of what is considered to represent detached boulders as well as sections of intact bedrock. However, due to the size of the blocks a clear distinction was difficult to identify based on observations alone.

The area within the south east corner of the site and within the adjacent unformed Weekes Road alignment displayed indications of previous movement including detached sandstone blocks apparently undergoing downslope creep and, likely more recently, evidence of separation of mortar within stabilized blocks. The gradual slope within the area becomes steep to the south and it is considered that the movement likely represents a creep or downslope migration of colluvial soils rather than a stability hazard.

Photograph 4 and 5: View of the rear south of the site looking broadly north east at detached blocks apparently creeping downslope (4) and separation within mortared blocks

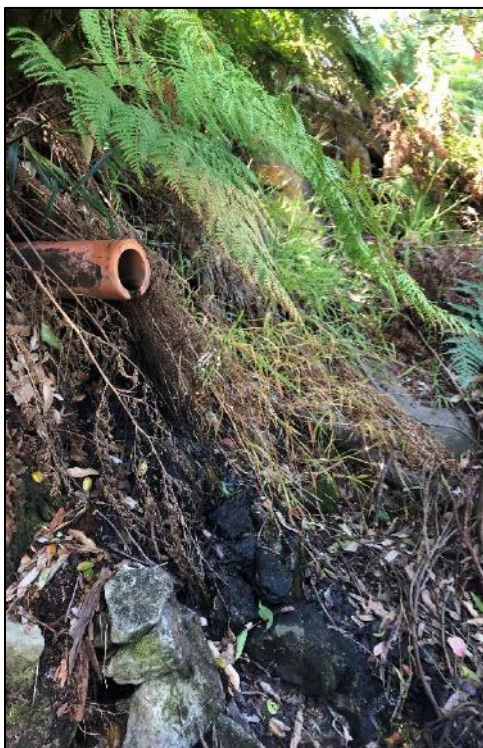
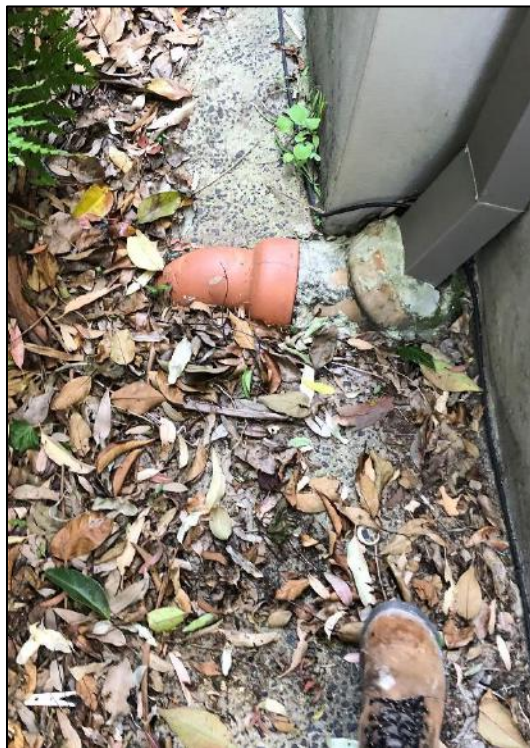
To the south east of the proposed works location a stormwater water pipe was observed discharging onto the slope however indications of erosion or rilling were not apparent immediately below the outlet (see Photograph 6).

*Photograph 6 and 7: View of stormwater pipe discharging onto slope below site (6) and adequate stormwater transfer away from site residence*

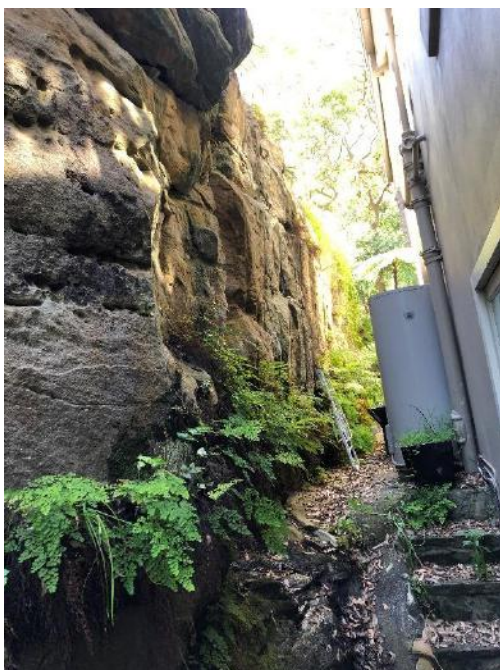
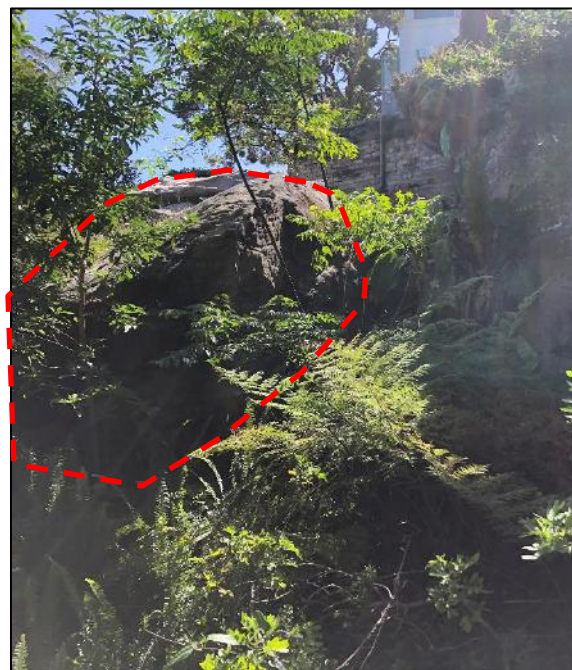
The property structures to the west of the site (No.49 - No.51) are constructed on the top of the cliff line (shown in Photograph 8) and appear in good condition with no unfavourable, continuous defects observed within the cliff to indicate a potential mechanism for instability. There was evidence of relatively large-scale prior instability (likely predevelopment within the area) and at least one large detached block was observed in No.49 to No.51 to the south of the main dwelling as shown in Photograph 9.

*Photograph 8 and 9: View of cliff line near the west boundary of the site and detached boulder in No.49 to No.51*
