Client: Point Polaris			Site Name: Forestway Shopping Centre			Site Address: Corner of Waringah Road and Forest Way, Frenchs Forest NSW 2086						Client No.: P0132		Job No.: 58718-001		
Area / Level	Room & Location	Feature	Item Description	Hazard Type	Sample No.	Sample Status	Friability	Disturb. Potential	Condition	Risk Status	Approx. Quantity	Recommendations & Comments		Control Priority	Reinspect Date	Photo No.
Exterior - roof	West end	Roof covering	Bituminous membrane	Asbestos	Not sampled: would damage integrity	Suspected Negative	-	-	-	-	-	Suspected negative due to age and appearance.		-	-	1
Exterior - roof	North east	Around ductwork through wall	Fibre cement sheeting	Asbestos	58718-001-003	Positive	Non-friable	Low	Fair	Low	4m ²	Maintain in current condition if to remain in-situ. Remove under controlled non-friable asbestos removal conditions prior to refurbishment or demolition works by a Class B (non-friable) licensed asbestos removal contractor.		P4	Aug-23	2

Appendix D: Photographs

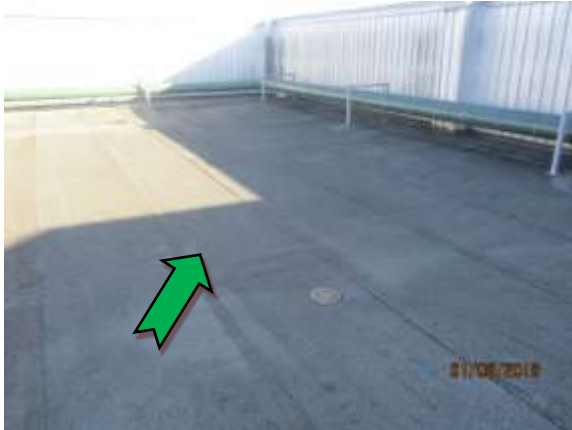
Photo 1. Exterior, western roof, roof covering – suspected non asbestos-containing bituminous membrane.

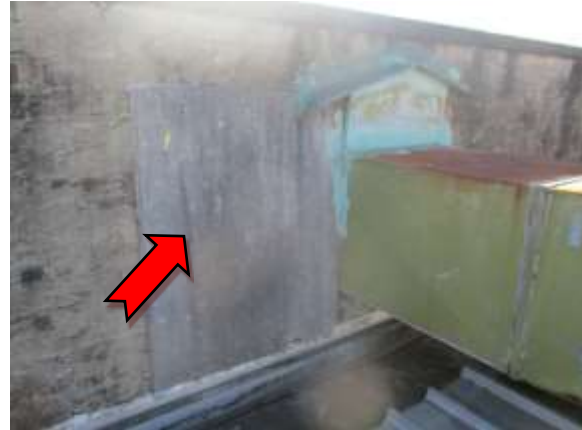
Photo 2. Exterior, north east roof, around ductwork – asbestos-containing fibre cement sheet.

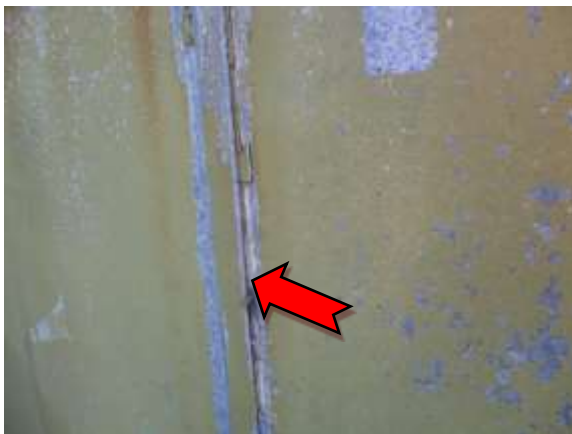
Exterior - roof	Throughout	Ductwork	Mastic sealant	Asbestos	58718-001-002	Positive	Non-friable	Low	Good	Low	100m	Label as containing asbestos and maintain in current condition if to remain in-situ. Remove under controlled non-friable asbestos removal conditions prior to refurbishment or demolition works by a Class B (non-friable) licensed asbestos removal contractor.		P4	Aug-23	3
Exterior - roof	Throughout	Ductwork - reheat units	Millboard insulation	Asbestos	Not sampled: inaccessible	Suspected Positive	Friable	Low	Unknown	Medium	6 units	Confirm status, label as containing asbestos and maintain in current condition if to remain in-situ. Remove under controlled friable asbestos removal conditions prior to refurbishment or demolition works by a Class A (friable) licensed asbestos removal contractor.		P3	Aug-23	4
Exterior, roof hut 1	Adjacent doorway	Infill panel	Fibre cement sheeting	Asbestos	58718-001-004	Positive	Non-friable	Low	Good	Low	1m ²	Maintain in current condition if to remain in-situ. Remove under controlled non-friable asbestos removal conditions prior to refurbishment or demolition works by a Class B (non-friable) licensed asbestos removal contractor.		P4	Aug-23	5

Photo 3. Exterior, roof, throughout ductwork – asbestos-containing mastic sealant.

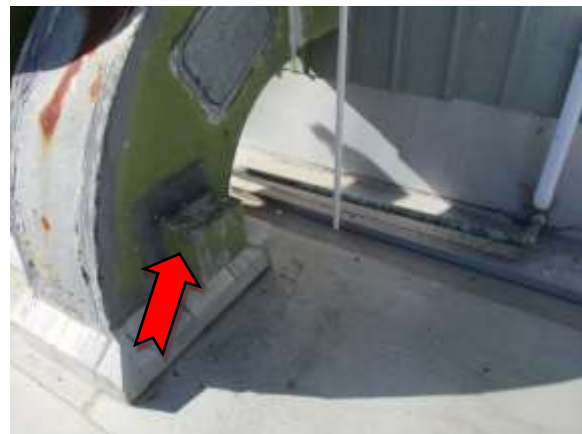
Photo 4. Exterior, roof, throughout ductwork reheat units – suspected asbestos-containing millboard insulation.

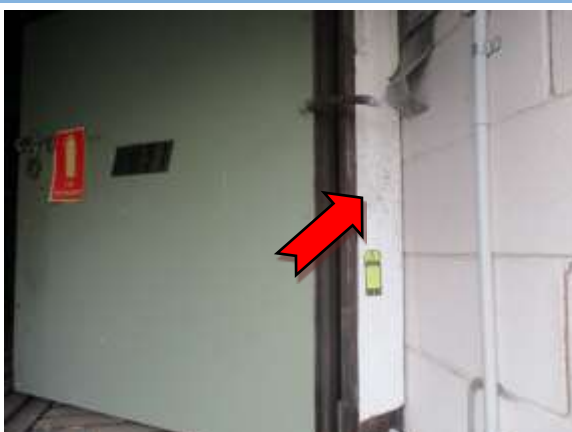
Photo 5. Exterior, roof hut 1, adjacent doorway, infill panel – asbestos-containing fibre cement sheeting.

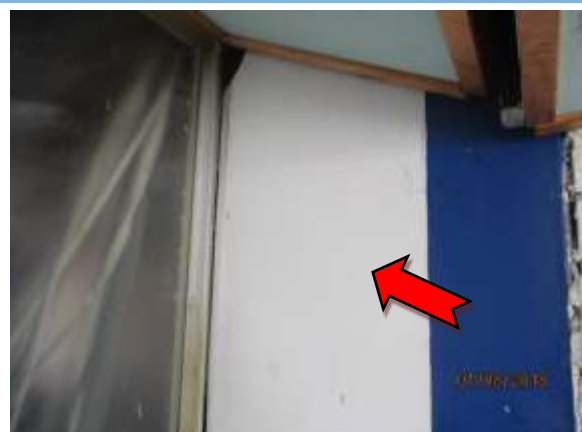
Exterior, roof hut 1	North	Awning and eaves	Fibre cement sheeting	Asbestos	58718-001-005	Positive	Non-friable	Low	Fair	Low	10m ²	Maintain in current condition if to remain in-situ. Remove under controlled non-friable asbestos removal conditions prior to refurbishment or demolition works by a Class B (non-friable) licensed asbestos removal contractor.		P4	Aug-23	6
Exterior / Interior	Roof space above shopping mall	Window frames	Window caulking	Asbestos	58718-001-016	Negative - treat as positive	Non-friable	Low	Fair	Low	3000m	Note that Greencap's previous report indicated the presence of positive window mastic. Prensa's sampling produced negative results. A mixture of positive asbestos-containing and negative non-asbestos-containing caulking / mastic may be present. Prensa recommends all is treated as asbestos continuing until such time as a more comprehensive sampling strategy is commissioned.		P4	Aug-23	7

Photo 6. Exterior, roof hut 1, north, awning and eaves – asbestos-containing fibre cement sheeting.

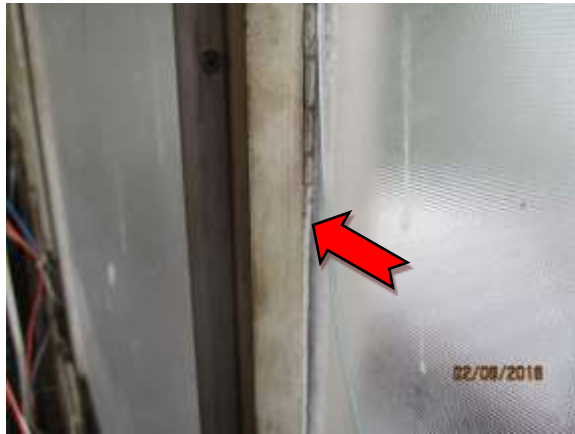
Exterior / Interior	Roof space above shopping mall	Window frames	Window caulking	Asbestos	58718-001-017	Negative - treat as positive	Non-friable	Low	Fair	Low	3000m	Note that Greencap's previous report indicated the presence of positive window mastic. Prensa's sampling produced negative results. A mixture of positive asbestos-containing and negative non-asbestos-containing caulking / mastic may be present. Prensa recommends all is treated as asbestos continuing until such time as a more comprehensive sampling strategy is commissioned.		P4	Aug-23	7
Exterior / Interior	Roof space above shopping mall	Window frames	Window caulking	Asbestos	58718-001-018	Negative - treat as positive	Non-friable	Low	Fair	Low	3000m	Note that Greencap's previous report indicated the presence of positive window mastic. Prensa's sampling produced negative results. A mixture of positive asbestos-containing and negative non-asbestos-containing caulking / mastic may be present. Prensa recommends all is treated as asbestos continuing until such time as a more comprehensive sampling strategy is commissioned.		P4	Aug-23	7

Photo 7. Exterior/interior, roof space above shopping mall, window frames – non asbestos-containing window caulking treat as asbestos-containing.

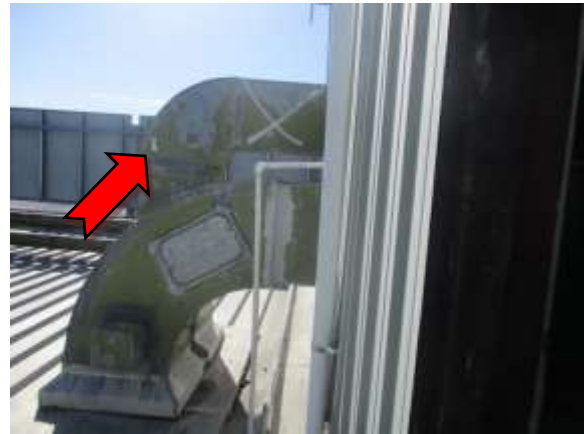
Exterior, roof	Adjacent huts	Original ductwork	Mastic sealant	Asbestos	Not sampled: inaccessible	Suspected Positive	Non-friable	Low	Good	Low	100m	Confirm status, label as containing asbestos and maintain in current condition if to remain in-situ. Remove under controlled non-friable asbestos removal conditions prior to refurbishment or demolition works by a Class B (non-friable) licensed asbestos removal contractor.		P4	Aug-23	8
Exterior, ground level	Adjacent Shop 12, above substation entry	Infill panel	Fibre cement sheeting	Asbestos	53175-001-016	Positive	Non-friable	Low	Good	Low	5m ²	Label as containing asbestos and maintain in current condition if to remain in-situ. Remove under controlled non-friable asbestos removal conditions prior to refurbishment or demolition works by a Class B (non-friable) licensed asbestos removal contractor.		P4	Aug-23	9
Exterior	Throughout walls	Expansion joints	Mastic sealant	Asbestos	Refer to: 58718-001-008	Suspected Positive	Non-friable	Low	Good	Low	100m	Maintain in current condition if to remain in-situ. Remove under controlled non-friable asbestos removal conditions prior to refurbishment or demolition works by a Class B (non-friable) licensed asbestos removal contractor.		P4	Aug-23	-

Photo 8. Exterior, roof, adjacent huts, original ductwork – suspected asbestos-containing mastic sealant.

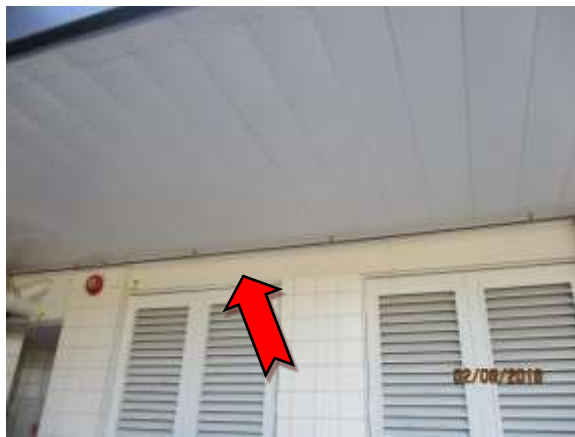
Photo 9. Exterior, ground level, adjacent shop 12, above substation entry, infill panel – asbestos-containing fibre cement sheeting.

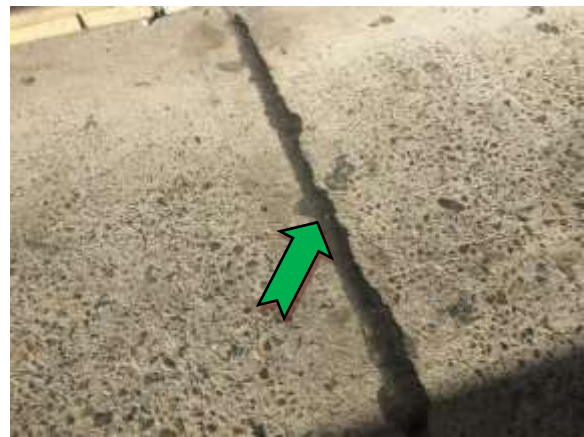
Photo 10. Exterior, throughout floor, expansion joints – non asbestos-containing mastic sealant.

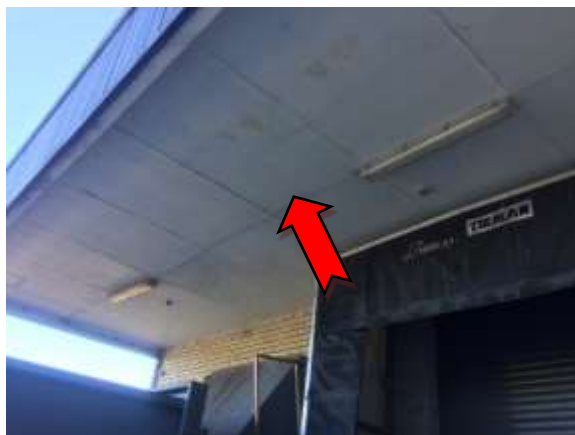
Exterior	Throughout floor	Expansion joints	Mastic sealant	Asbestos	58718-002-002	Negative	-	-	-	-	-	-		-	-	10
Exterior	Shop 33 loading dock	Awning	Fibre cement sheeting	Asbestos	58718-002-003	Positive	Non-friable	Low	Good	Low	30m ²	Label as containing asbestos and maintain in current condition if to remain in-situ. Remove under controlled non-friable asbestos removal conditions prior to refurbishment or demolition works by a Class B (non-friable) licensed asbestos removal contractor.		P4	Aug-23	11

Photo 11. Exterior, shop 33 loading docks, awning – asbestos-containing fibre cement sheeting.

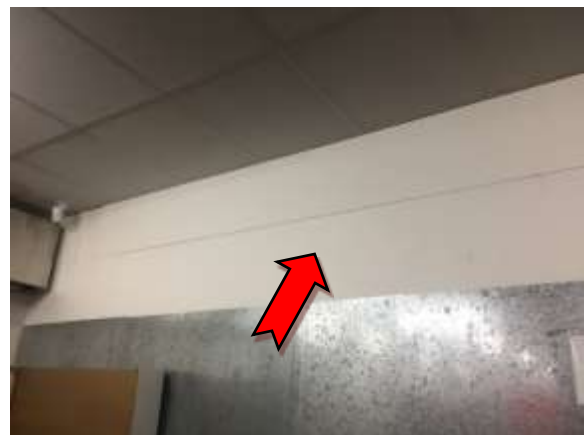
Photo 12. Exterior, shop 33 loading dock, infill panel – non asbestos-containing infill panel.

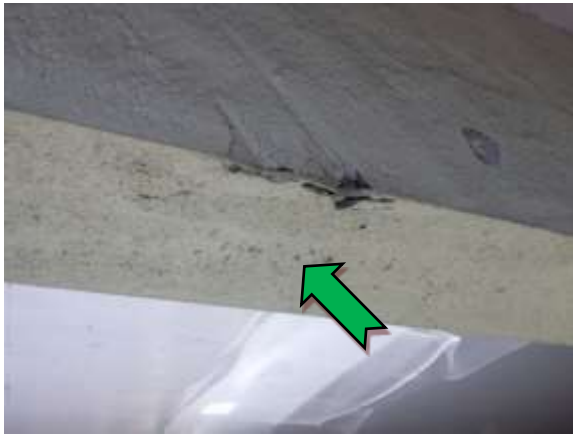
Photo 13. Exterior, car park, beams – non asbestos-containing textured coating.

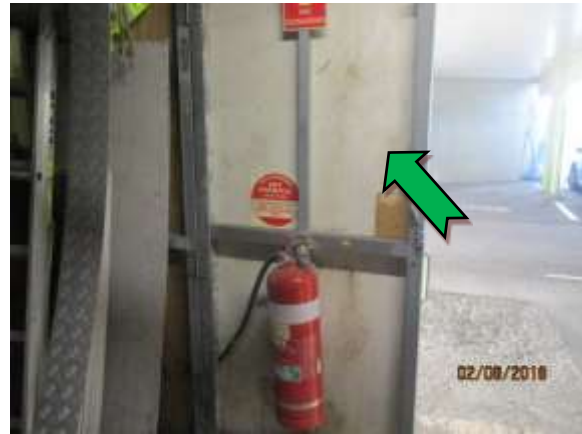
Photo 14. Exterior, maintenance room beneath ramp, door panels – non asbestos-containing fibre cement sheeting.

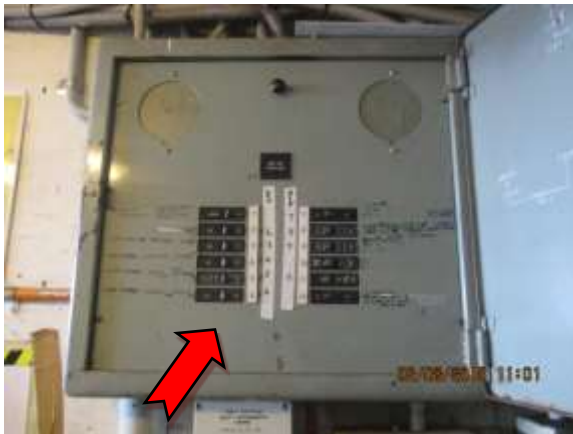
Photo 15. Exterior, car park scrubber machine room, electrical backing board – suspected asbestos-containing bituminous backing board.

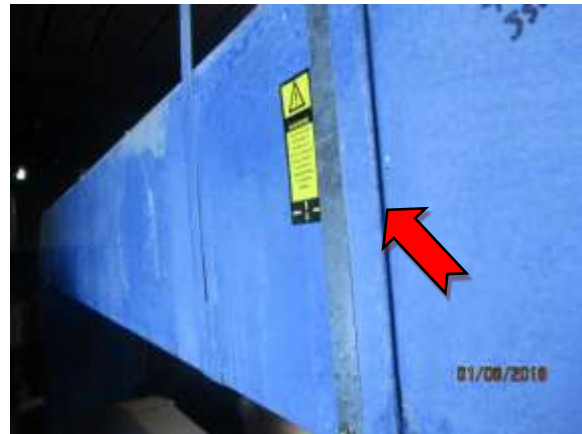
Photo 16. Roof huts 1 to 6, throughout, original ductwork – suspected asbestos-containing mastic sealant.

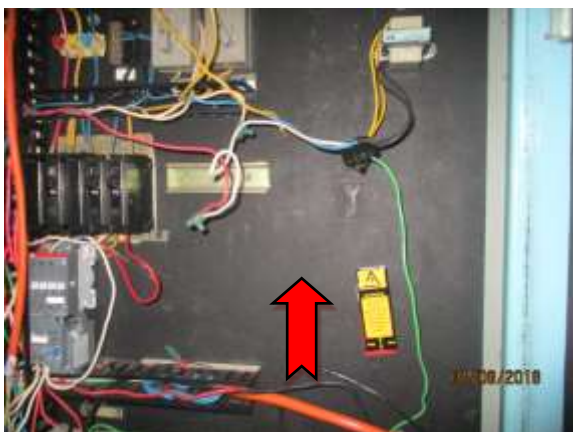
Photo 17. Roof hut 1 to 6, throughout, electrical backing board – suspected asbestos-containing bituminous backing board.

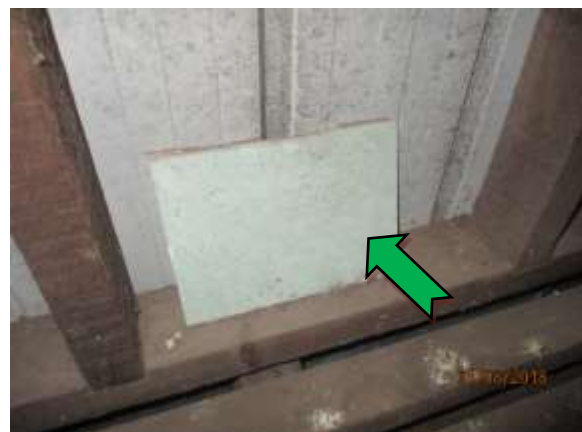
Photo 18. Roof hut 2, adjacent doorway, redundant – non asbestos-containing fibre cement sheet.

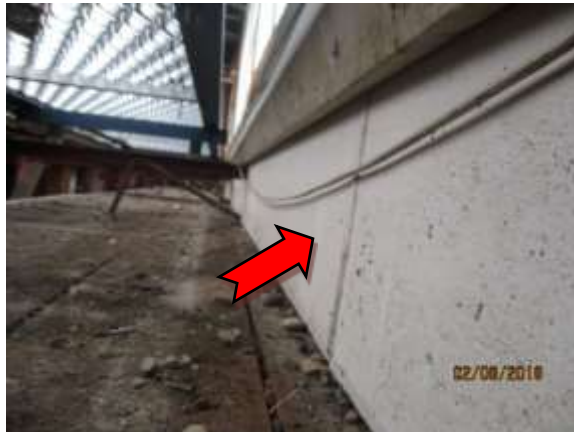
Photo 19. Roof level, roof space above shopping mall, beneath window, infill panels – asbestos-containing fibre cement sheeting.

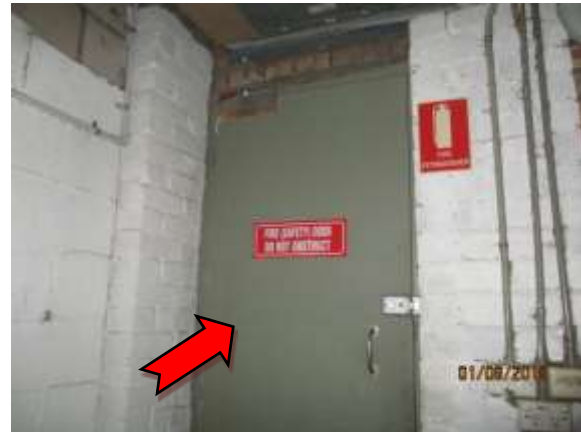
Photo 20. Level 1, plant room 1, south east, single fire door – suspected-asbestos containing insulation.

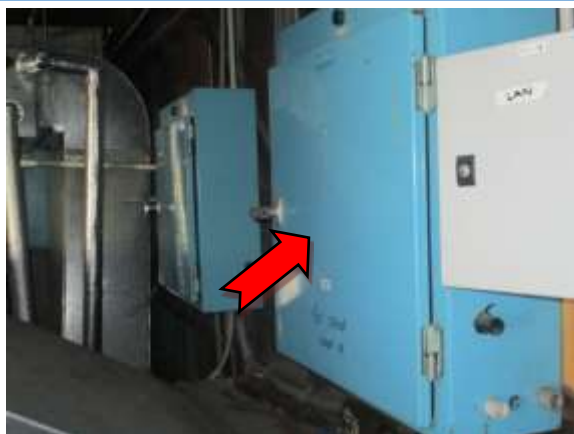
Photo 21. Level 1, south-west, electrical backing board – suspected asbestos-containing bituminous backing board.

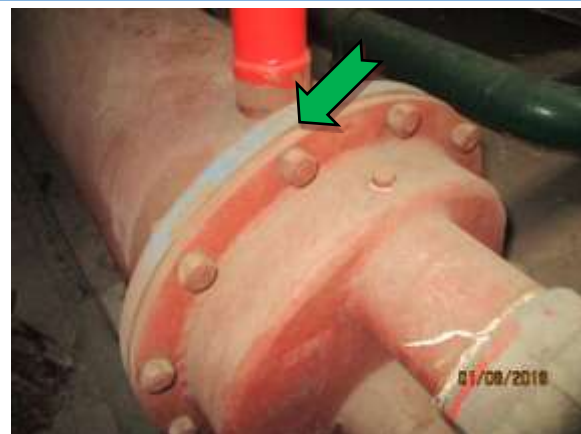
Photo 22. Level 1, plant room 1, red vessel – non asbestos-containing gasket material.

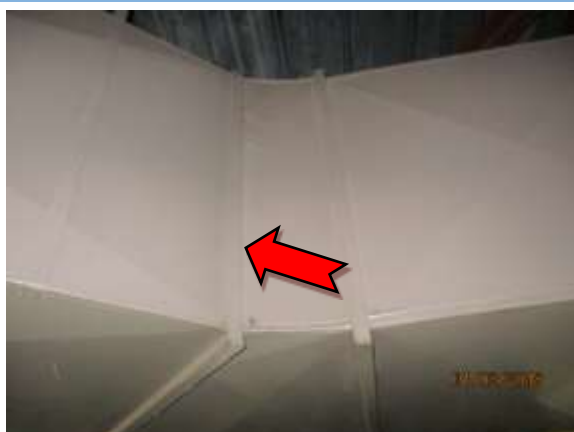
Level 1	Plant room 1	To red vessel	Gasket material	Asbestos	58718-001-006	Negative	-	-	-	-	-	-	-	-	22
Level 1	Plant room 1	Ductwork	Mastic sealant	Asbestos	58718-001-007	Positive	Non-friable	Low	Good	Low	40m	Label as containing asbestos and maintain in current condition if to remain in-situ. Remove under controlled non-friable asbestos removal conditions prior to refurbishment or demolition works by a Class B (non-friable) licensed asbestos removal contractor.	P4	Aug-23	23

Photo 23. Level 1, plant room 1, ductwork – asbestos-containing mastic sealant.

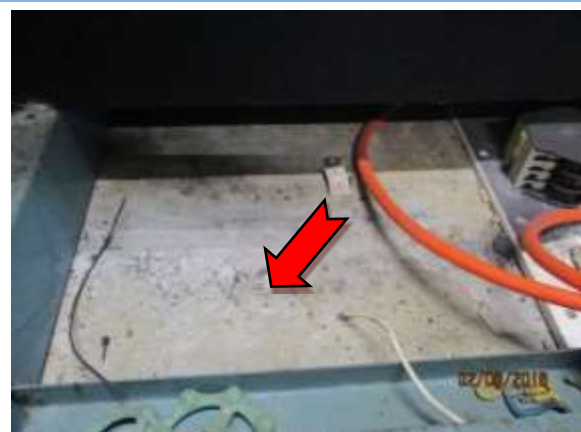
Photo 24. Level 1, plant room 2, within electrical a/c switchboard – asbestos-containing debris.

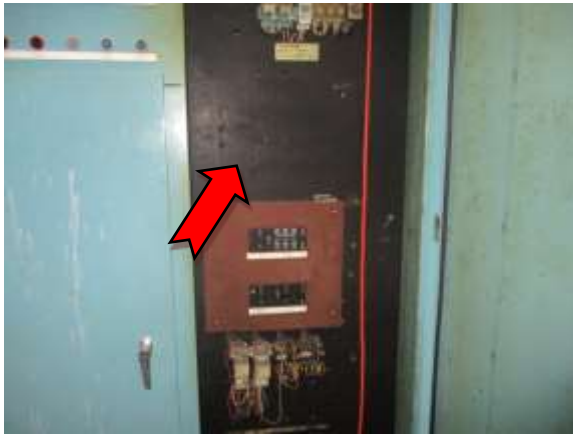
Photo 25. Level 1, plant room 2, electrical backing board – suspected asbestos-containing bituminous backing board.

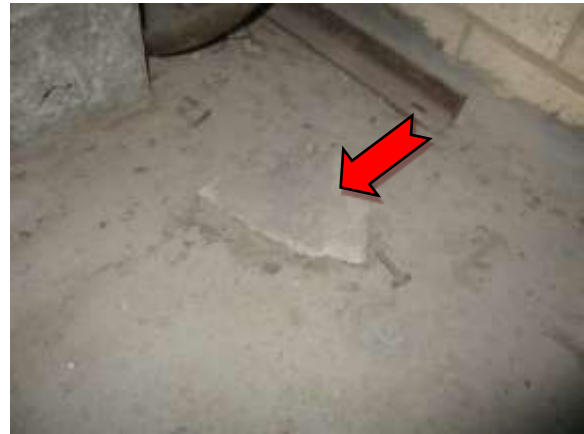
Photo 26. Level 1, plant room 2, north-east on ground – asbestos-containing fibre cement sheeting.

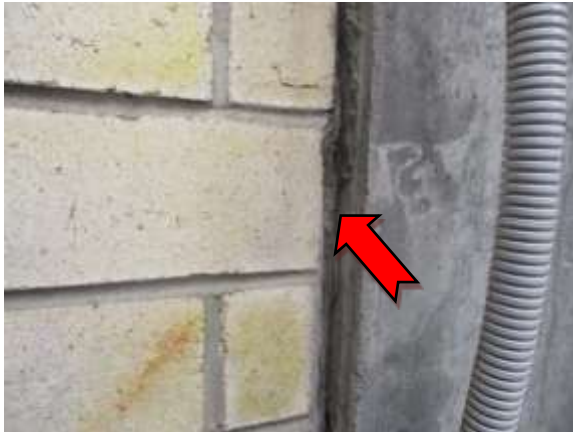
Level 1	Plant room 3 (Woolworths)	Walls	Mastic sealant	Asbestos	58718-001-008	Positive	Non-friable	Low	Fair	Low	10m	Encapsulate exposed sections, label as containing asbestos and maintain in a good condition if to remain in-situ. Remove under controlled non-friable asbestos removal conditions prior to refurbishment or demolition works by a Class B (non-friable) licensed asbestos removal contractor.	P4	Aug-23	27
Level 1	Shop 1 (Woolworths), back of house	Floor	Vinyl floor tiles	Asbestos	58718-001-009A	Negative	-	-	-	-	-	-	-	-	28
Level 1	Shop 1 (Woolworths), back of house	Floor	Adhesive	Asbestos	58718-001-009B	Negative	-	-	-	-	-	-	-	-	-
Level 1	Shop 1 (Woolworths), back of house	Floor	Screed	Asbestos	58718-001-009C	Negative	-	-	-	-	-	-	-	-	-
Level 1	Corridor, throughout	Floor	Vinyl floor tiles	Asbestos	58718-002-001	Positive	Non-friable	Low	Fair	Low	50m ²	Label as containing asbestos and maintain in current condition if to remain in-situ. Remove under controlled non-friable asbestos removal conditions prior to refurbishment or demolition works by a Class B (non-friable) licensed asbestos removal contractor.	P4	Aug-23	29

Photo 27. Level 1, plant room 3 (Woolworths), walls – asbestos-containing mastic sealant.

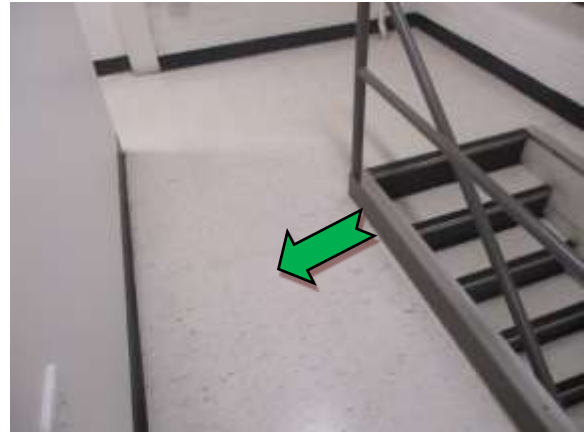
Photo 28. Level 1, shop 1 (Woolworths), back of house, floor – non asbestos-containing vinyl floor tiles.

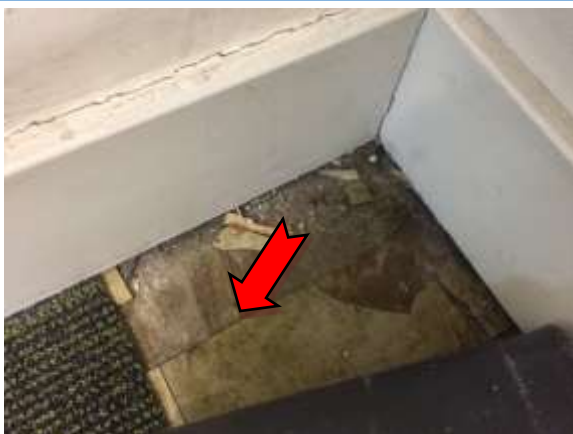
Photo 29. Level 1, corridor throughout, floor – asbestos-containing vinyl floor tiles

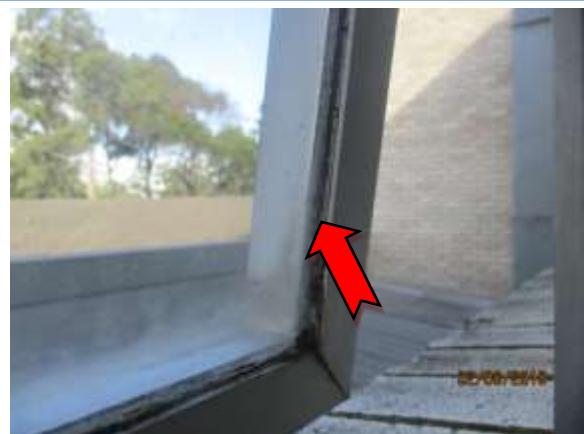
Level 1	Commercial suites, throughout	Window frames	Window caulking	Asbestos	58718-001-019	Negative - treat as positive	Non-friable	Low	Fair	Low	3000m	Note that Greencap's previous report indicated the presence of positive window mastic. Prensa's sampling produced negative results. A mixture of positive asbestos-containing and negative non-asbestos-containing caulking / mastic may be present. Prensa recommends all is treated as asbestos continuing until such time as a more comprehensive sampling strategy is commissioned.	P4	Aug-23	-
Level 1	Male w.c. - cleaners cupboard	Wall - dividing	Fibre cement sheeting	Asbestos	53175-001-012	Positive	Non-friable	Low	Fair	Low	2m ²	Label as containing asbestos and maintain in current condition if to remain in-situ. Remove under controlled non-friable asbestos removal conditions prior to refurbishment or demolition works by a Class B (non-friable) licensed asbestos removal contractor.	P4	Aug-23	31

Photo 30. Level 1, commercial suites, throughout, window frames – non asbestos-containing window caulking. Treat as asbestos-containing

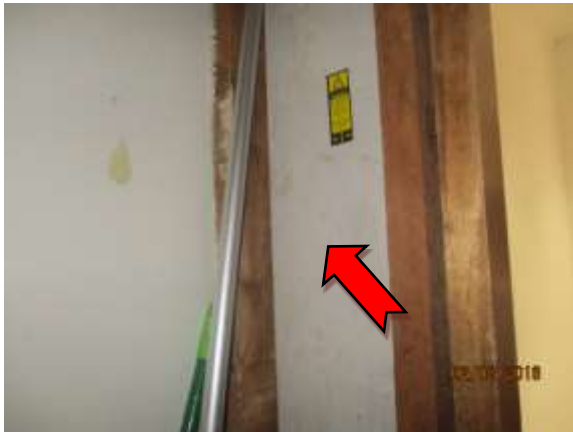
Photo 31. Level 1, male w.c., cleaner's cupboard, wall divide – asbestos-containing fibre cement sheeting.

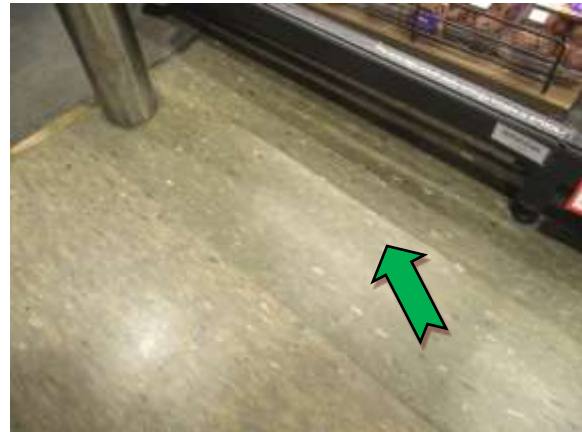
Photo 32. Ground level, shop 1 (Woolworths) sales floor, floor – non asbestos-containing green vinyl floor tiles.

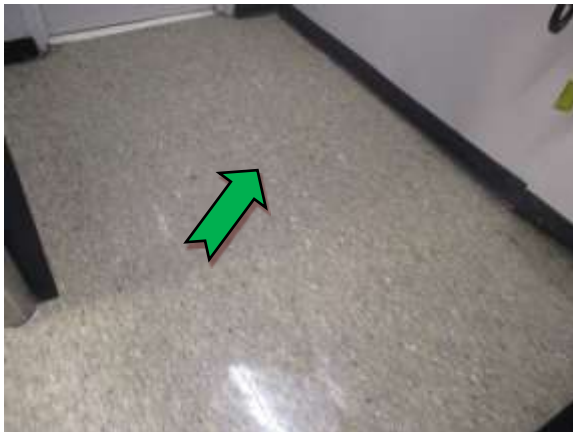
Photo 33. Ground level, shop 1 (Woolworths) sales floor, floor – non asbestos-containing brown/green vinyl floor tiles.

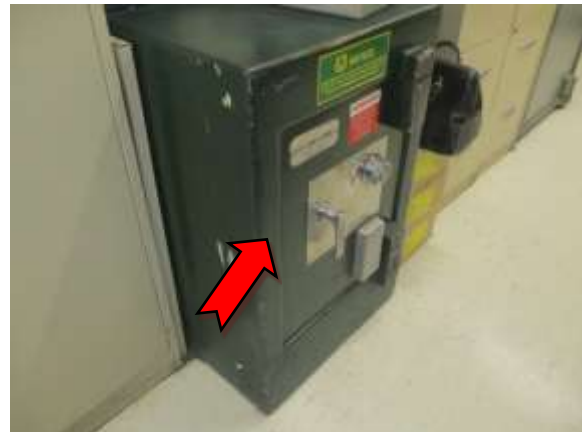
Photo 34. Ground level, shop 1 (Woolworths) cash office, safe – suspected asbestos-containing internal insulation.

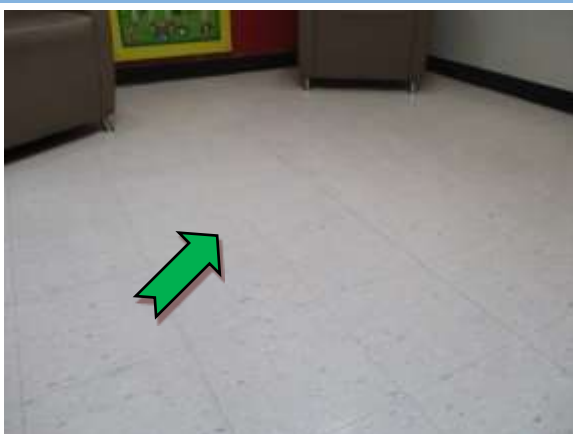
Photo 35. Ground level, baby change, floor – non asbestos-containing vinyl floor tiles.

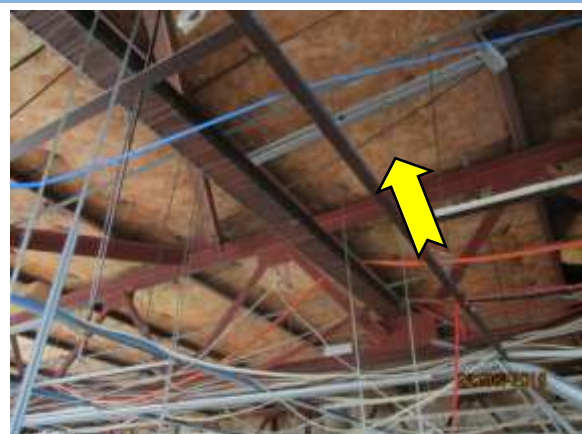
Photo 36. Roof level, roof space above shopping mall, roof – suspected SMF-containing insulation batts.

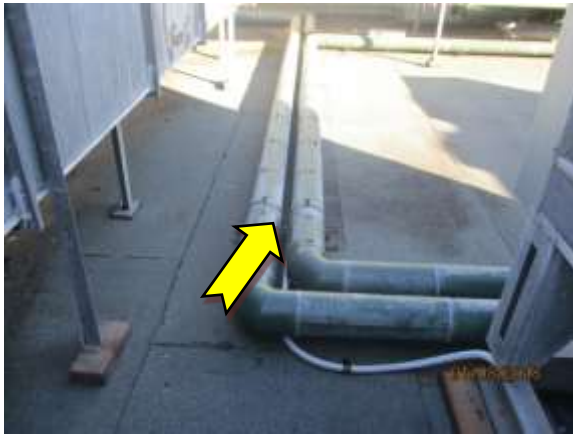
Photo 37. Roof, throughout, pipe – suspected SMF-containing insulation.

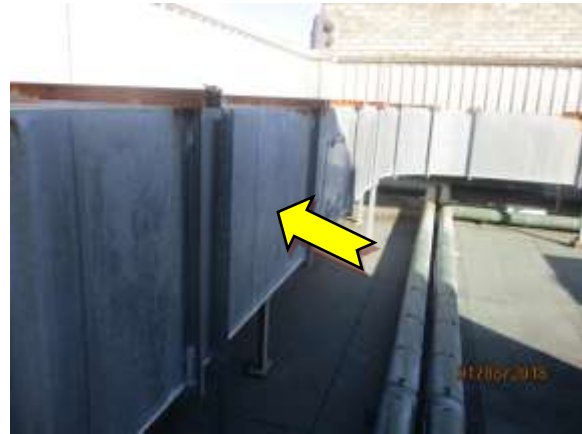
Photo 38. Roof, throughout, duct – suspected SMF-containing insulation.

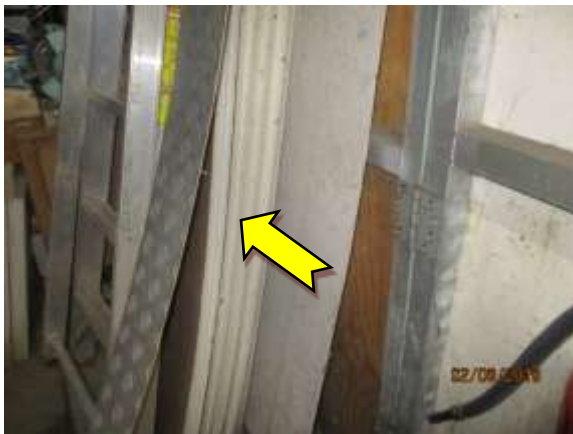
Photo 39. Exterior, maintenance room beneath ramp, adjacent door – suspected SMF-containing compressed ceiling tiles.

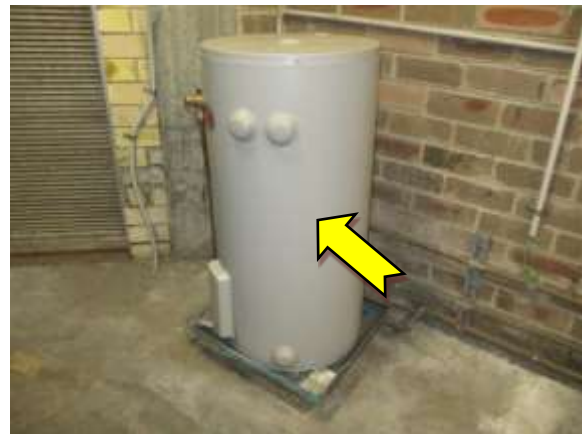
Photo 40. Level 1, plant room 3 (Woolworths), hot water heater – suspected SMF-containing insulation.

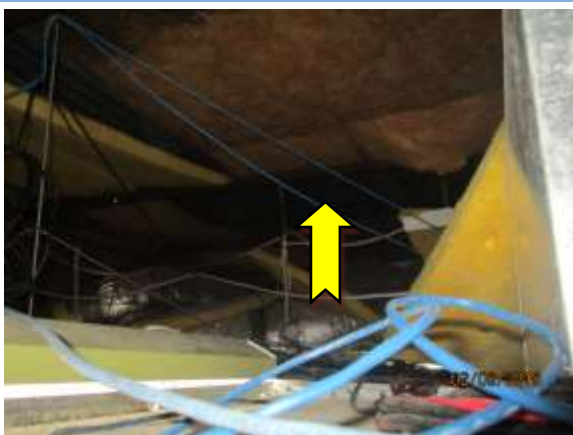
Photo 41. Level 1, throughout underside of roof – suspected SMF-containing sarking insulation.

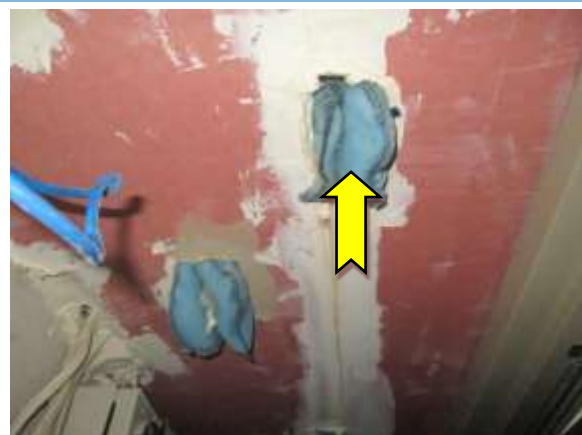
Photo 42. Ground level, corridor to suite 11, penetrations – suspected SMF-containing pillow insulation.

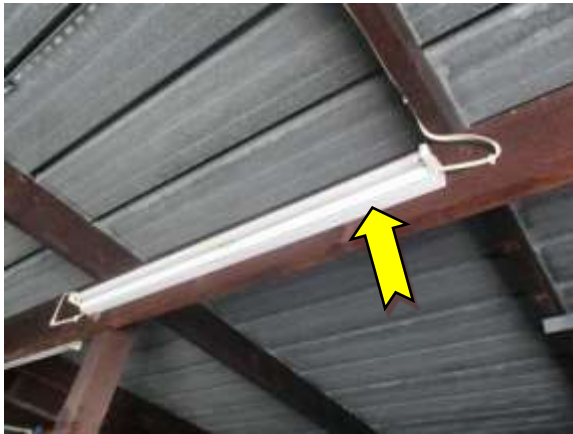
Photo 43. Roof huts, throughout, fluorescent light fitting-single tube – suspected non PCB-containing capacitor.

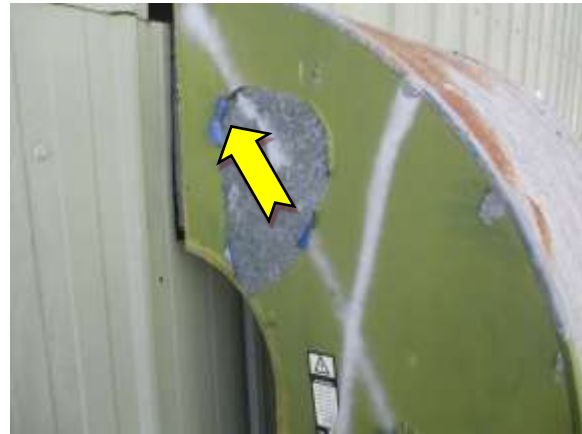
Photo 44. Roof level, west roof section, duct – lead-containing green upper, blue lower coloured paint system.

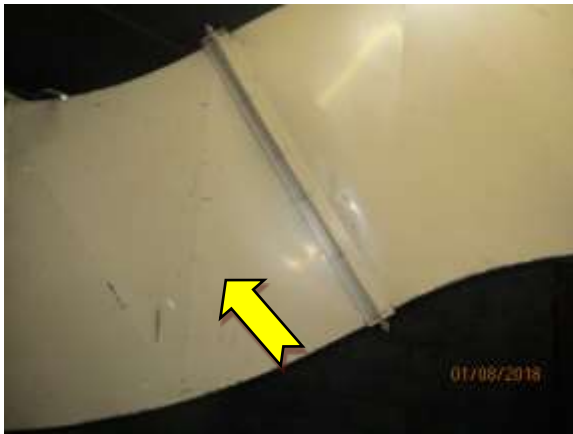
Photo 45. Level 1, plant room 1, plant and equipment – lead-containing beige upper coloured paint system.

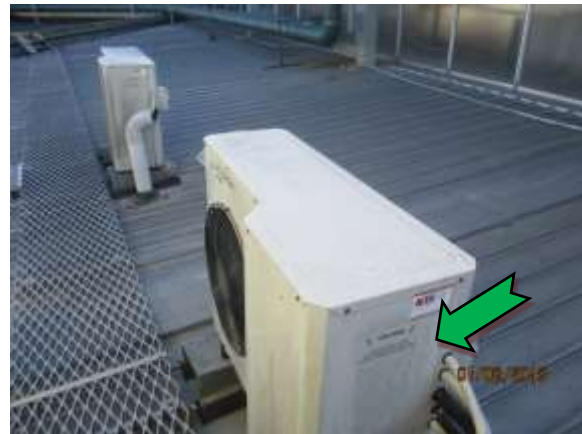
Photo 46. Roof, throughout, air conditioning unit – non ODS-containing air conditioning unit.

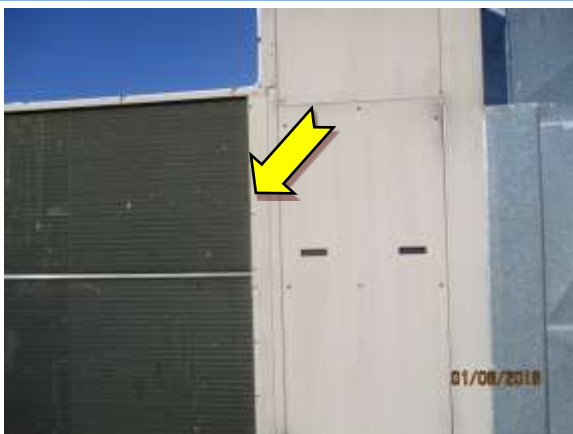
Photo 47. Roof, west end, chiller – suspected ODS-containing unknown refrigerant.

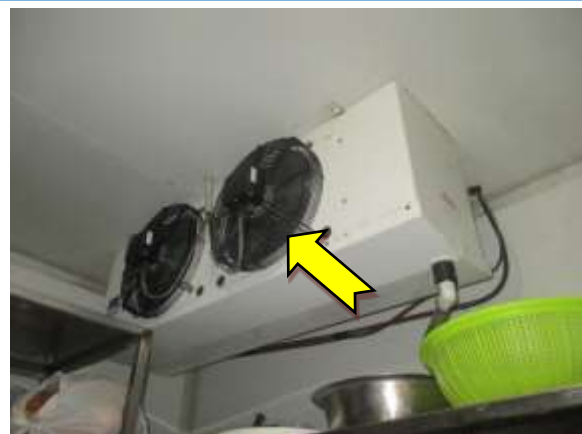
Photo 48. Ground level, shop 30 Vina Bakehouse – suspected ODS-containing refrigerator.

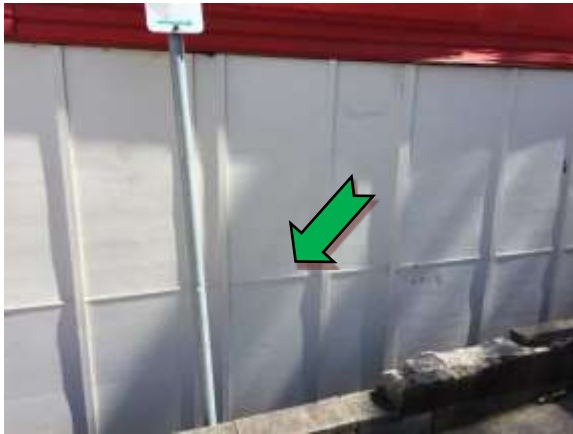
Photo 49. Exterior, liquorland, eastern elevation, wall cladding – non asbestos-containing fibre cement sheeting.

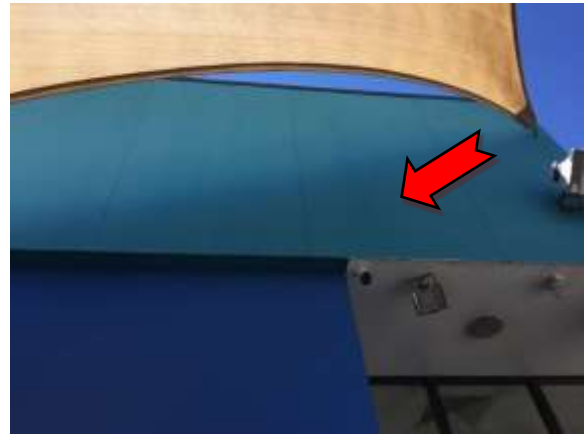
Photo 50. Exterior, car wash, surrounding building, at height – suspected asbestos-containing fibre cement sheeting.

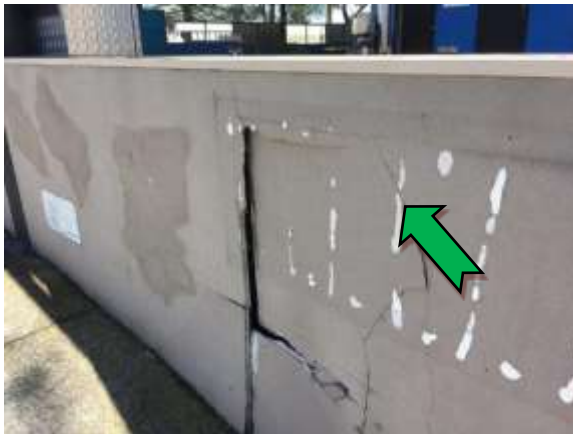
Photo 51. Exterior, car park, retaining wall – non asbestos-containing fibre cement sheeting.
