Geotechnical Assessment

Project: Alterations & Additions
8 Michele Road, Cromer NSW

Prepared for:
Rapid Plans

Ref: AG 25048
13 February 2025

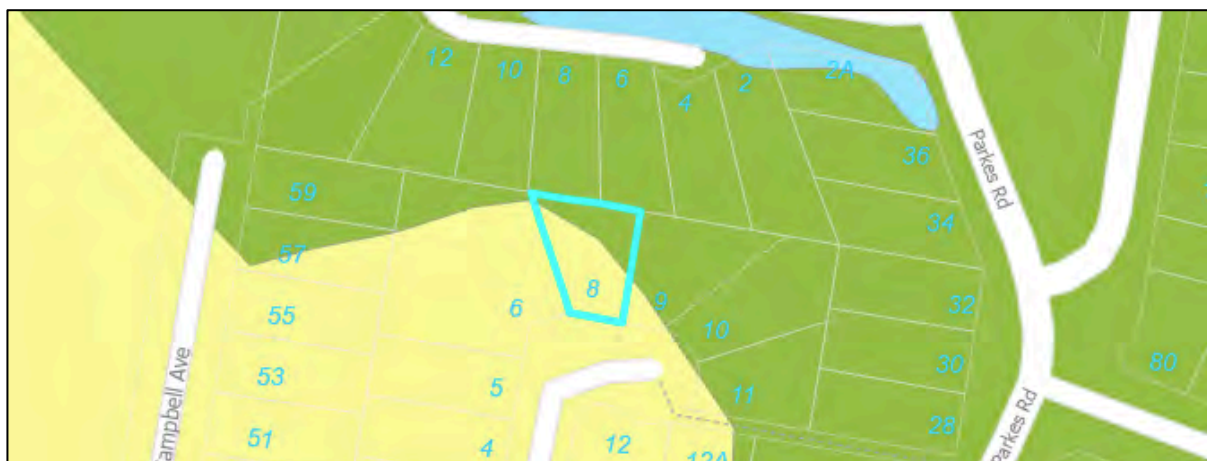
Image 2. Warringah Landslip Risk Map:
8 Michele Road, Cromer NSW (© NBC Maps)

- No evidence of significant soil creep, tension cracks or landslip instability were identified across the site or on adjacent properties as viewed from the subject site at the time of our inspection.
- The property is classified as **Area A & D** with reference to Northern Beaches Council WLEP – Warringah Landslip Risk Map (**Image 2**).

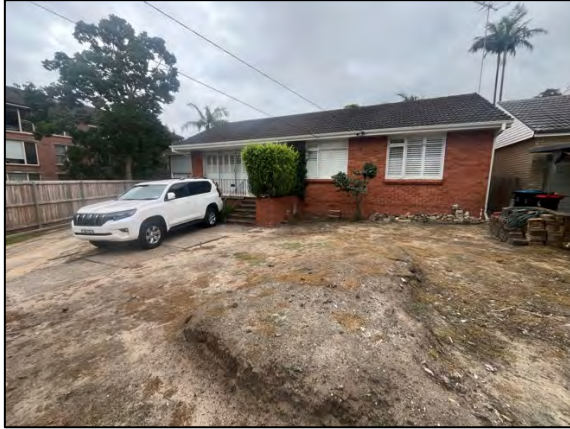
Photo 1: Residence frontage

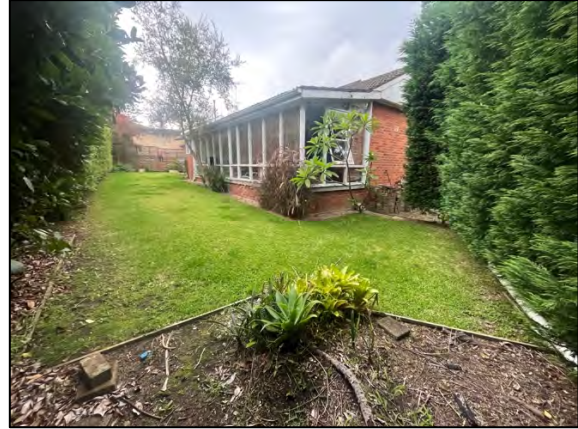
Photo 2: Residence rear

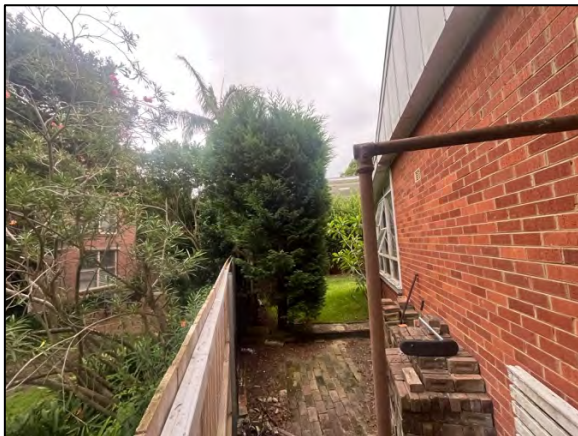
Photo 3: Looking north along eastern boundary

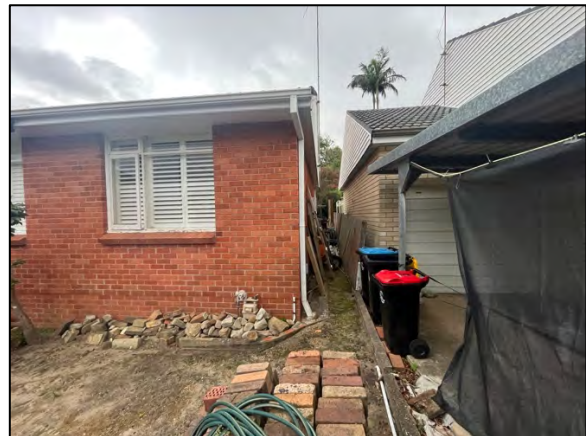
Photo 4: Looking north along western boundary
