REPORT ON GEOTECHNICAL SITE INVESTIGATION

PROPOSED RESIDENIAL DWELLING HOUSE

LOT 3, 1110 BARRENJOEY ROAD, PALM BEACH

Project No.: 2020-232

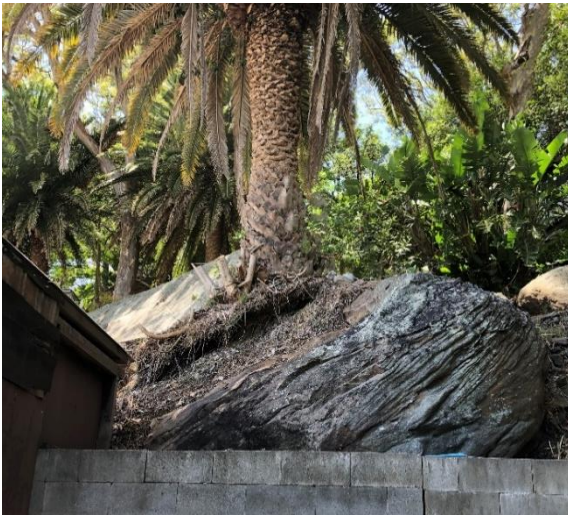
Photograph-3: Wash out under roots of palm tree, looking east

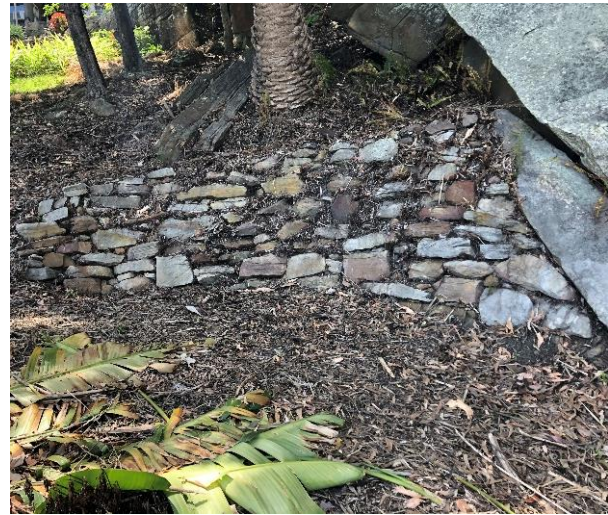
A middle-terraced level exists just to the east of the front terraced area at approximately R.L. 16.5m, this region is located between large angular sandstone boulders. A large ($\approx 48\text{m}^3$) angular, north east – south west striking, west north west dipping ($\approx 65^\circ$) sandstone boulder is located on the high east side of this middle-terraced level. A dry stack, subvertical sandstone rock retaining wall is located on the northern side of this boulder. This retaining wall appears to be stable at present, however it is not engineer designed and subject

to poor construction methodology and slow degradation from creep pressures. The angular boulder and retaining wall are shown in Photograph 4 and 5.

Photograph-4: Retaining wall to the north of sandstone boulder along the eastern edge of the middle-terraced region, looking east

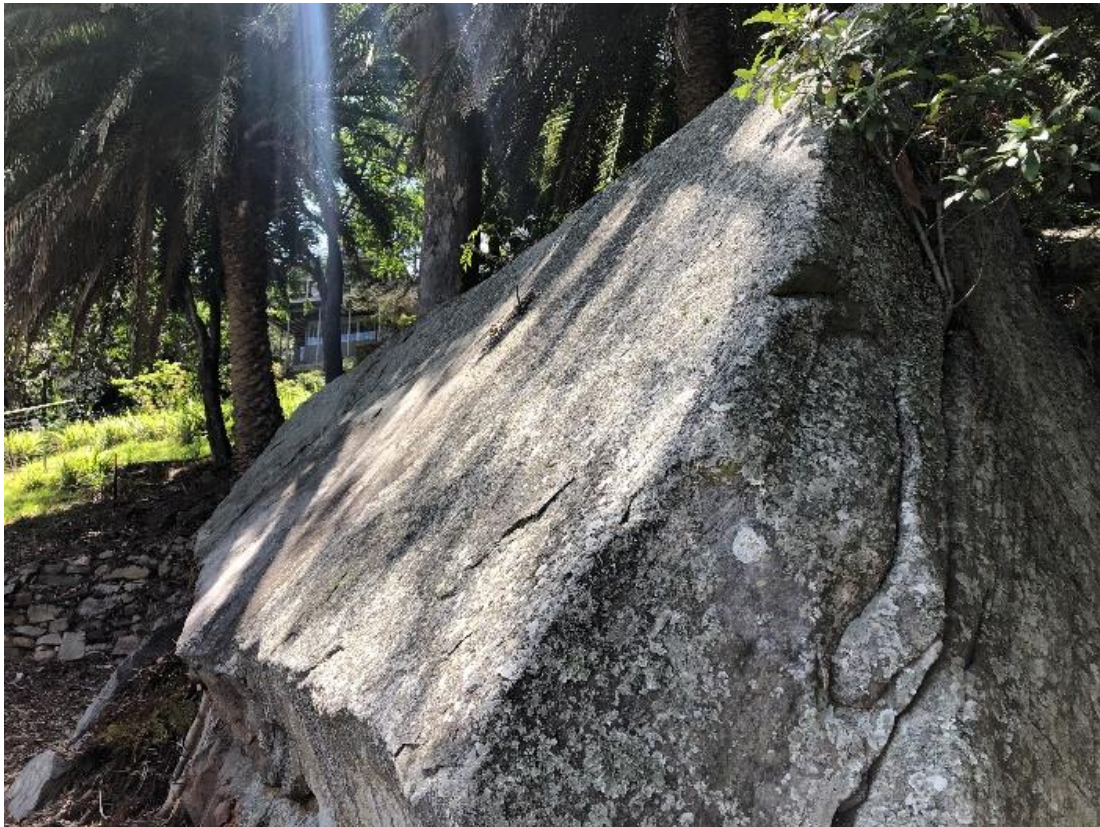
Photograph-5: Massive, angular sandstone boulder within the middle-terraced region, looking north-east

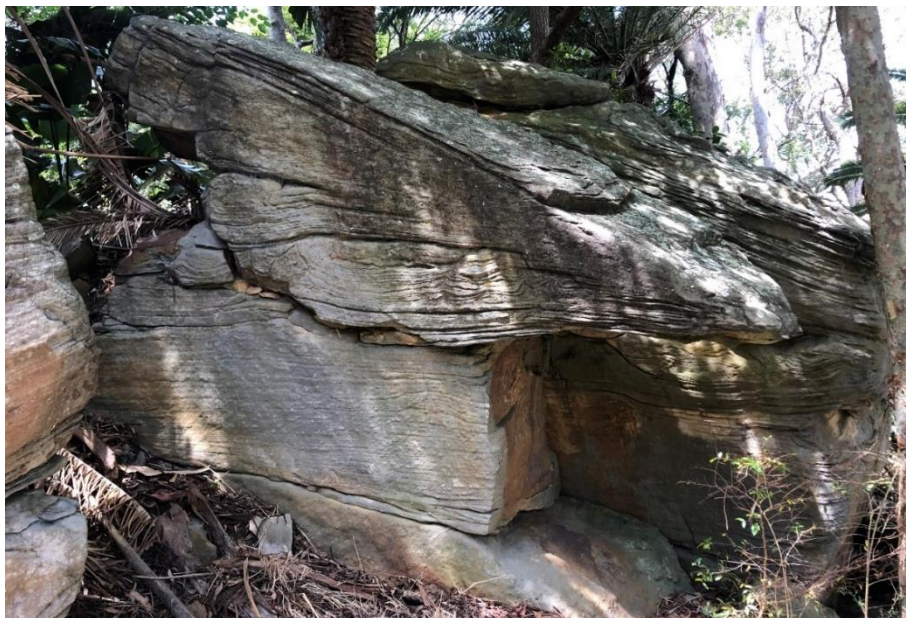
Within this north-eastern section of boulders, another series of four large boulders clustered together were identified, these boulders are shown in Photographs 6 – 9. The northern side of the series includes a detached angular boulder resting on top of another detached unit, both units are orientated down slope bearing onto a largely buried boulder. The upper triangular boulder, lower rectangular boulder and their founding conditions are shown in Photograph 6.

The upper triangular boulder is approximately 2.3m^3 , with the lower rectangular boulder approximately 4.0m^3 . Both units have become detached along sub-horizontal planes. The upper and possibly lower detached units are interpreted as being susceptible to instability due to sliding or overturning failure. The adjacent boulder to the south has an approximate volume of 35m^3 and weight of approximately 85 tonnes. This boulder has rotated to rest on the adjacent rectangular boulder, with the base of the boulder embedded into the soil slope. It is considered likely that this boulder is also susceptible to instability due to boulder sliding and appears to be an influence on the adjacent boulders to the north.

Photograph-6: Southern view of boulder instability region, including the upper triangle boulder bearing onto the lower rectangular boulder and embedded boulder below.

The boulders buried across the soil slope are likely creeping with the soil. Excavation adjacent to or into these boulders is likely to disturb and cause instability. Some boulders directly overlie other boulders along unfavourable defects and are considered relatively unstable. Reference has been made (Drawing No.: DA2004) to boulder(s) within the eastern portion of the site; “rock cut back or retained as required”. It should be noted that for any rock fall hazards, the preference is removal however this may be difficult to achieve in the current conditions. If this cannot be completed, then stabilising systems are required (i.e. rock bolts/shotcrete). CGC must be consulted prior to any boulder removal or stabilisation works.

support system. If removal of boulders is not possible, a combination of rock bolts/anchors, bracing and shotcrete are considered necessary due to the multiple forces acting in different directions on the boulders. It is also recommended that loose, small, unstable boulders be removed in the area of the proposed development prior to any construction work. Unstable boulders within a 1.0V:1.5H influence zone of an excavation base or medium strength bedrock surface are recommended to be removed or secured prior to any excavation on site. All boulder stabilisation works must be completed prior to any construction/excavation associated with the proposed works.

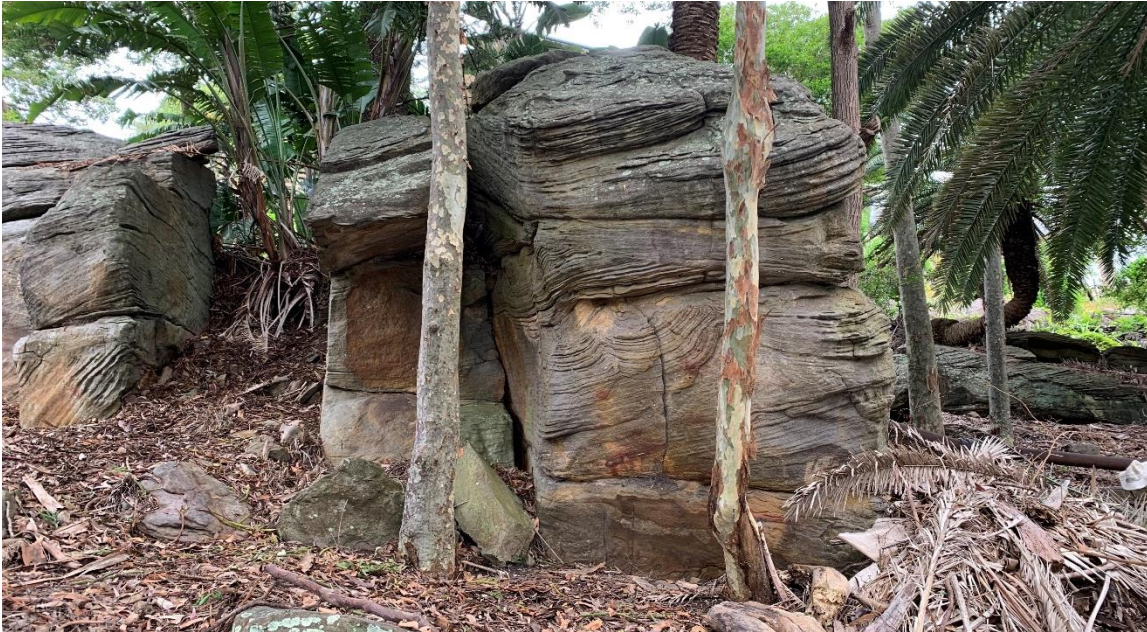
Photograph-7: Eastern view of boulder instability region, including the stacked boulder section to the left and large southern boulder to the right.

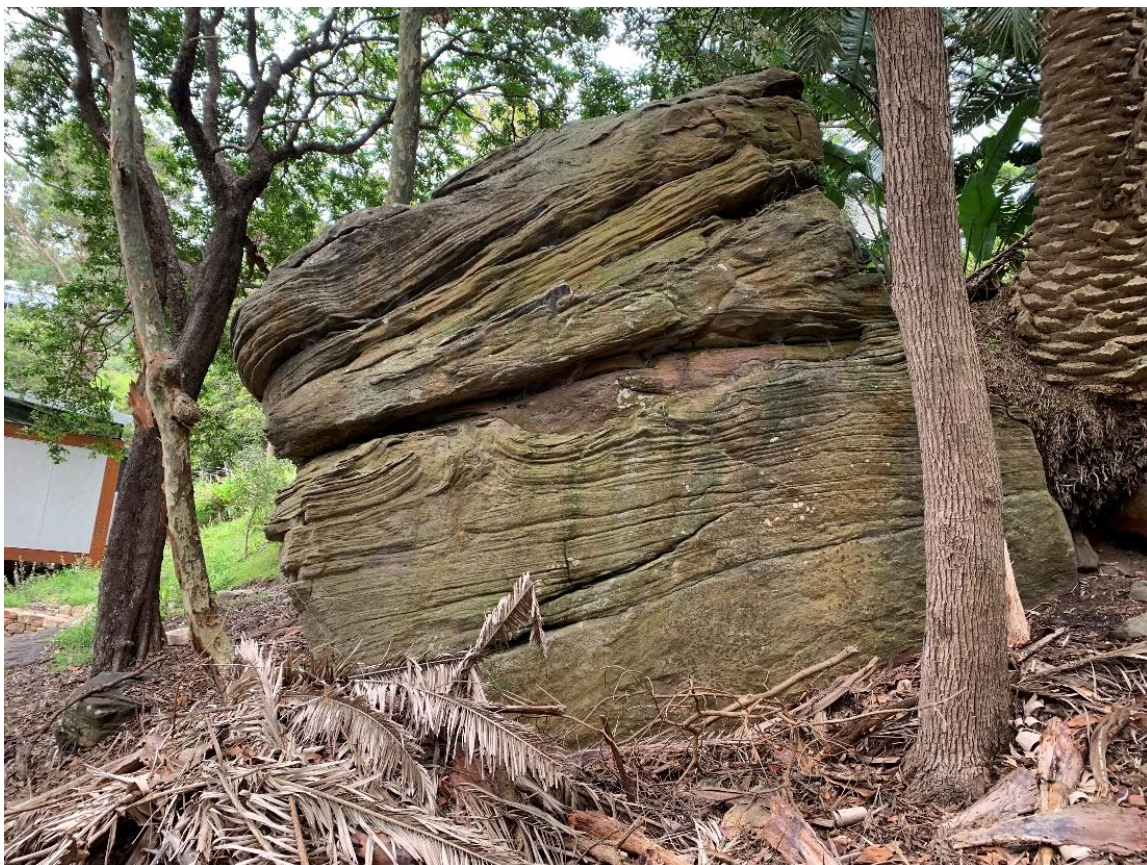
Photograph-8: Northern view of boulder instability region, including the large southern boulder

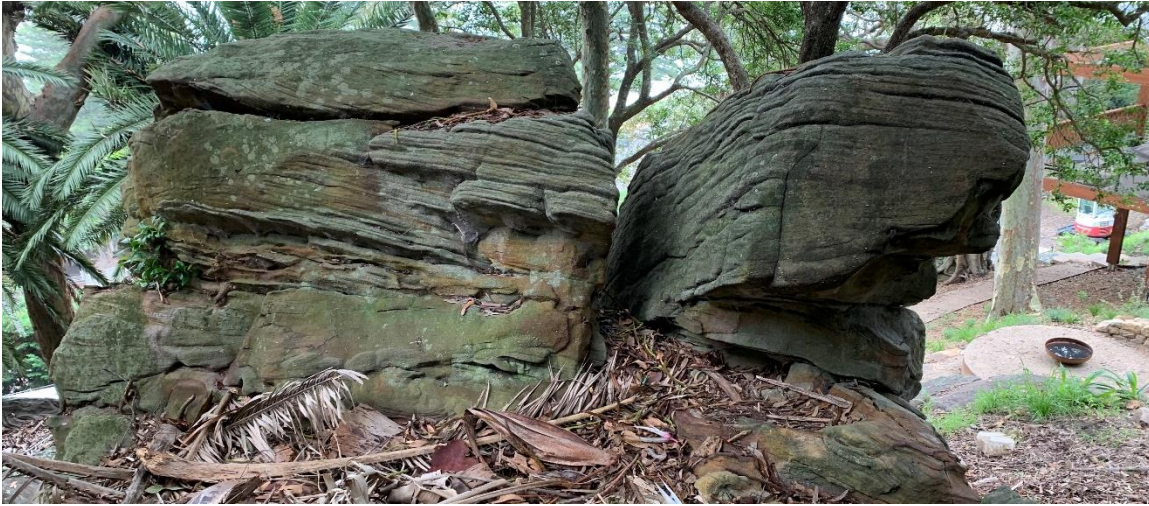
Photograph-9: Western view of boulder instability region, including the upper triangle boulder to the right and large southern boulder to the left.

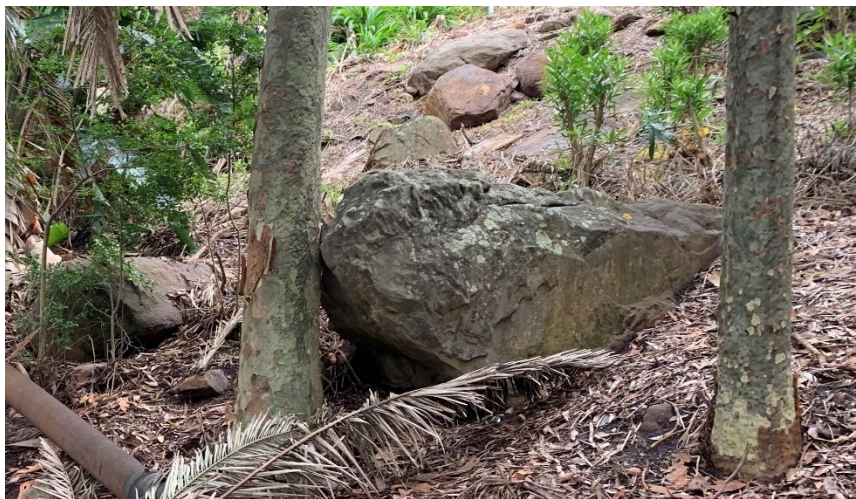
A central boulder section is positioned to the east of the large angular sandstone boulder shown in Photograph 5. Loose sandstone cobbles and boulders are positioned throughout this region embedded into the moderate to steep sloping terrain. The majority of these boulders are angular and slender in shape and largely orientated downslope. A number of these boulders are wedged into surrounding trees and vegetation, this is similarly seen in a boulder upslope which is stabilised by a tree positioned on the lower face of the boulder, this is shown in Photograph 10.

Photograph-10: Sandstone boulder stabilised by tree adjacent to eastern boundary of site, facing east

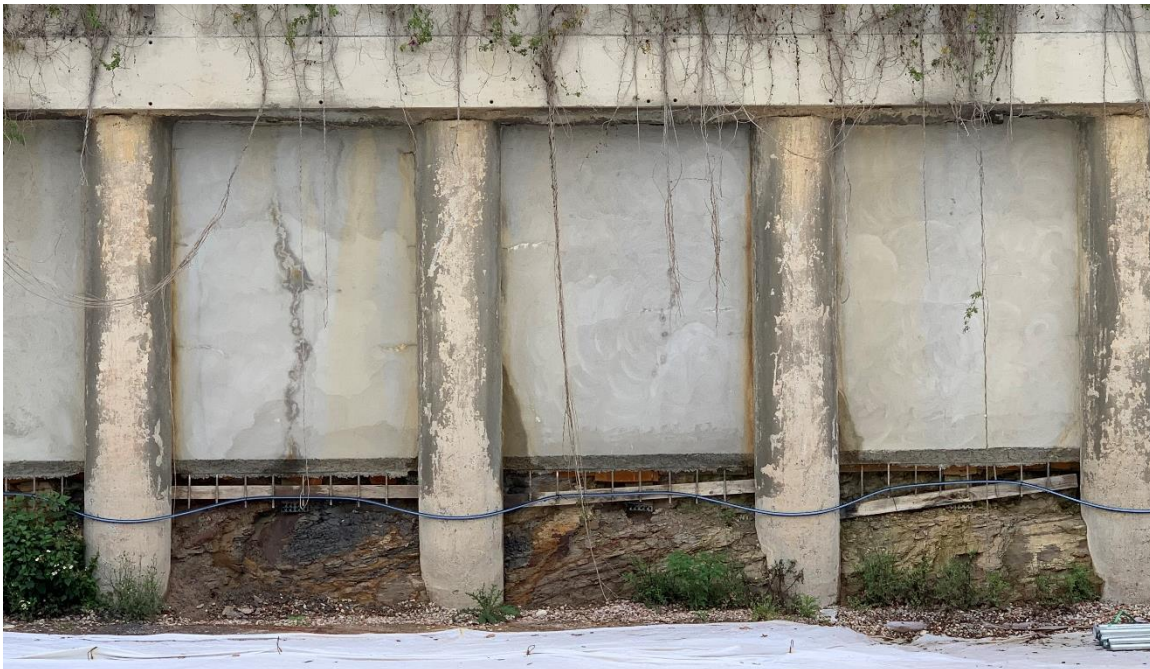
The neighbouring property to the west (No.1102 - 1104) contains a currently vacant block of land previously occupied by Palm Beach Fish & Chips, located at Barrenjoey Road street level. A vertical soldier pile retaining wall approximately 4.0m to 5.0m high is positioned along the rear boundary of the property adjacent to the site. The support wall is formed with bored concrete piers (600mm diameter) and intermediate concrete panels with a capping beam on top. This wall appears to be in very good condition with no visible signs of any settlement or rotation. Sub-vertically cut, highly to moderately weathered siltstone/shale bedrock is exposed at the base of the support wall, as shown in Photograph 11.

Photograph-11: Exposed siltstone and shale bedrock at the base of the concrete panel soldier pile wall at the rear excavation face of No.1104 Barrenjoey Road.

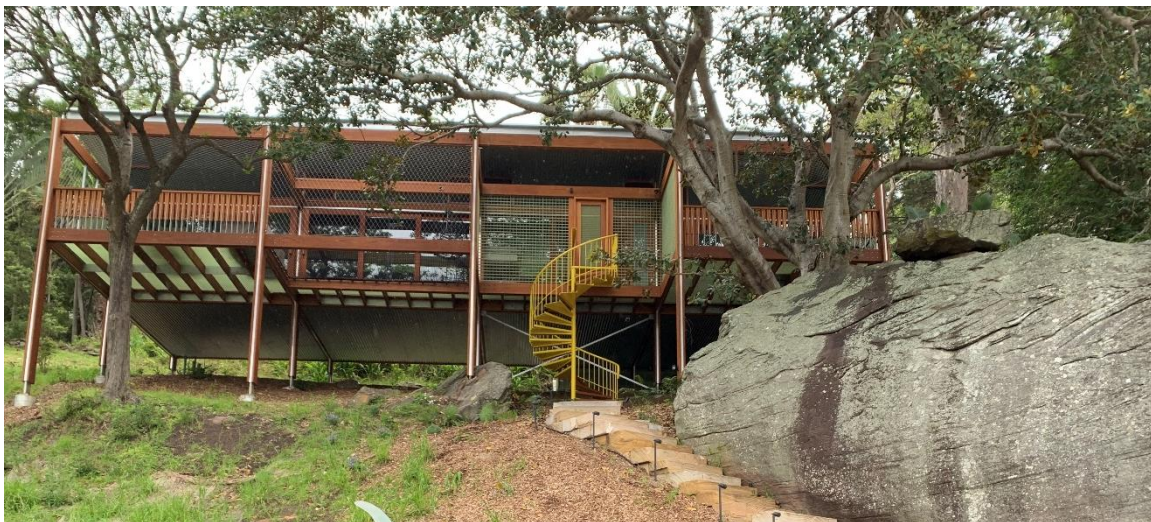
The neighbouring lot to the north (Lot 2, No.1110 Barrenjoey Road) forms the middle portion of No.1110 Barrenjoey Road and is situated within very similar topography as the site. A single storey suspended dwelling supported via wooden piers and concrete piles has recently been constructed. No bulk excavation was required as part of the construction with minor landscaping works within the front and southern side of the property identified. A very large sandstone boulder ($\approx 200\text{m}^3$) is located within the south-western corner of the lot and extends to the common boundary with the site. Resting on top of this boulder is a smaller detached boulder, which appears to be stable at present, this is shown in Photograph 12.

Photograph-12: Recently constructed dwelling within Lot 2, 1110 Barrenjoey Road, with large sandstone boulder and smaller detached unit on top, facing east

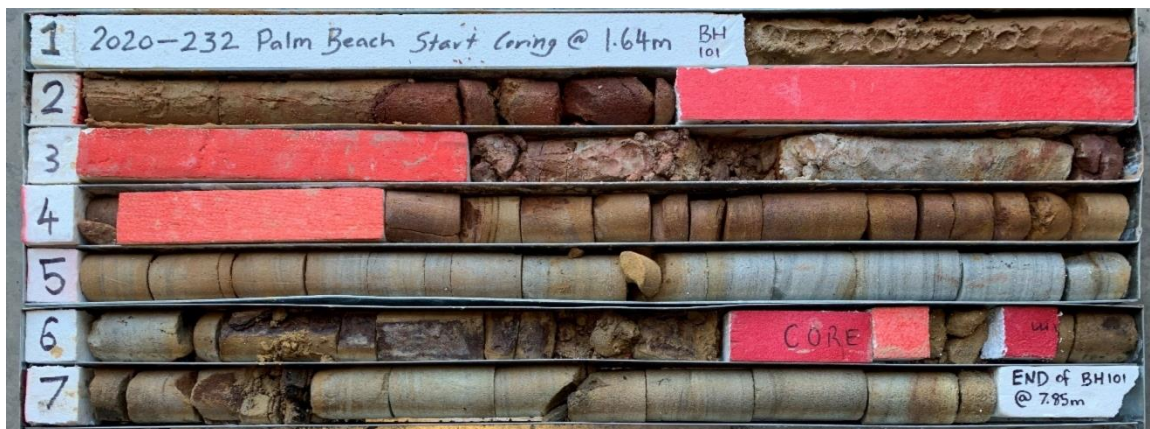
BH101 – 1.64m to 7.95m depth

BH101	Depth (m)	RL(AHD)	
Clay/ Sandstone ELS and Boulders	1.65m – 4.35m	14.85m – 12.15m	Hard clay/extremely weathered, extremely low strength sandstone bedrock grading to extremely low strength, highly weathered pale grey sandstone at 3.70m depth. An ironstone boulder embedded into the soil material was intersected at 2.30m.
Sandstone LS – MS	4.35m – 6.45m	12.15m – 10.05m	Low strength, moderately weathered, fine grained sandstone grading to medium strength, slightly weathered at 5.60m. Sub vertical joint defects encountered at 5.55m and 6.15m.
Sandstone ELS – VLS	6.45m – 6.90m	10.05m – 9.60m	An extremely weathered to highly weathered sandstone band with joint defects encountered above and below this zone.
Sandstone LS - MS	6.90m – 7.90m (END)	9.60m – 8.60m	Low to medium strength, moderately to slightly weathered, fine to medium grained, with joint defects encountered at 7.10m and 7.43m. Coarse grained sandstone interbedded with quartz gravel encountered 0.05m from end of core.

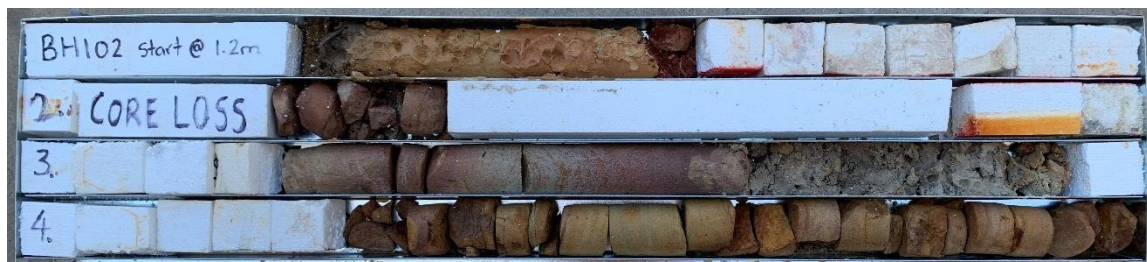
BH102 – 1.20m to 5.00m depth

BH102	Depth (m)	RL(AHD)	
Clay/ Sandstone ELS and Boulders	1.20m – 4.25m	15.20m – 12.15m	Medium to high plasticity clay/extremely weathered, extremely low strength sandstone bedrock. At least one sandstone boulder was intersected between 2.15m and 3.60m with soil material overlying and underlying.
Sandstone LS	4.25m – 5.00m	12.15m – 11.40m	Low strength, highly weathered, fine grained sandstone. Sub vertical joint defects encountered at approximately 0.20m spacing between 4.34m and 4.77m.

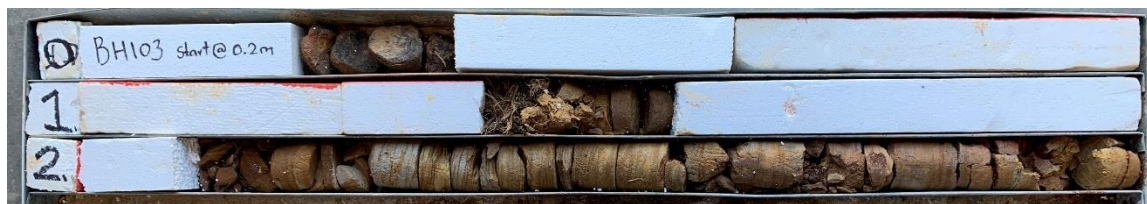
BH103 – 0.20m to 3.00m depth

BH103	Depth (m)	RL(AHD)	
Clay/ Sandstone ELS and Boulders	0.20m – 2.15m	21.60m – 19.65m	Topsoil/colluvium from surface with a sandstone boulder encountered at 0.20m, likely medium to high plasticity clay with roots and cobbles/boulders to 2.15m.
Sandstone LS	2.15m – 3.00m	19.65m – 18.80m	Low strength, highly weathered, fine grained, thinly laminated sandstone. Poor core condition recovery due to portable equipment, potential for bedding or joint defects.
