Report Title: Geotechnical Report 25 Alleyne Avenue, North Narrabeen
Report Date: 15/12/21

GEOTECHNICAL INVESTIGATION:

New House at **25 Alleyne Avenue, North Narrabeen**

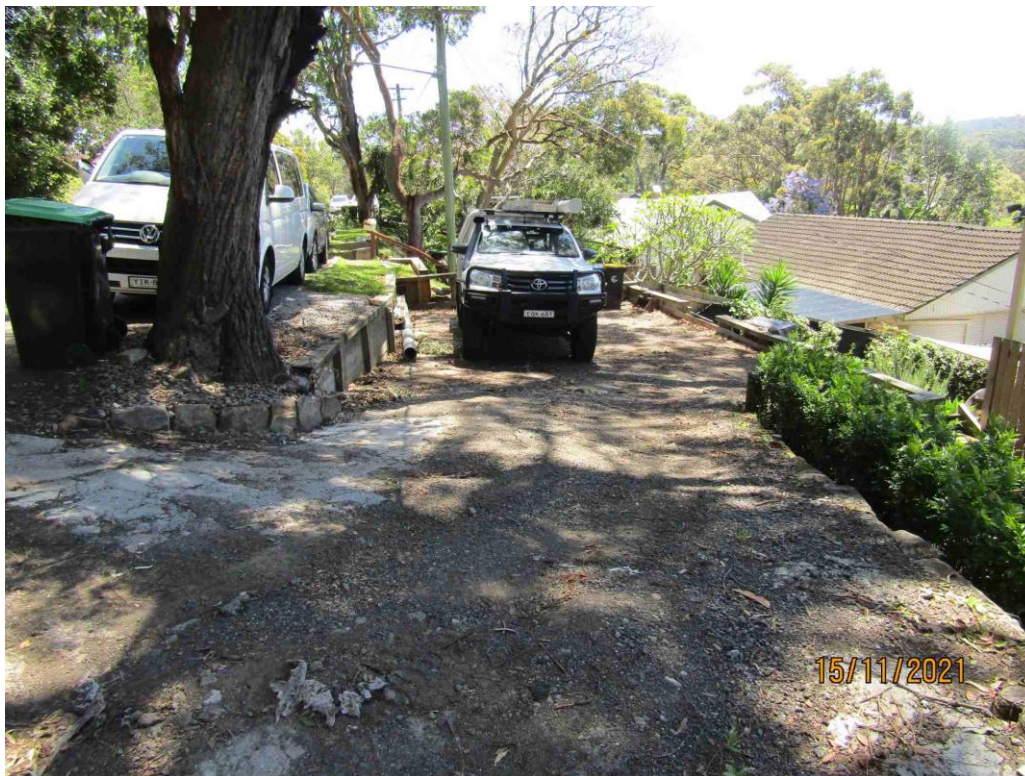
Photo 1

- 2.3** At the road frontage, a gravel driveway runs to a gravel parking area (Photo 1). Fill provides a level platform for the parking area. The fill is supported by a timber retaining wall ~1.5m high (Photo 2). The wall is tilting at up to ~6.3° downslope, but will be demolished as part of the proposed works. A lawn area extends off the downhill side of the retaining wall. A sandstone and timber retaining wall up to ~1.9m high supports the fill for the lawn and a cut for a stone paved area below (Photo 3). The

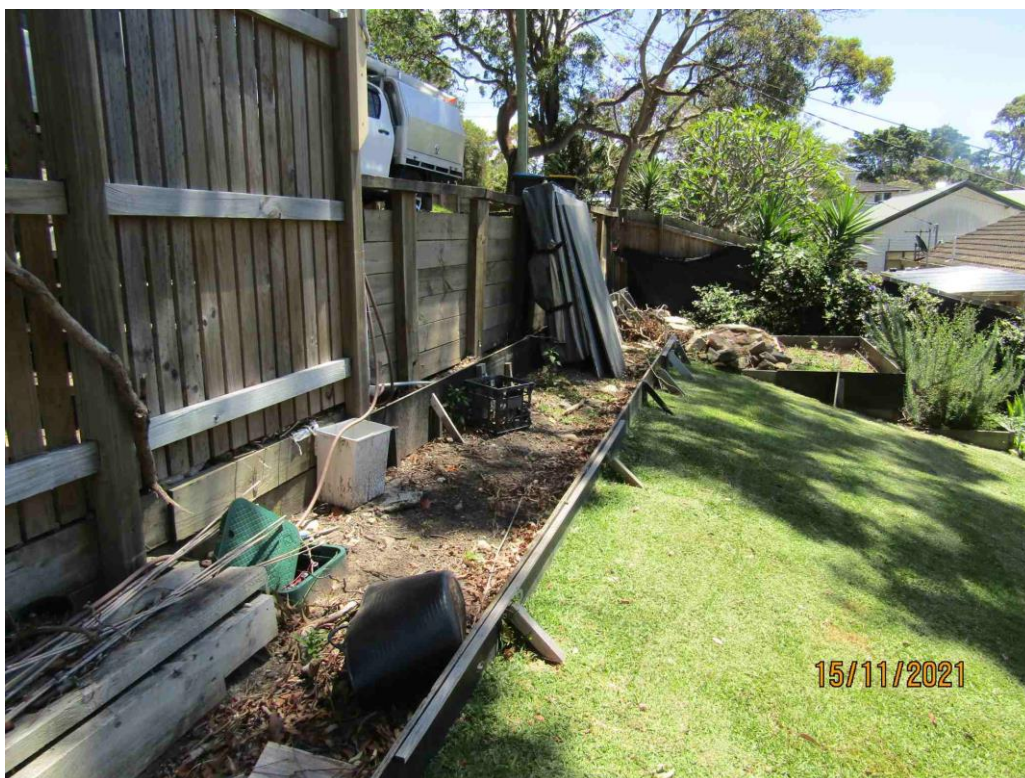
Photo 2

- Flush with the existing parking area and timber retaining wall (Photo 2), however the timber retaining wall and part of the parking area will be demolished as part of the proposed works.
- ~0.5m from the W common boundary and ~1.5m from the W neighbouring house and pergola.
- Flush with the E common boundary and ~2.7m from the E neighbouring house.

The existing ~1.5m high timber retaining wall supporting the fill for the parking area (Photo 2) and existing sandstone block retaining wall (Photo 3) are to be demolished from the top down prior to the excavation commencing. The fill, soil and clay behind the walls is to be battered at 1.0 Vertical to 1.7 Horizontal (30°) as the walls are demolished. The upper ~0.8m of the parking area fill will be excavated for the proposed new driveway. The remainder of the fill is to be removed or battered at 1.0 Vertical to 2.0 Horizontal (26°) prior to the excavation for the house commencing.

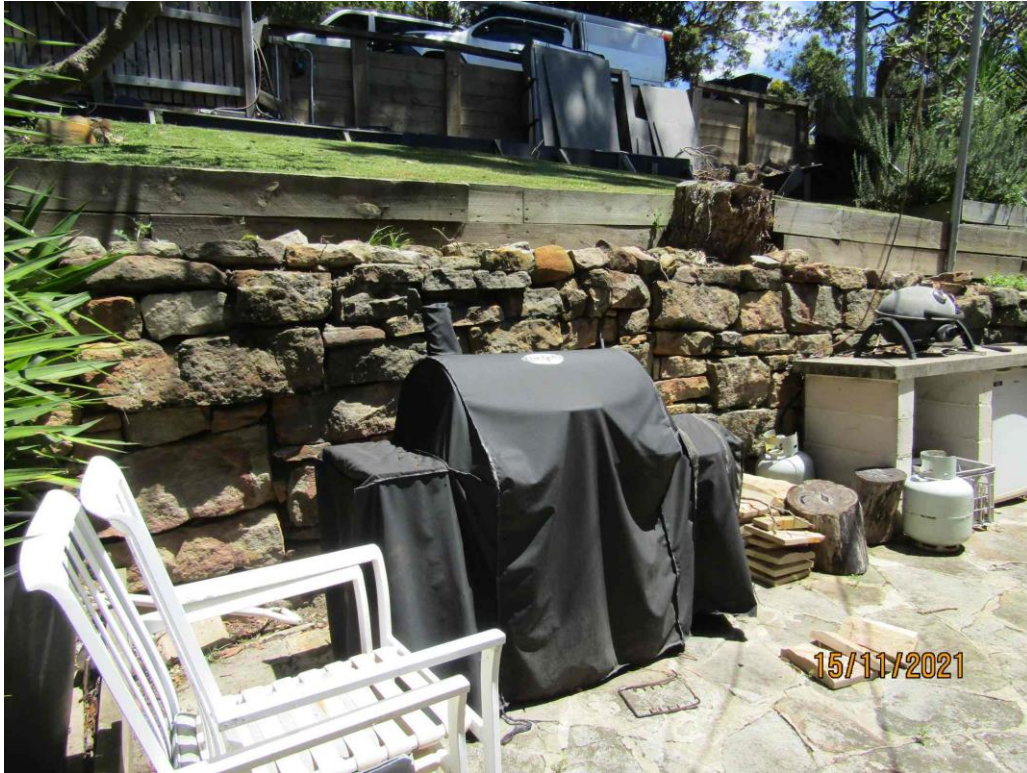
Photo 3

wall is bulging slightly, but will be demolished as part of the proposed works. The old single storey weatherboard clad house is supported by sandstone block walls, sandstone block piers and timber posts (Photos 4 & 5). The supporting walls and piers stand vertical and show no significant signs of movement (Photo 6). Lawn and garden areas extend off the downhill side of the house (Photos 5 & 7). Fill provides level platforms in the slope for the lawn and garden areas. The upper fills are supported by low sandstone block retaining walls. The lower fill is unsupported but is battered at stable angles. No signs of slope instability were observed on the property. The adjoining neighbouring properties were observed to be in good order as seen from the street and subject property.

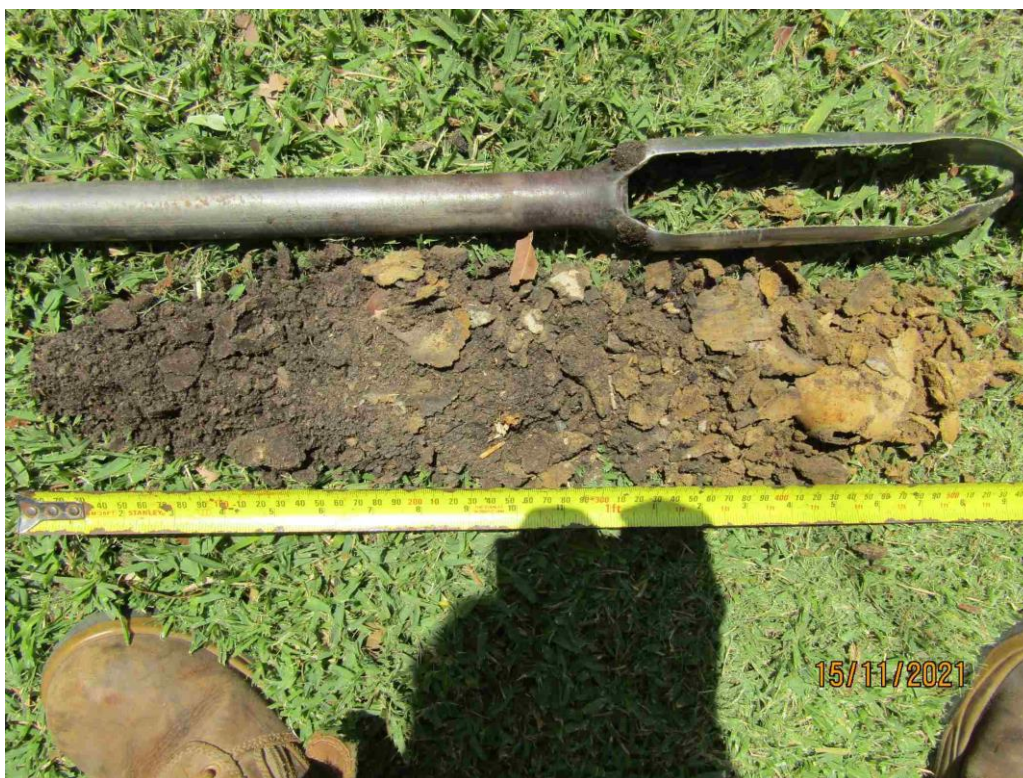
AUGER HOLE 1 (~RL38.5) – AH1 (photo 8)

Depth (m)	Material Encountered
0.0 to 0.4	TOPSOIL , sandy soil, dark brown, moist, fine to medium grained.
0.4 to 0.5	SANDY CLAY , orange, firm to stiff, dry to moist.

End of Test @ 0.5m in firm to stiff sandy clay. No watertable encountered.

Photo 8: AH1 – Downhole is from left to right.

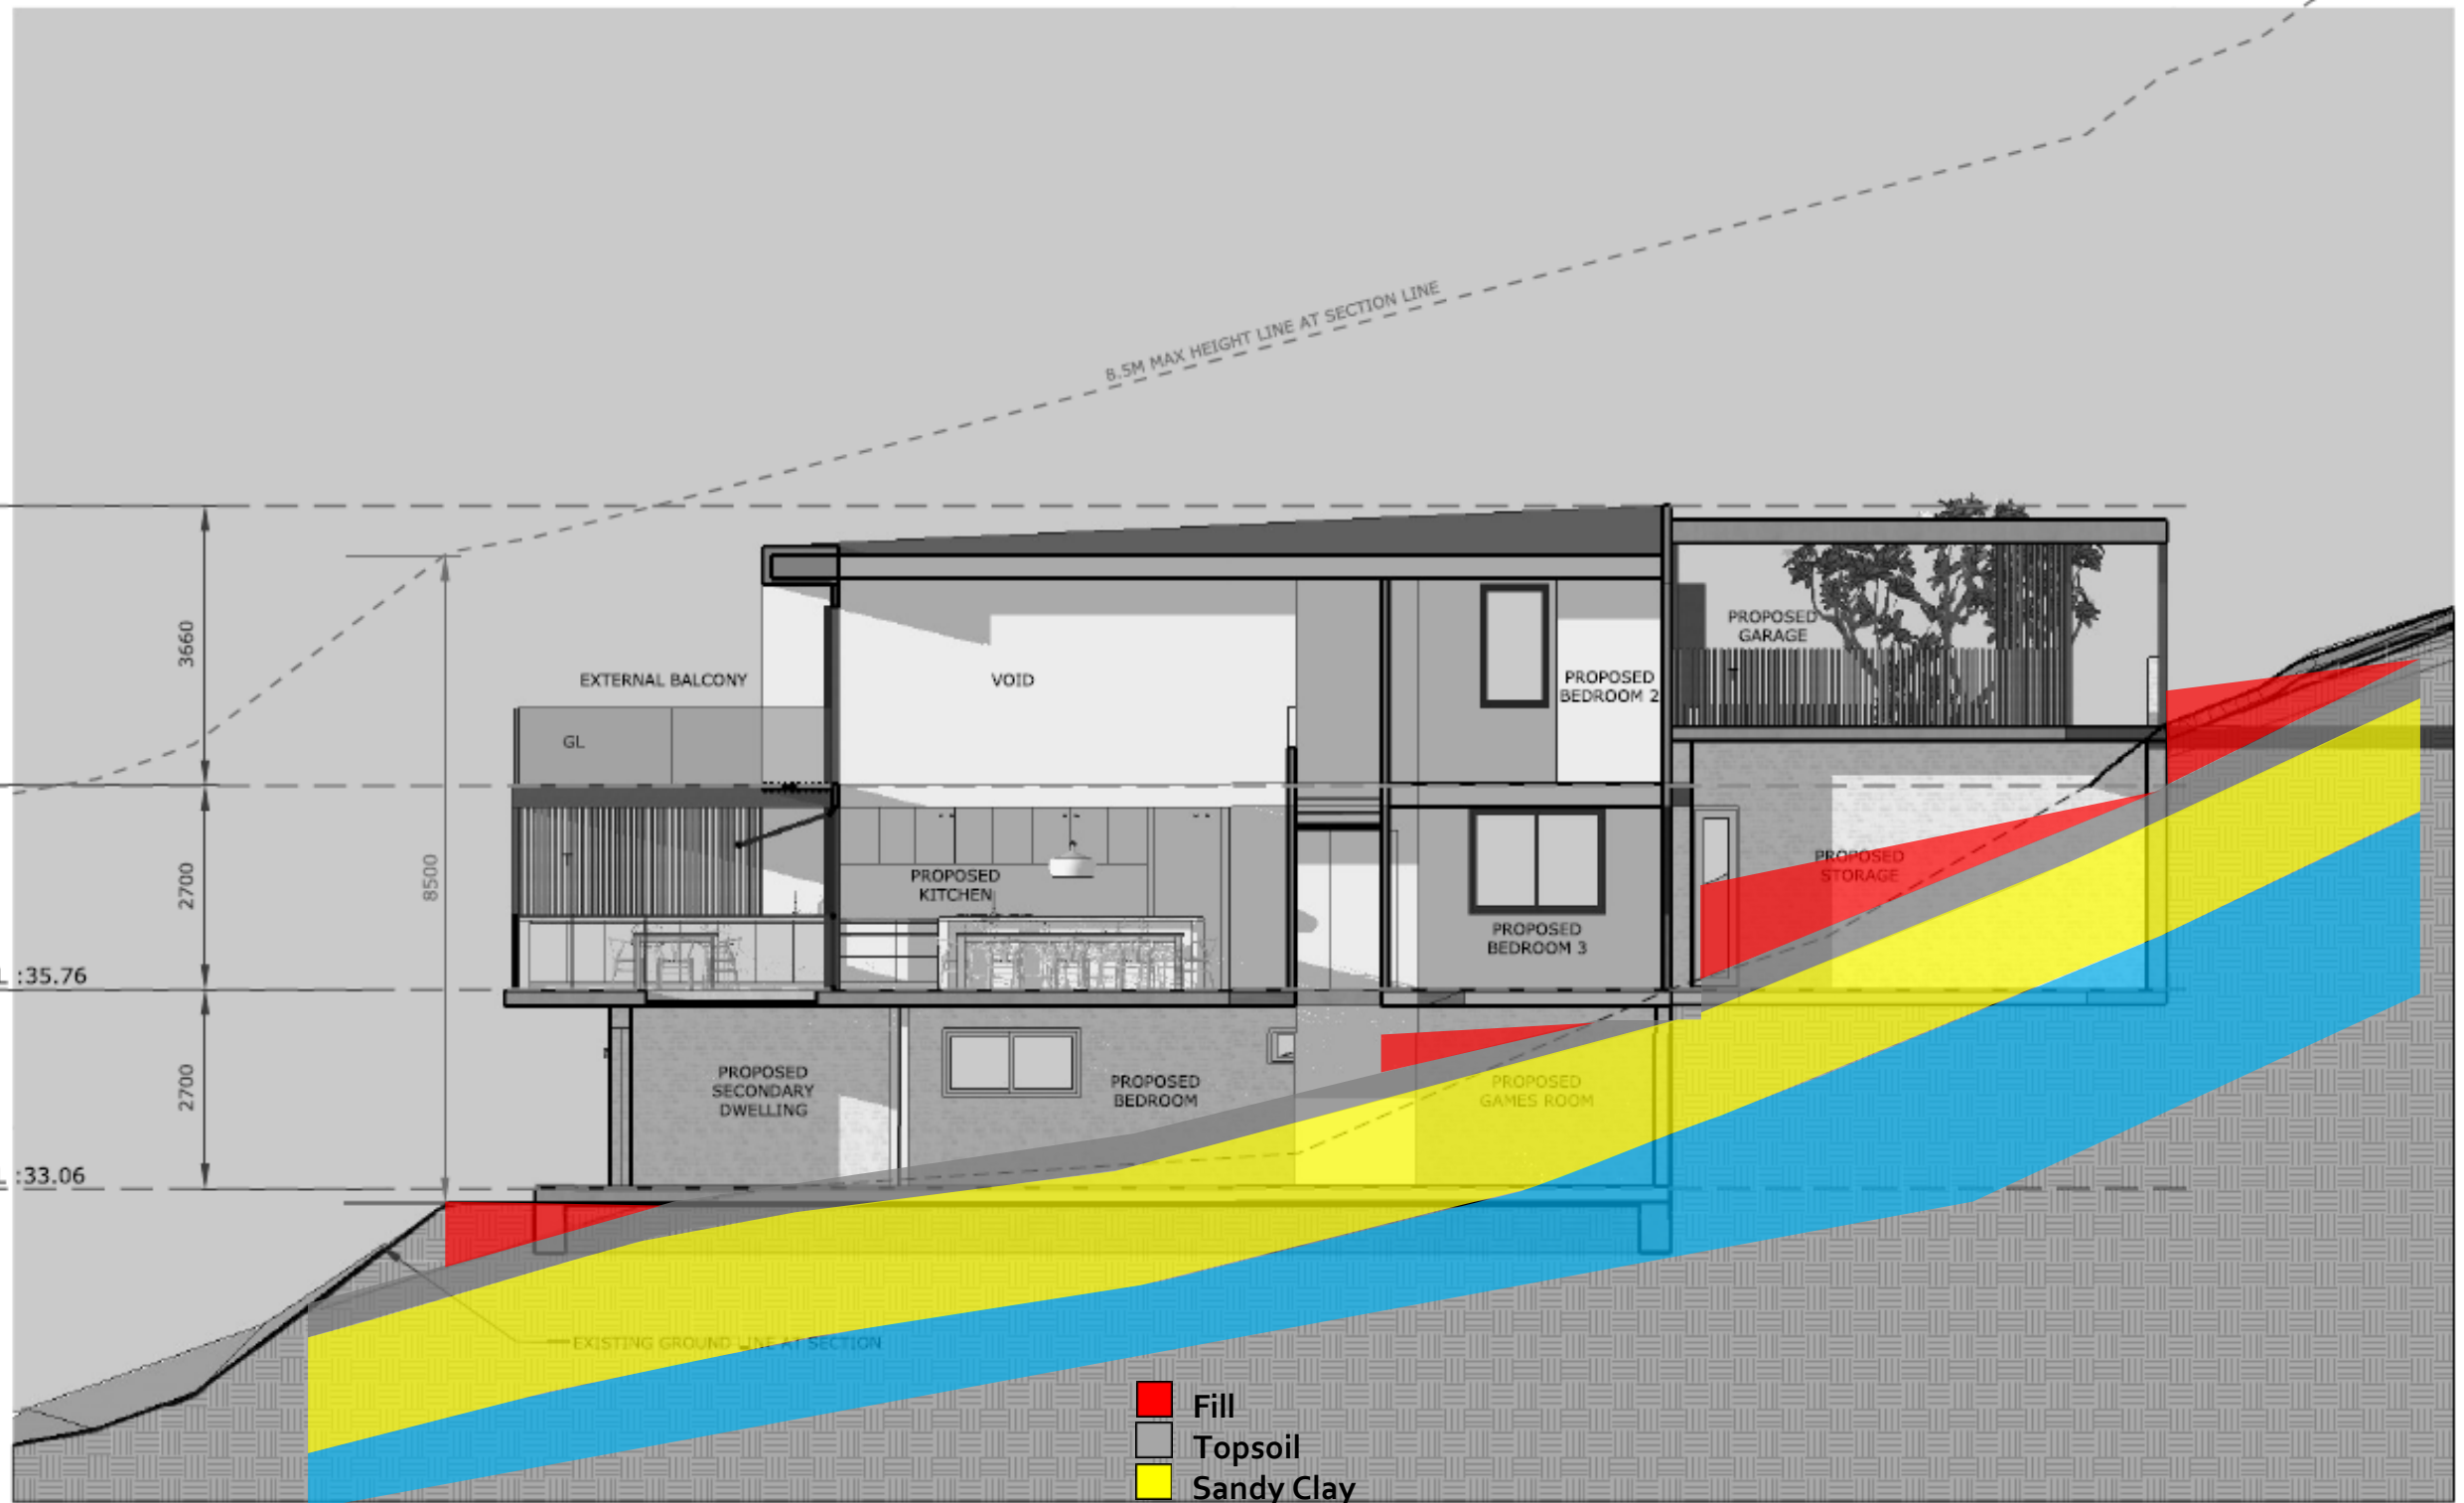
SECTION Y 1:50 @ A1 OR 1:100 @ A3

The slope materials are colluvial at the near surface and residual at depth. In the test locations, the ground materials consist of fill and topsoil over firm to stiff sandy clays. Fill to a maximum depth of ~1.5m provides a level platform for the parking area and level platforms for lawn and garden areas across the property. The clays merge into the weathered zone of the under lying rock at depths from between ~1.7m to ~2.1m below the current surface. The weathered zone of the underlying rock is interpreted as Extremely Low Strength Shale. It is to be noted that this material is a soft rock and can appear as a mottled stiff clay when it is cut up by excavation equipment. Type Section attached for a diagrammatical representation of the expected ground materials.

■ Fill
■ Topsoil
■ Sandy Clay
■ Narrabeen Group Rocks – Extremely Low Strength Shale - after being cut up by excavation equipment can resemble a stiff to hard clay.
