## **GEOTECHNICAL INVESTIGATION:**

### **Alterations and Additions at 37 Daly Street, Bilgola Plateau**

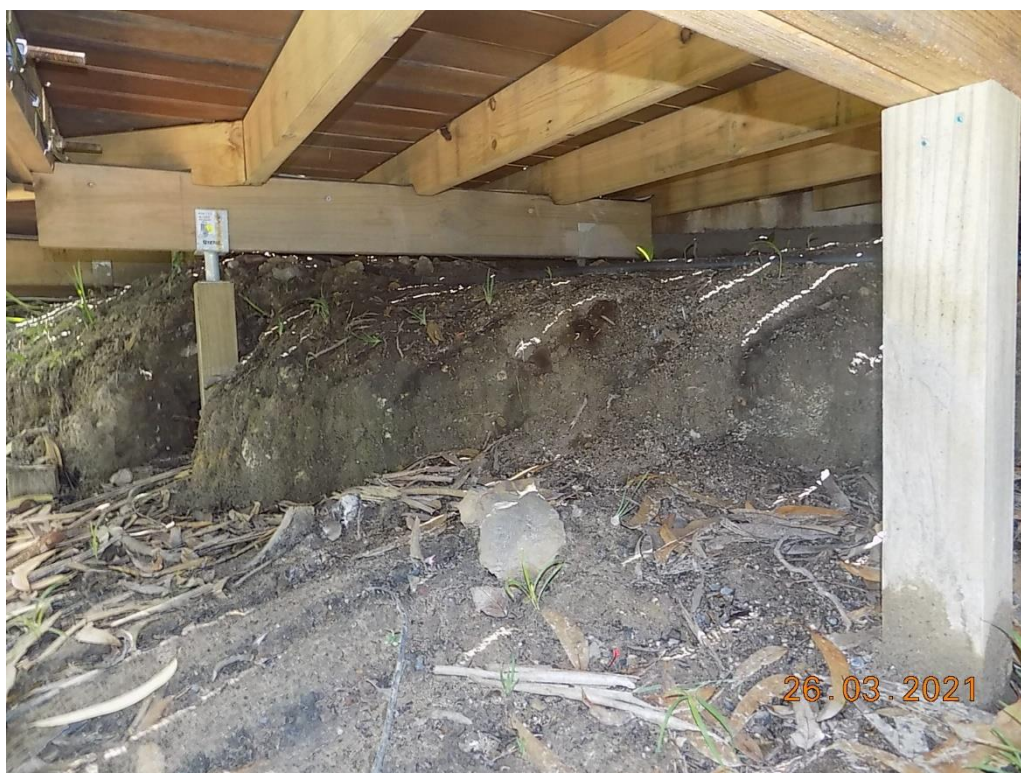
Photo 4

- 2.1** The site was inspected on the 26<sup>th</sup> March, 2021.
- 2.2** This residential property is on the high side of the road and has a E aspect. It is located on the moderate to gently graded upper reaches of a hillslope. The natural slope rises across the property at an average angle of ~10°. The slopes above and below the property continue at moderate angles.
- 2.3** At the road frontage, a concrete driveway runs up the slope to a brick garage at the S side of the house (Photo 1). The garage has been cut into the slope. The cut for the garage is supported by a stable concrete block retaining wall (Photo 2). Along the driveway, between the road frontage and the garage, a ~1.0m high sandstone block retaining wall supports a cut for an additional parking area (Photo 3). A timber deck and pool extend off the downhill side of the house. The deck is supported on

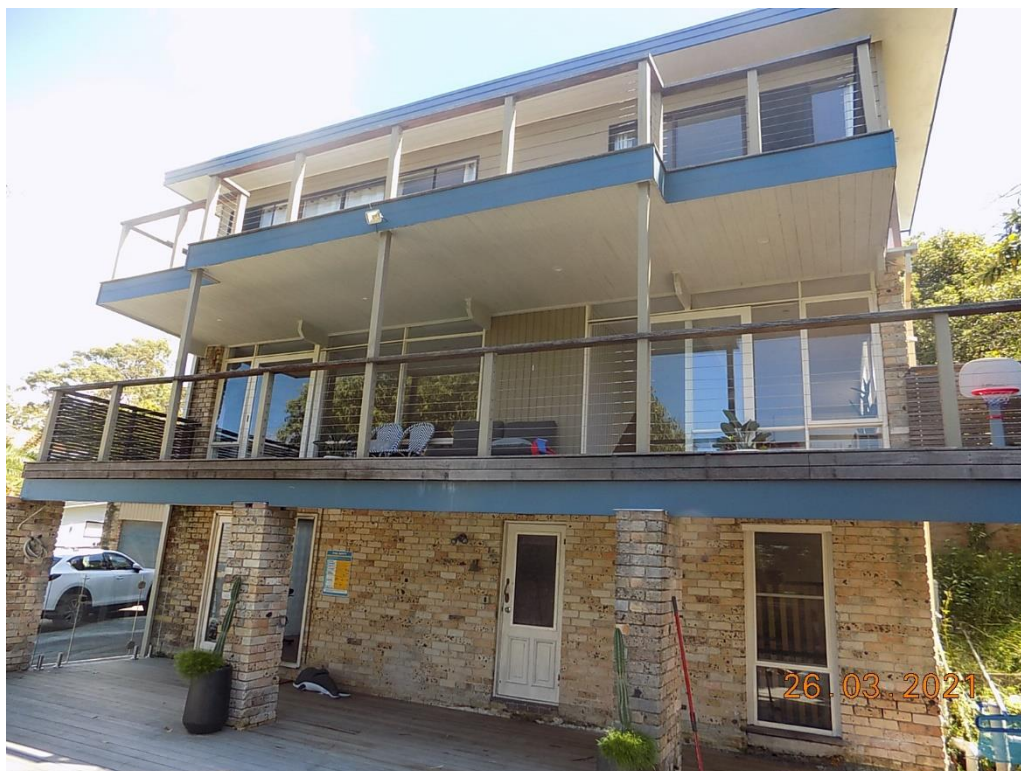
Photo 5

wooden posts (Photo 4). The pool is cut directly into the slope. A part three-storey brick and timber framed and clad house is supported on brick walls and brick piers (Photo 5). The house displays no significant signs of movement in the external supporting walls. Access to the foundation space was unavailable at the time of inspection. The brick piers supporting the deck on the downhill side of the house stand vertical and are to be removed as part of the proposed works. The cut for the levelled terrace on the uphill side of the house is supported by a stable rendered brick retaining wall, ~0.6m high (Photo 6). A gently sloping garden continues to the upper common boundary. A ~2.5m high brick retaining wall lines the upper boundary and supports a fill for the neighbouring property above (Photo 7). A vertical tension crack reaching a maximum width of ~4cm runs up the return of the wall immediately behind the downhill face (Photo 8). The face of the wall is covered in creeper and was unable to be assessed adequately during our inspection. See **Section 16** for recommendations regarding this wall.

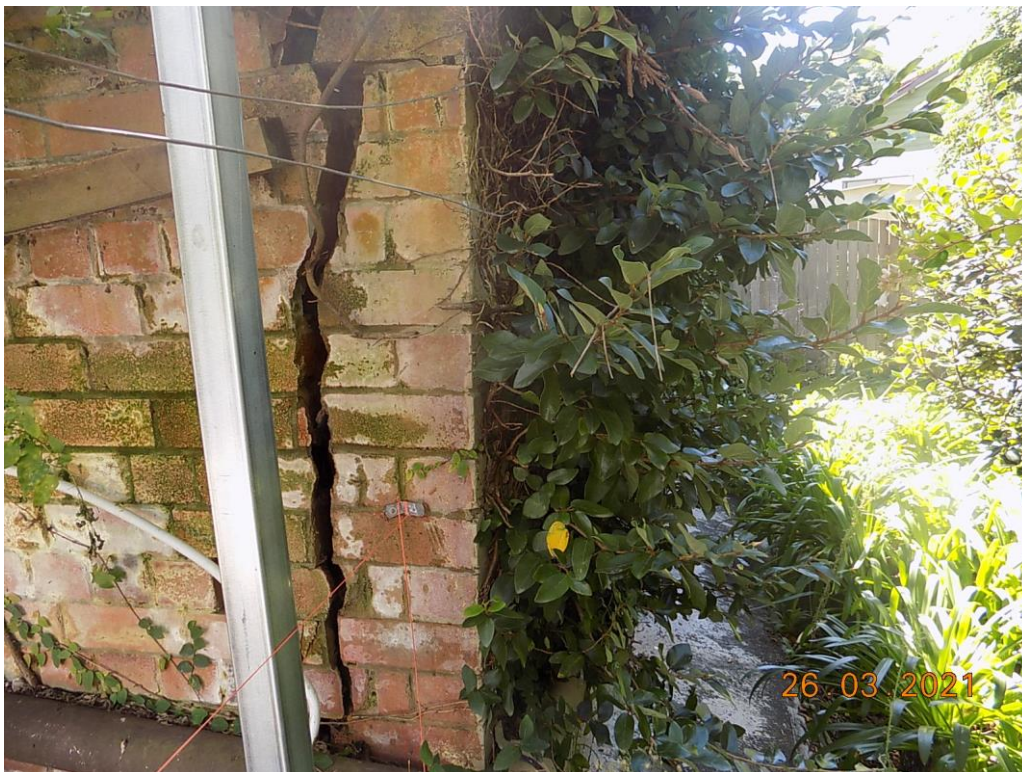
Photo 8

HAZARDS	Hazard Four	Hazard Five
TYPE	The proposed excavations undercutting the footings of the house causing failure.	Further movement or cracking of the brick retaining wall above the house that causes failure.
LIKELIHOOD	'Possible' ( $10^{-3}$ )	'Likely' ( $10^{-2}$ )
CONSEQUENCES TO PROPERTY	'Medium' (35%)	'Medium' (15%)
RISK TO PROPERTY	'Moderate' ( $2 \times 10^{-4}$ )	'High' ( $2 \times 10^{-3}$ )
RISK TO LIFE	$5.3 \times 10^{-5}$ /annum	$1.3 \times 10^{-5}$ /annum
COMMENTS	This level of risk to life and property is 'UNACCEPTABLE'. To move risk to 'ACCEPTABLE' levels, the recommendations in <b>Section 13</b> are to be followed.	This level of risk to life and property is 'UNACCEPTABLE'. To move the risk to 'ACCEPTABLE' levels, the recommendations in <b>Section 16</b> are to be followed.

The cracked boundary wall (Photo 8) has been assessed by the Scott Baty of SDA structures, the site structural engineer. His written advice from the 29.4.21 is as follows: "While the wall has a 50mm lean across the top for the full length, it appears stable in the short term, though structural remediation works will be necessary within the next 12 months to ensure long term stability for the wall". It is proposed to install a row of anchors to support the wall. The support will be detailed by SDA Structures. These remedial works are to be carried out within the recommended time frame.

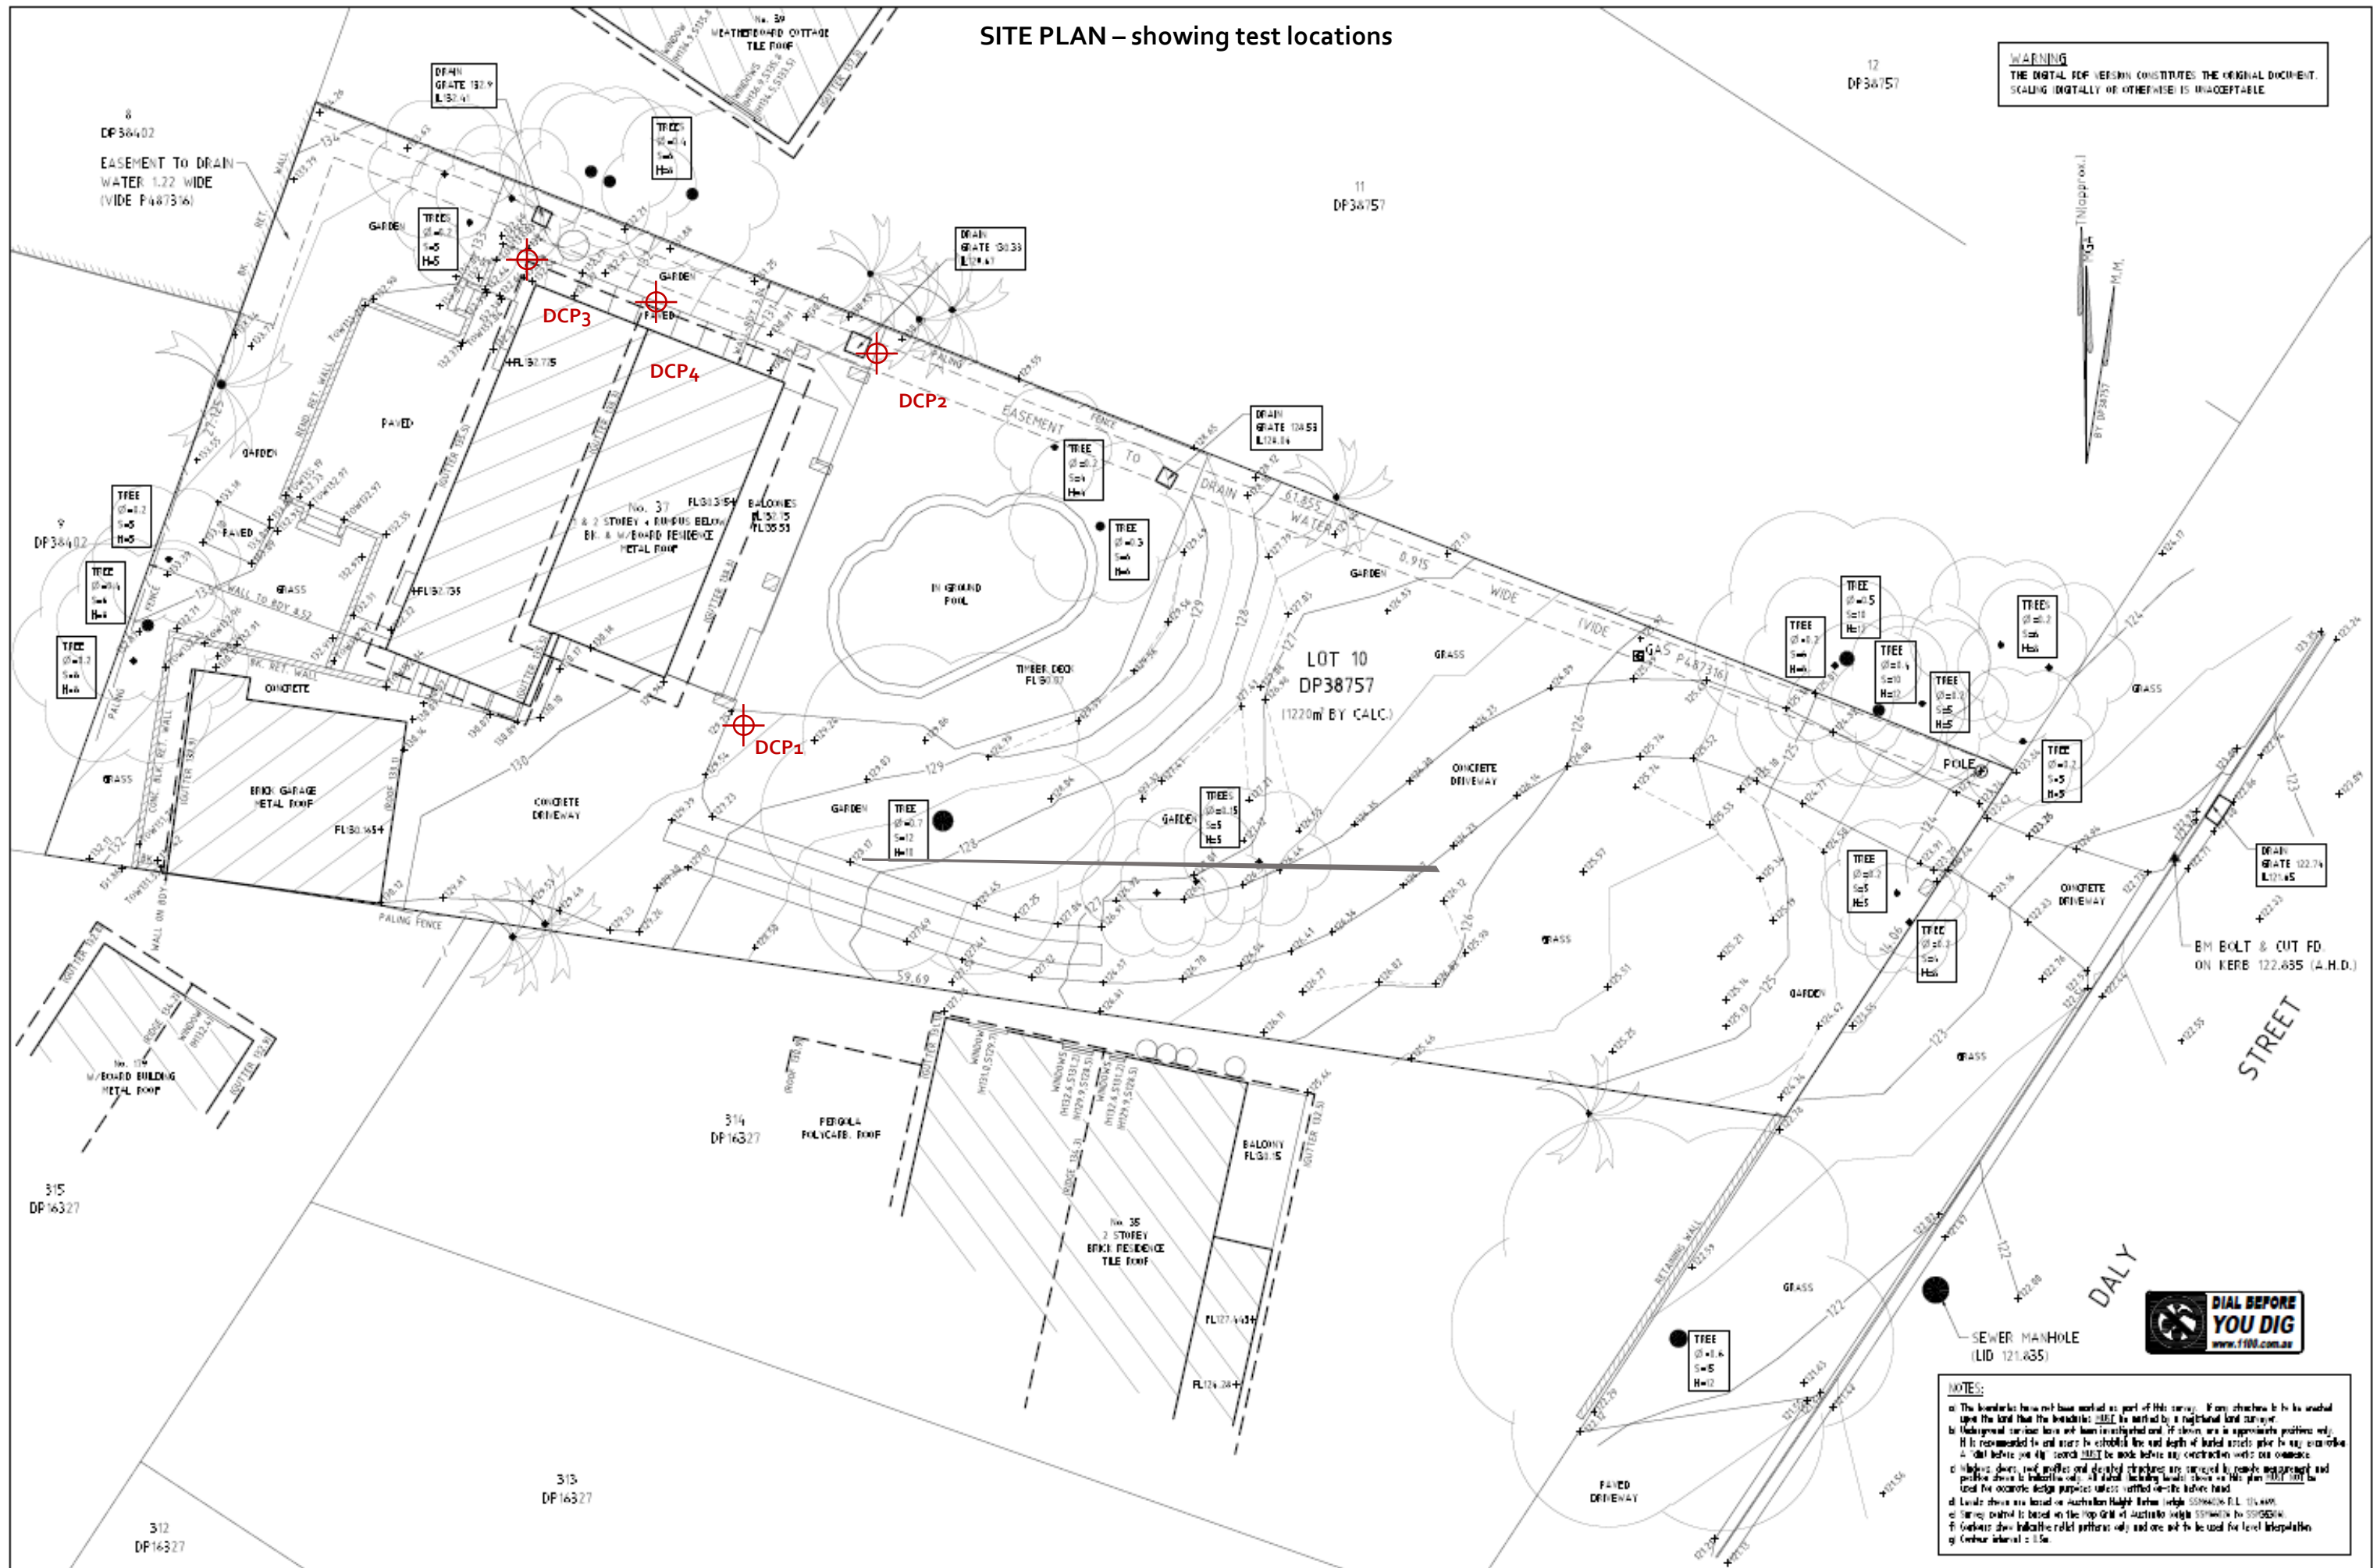
# SITE PLAN – showing test locations

Four Dynamic Cone Penetrometer (DCP) tests were put down to determine the relative density of the overlying soil and the depth to bedrock. The locations of the tests are shown on the site plan attached. It should be noted that a level of caution should be applied when interpreting DCP test results. The test will not pass through hard buried objects so in some instances it can be difficult to determine whether refusal has occurred on an obstruction in the profile or on the natural rock surface. This is not expected to be an issue for the testing on this site. However, excavation and foundation budgets should always allow for the possibility that the interpreted ground conditions in this report vary from those encountered

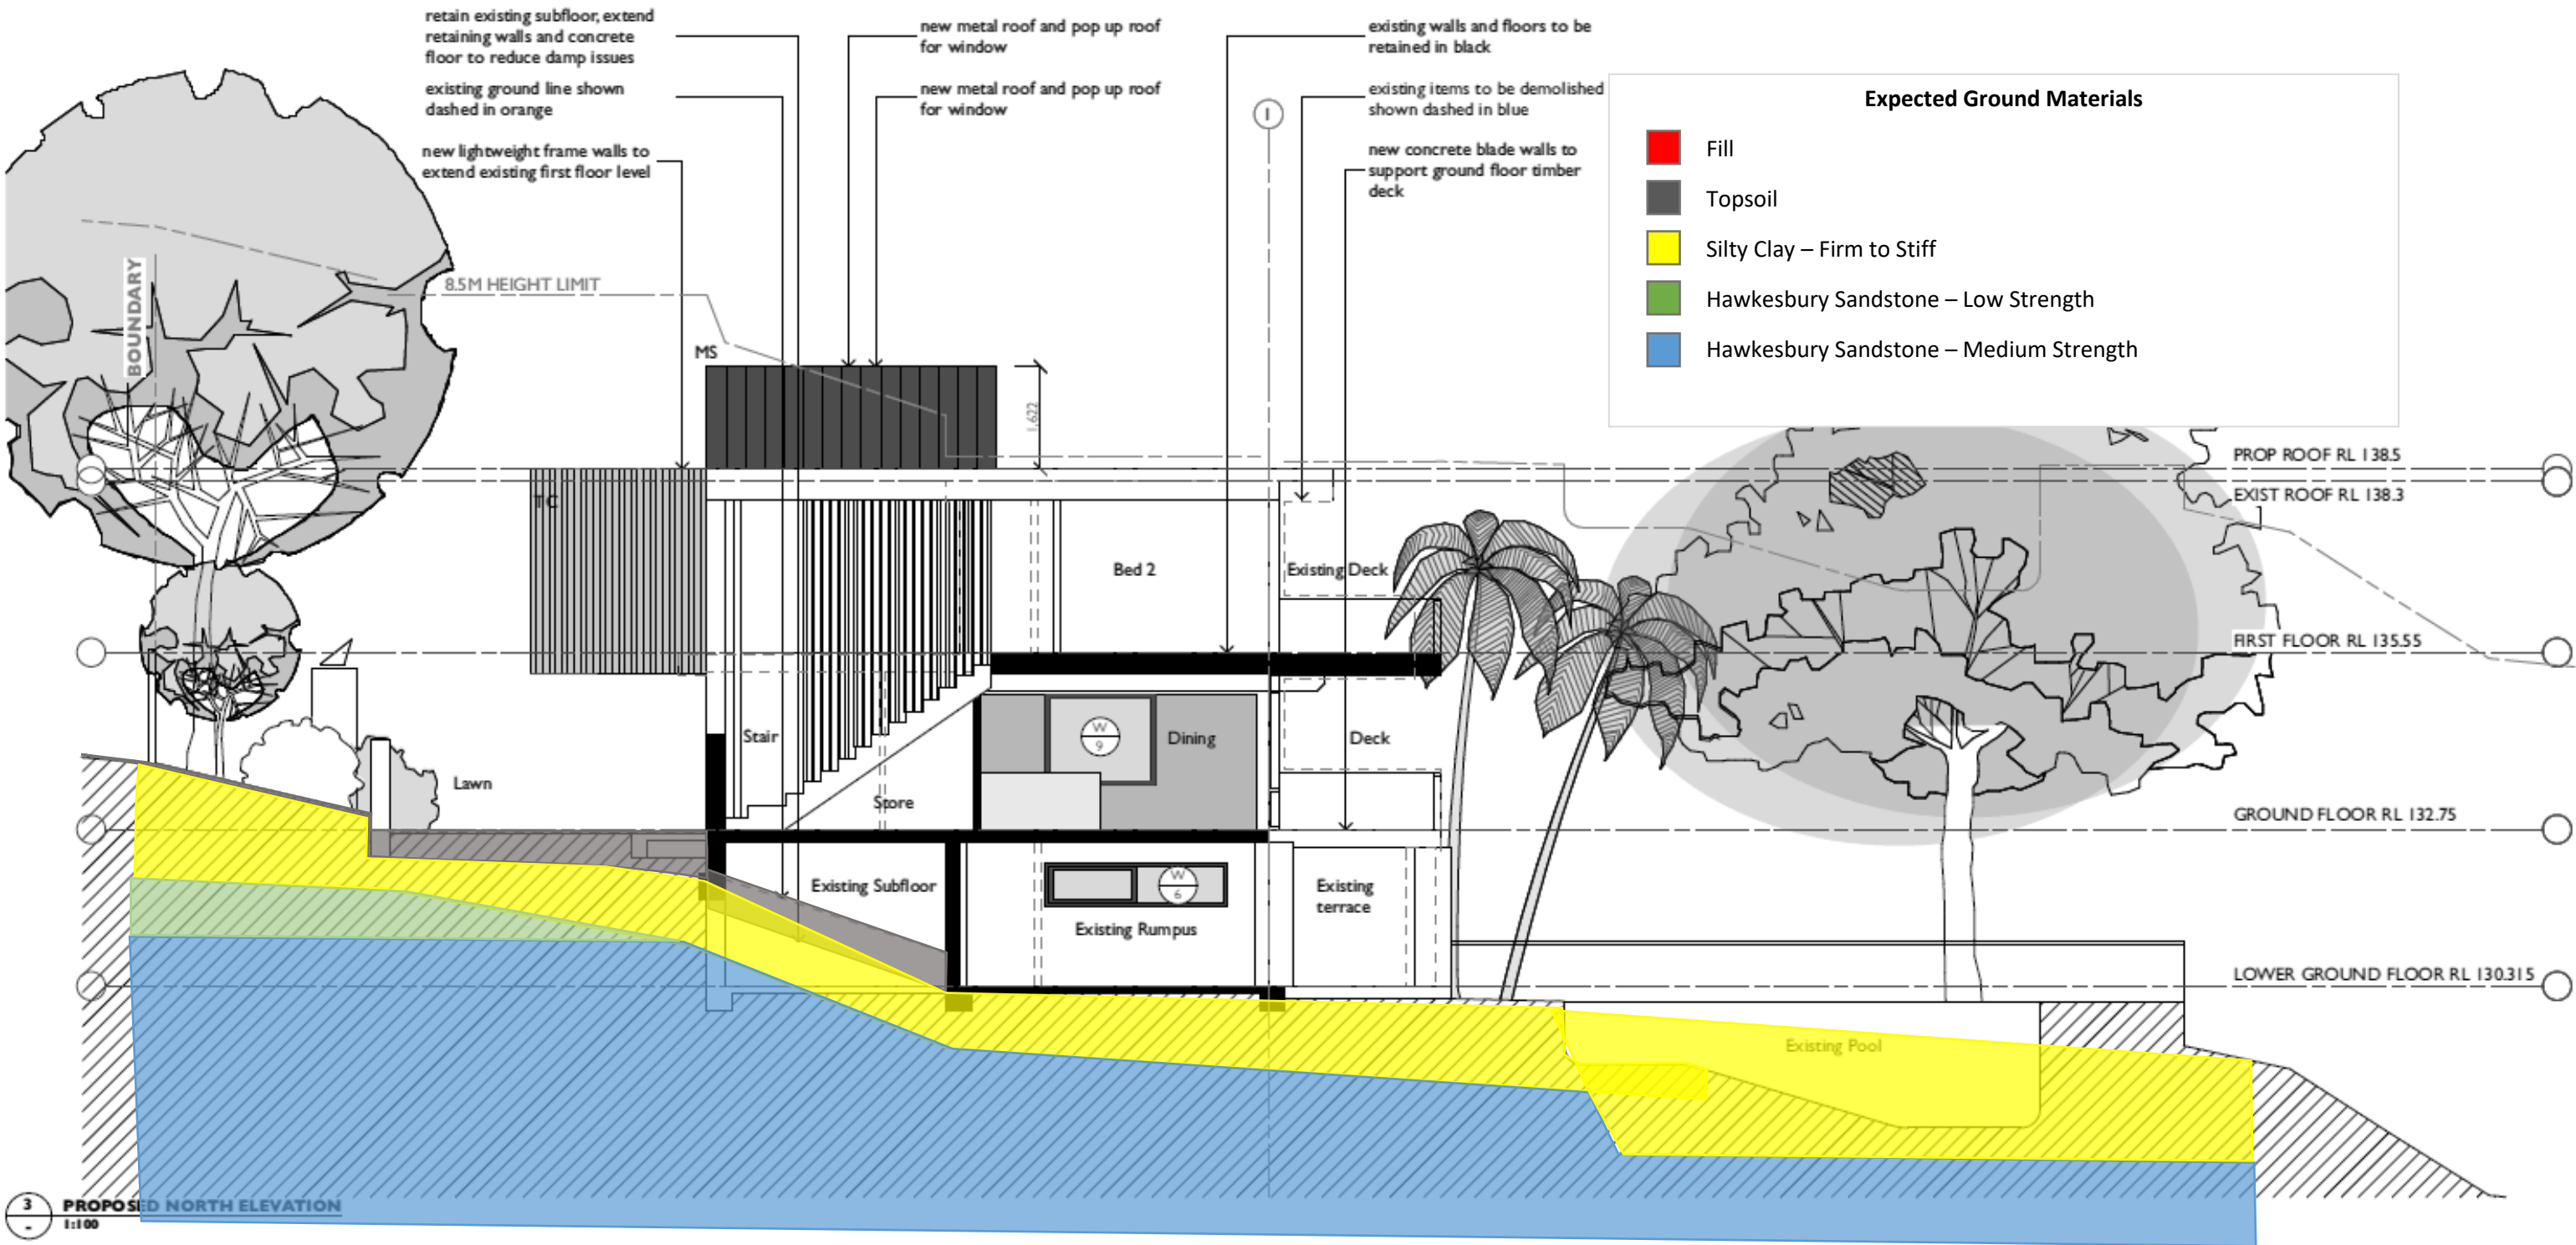
## TYPE SECTION – Diagrammatic Interpretation of expected Ground Materials

slightly deeper due to the presence of fill and due to the stepped nature of the underlying bedrock. As the DCP was bouncing at the end of three of the four tests, Medium Strength Rock is expected to underlie the entire site. See Type Section attached for a diagrammatical representation of the expected ground materials.
