J6048. 23rd May, 2025. Page 1.

GEOTECHNICAL INVESTIGATION:

New Pool at 3 Irrubel Road, Newport

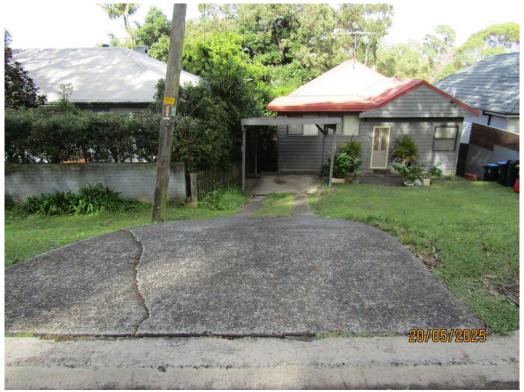
Photo 1

- 2.3 Fill provides a level platform for the road. The fill is battered at stable angles across the road reserve. At the road frontage, a concrete driveway runs down the slope to a carport at the NE side of the house (Photo 1). The part two storey house is supported on brick walls and piers (Photos 1 & 2). The supporting walls show no significant signs of movement and the supporting piers stand vertical (Photo 3). A low concrete block retaining wall supports a fill for a lawn area at the downhill side of the house (Photo 4). The wall displays some vertical cracks, but will be mostly demolished as part of the proposed works. Another lawn area extends from the downhill side of the retaining wall to the downhill property boundary (Photos 5 & 6). No signs of slope

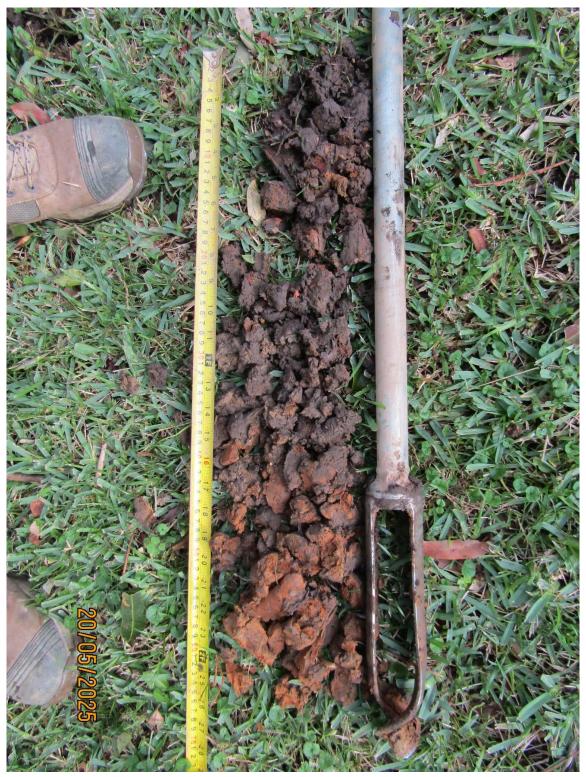
AUGER HOLE 1 (~RL23.9) – AH1 (Photo 7)

Depth (m)	Material Encountered
0.0 to 0.4	FILL , sandy soil and clay, with some rock fragments, dark brown, orange, damp, fine to coarse grained.
0.4 to 0.6	CLAY, orange/brown, firm to stiff, moist.

End of hole @ 0.6m in firm to stiff clay. No water table encountered.

Photo 7: AH1 – Downhole is from top to bottom.

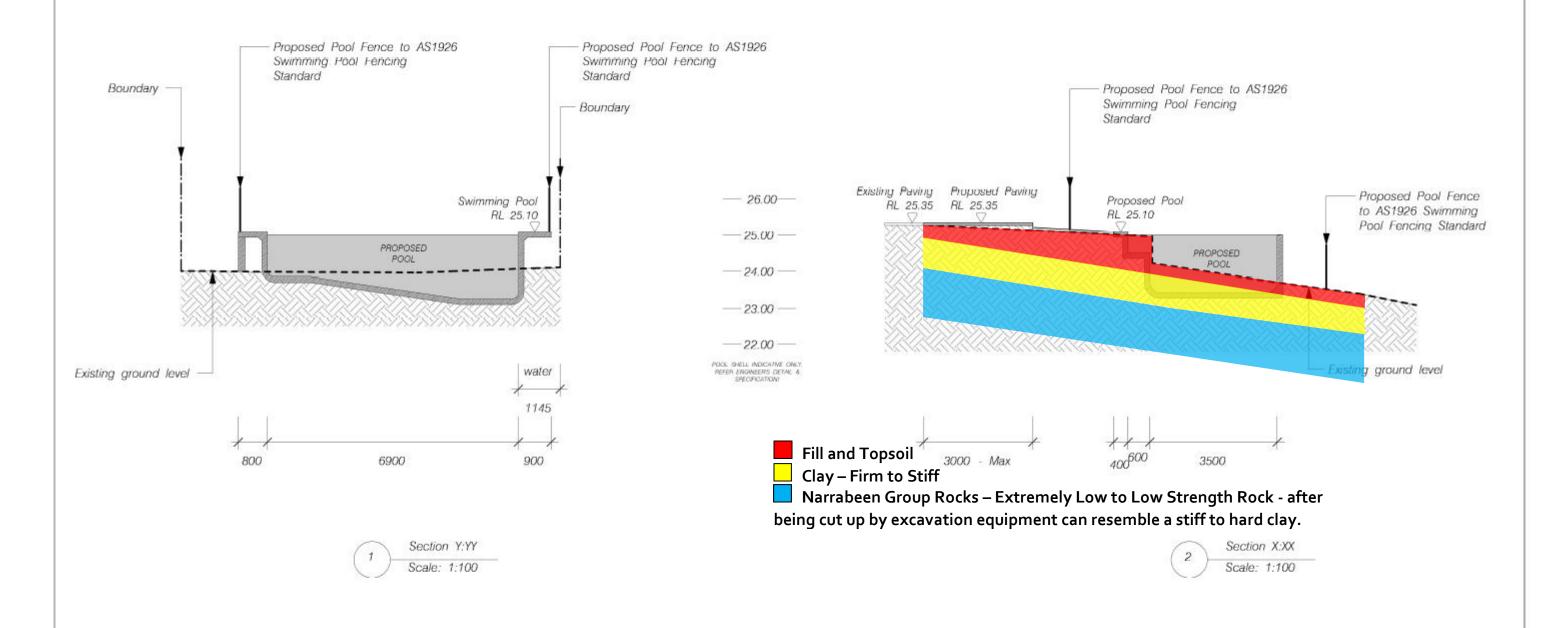
TYPE SECTION – Diagrammatical Interpretation of expected Ground Materials

The slope materials are colluvial at the near surface and residual at depth. In the test locations, the ground materials consist of fill and a thin topsoil over Firm to Stiff Clays. Fill to a maximum depth of ~0.8m provides level platforms for lawn areas across the property. In the test locations, the clays merge into the weathered zone of the underlying rock at an average depth of ~1.2m below the current surface. The weathered zone of the underlying rock is interpreted as Extremely Low to Low Strength Rock. It is to be noted that this material is a soft rock and can appear as a mottled stiff clay when it is cut up by excavation equipment.

See Type Section attached for a diagrammatical representation of the expected ground
