Report Title: Geotechnical Report 1164 Barrenjoey Road, Palm Beach
Report Date: 6/11/24

GEOTECHNICAL INVESTIGATION:

New House at **1164 Barrenjoey Road, Palm Beach**

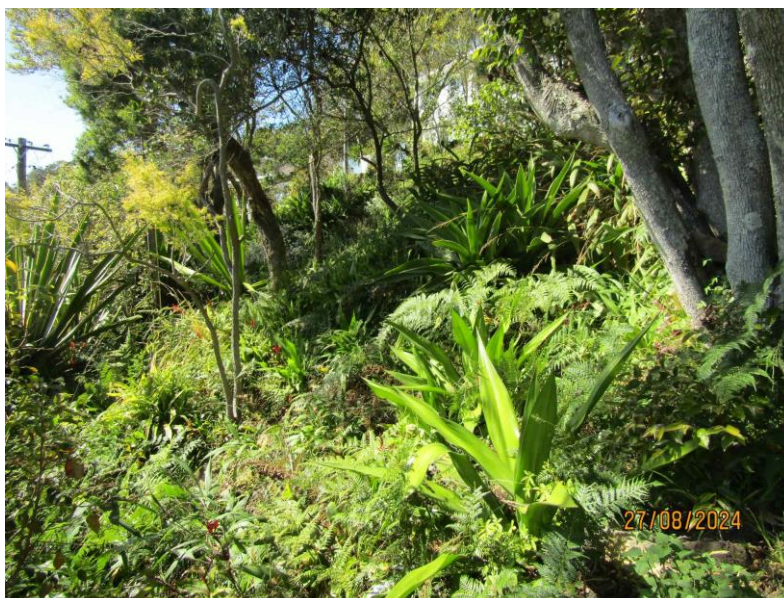
Photo 1

2.3 A steeply graded garden area rises from the road frontage (Photos 1 & 2). Fill to an estimated depth of ~1.0m provides a level platform for a lawn area at the downhill side of the house (Photo 3). The fill batter merges into the natural steep slope below (Photos 1 & 2). The single storey house with balcony is supported on sandstone block walls, sandstone block piers and brick piers (Photos 3 & 4). Some of the supporting piers are tilting downslope slightly (Photo 4), but the house will be demolished as part of the proposed works. Medium Strength Sandstone bedrock outcrops at the uphill side of the house and steps up the steep slope at the uphill side of the property (Photos 5 to 7). Some of the exposed rock faces display some minor jointing and undercutting, but appear to be currently stable. The slope across the uphill side of the property is densely vegetated (Photo 8).

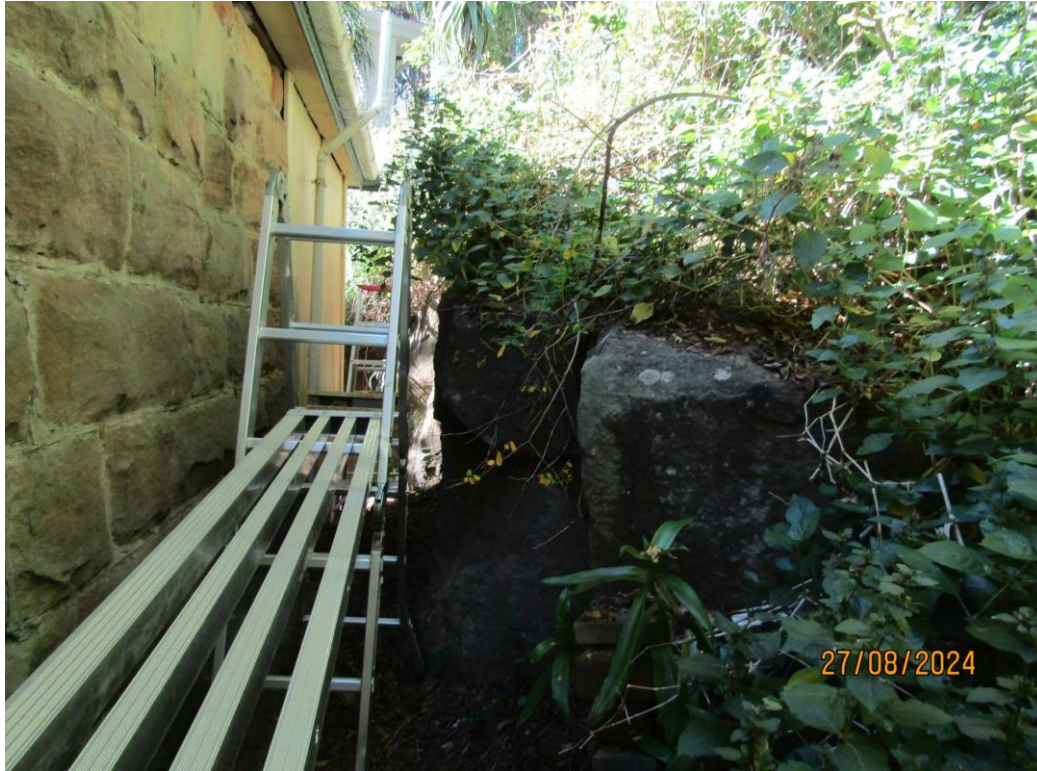
Photo 5

The uphill side of the property is underlain by fill and topsoil over Medium Strength Sandstone bedrock that was exposed at the surface at various locations (Photos 5 to 7). DCPs 1 to 4 encountered this ground material at depths of between ~0.9m to ~1.8m below the current surface, being deeper in the filled areas and slightly variable due to the stepped nature of the rock. The contact between Hawkesbury Sandstone and the Narrabeen Group Rocks is interpreted to be at a level close to the ground floor of the existing house. Below this level the downhill side of the proposed works are interpreted to be underlain by the Narrabeen Group Rocks.

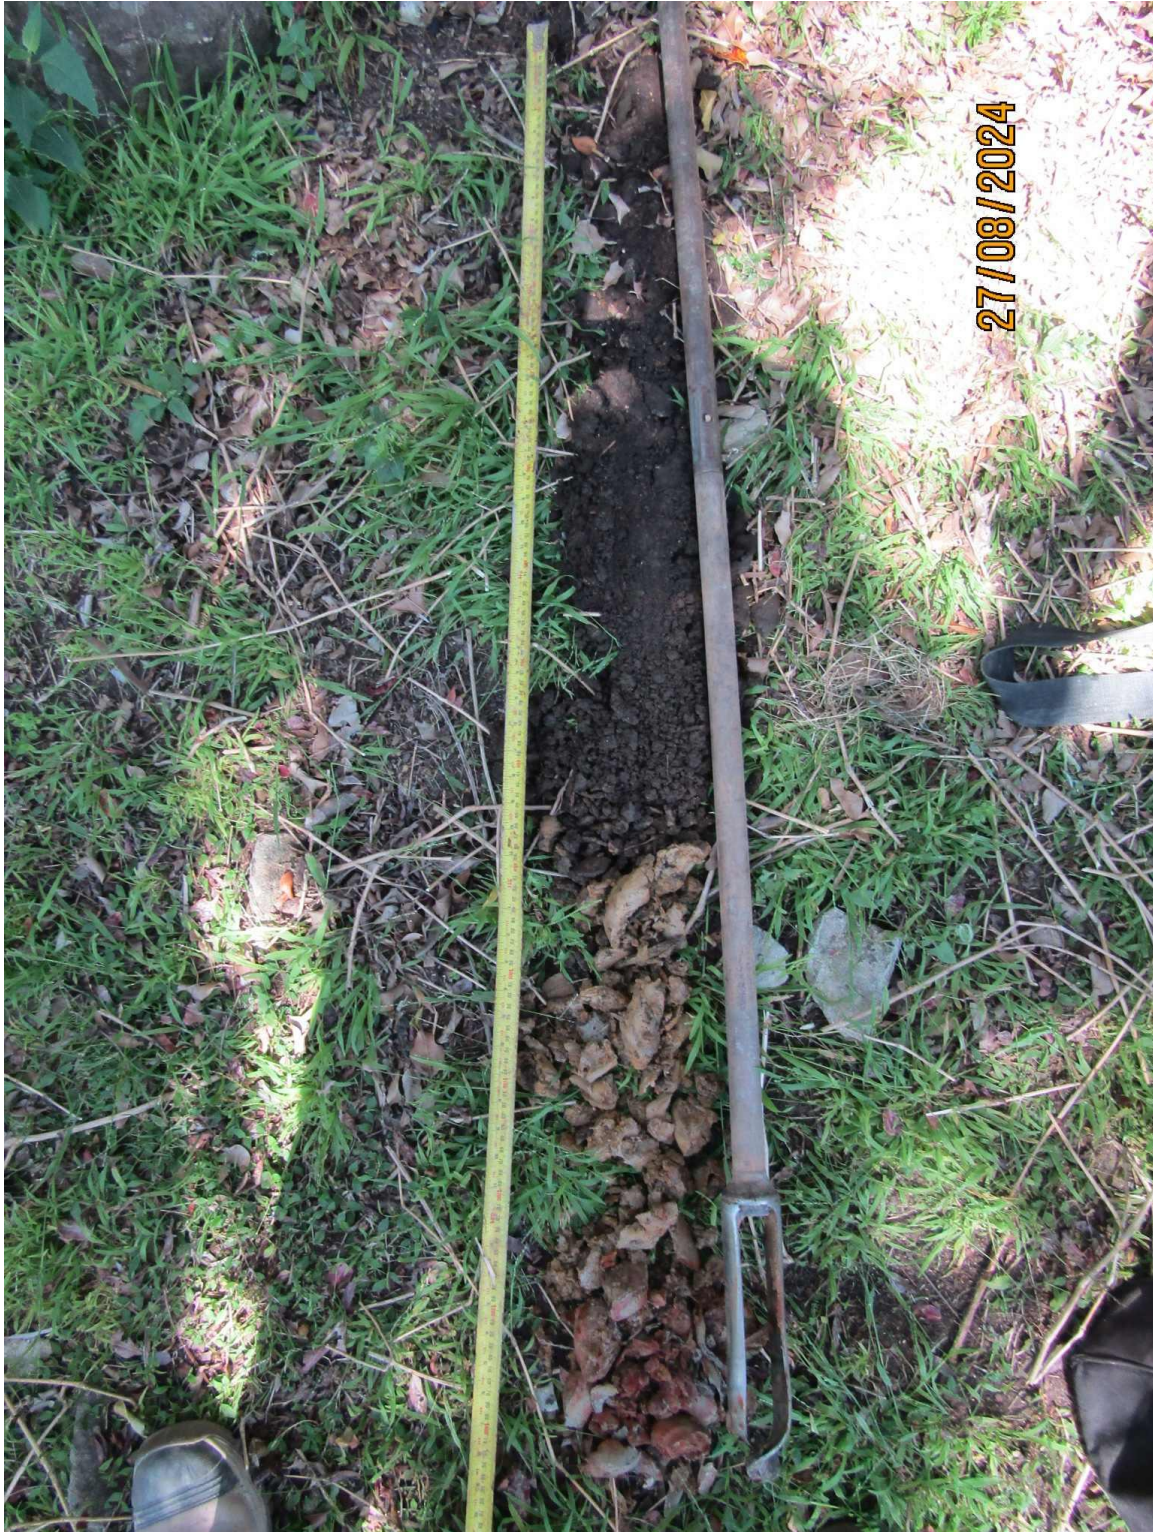
Depth (m)	Material Encountered
0.0 to 0.4	FILL , sandy soil, with some rock fragments, dark brown, dry, fine to coarse grained.
0.4 to 0.9	TOPSOIL , sandy soil, dark brown, moist, fine to medium grained.
0.9 to 1.2	CLAY , yellow brown, stiff to very stiff, moist.
1.2 to 1.4	CLAY , derived from weathered shale, grey, orange red, maroon, mottled, very stiff to hard, moist.

Refusal @ 1.4m on weathered shale. No water table encountered.

Photo 9: AH1 – Downhole is from top to bottom.

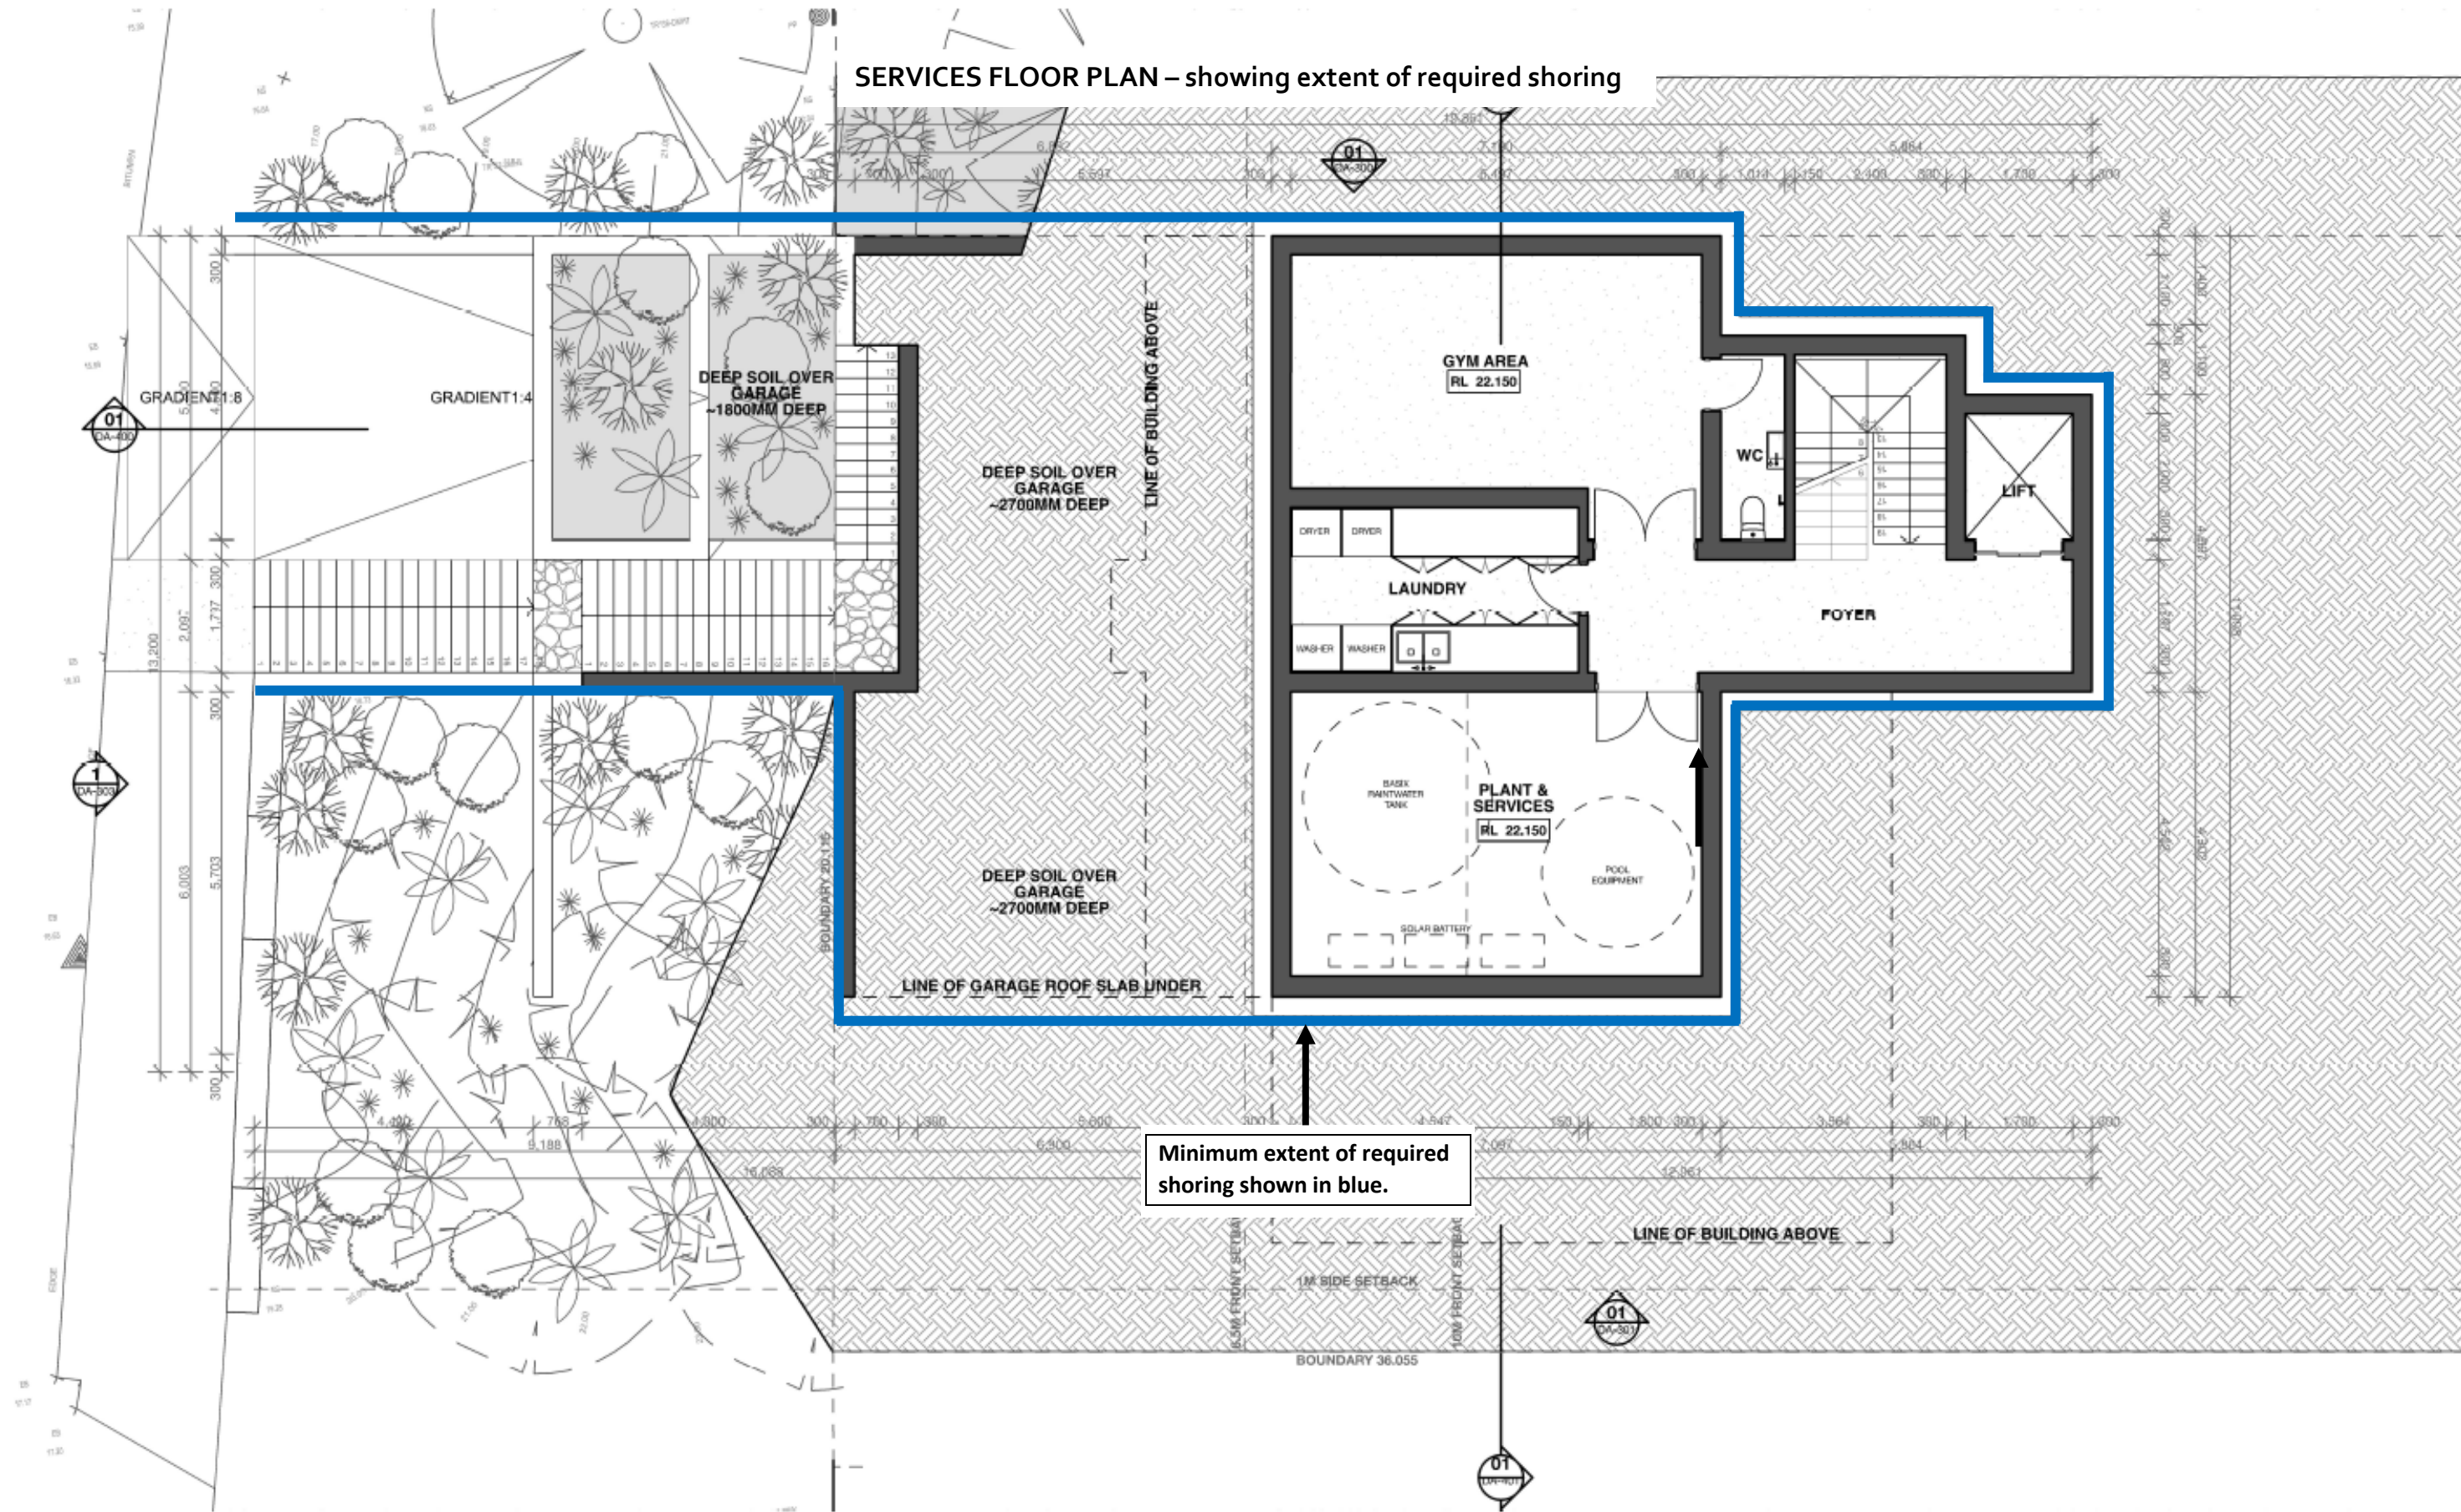
SERVICES FLOOR PLAN – showing extent of required shoring

Minimum extent of required shoring shown in blue.

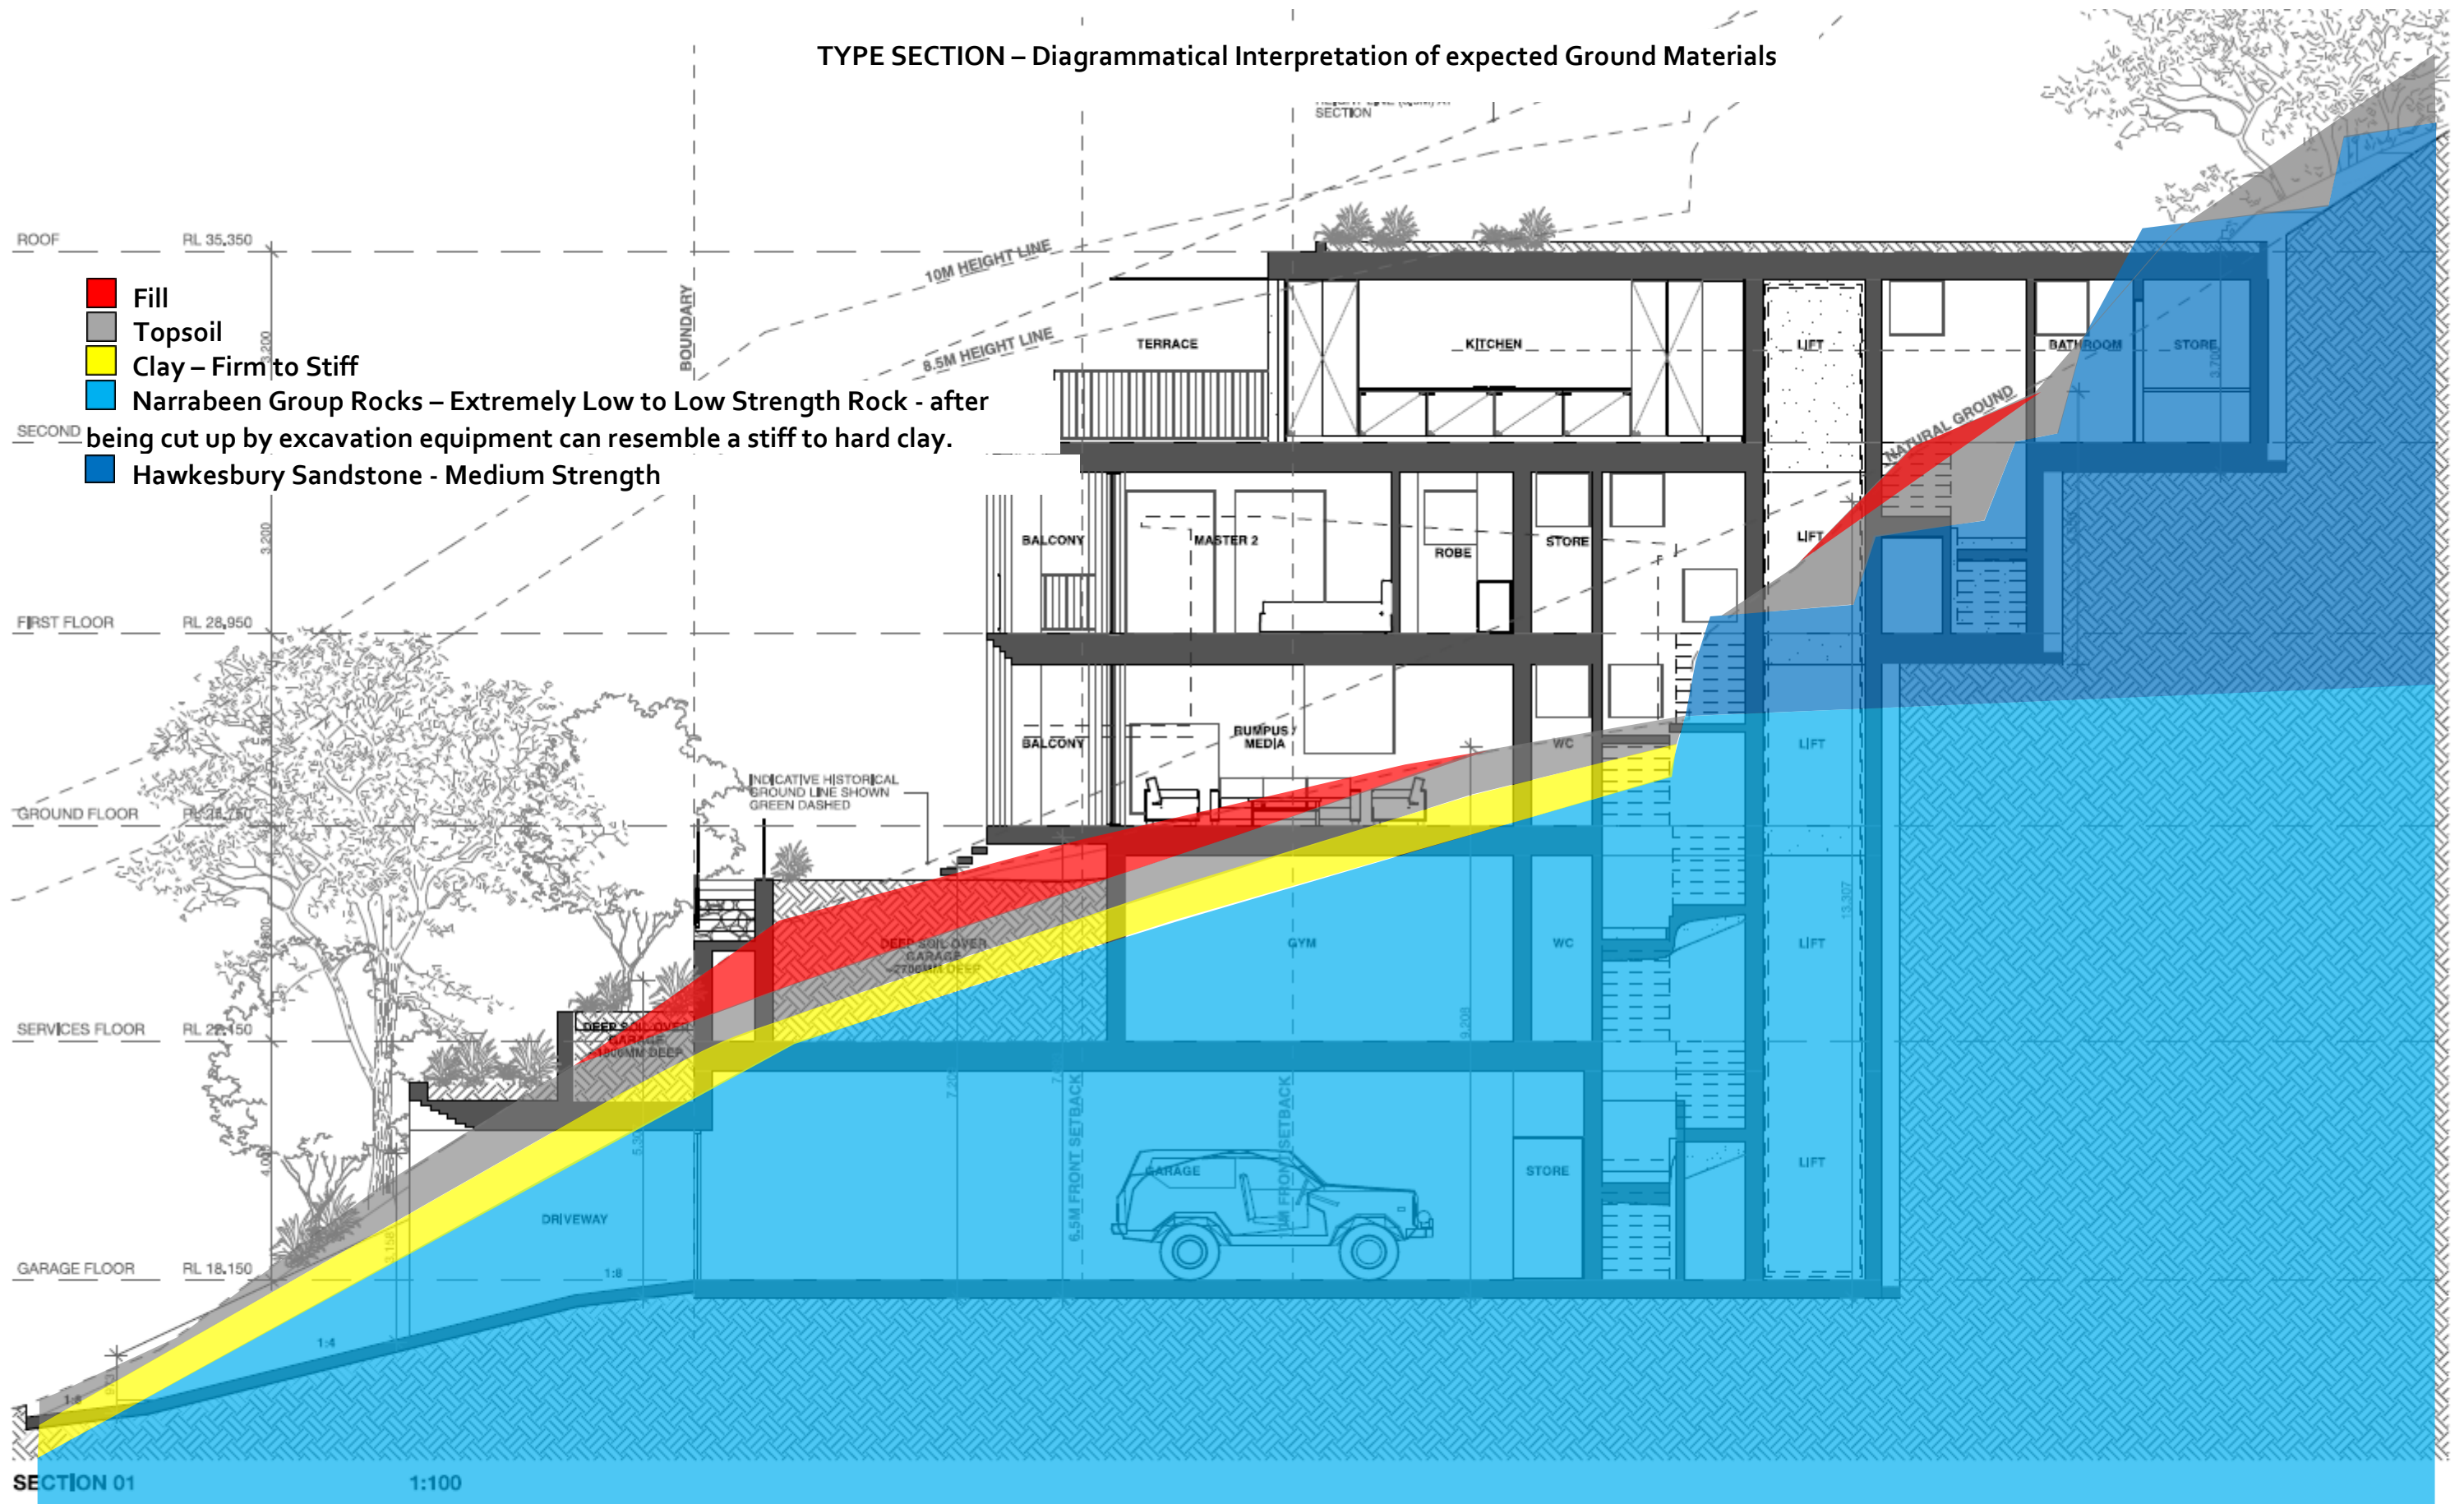
TYPE SECTION – Diagrammatical Interpretation of expected Ground Materials

The downhill side of the property is underlain by fill, topsoil, and clay over weathered rock. In DCPs 6 & 8, the clays merge into the weathered zone of the underlying rock at depths of between ~1.4m to ~2.1m below the current surface, being deeper where the fill is deeper (DCP6). The weathered zone of the underlying rock is interpreted as Extremely Low to Low Strength Rock. It is to be noted that this material is a soft rock and can appear as a mottled stiff clay when it is cut up by excavation equipment. See Type Section attached for a diagrammatical representation of the expected ground materials.
