2401 TOTAL SURVEYING SOLUTIONS 24
PENRITH AVE WHEELER HEIGHTS

24/06/2019

Sewer Reference: LINE 1
 Section Numer: 1
 Start node: SWP B
 End node: SWP A

Inspection Report

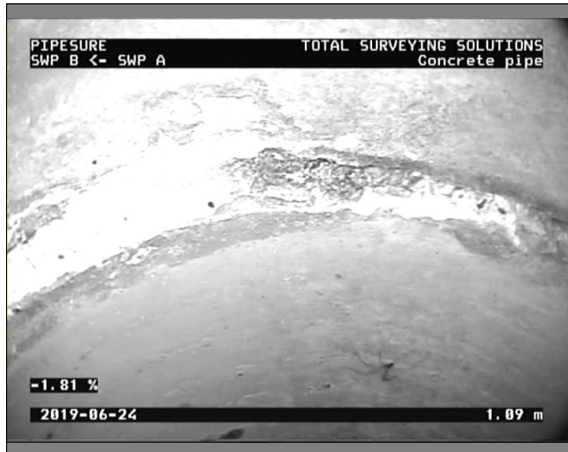
| | | 1.09 | JDR | Joint displaced radially, radial displacement 11-20mm , at 11 o'clock | 5; |

Photo: 1_3A, 00:01:02
1.09m, Joint displaced radially, radial displacement 11-20mm ,
at 11 o'clock

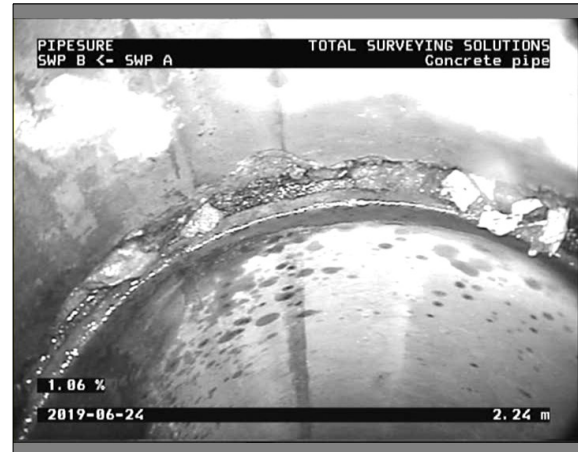
| | | 2.24 | BM | Breaking, some pieces are missing, at joint, length of break 100 , from 12 to 12 o'clock | 60; |

Photo: 1_4A, 00:01:39
2.24m, Breaking, some pieces are missing, at joint, length of
break 100 , from 12 to 12 o'clock

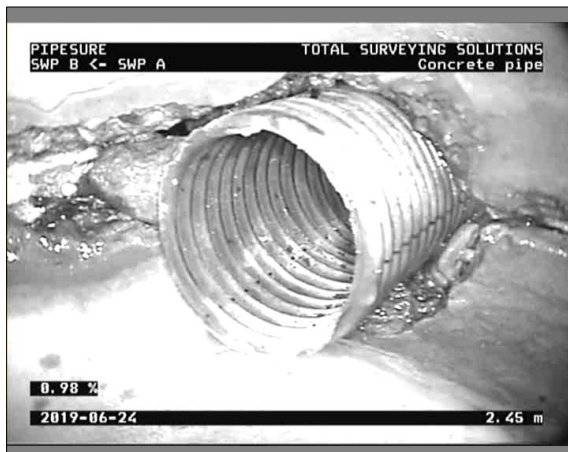
Photo: 1_5A, 00:02:05
2.45m, Junction open, good workmanship, diameter 100mm ,
General Comments agg line, at 1 o'clock / agg line

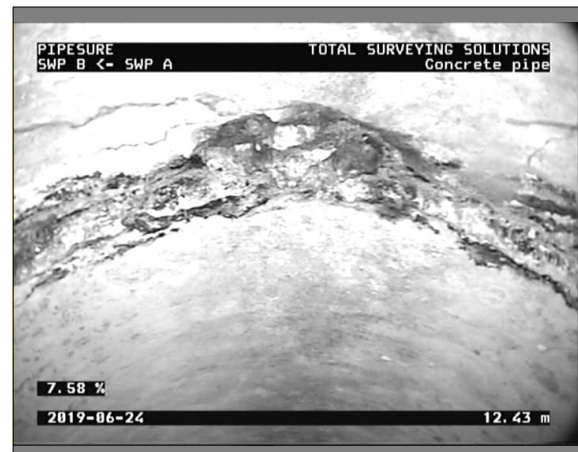
| | | 12.43 | SS | Spalling of the conduit fabric, localized chipping of one or more of each, at joint , from 12 to 12 o'clock | 20; |

Photo: 1_6A, 00:03:27
12.43m, Spalling of the conduit fabric, localized chipping of one
or more of each, at joint , from 12 to 12 o'clock

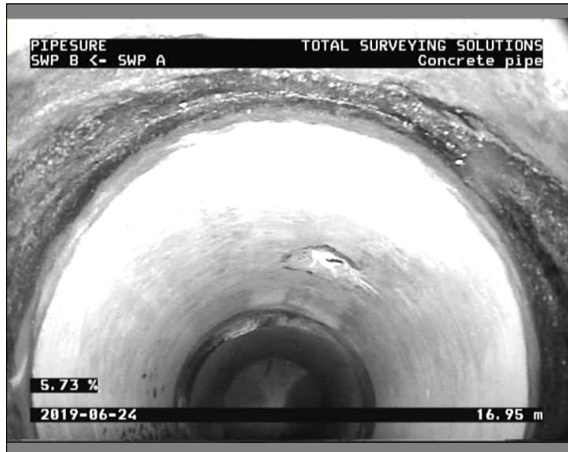
Photo: 1_7A, 00:04:26
16.95m, Infiltration, sweating, at joint , from 12 to 12 o'clock

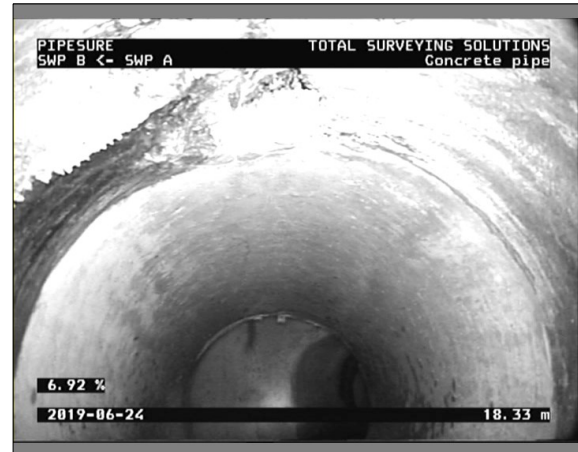
| | | 18.33 | SS | Spalling of the conduit fabric, localized chipping of one or more of each, at joint , from 12 to 12 o'clock | 20; |

Photo: 1_8A, 00:05:27
18.33m, Spalling of the conduit fabric, localized chipping of one or more of each, at joint , from 12 to 12 o'clock

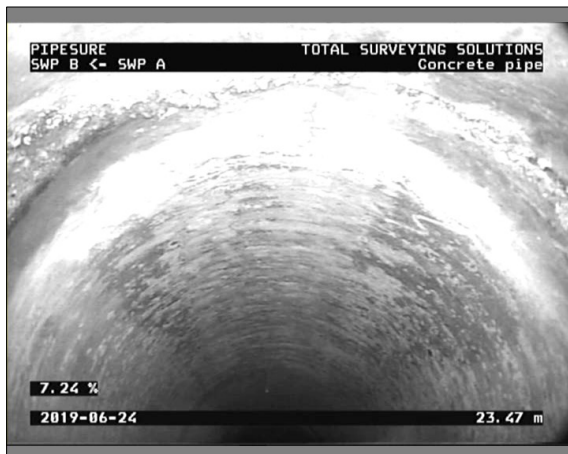
Photo: 1_11A, 00:07:34
23.46m, Infiltration, sweating, at joint , from 12 to 12 o'clock

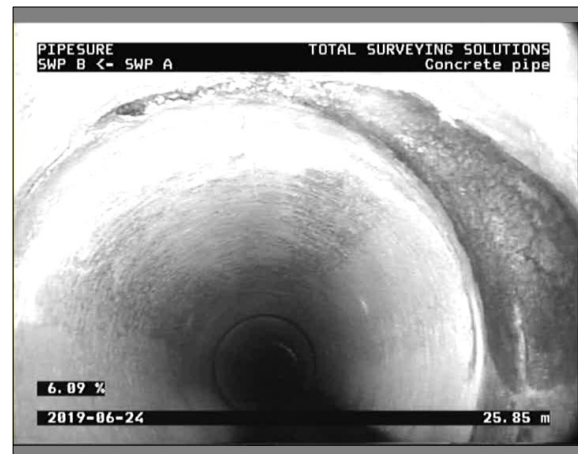
Photo: 1_12A, 00:08:16
25.85m, Infiltration, sweating, at joint , from 1 to 6 o'clock

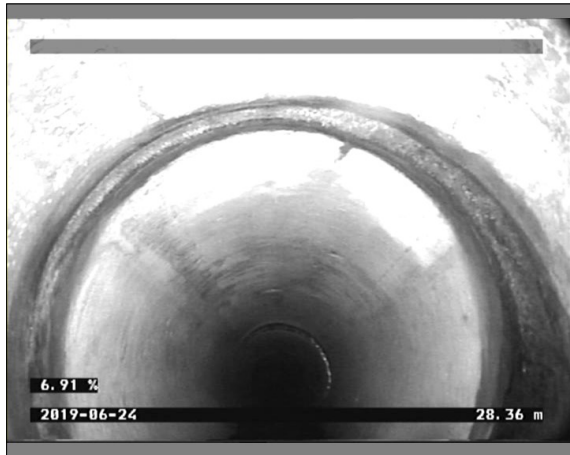
Photo: 1_13A, 00:09:06
28.36m, Infiltration, sweating, at joint , from 12 to 12 o'clock

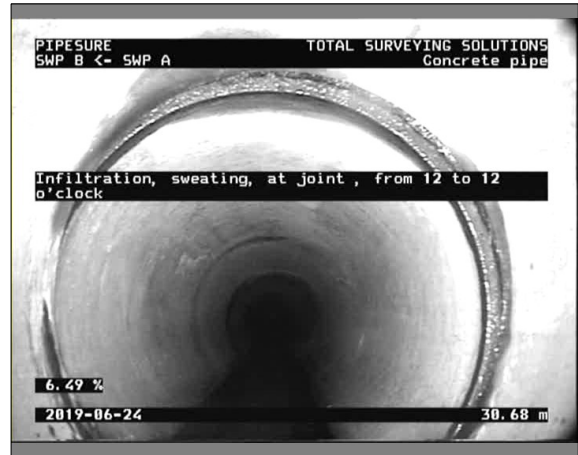
Photo: 1_14A, 00:09:42
30.68m, Infiltration, sweating, at joint , from 12 to 12 o'clock

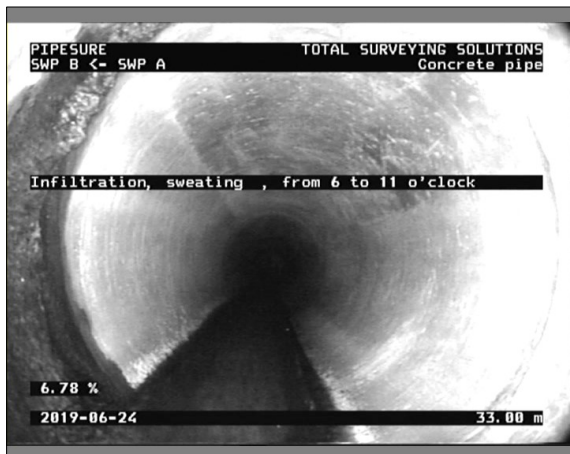
Photo: 1_15A, 00:10:08
33m, Infiltration, sweating , from 6 to 11 o'clock

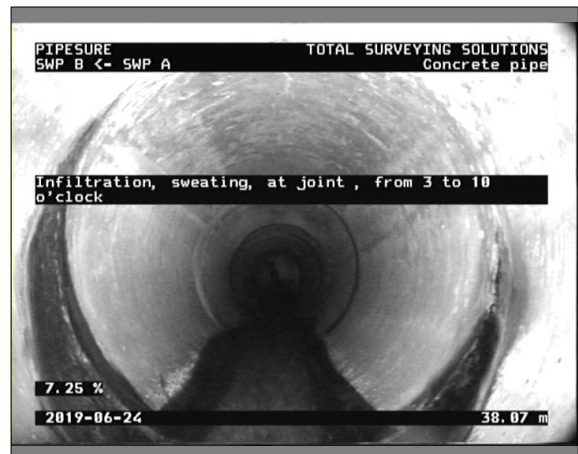
Photo: 1_16A, 00:10:50
38.07m, Infiltration, sweating, at joint , from 3 to 10 o'clock

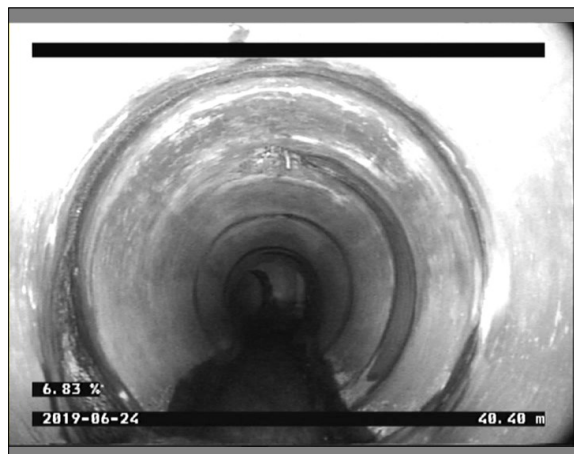
Photo: 1_17A, 00:11:19
40.4m, Infiltration, sweating, at joint , from 12 to 12 o'clock
