ARBORICULTURAL IMPACT ASSESSMENT REPORT

Site Address: 231-233 McCarrs Creek Road,
CHURCH POINT, NSW, 2105

Inspection Dates: 30th September 2021
Report Date: 12th October 2021
Revised Date: 2nd May 2022

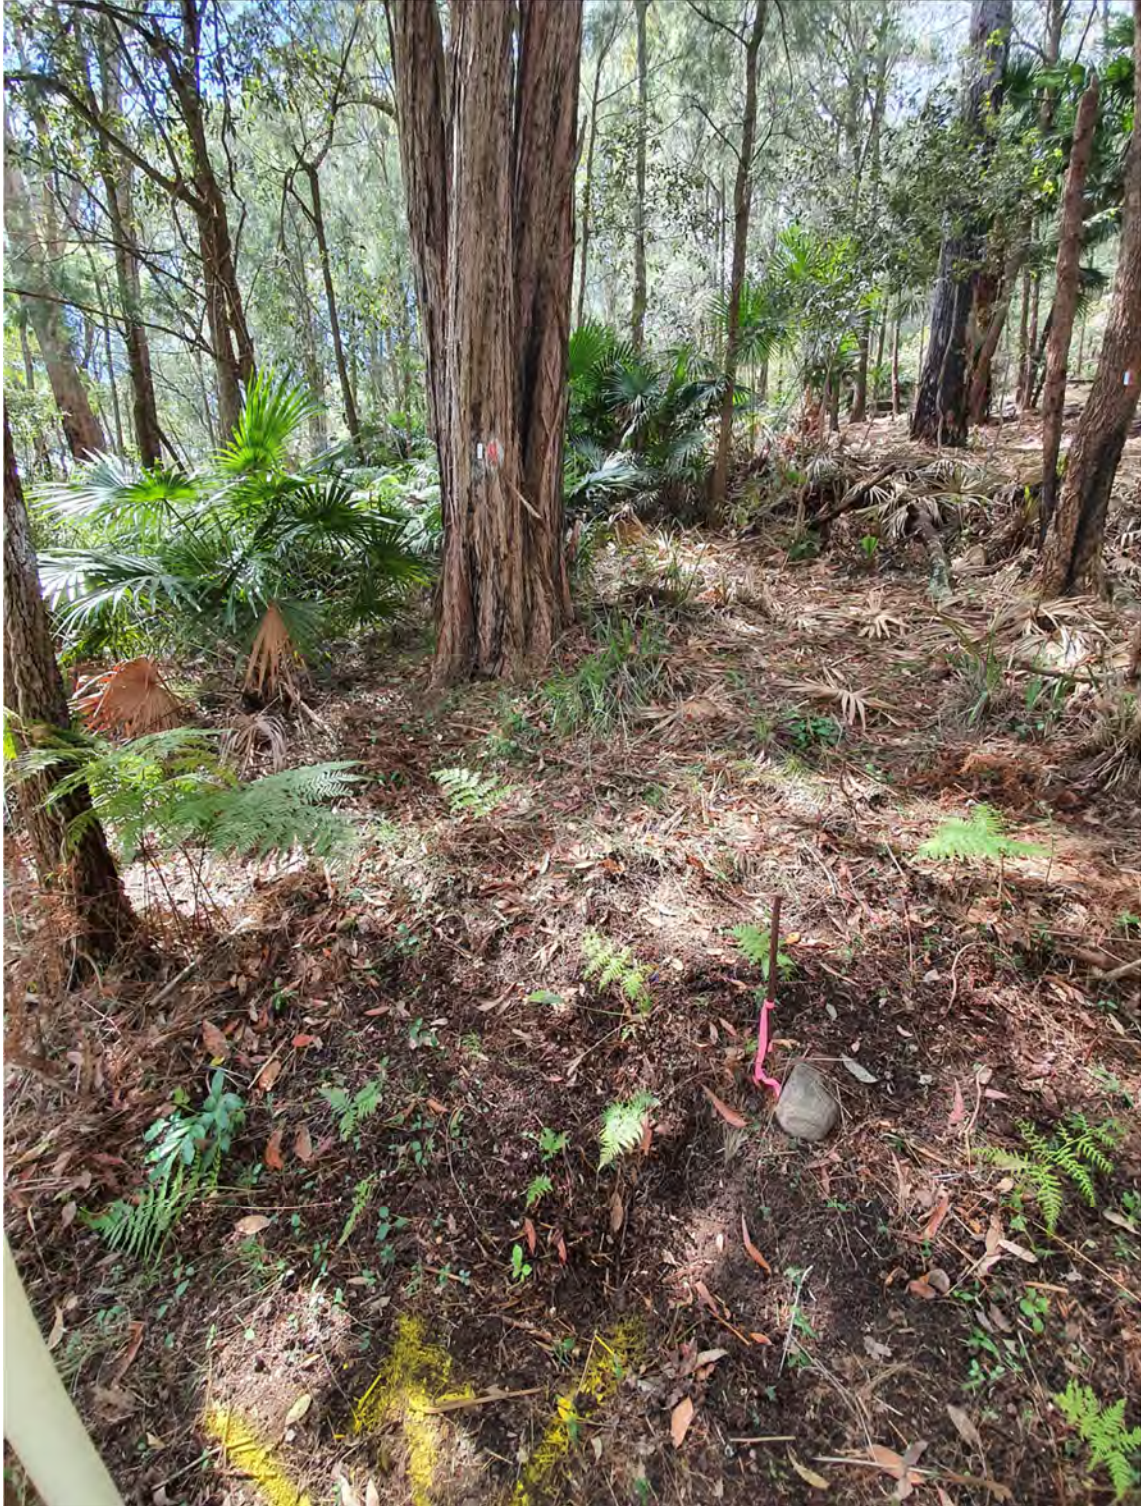
Image 3: A view of the site from the South-western Boundary looking to the northeast. Tree 1 [centre], Tree2 [right].

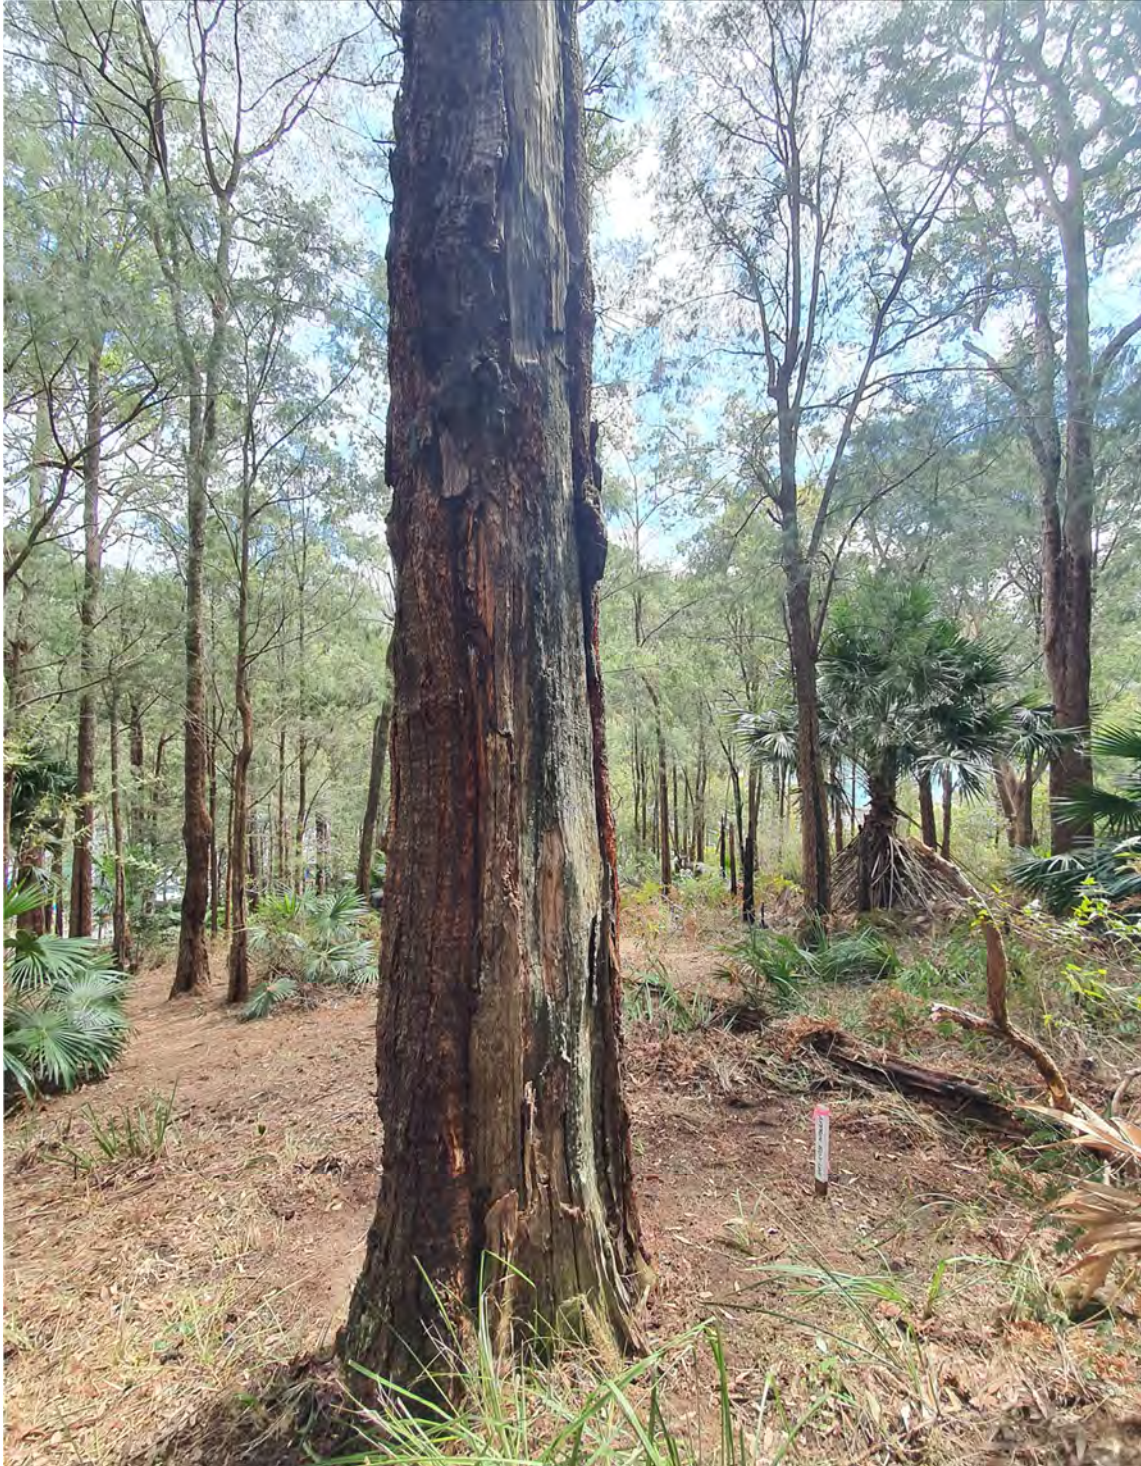
Image 4: A view from the South-Eastern Boundary looking Northwest. Tree 10 [centre] with extensive cambium dieback visible.

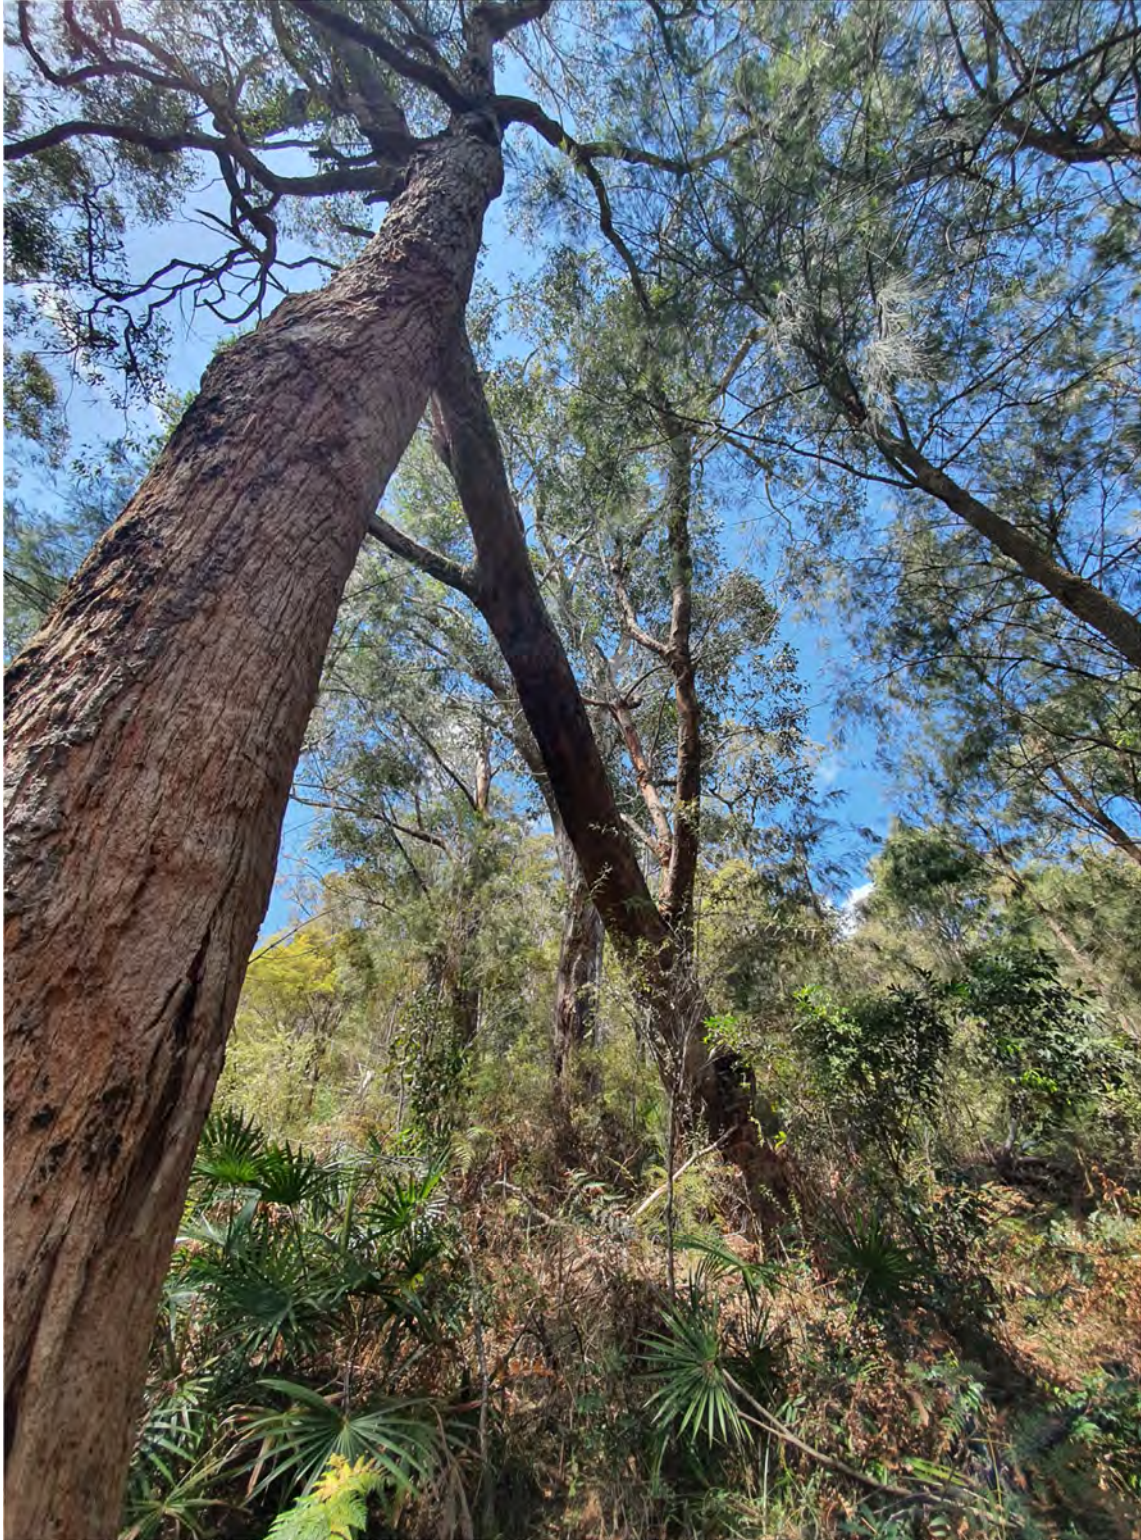
- 3.4.7 The neighbouring Tree 12 (Blackbutt) is a large remnant tree within the National Park. It presented with a critical lean of 25° above horizontal towards the development site.

Image 5: The critical lean of Tree 12 before Hazard reduction burning.

5.2.3 It is recommended that the removal of T12 (Blackbutt) occurs irrespective of development. This tree is located on adjoining land & the removal of this tree is *subject to discussions* with the relevant landowner & council.

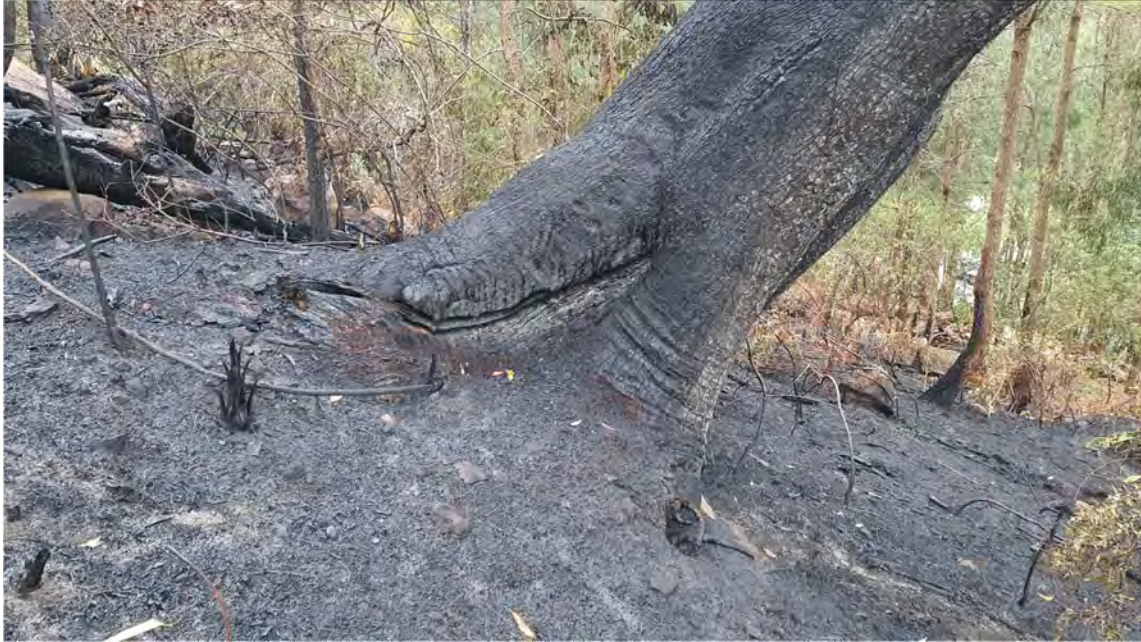
- Subsequent assessment of the tree following the hazard reduction burn has revealed this tree is growing atop a natural sandstone rock scarp & appears to be in a state of active failure due to signs of soil & bark separation.

This tree was observed in a state of active failure & poses a high risk of failure, impacting the development site.

Image 6: Tree 12 as seen following the Hazard Reduction burn. Cambium and soil separation was noted indicating this tree is at a high risk of failure in the near future.

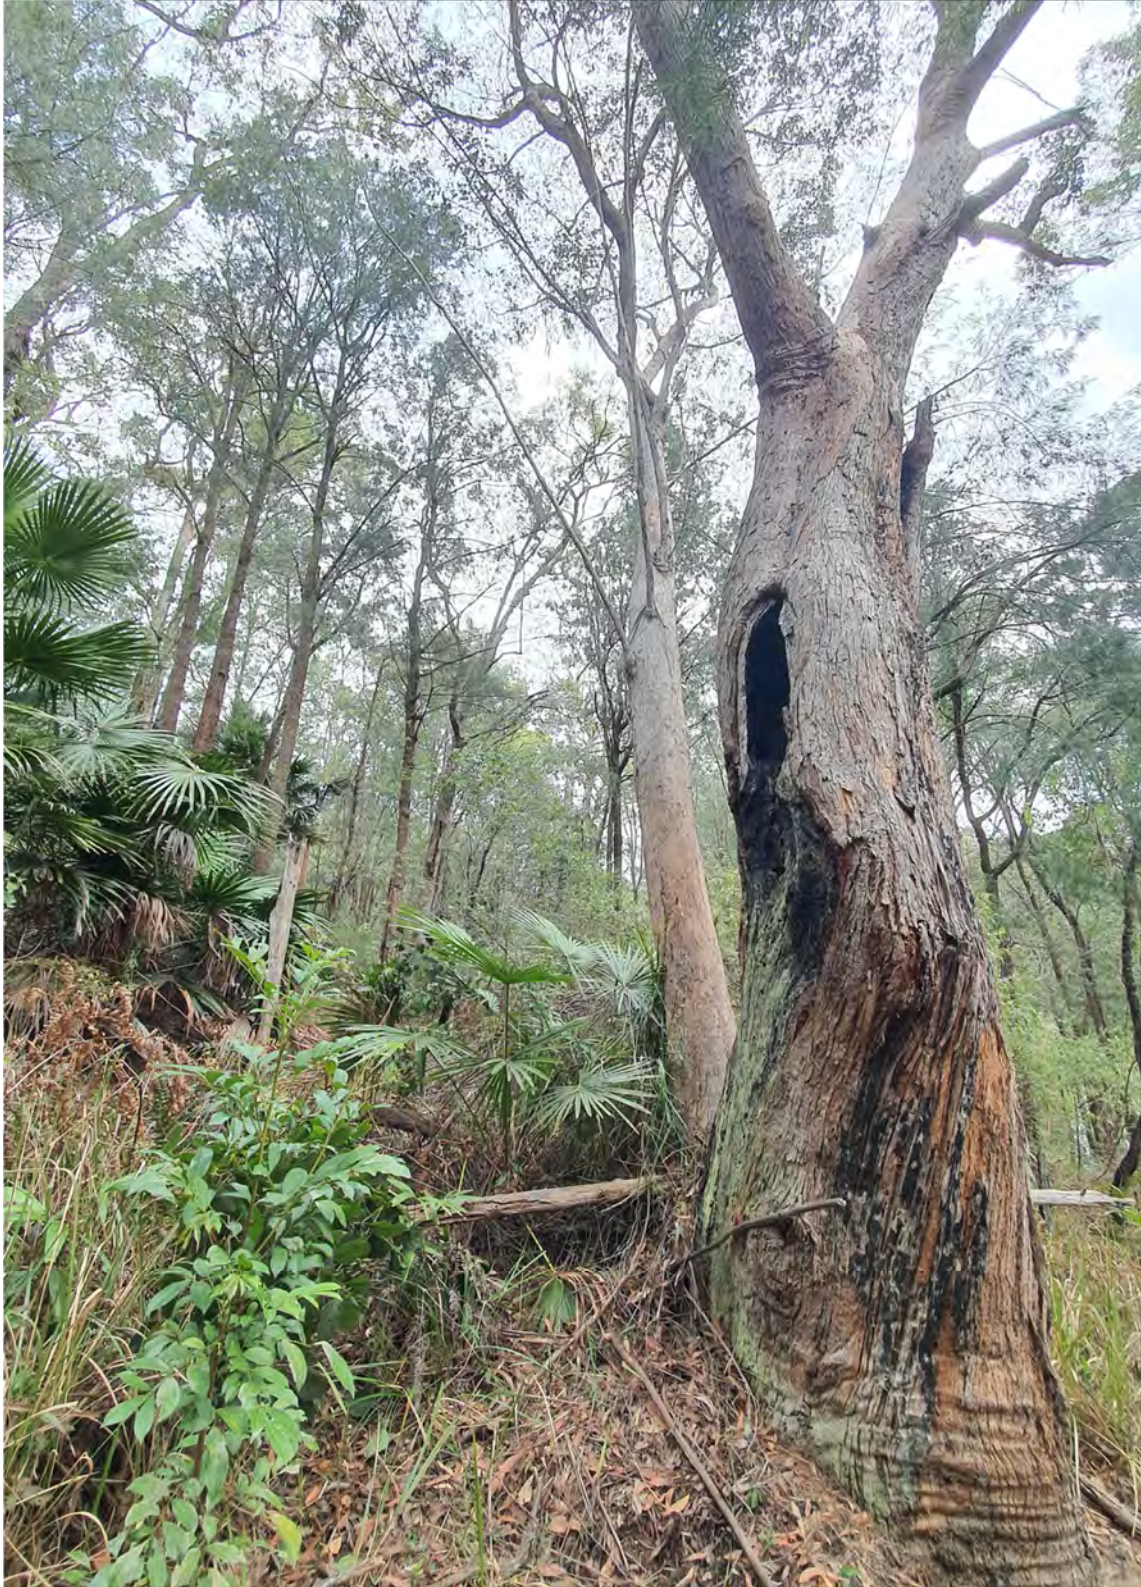
Image 8: Tree 21 [right] with previous fire damage formed hollow.
