Geotechnical Assessment

Project: Alterations & Additions
77 Bungan Head Road, Newport NSW

For Alterations & Additions at

77 Bungan Head Road, Newport NSW

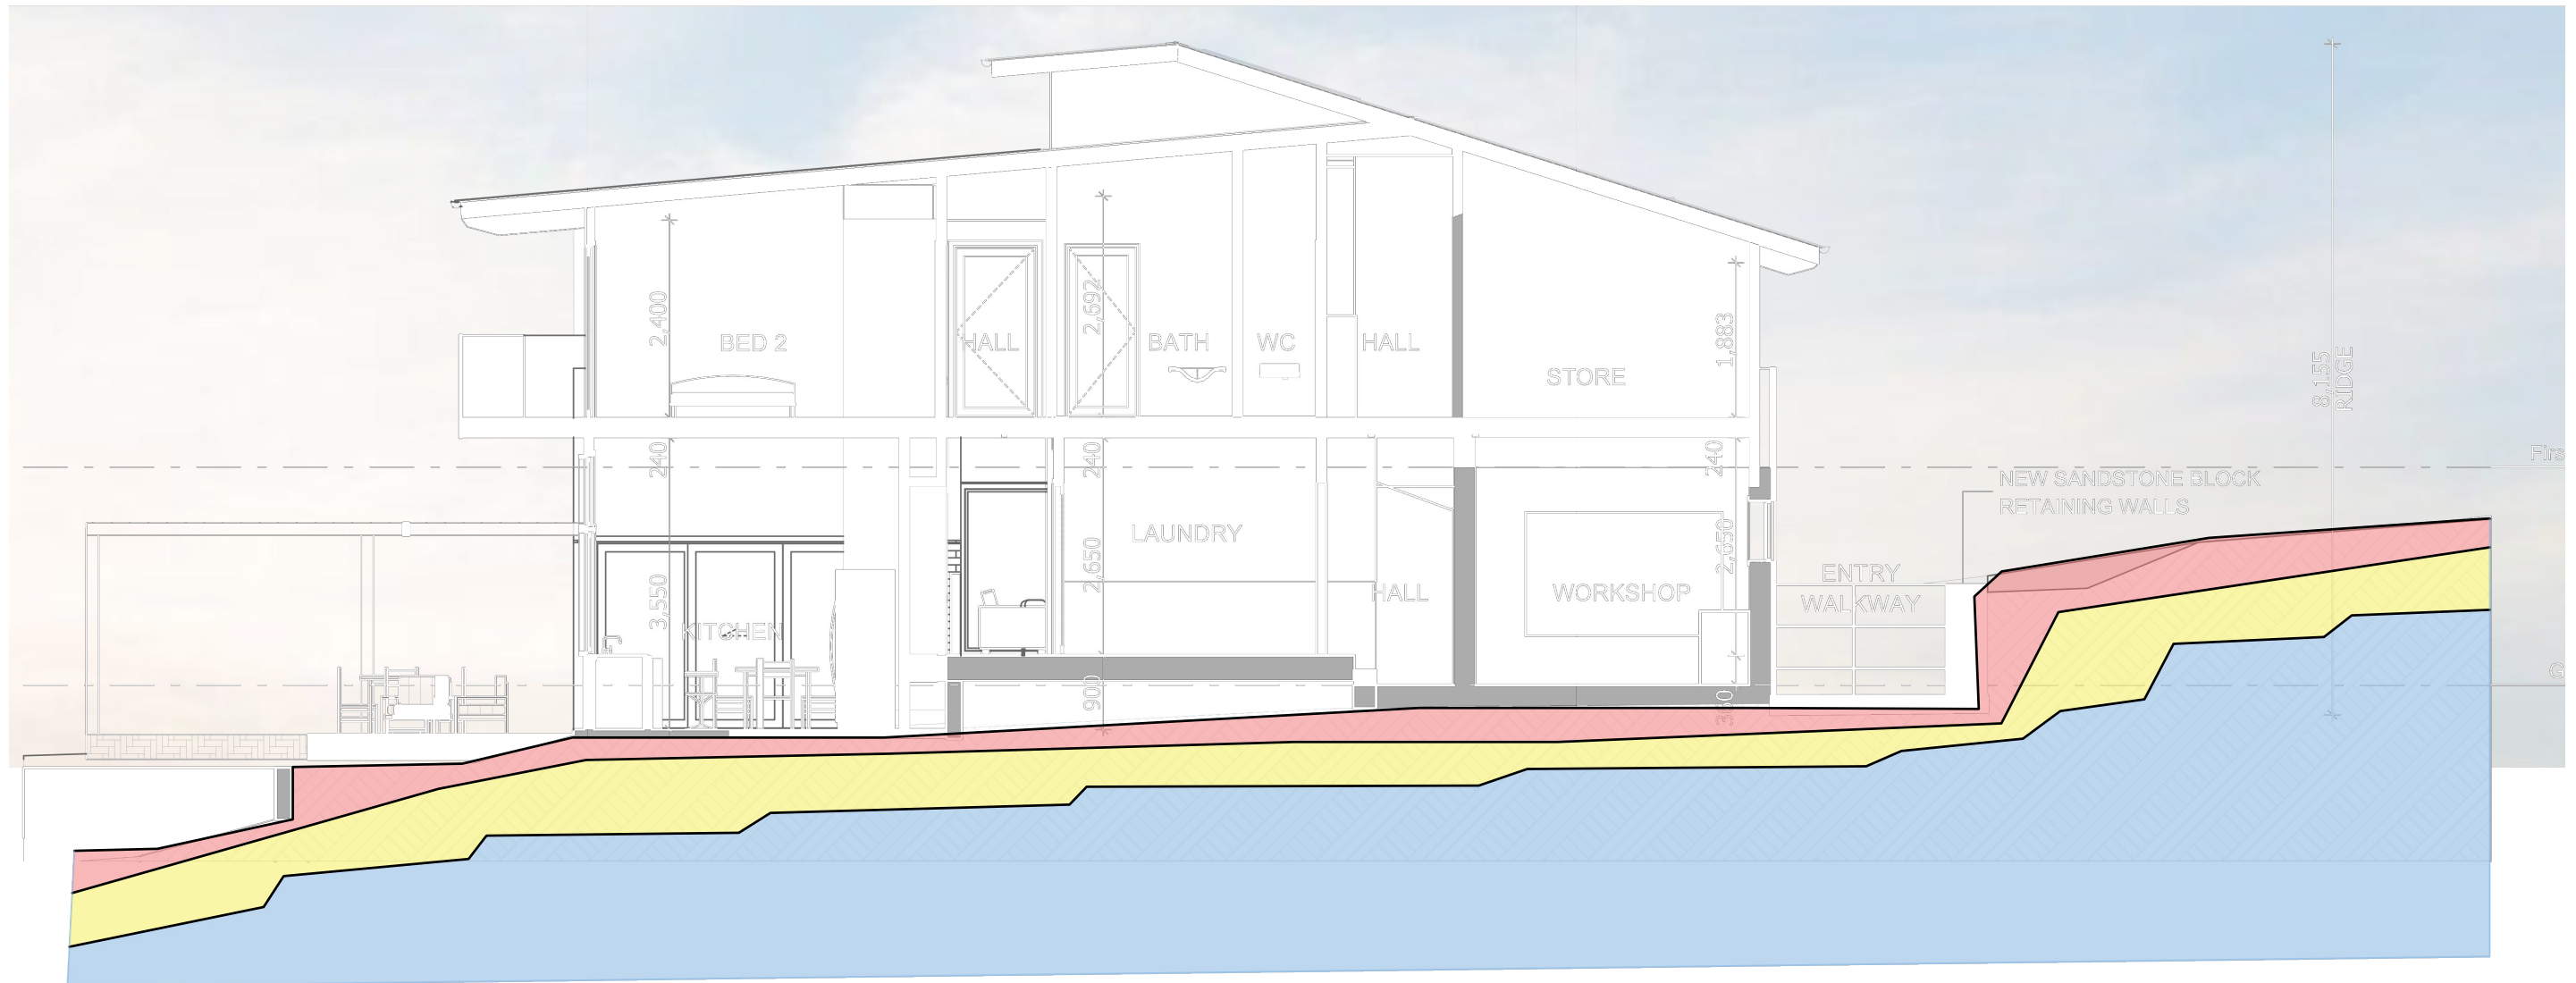
INFERRED GEOLOGICAL SECTION

INTERPRETED SUBSURFACE SECTION ONLY.
ACTUAL GROUND CONDITIONS MAY VARY.

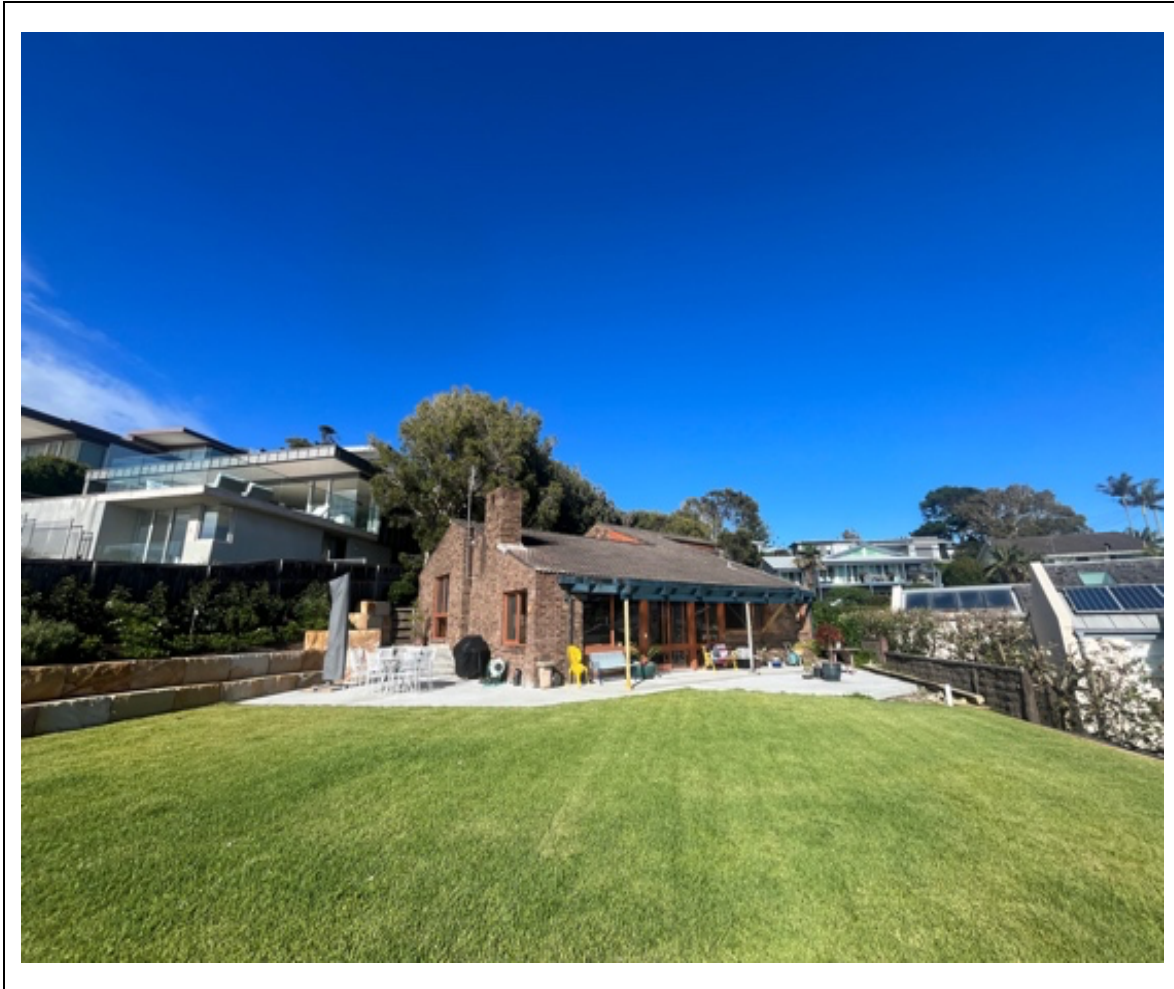
Site photos

A site plan is included in Appendix A. The six photos presented in Appendix B show the general conditions of the site on the day of the site visit conducted by AscentGeo.

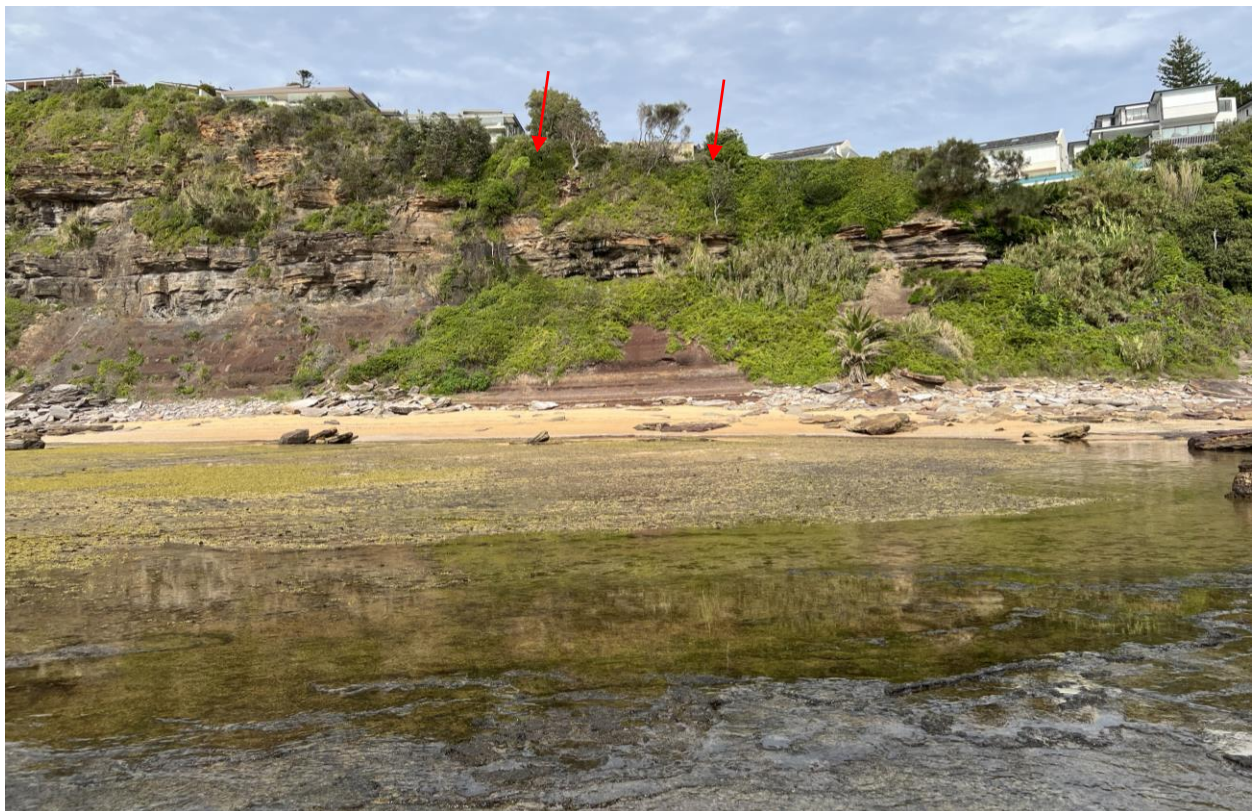
Figure 3: View of cliff face and rock platform seaward of site (approximately between arrows) on 4 January 2024, facing west

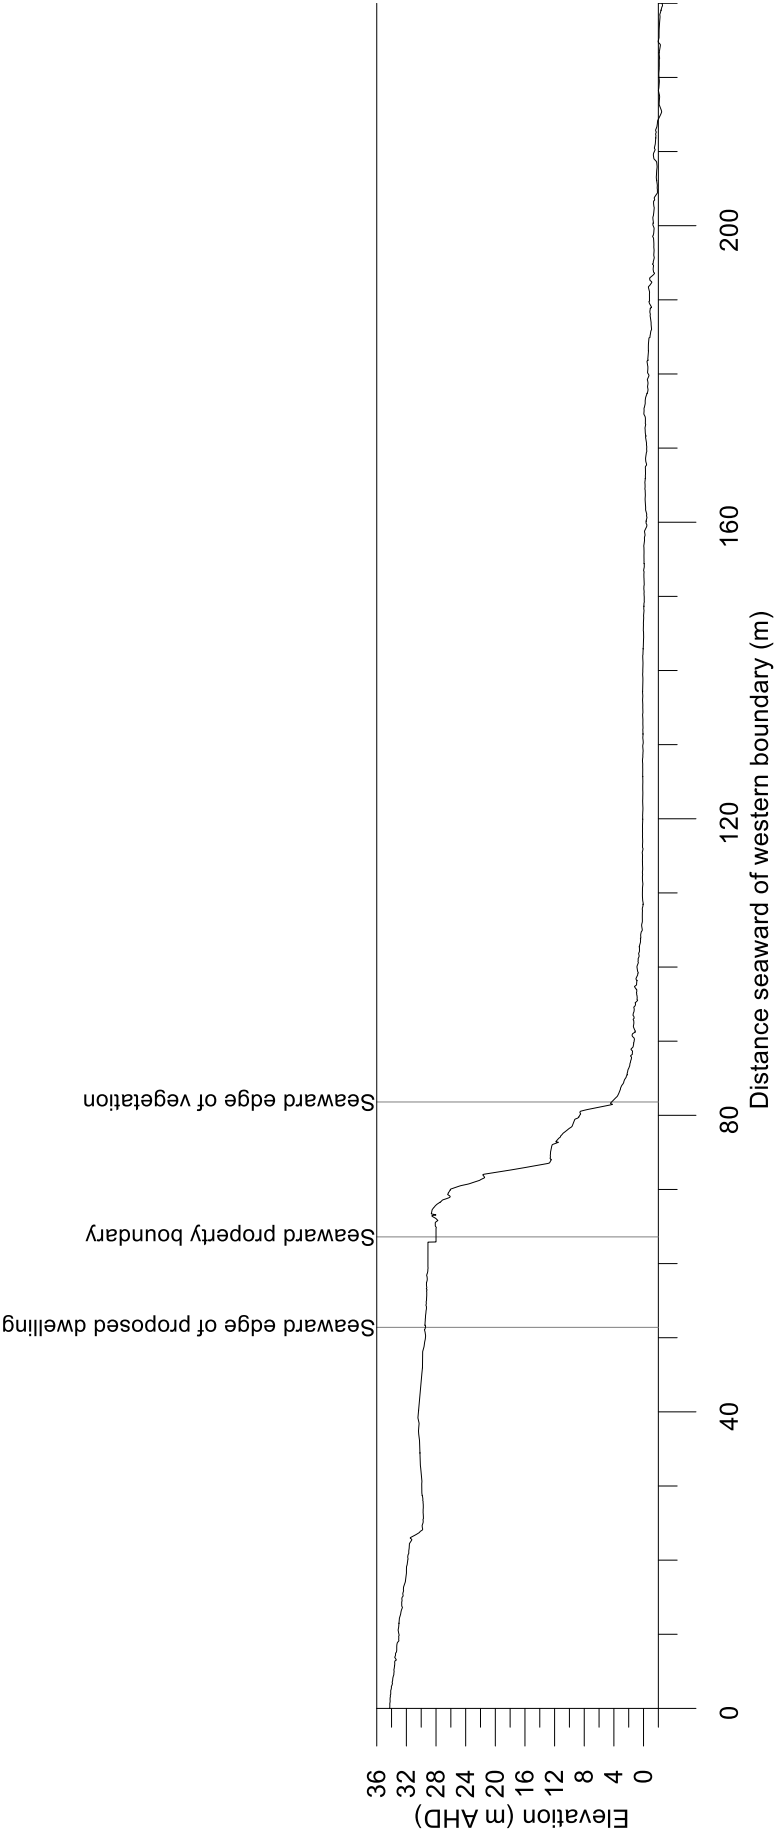
Figure 4: Section A through site and adjacent cliff and down to rock platform and offshore
