Report Title: Geotechnical Report 57 Crescent Road, Newport
Report Date: 6/11/24

GEOTECHNICAL INVESTIGATION:

Additions and Alterations and New Garage at 57 Crescent Road, Newport

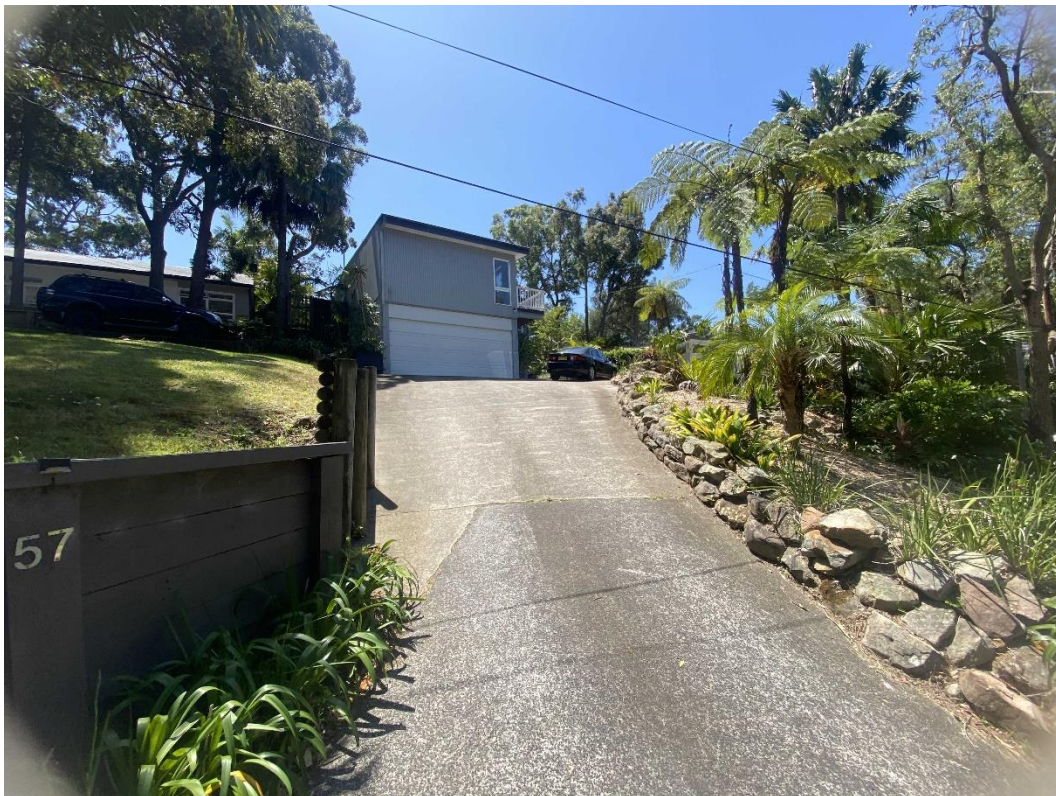
Photo 1

- 2.3** At the road frontage, a concrete driveway runs up the slope past a parking area to a garage underneath the downhill side of the house (Photo 1). In between the road frontage and the house is a moderately sloping fill batter for the parking area. The fill batter is supported by a stable stack rock retaining wall reaching up to $\sim 2.0\text{m}$ high (Photo 2). Two stable brick retaining walls reaching up to $\sim 1.2\text{m}$ terrace the W side of the property adjacent to the house. The part two-storey house is supported on external rendered brick walls (Photo 3). The supporting brick walls of the house show

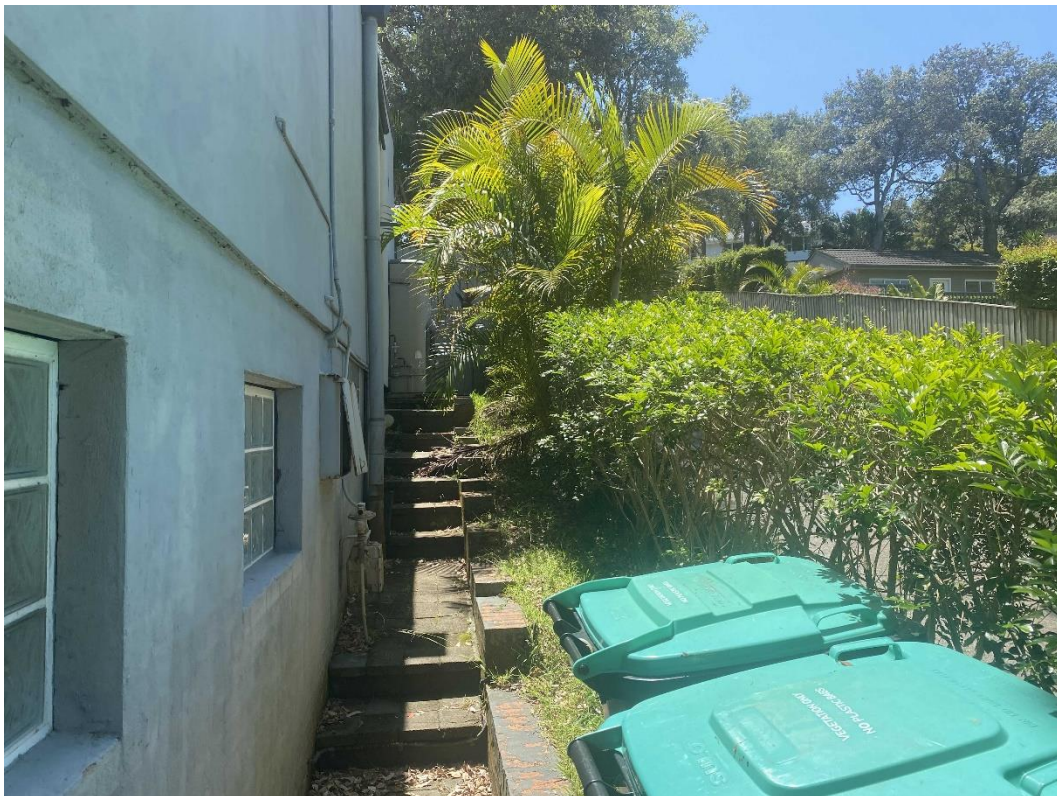
Photo 3

no significant signs of movement. Access to the foundation space of the house was not available at the time of inspection. The cut for a level patio and upper floor of the house is supported by a stable rendered masonry retaining wall reaching ~1.5m high (Photo 4). A gently sloping lawn area extends from the uphill side of this wall to the upper common boundary (Photo 5).

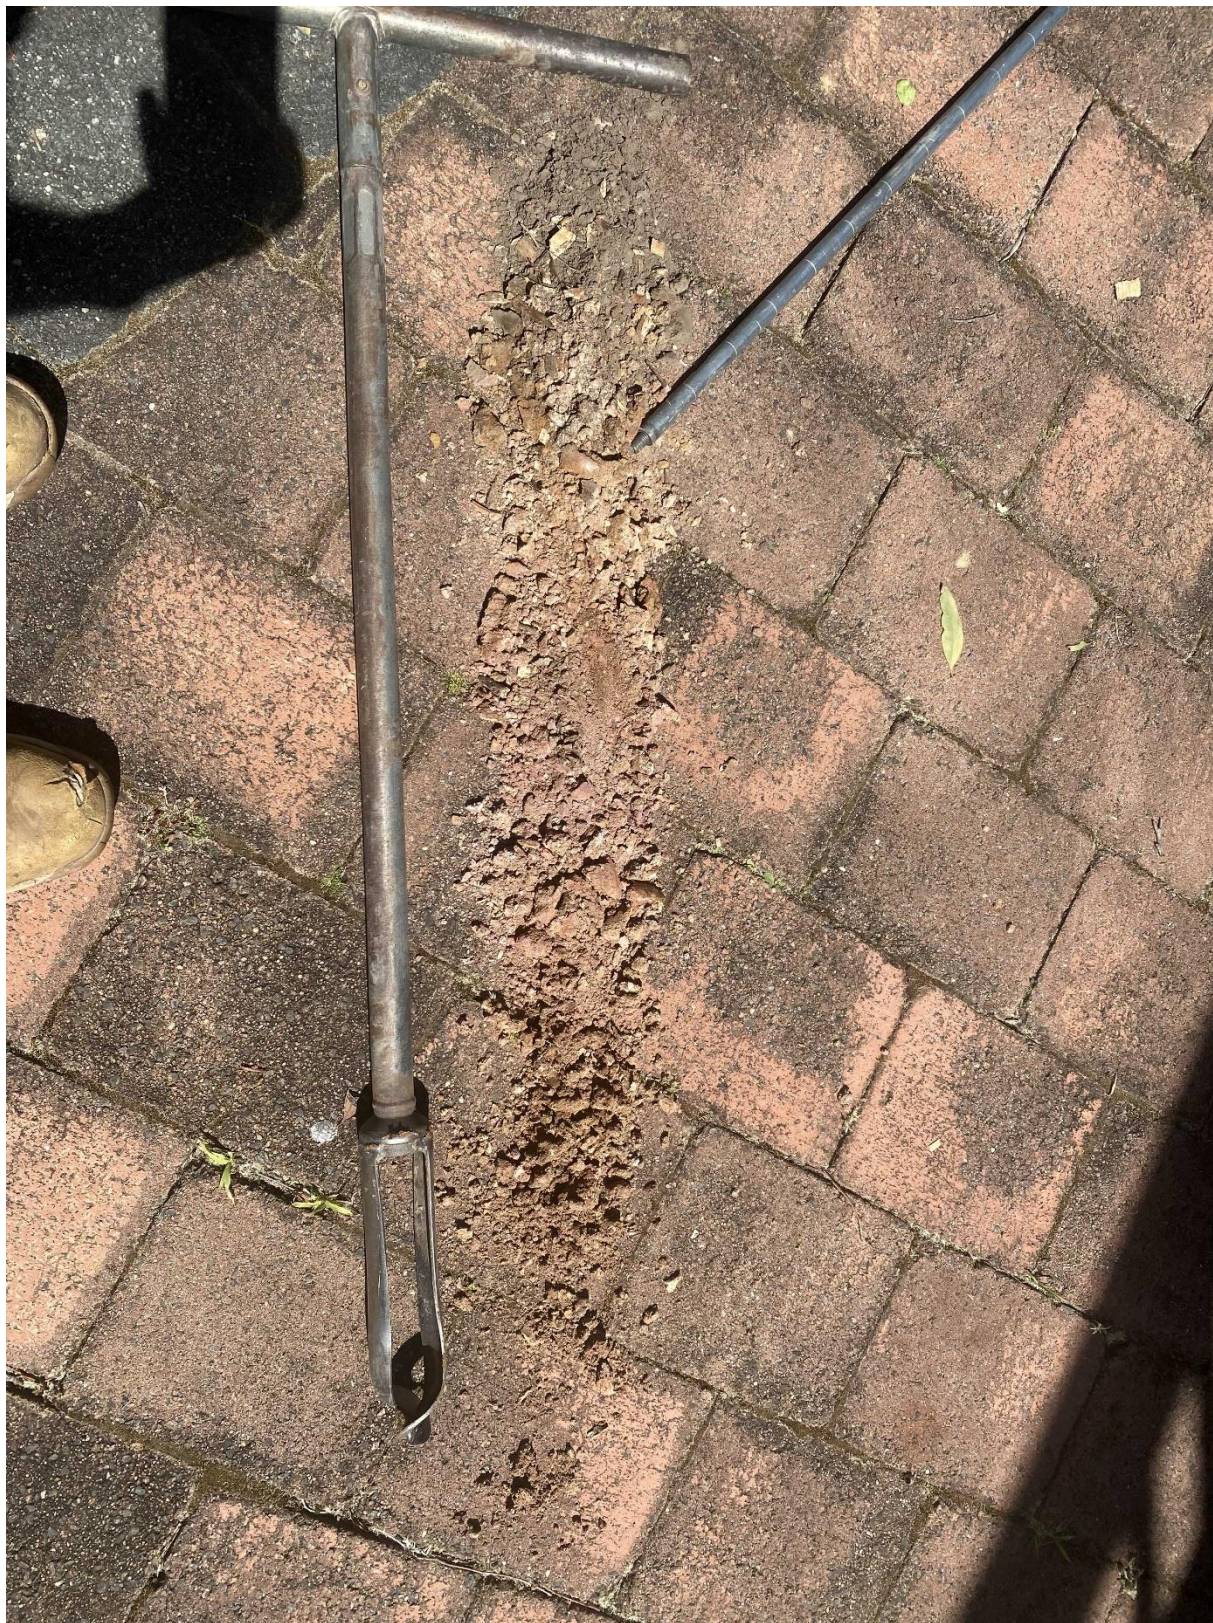
Photo 6 (Top to bottom)

AUGER HOLE 1 (~RL15.0) – AH1 (Photo 6)

Depth (m)	Material Encountered
0.0 to 0.9	FILL , disturbed weathered rock and clay, fine to medium grained, medium dense, trace of rock fragments, dry.

End of test @ 0.9m. Auger refusing on fill. No water table encountered.

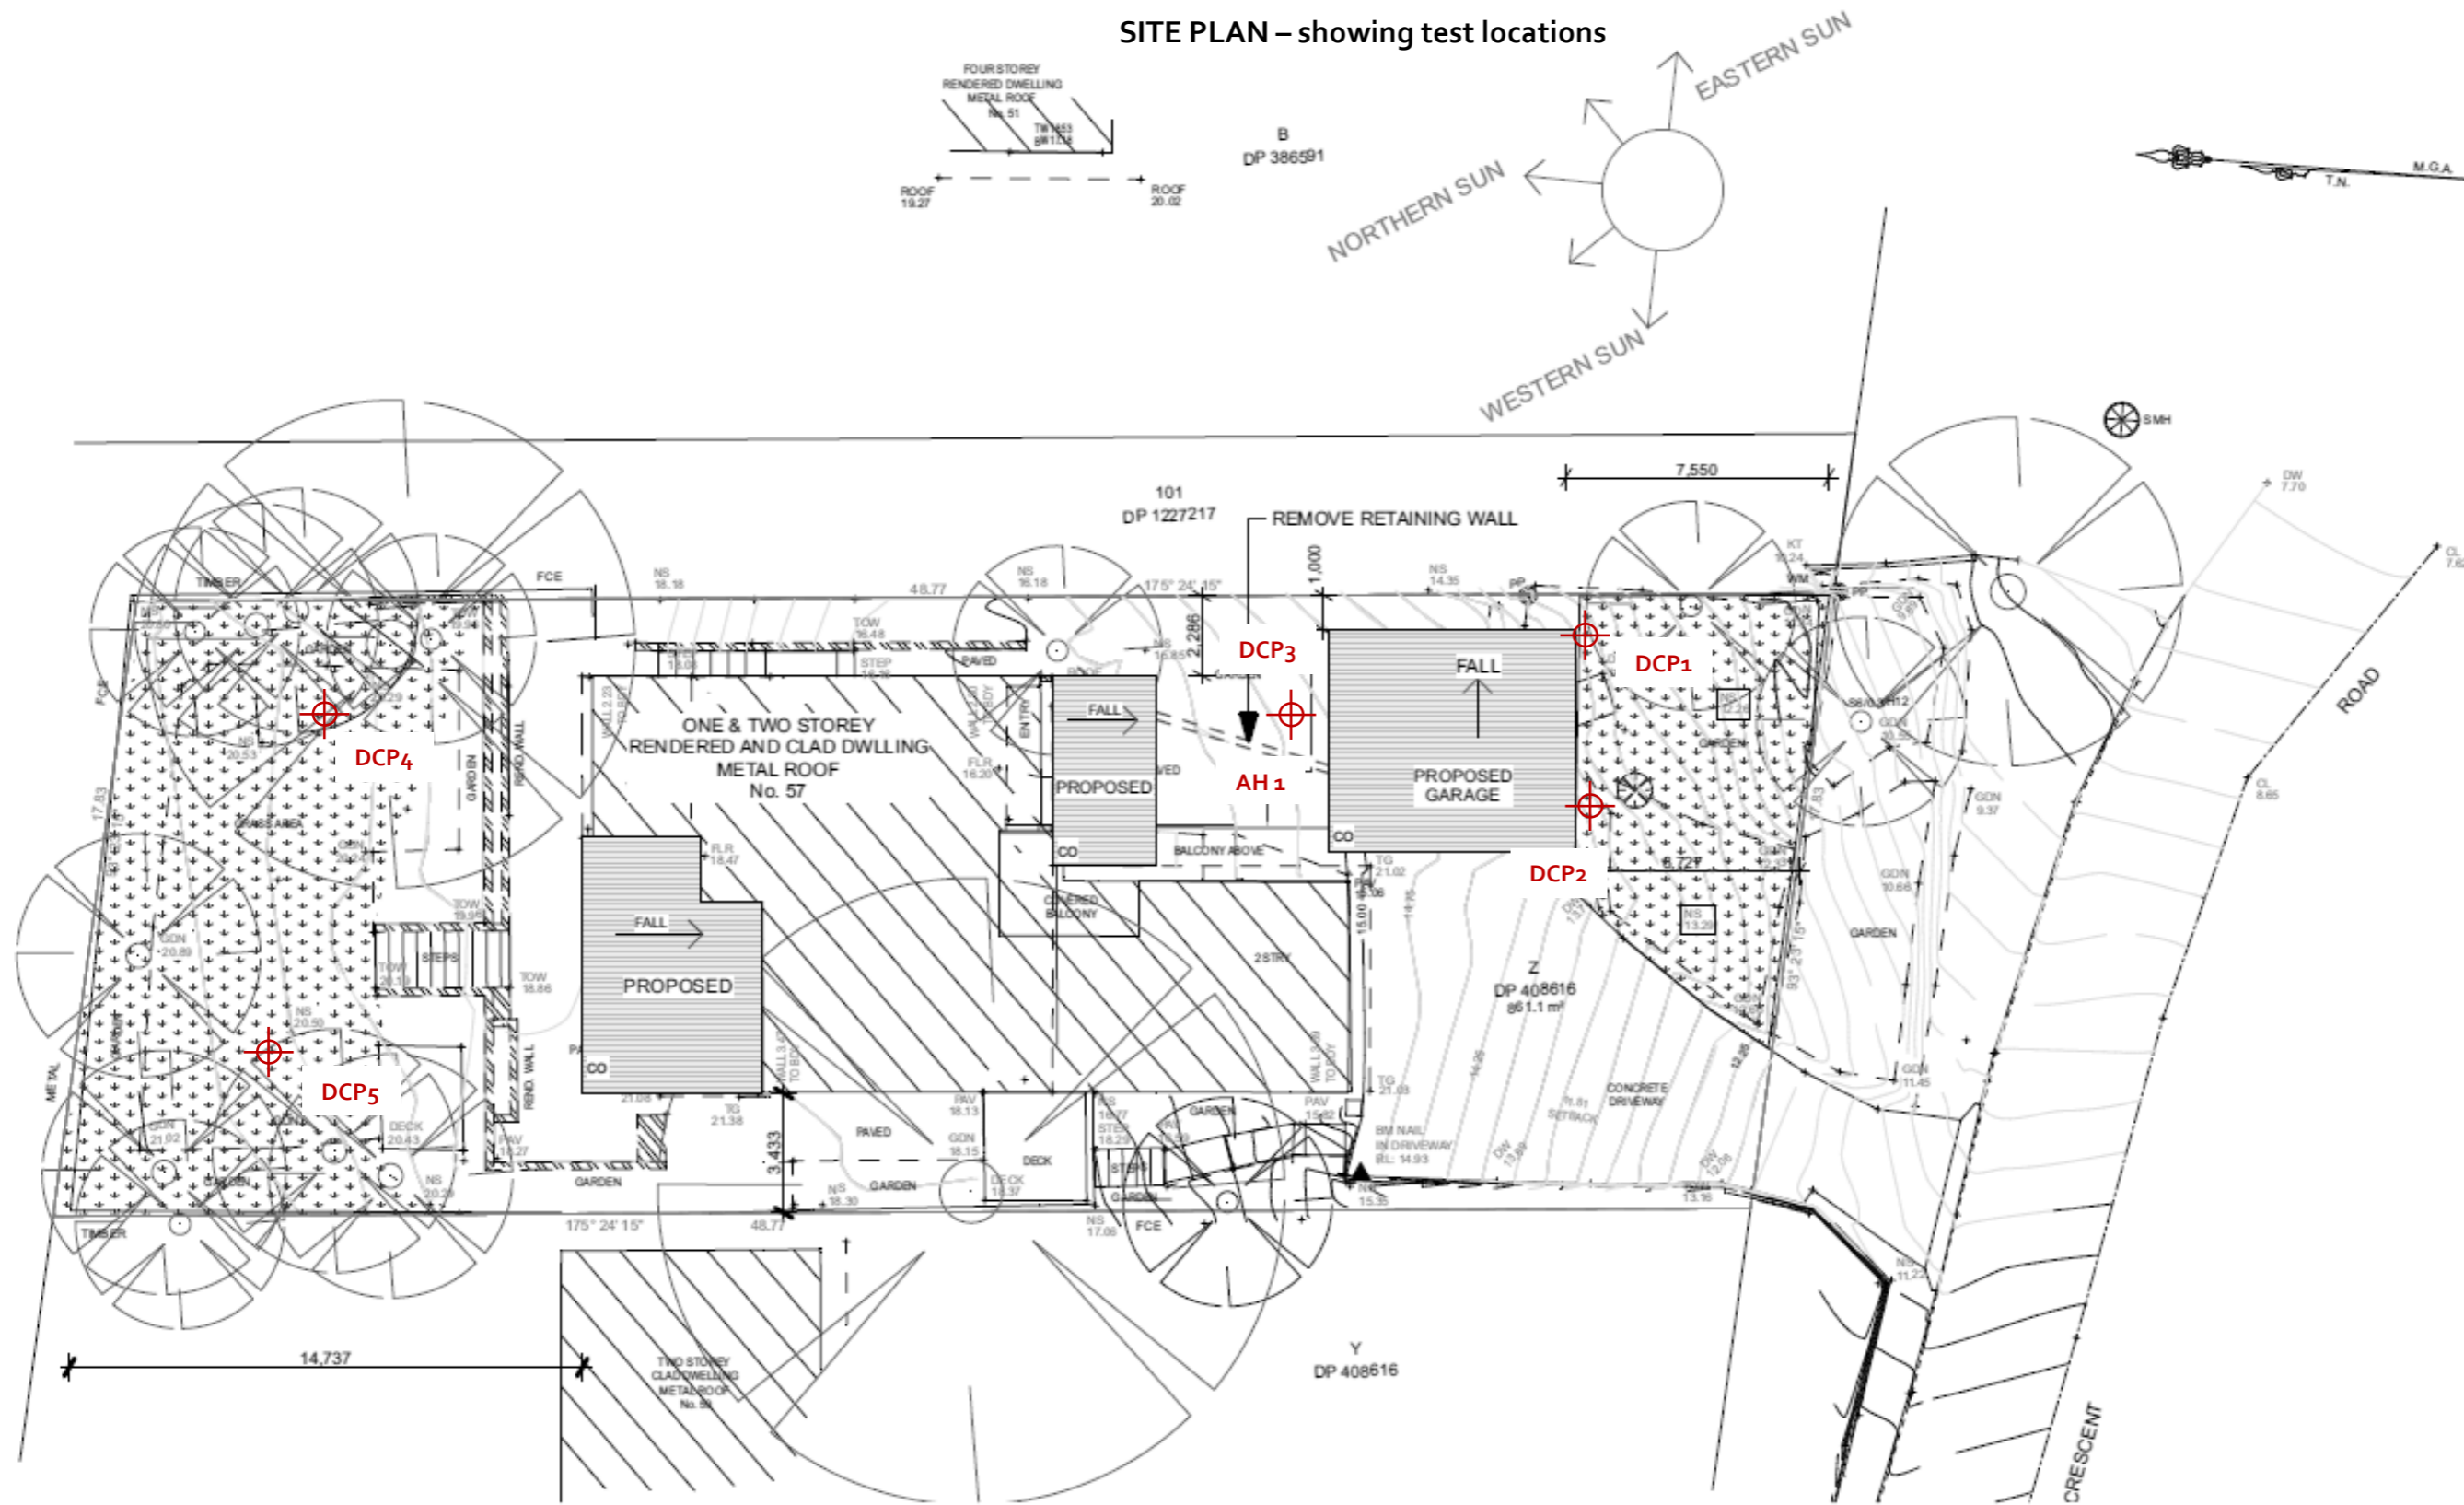
SITE PLAN – showing test locations

One hand Auger Hole (AH) was put down to identify soil materials. Five Dynamic Cone Penetrometer (DCP) tests were put down to determine the relative density of the overlying soil and the depth to weathered rock. The locations of the tests are shown on the site plan attached. It should be noted that a level of caution should be applied when interpreting DCP test results. The test will not pass through hard buried objects so in some instances it can be difficult to determine whether refusal has occurred on an obstruction in the profile or on the natural rock surface. This is not expected to be an issue for the testing on this site. However, excavation and foundation budgets should always allow for the possibility that the interpreted ground conditions in this report vary from those encountered during excavations. See the appended "Important information about your report" for a more comprehensive explanation. The results are as follows:

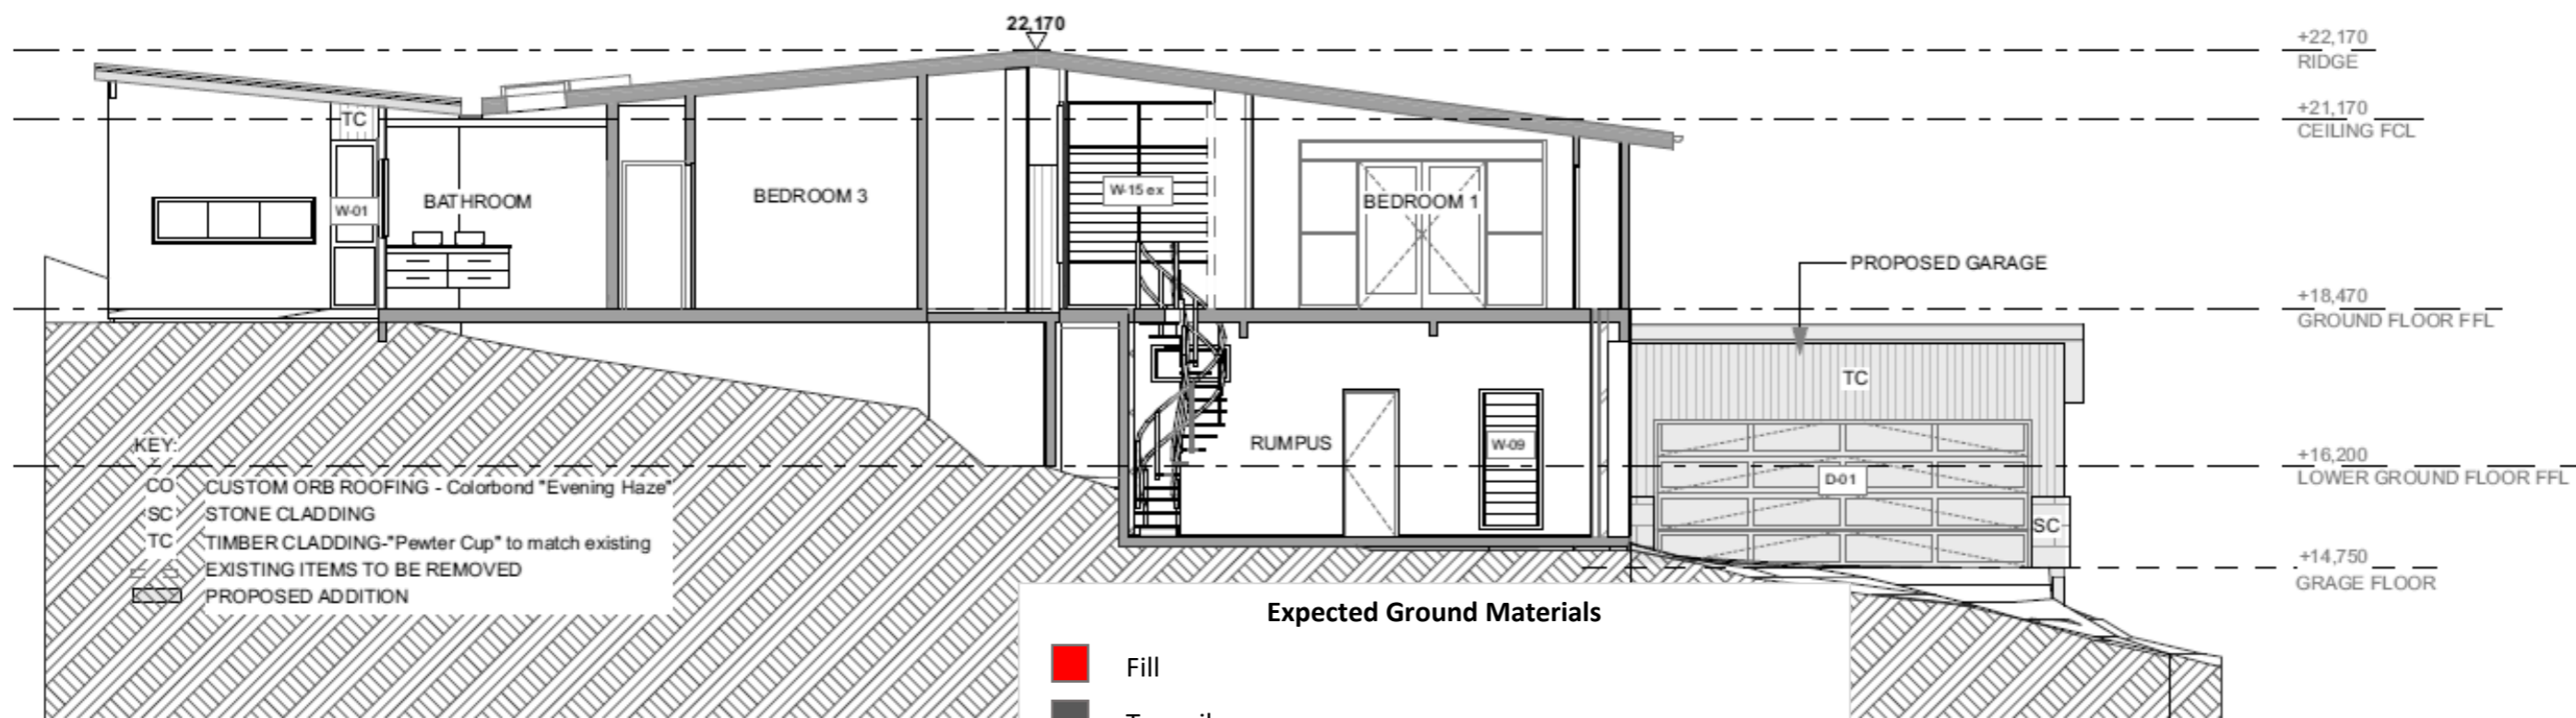
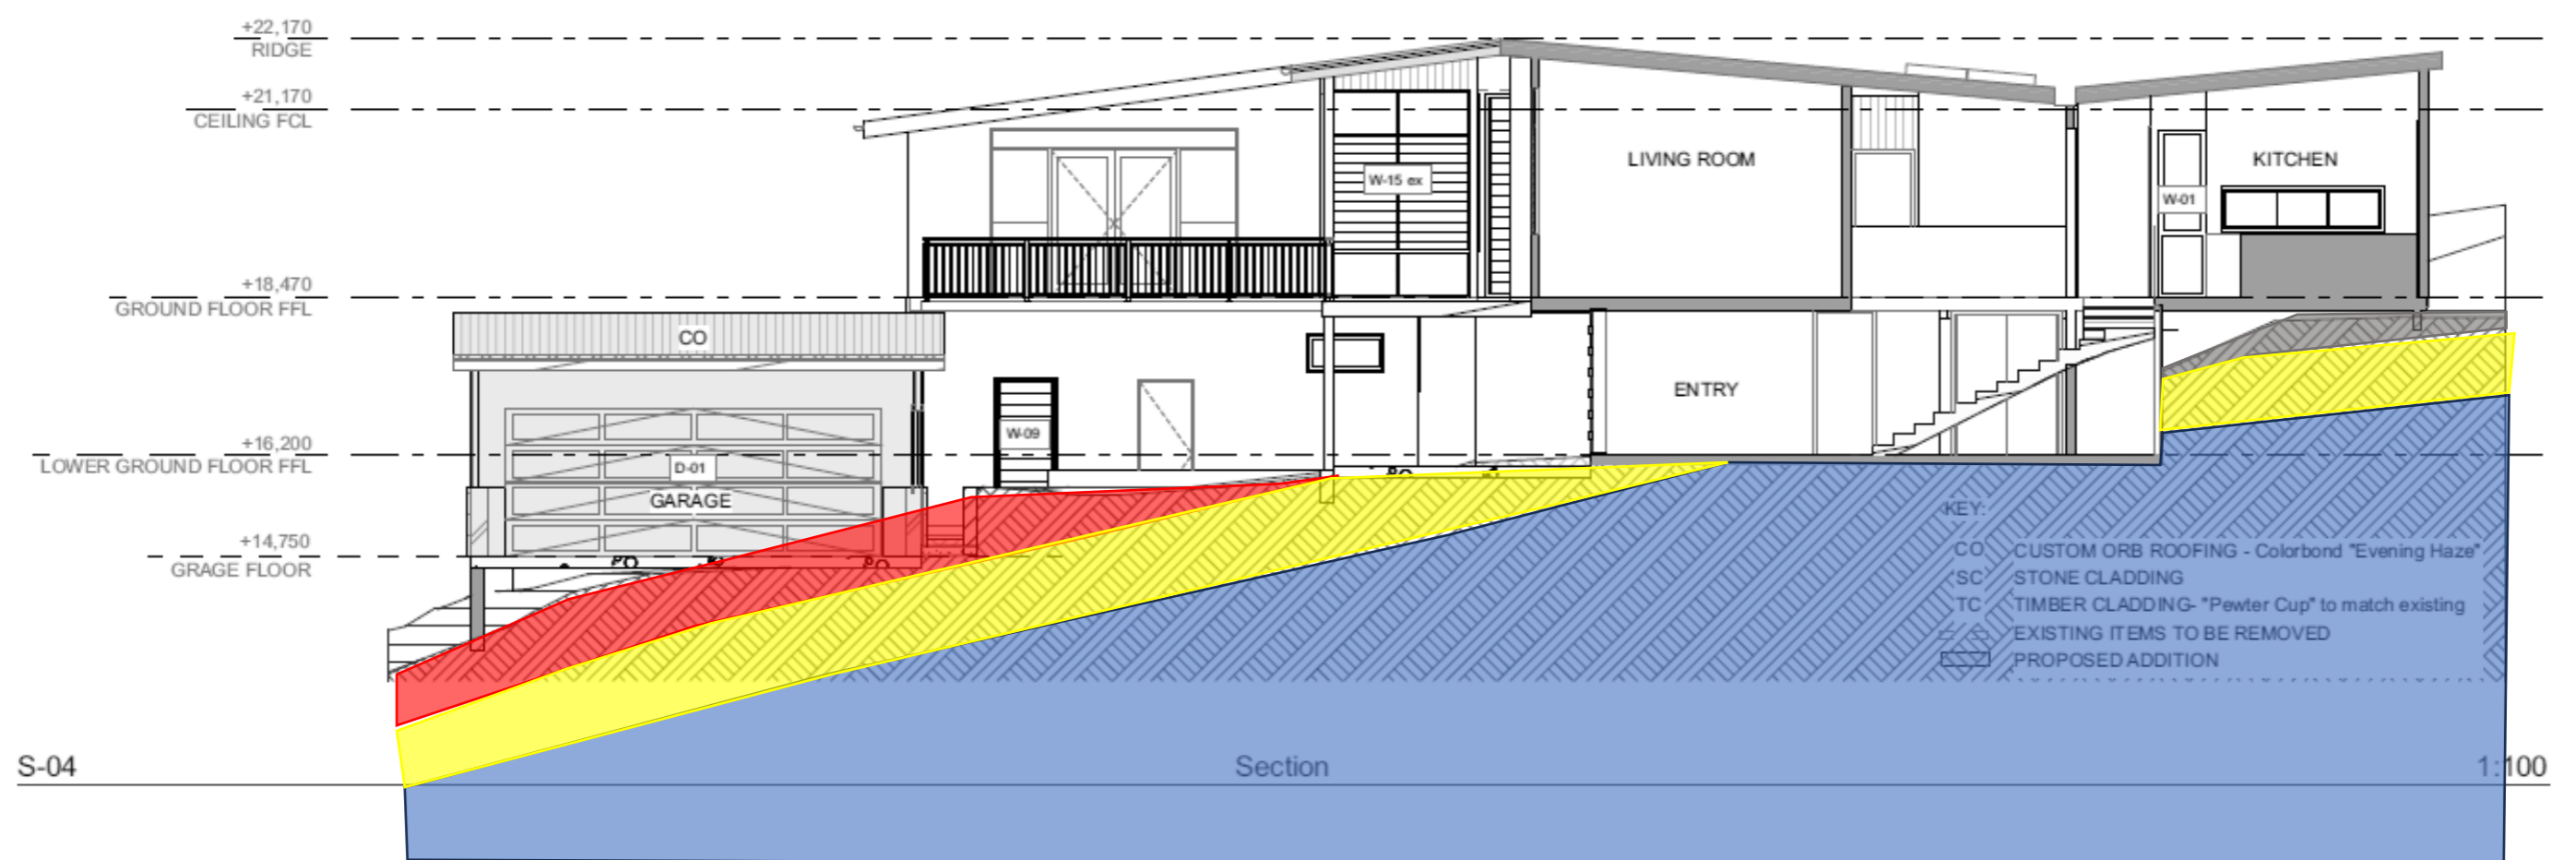
TYPE SECTION – Diagrammatical Interpretation of expected Ground Materials

The slope materials are colluvial at the near surface and residual at depth. In the test locations, the ground materials consist of soils and clays. Fill has been placed in the location of the proposed garage to terrace the slope. The clays merge into the underlying weathered rock at depths of between ~1.2m to ~1.8m below the current surface. The weathered zone is interpreted to be Extremely Low Strength Shale. See Type Section attached for a diagrammatical representation of the expected ground materials.
