Geotechnical Assessment

Project: New Pool and Associated Works
12 Goodwin Road, Newport NSW.

REF: AG 20034
31st March, 2020

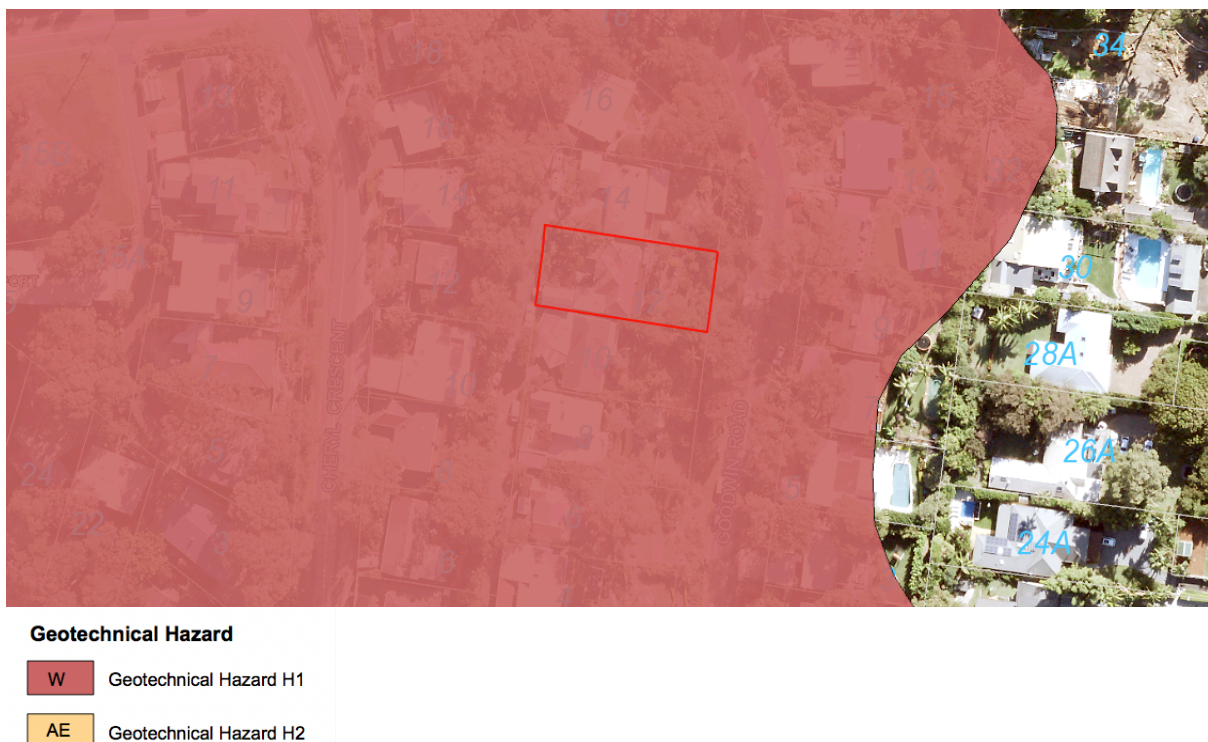
- No evidence of significant soil creep, tension cracks or other indicators of slope instability were identified at the time of our inspection.
- The existing structure displayed no evidence of significant cracking or settlement that could be attributed to slope instability.
- The property is classified '**Geotechnical Hazard H1**' in Northern Beaches Council PLEP Geotechnical Hazard Map (PLEP Geotechnical Hazard Map **Image 2** below).

Image 2: 12 Goodwin Road, Newport NSW – **Geotechnical Hazard Map**– Red polygon (PLEP 2014)

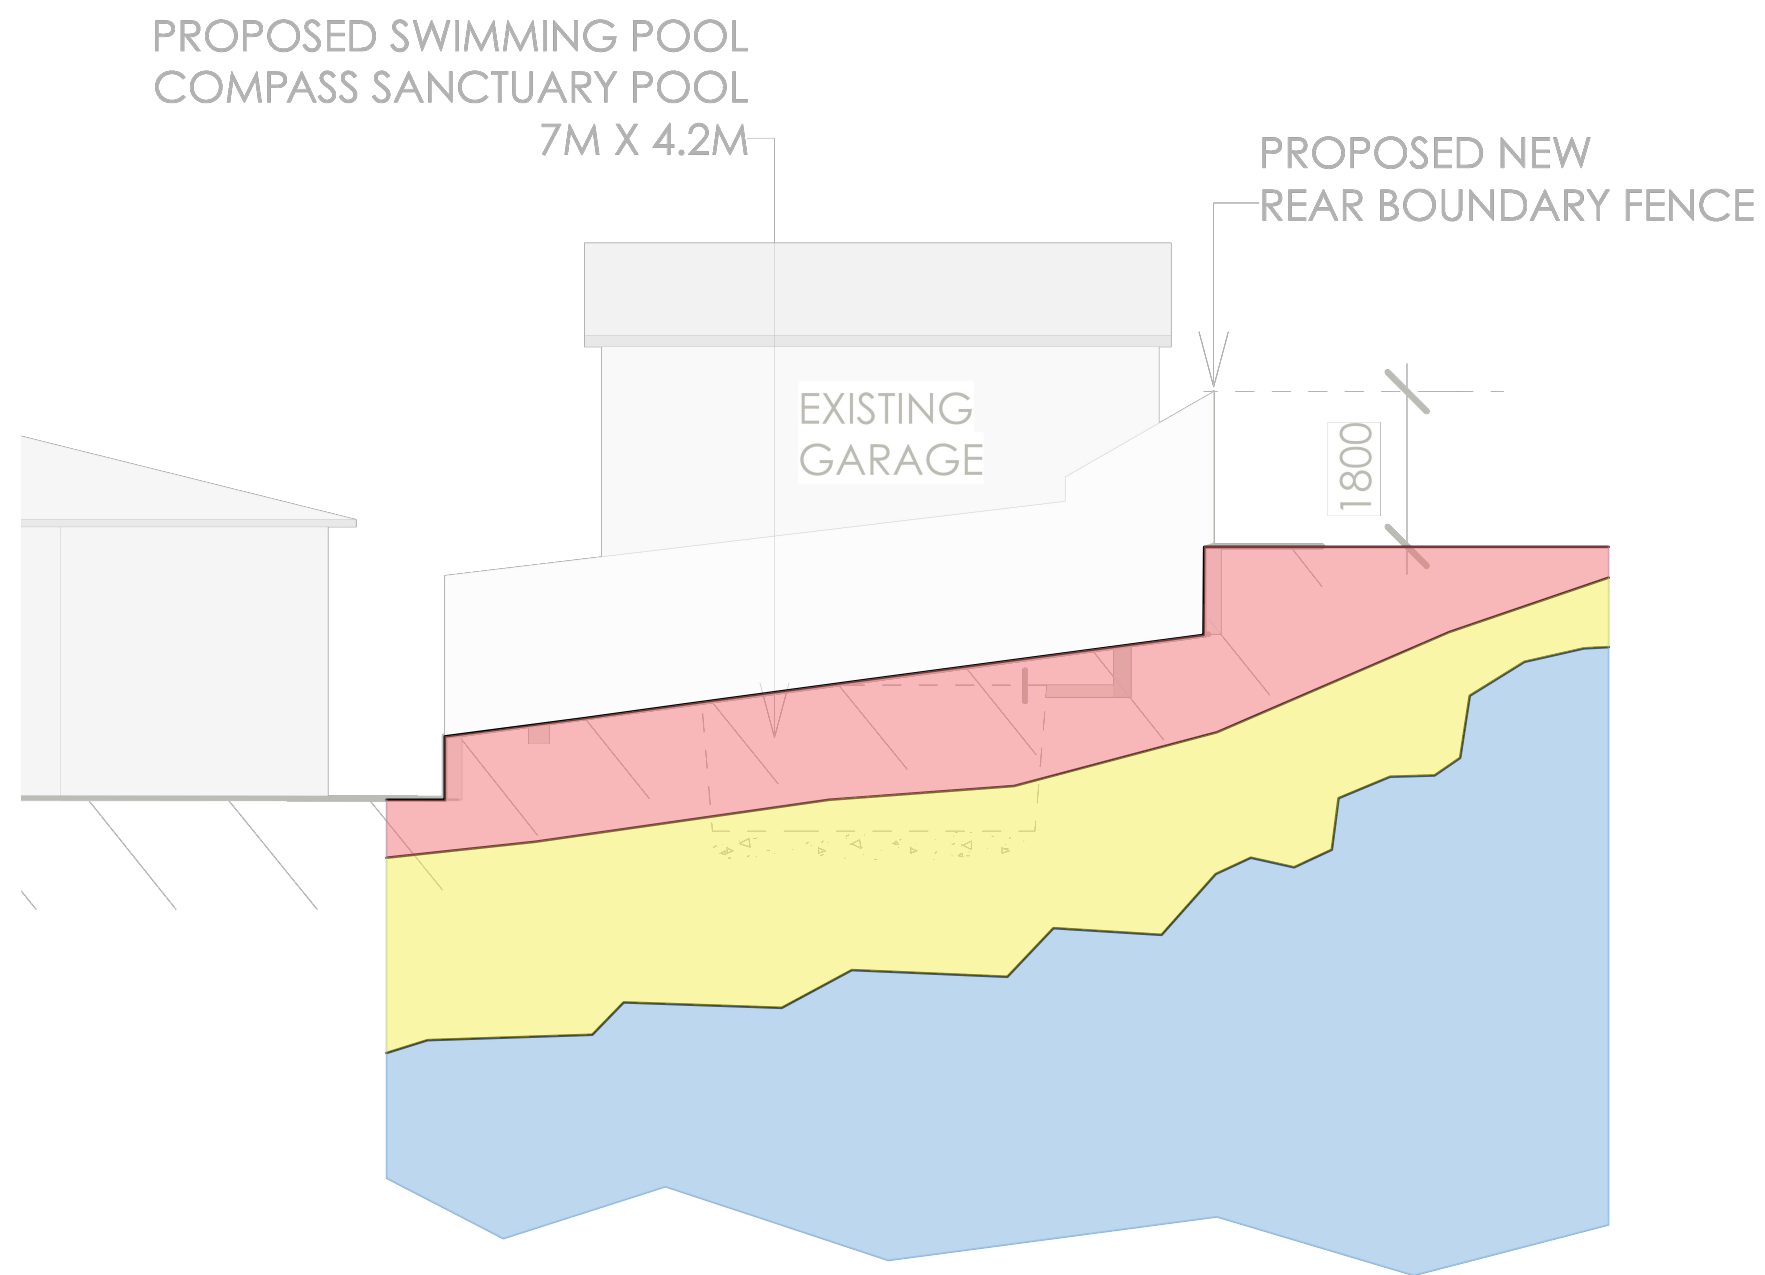
INFERRED GEOLOGICAL SECTION
SCALE NTS

The slope across the subject site has an average gradient of ~20 degrees. The soil profile is interpreted to be comprised of deep uncontrolled fill and sandy topsoil, with clayey sands and clays overlying weathered shale and sandstone bedrock at depths between 3550mm to 4100mm across the site of proposed works. The likelihood of the slope failing is assessed as '**UNLIKELY**', the consequences of such a failure are assessed as '**MINOR**'. The risk to property is '**LOW**'. The existing conditions and proposed development are considered to constitute an '**ACCEPTABLE**' risk to life and a '**LOW**' risk to property provided that the recommendations outlined in **Section 3.6** are adhered to.

INTERPRETED SUBSURFACE SECTION ONLY.
ACTUAL GROUND CONDITIONS MAY VARY.
